## Highlands and Islands Enterprise and the funicular Court Cases. Part 2.

### Who was responsible for the failures of the beam?

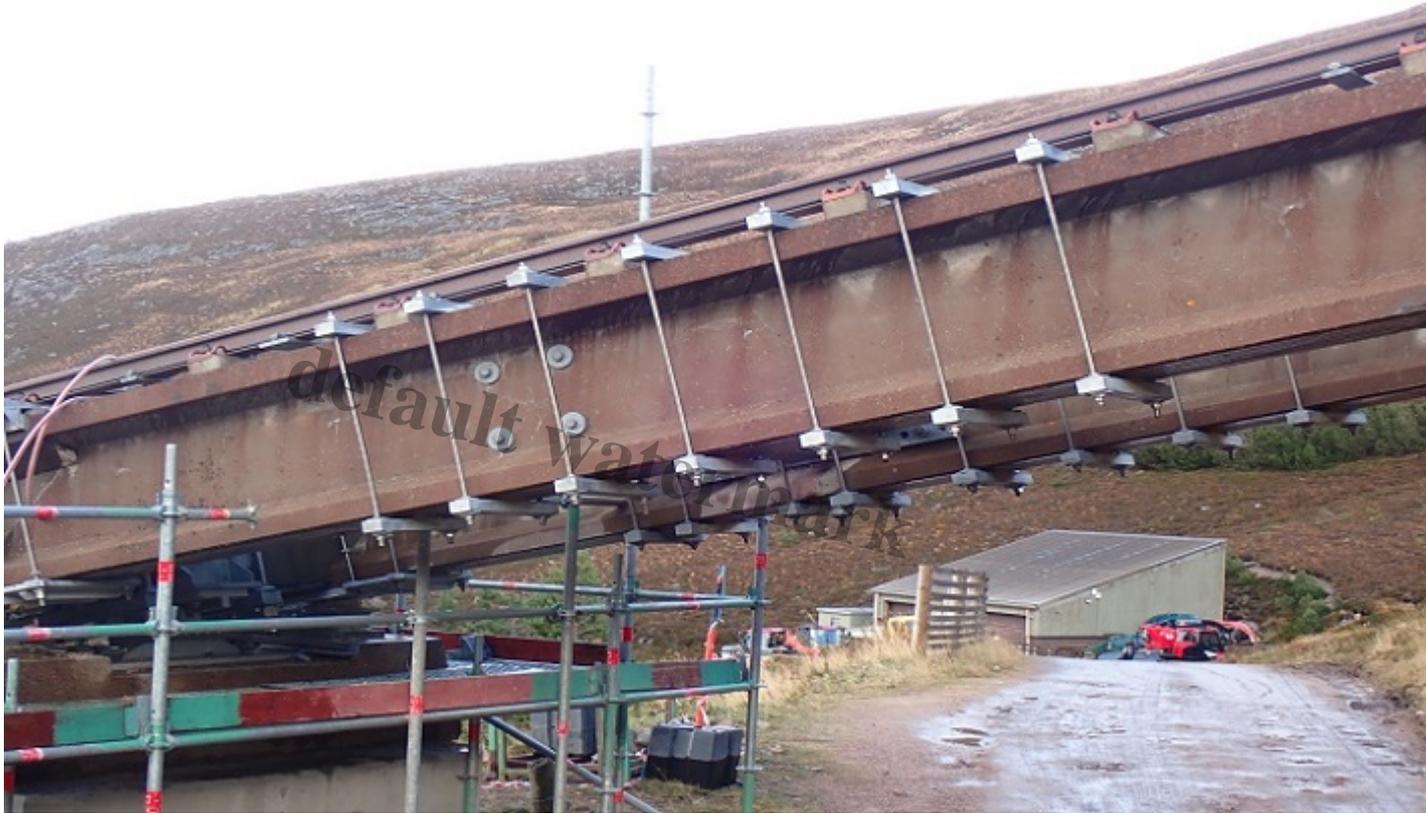
Photo 1. Steel braces reinforcing the beam: there are seven visible on the near beam, eight on the beam behind. What are they all for? Photo credit Parkswatch reader.

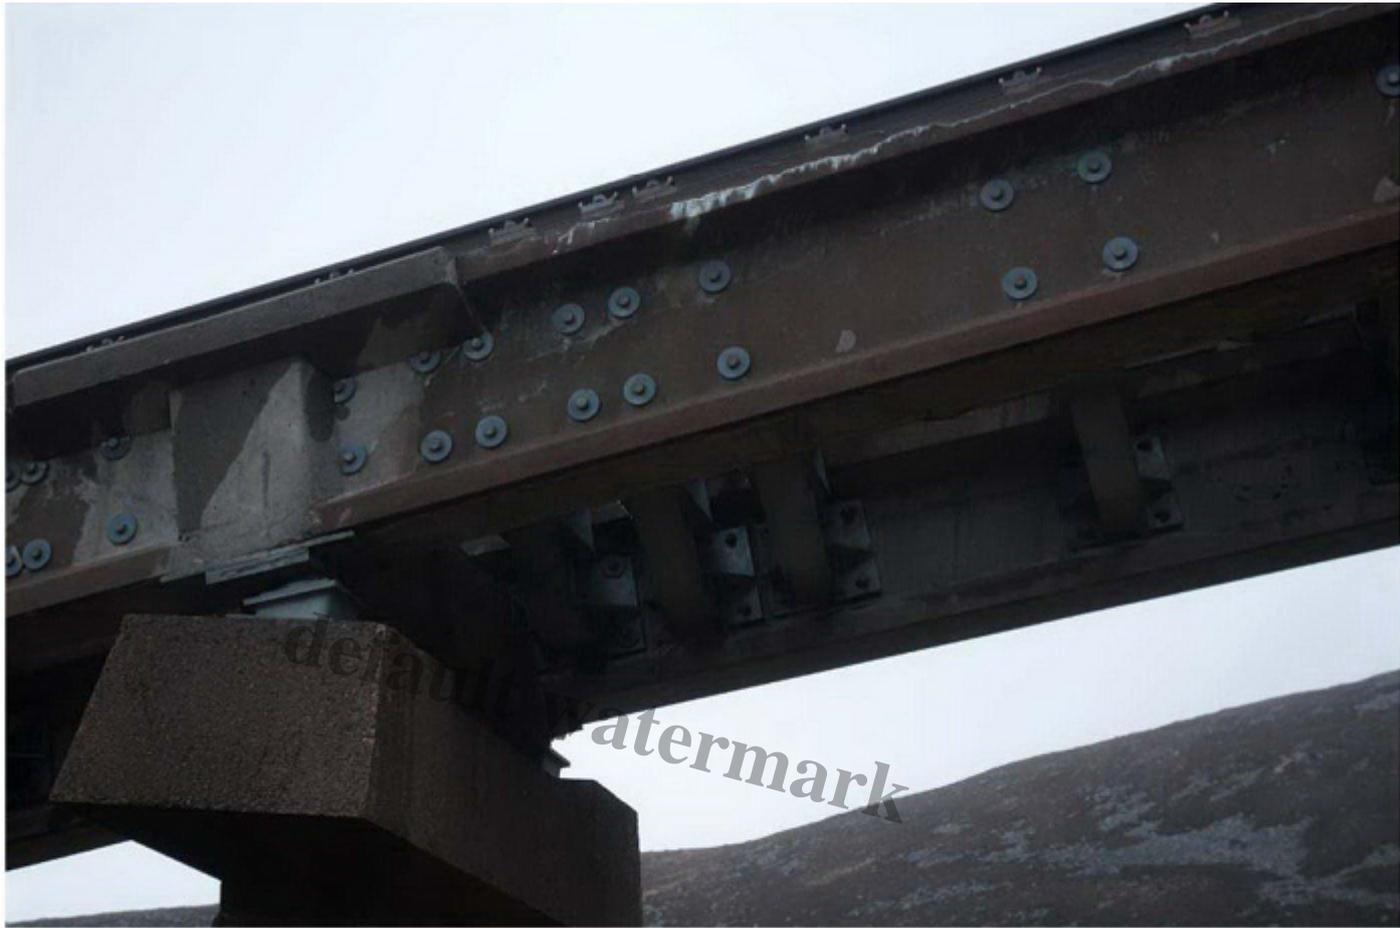
### View of side face of Beam 51/R

*2.2 A crack was clearly seen running along the length of the beam positioned at about mid height of the top flange. It appeared to extend from the lower end up to about mid span. See appendix B for a sketch and photo showing this.*

- The writer has been carrying out annual inspections for the last three years. This feature was observed **for the first time during last year's inspection.***
- The crack is evident on both sides of the beam at the same height and over the same length*

- The crack is particularly evident due to calcite bleed, showing up white. This was seen as significant at the low end, diminishing along the length.

5.1 It was concluded that the observed crack were a developing situation, due to the fact that it was only first noticed in 2016 and that the calcite bleed is more developed at one end.

5.2 It is thought that the problem is a latent defect within the original fabrication of the beams, most likely due to a cold joint within the concrete pour.

5.3 It was concluded that there is no imminent danger of the beams collapsing.

5.4 If left the beams will continue to deteriorate and stability issues would arise.

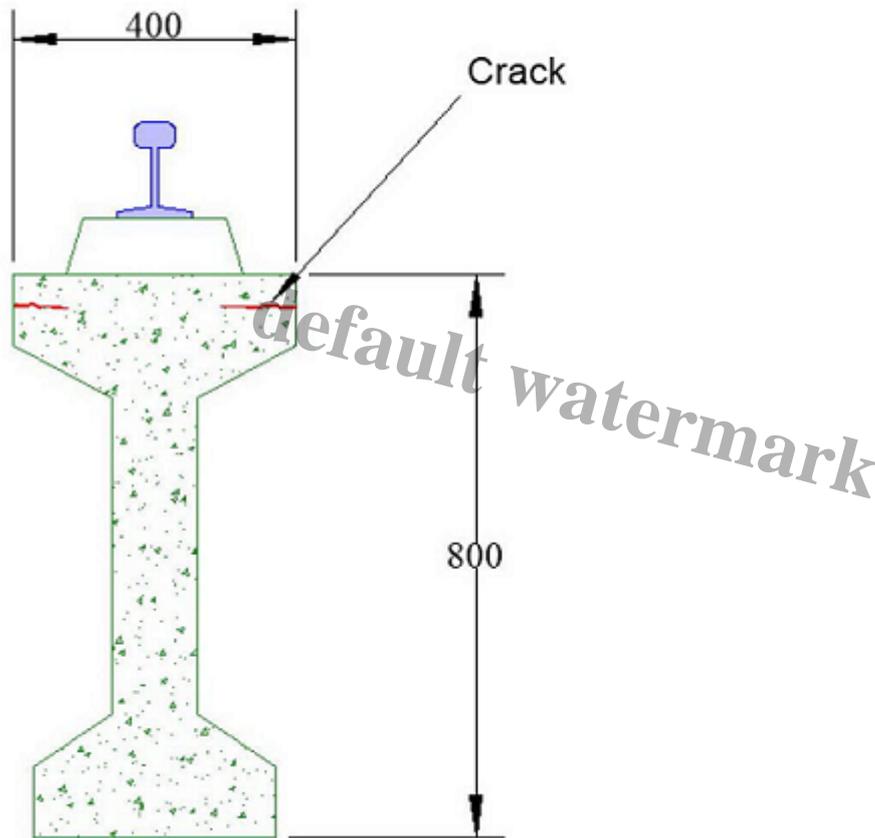
## Appendix B, crack location:

Cross section of rail beams, showing location of cracks in top flange.

In Appendix B shown above the red lines are the cracks in the beam, BUT, as the beam end is hidden by the insitu casting, it is probably only a guess as to how deep the crack actually extended. The crack may have extended right across the top flange meaning it had completely delaminated! These beams are about 18m long and the crack extended up to about half its length; from being noticed in 2016 to almost 9m in 2017!!!

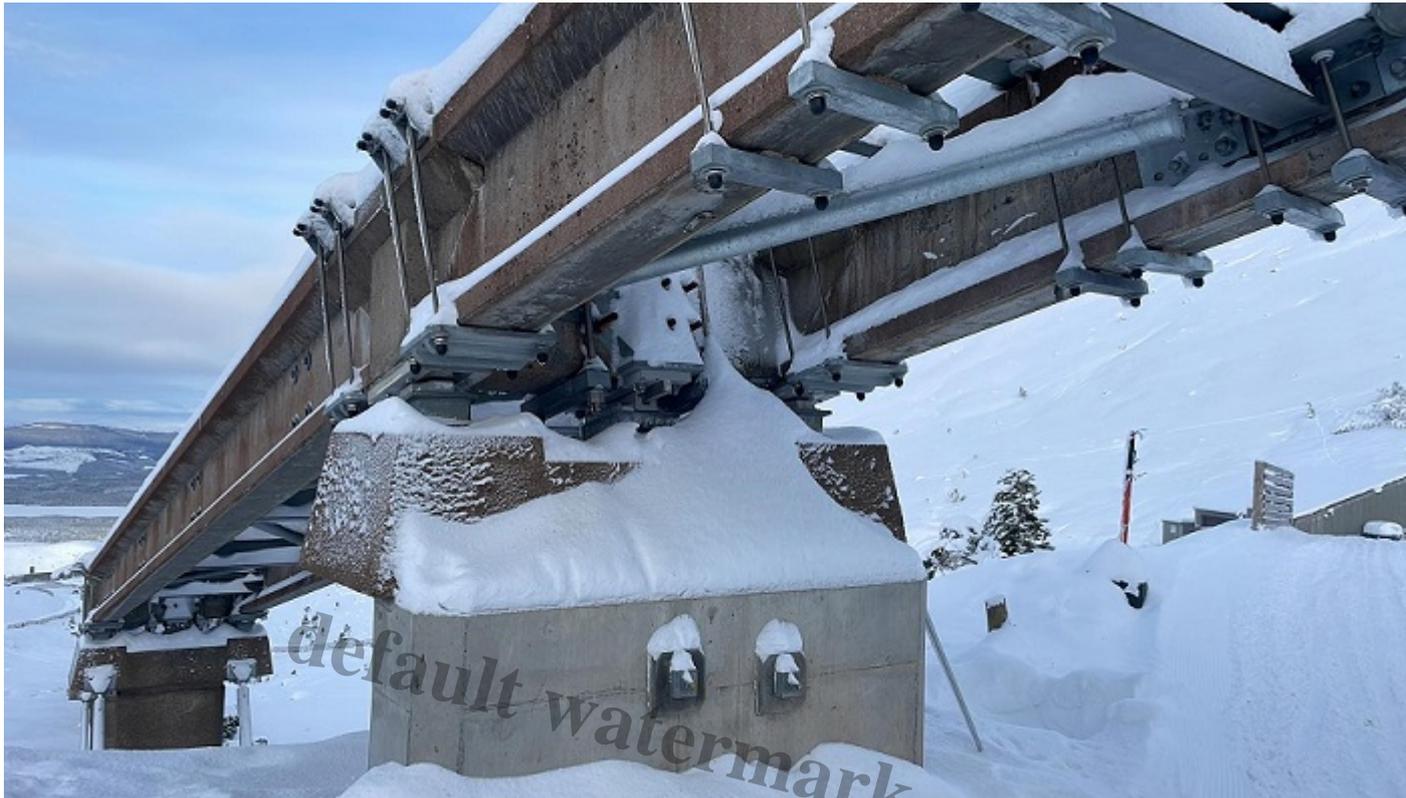
Photo 2 Credit Parkswatch reader

Photo (1) top & (2) are of the same part of the track, but compare the amount of reinforcement on the upper beam in photo (1) to the lower seen in photo (2)! What is wrong with the upper beam? It is obviously in a worse state than the lower!

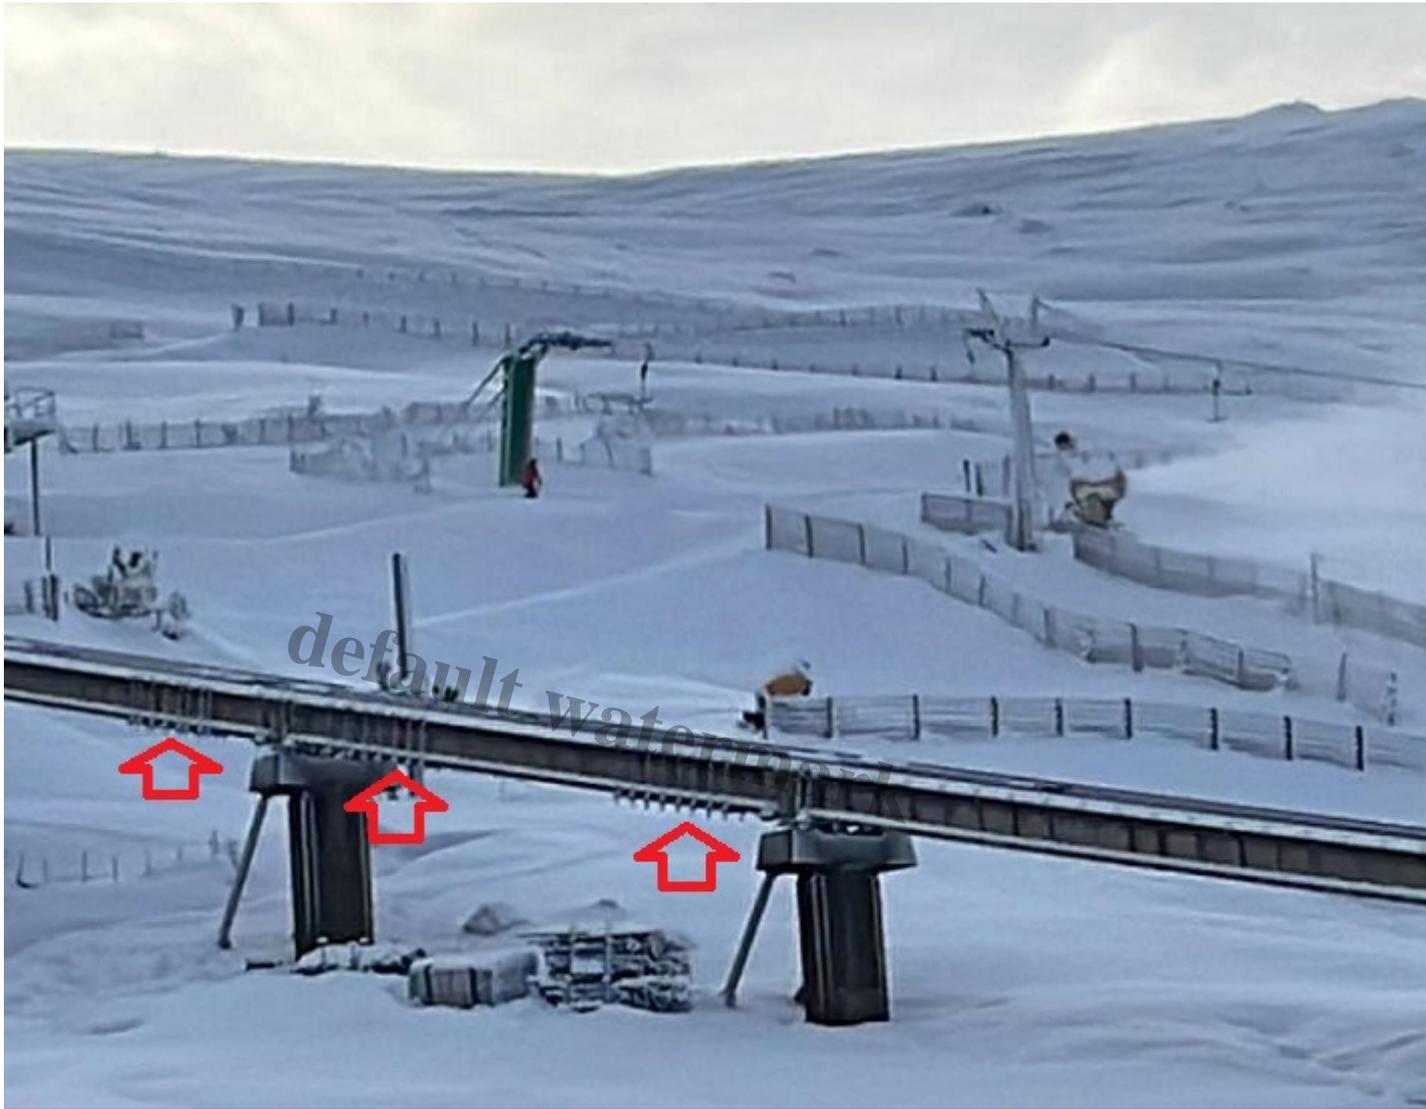
Photo 3 (notice one snow-making machine is in use, a second not). Photo credit parkswatch reader

And then on photos (3) & (4) the reinforcing, as far as can be seen, is mostly at the insitu blocks, **but** look again at photo (3). The upper two beams have quite a substantial amount of reinforcing, again suggesting the beams aren't strong enough. Is all this reinforcing an attempt to strengthen the beams and prevent further delamination? It certainly looks like it.

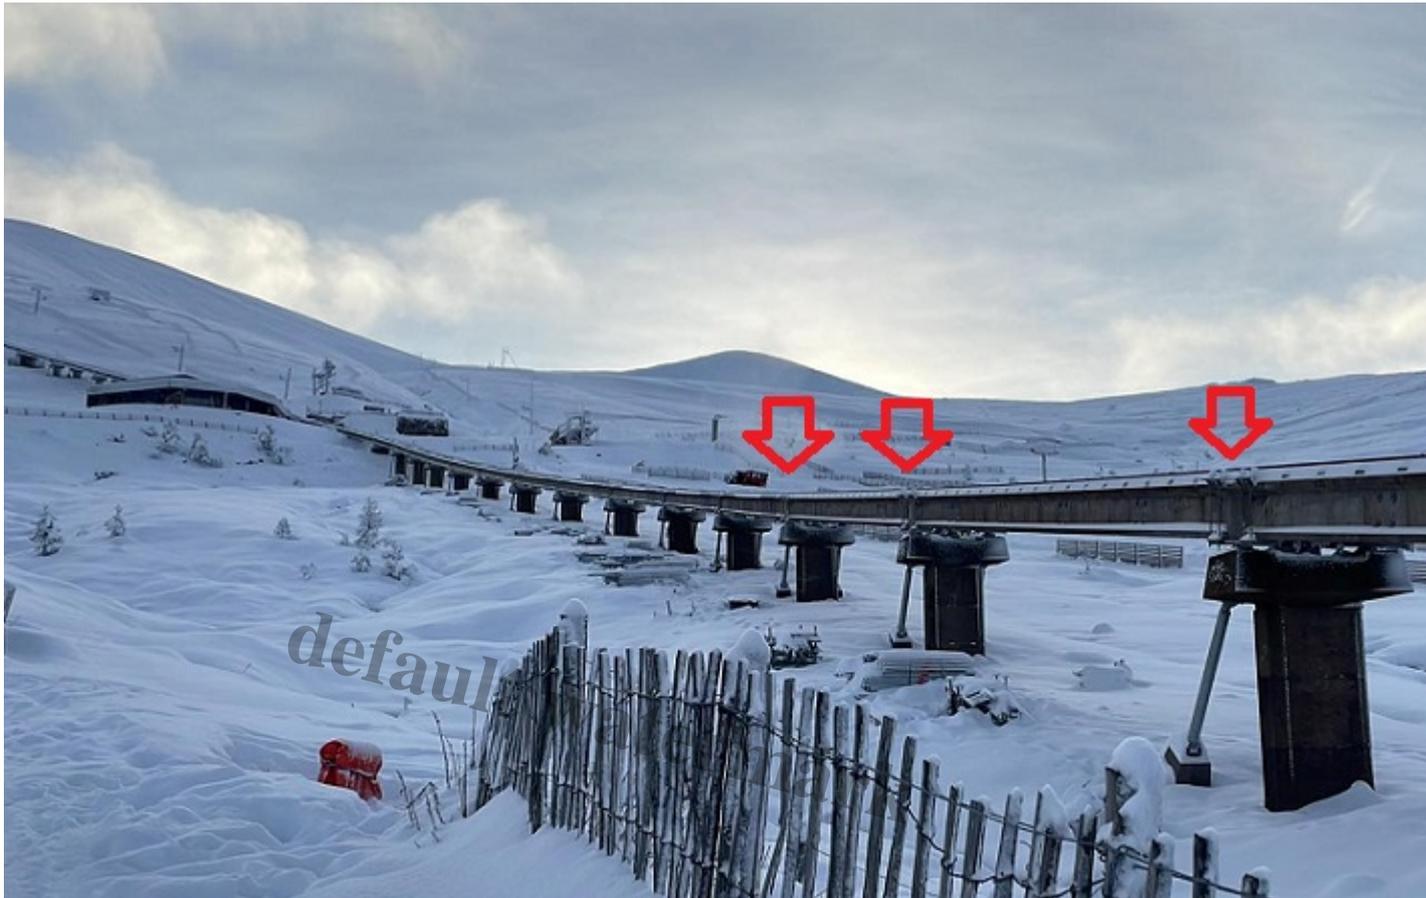
Photo (4) Red Arrows point to reinforcing by insitu blocks. Photo credit parkswatch reader.
