Highlands and Islands Enterprise and the funicular Court Cases. Part 2.

Who was responsible for the failures of the “I” beams?

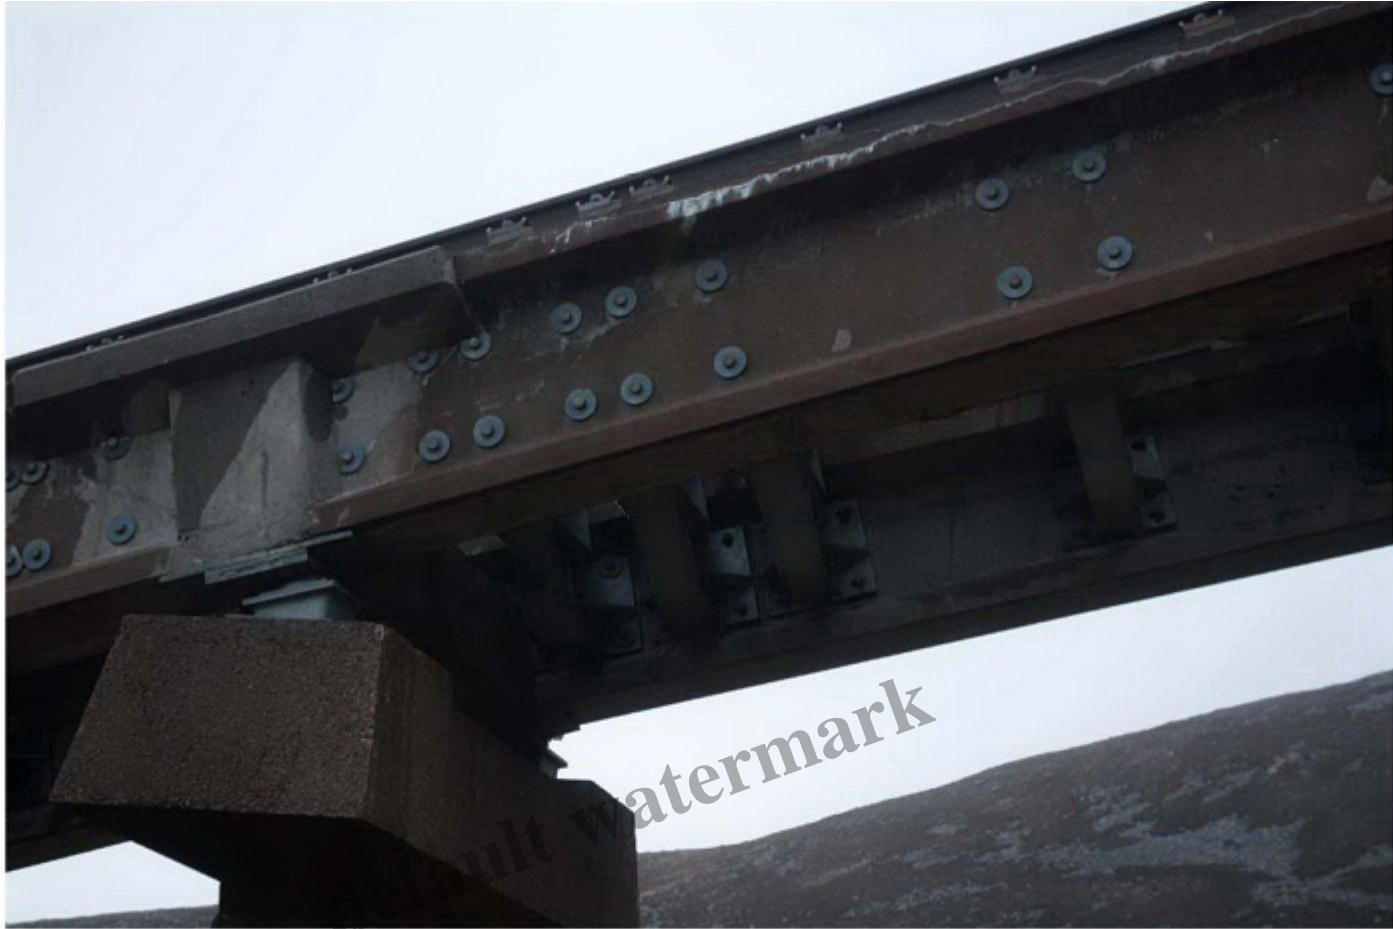
View of side face of Beam 51/R

"2 Field observations:

2.1 The beam in question was observed from ground level and was some 3m above head height.

2.2 A crack was clearly seen running along the length of the beam positioned at about mid height of the top flange. It appeared to extend from the lower end up to about mid span. See appendix B for a sketch and photo showing this.

- The writer has been carrying out annual inspections for the last three years. This feature was observed **for the first time during last year's inspection.***
- The crack is evident on both sides of the beam at the same height and over the same length*

- *The crack is particularly evident due to calcite bleed, showing up white. This was seen as significant at the low end, diminishing along the length.”*

5.1 It was concluded that *the observed crack were a developing situation, due to the fact that it was only first noticed in 2016 and that the calcite bleed is more developed at one end.*

5.2 *It is thought that the problem is a latent defect within the original fabrication of the beams, most likely due to a cold joint within the concrete pour.*

5.3 It was concluded that there is no imminent danger of the beams collapsing.

5.4 *If left the beams will continue to deteriorate and stability issues would arise.*

4.6 Corrosion of the reinforcement would be a long-term problem, which will not occur once the long-term repair has been carried out.

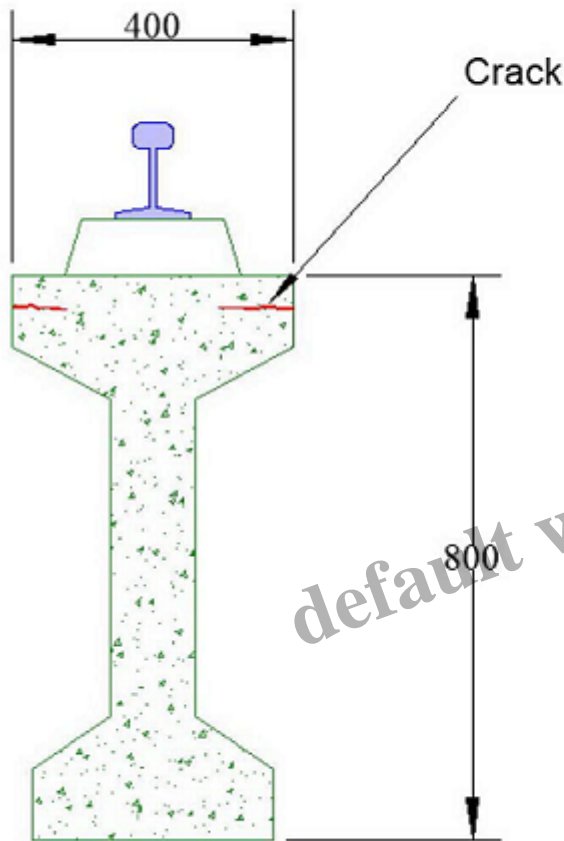
Appendix B, crack location:

Cross section of rail beams, showing location of cracks in top flange.

In Appendix B shown above the red lines are the cracks in the “I” beam, BUT, as the beam end is hidden by the insitu casting, it is probably only a guess as to how deep the crack actually extended. The crack may have extended right across the top flange meaning it had completely delaminated! These beams are about 18m long and the crack extended up to about half its length....9m; from *“being noticed” in 2016* to almost *9m in 2017!!!*

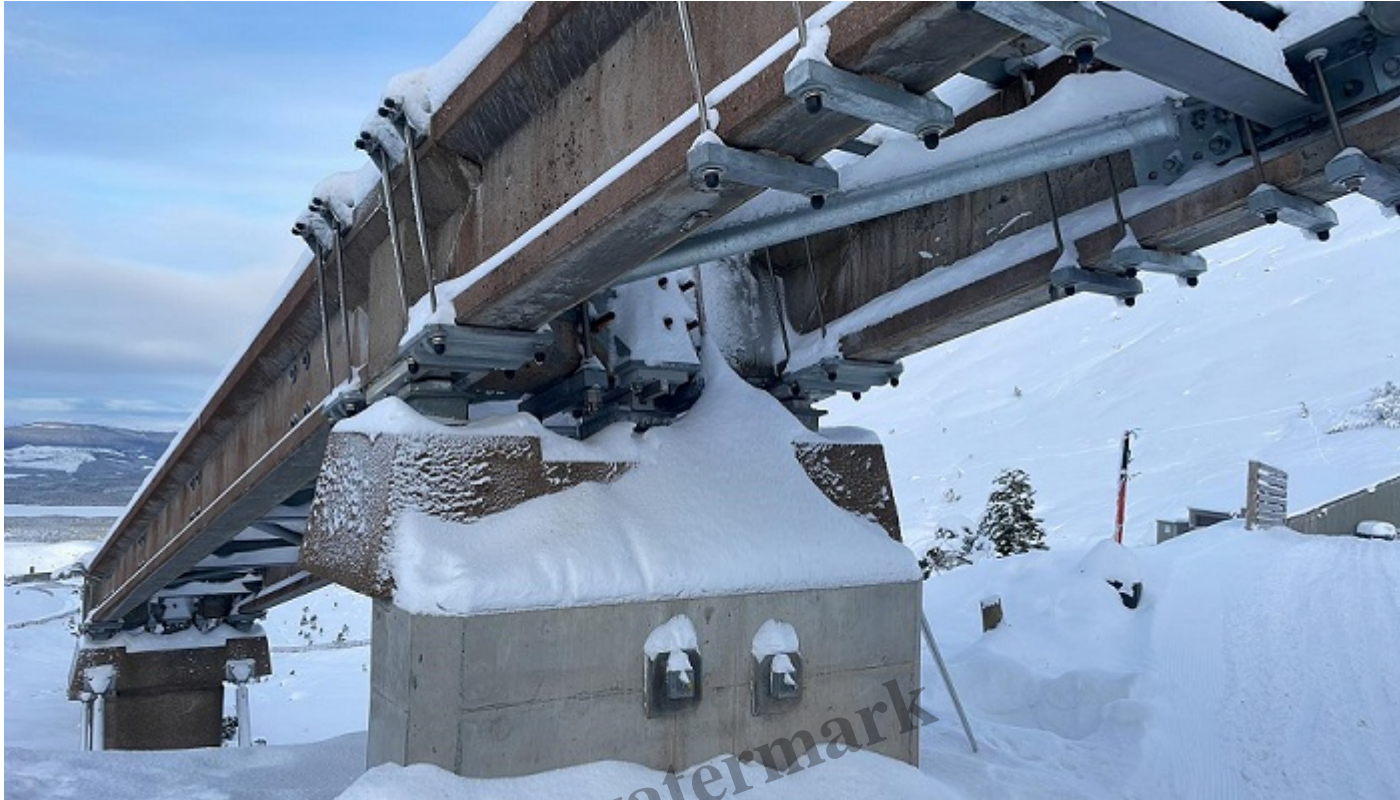
Photo 2 Credit Parkswatch reader

Photo (1) top & (2) are of the same part of the track, but compare the amount of reinforcement on the upper "I" beam in photo (1) to the lower seen in photo (2)! What is wrong with the upper beam? It is obviously in a worse state than the lower!
