## The Strengthening Works on the funicular railway.

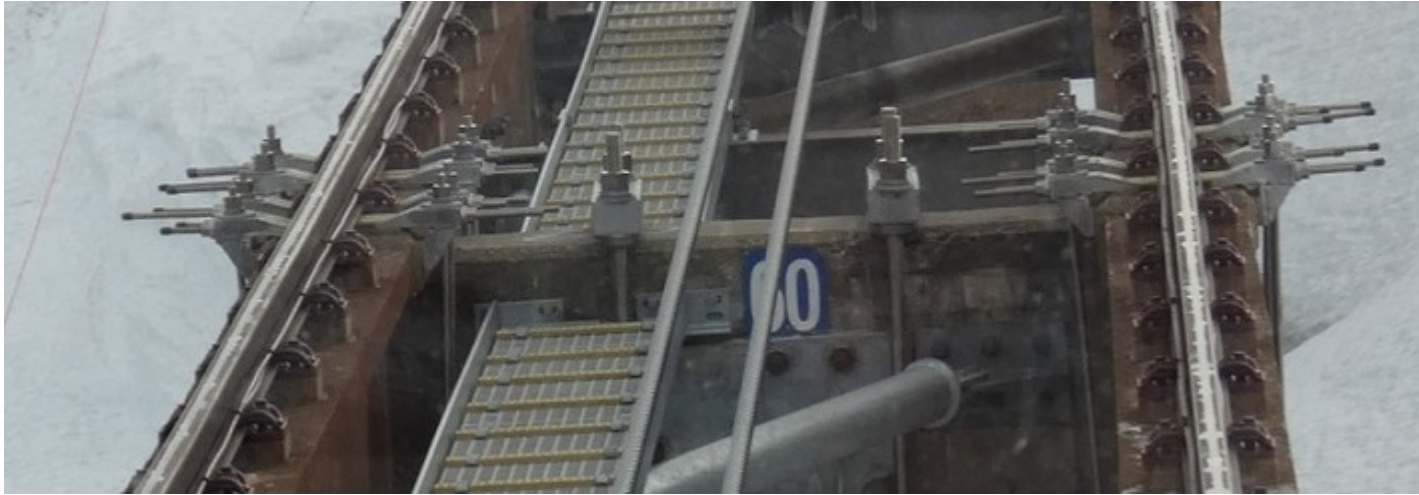
The outer and inner brackets

When I commented on this picture in my second post on the funicular court cases ([see here](#)) I had not realised that there are two different types of brackets holding the beams together. The second type can just be seen at the very edge of the left hand side, but, is better seen in this picture of pier 60 which appeared on social media last Saturday:-

The four outer brackets which are clamping the insitu blocks to the “I” beams are more complex than the two inner brackets around the insitu block. This indicates that there is a major problem at those joints, something that I have suggested and commented on before ([see here](#)) and ([here](#)), including the following screenshot which shows the “I” beams and in-situ joints:-

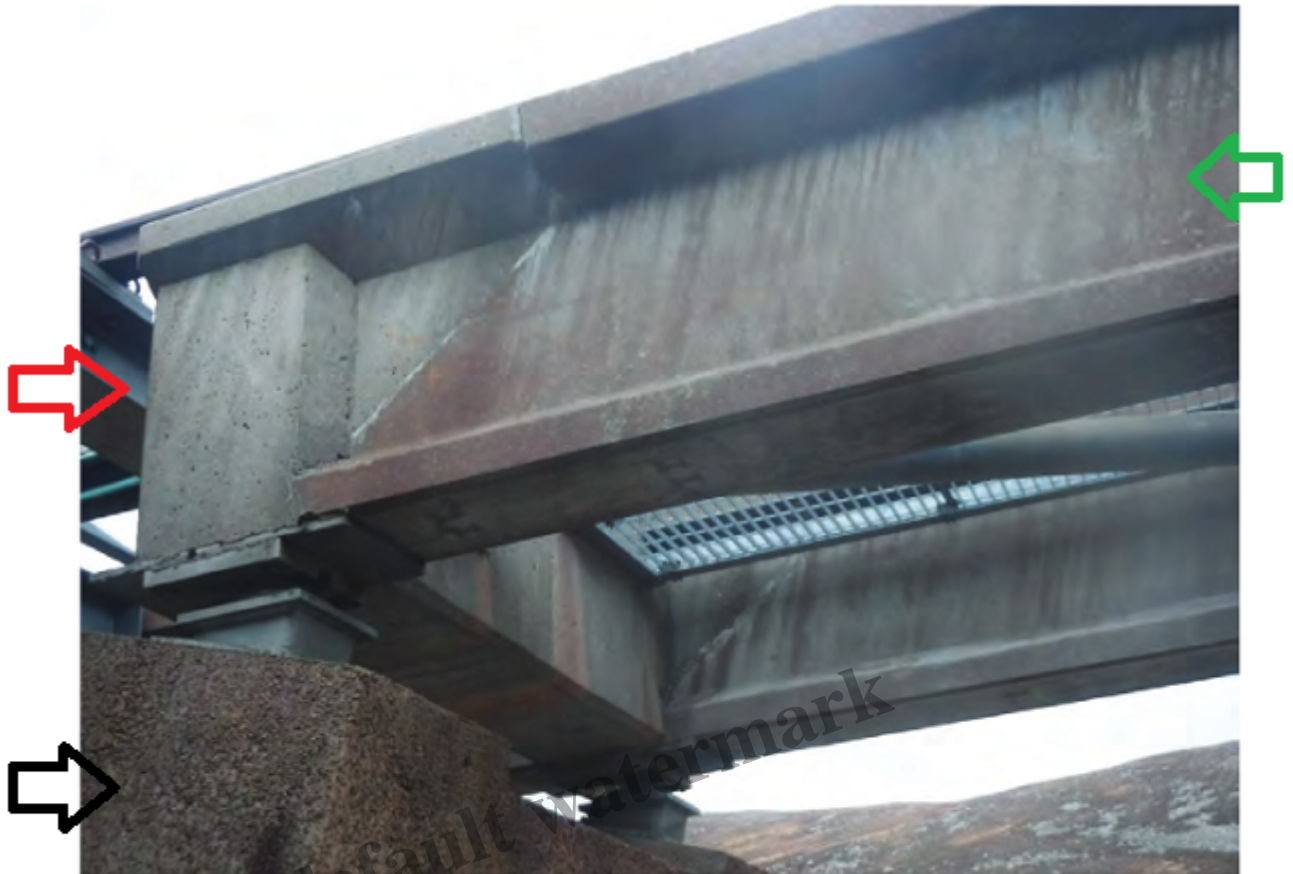
**Plate 24 - General view of surface markings to Pier 53 Right Beam, left support up.**

Green = “I” beam; Red = insitu block; Black = cross head.

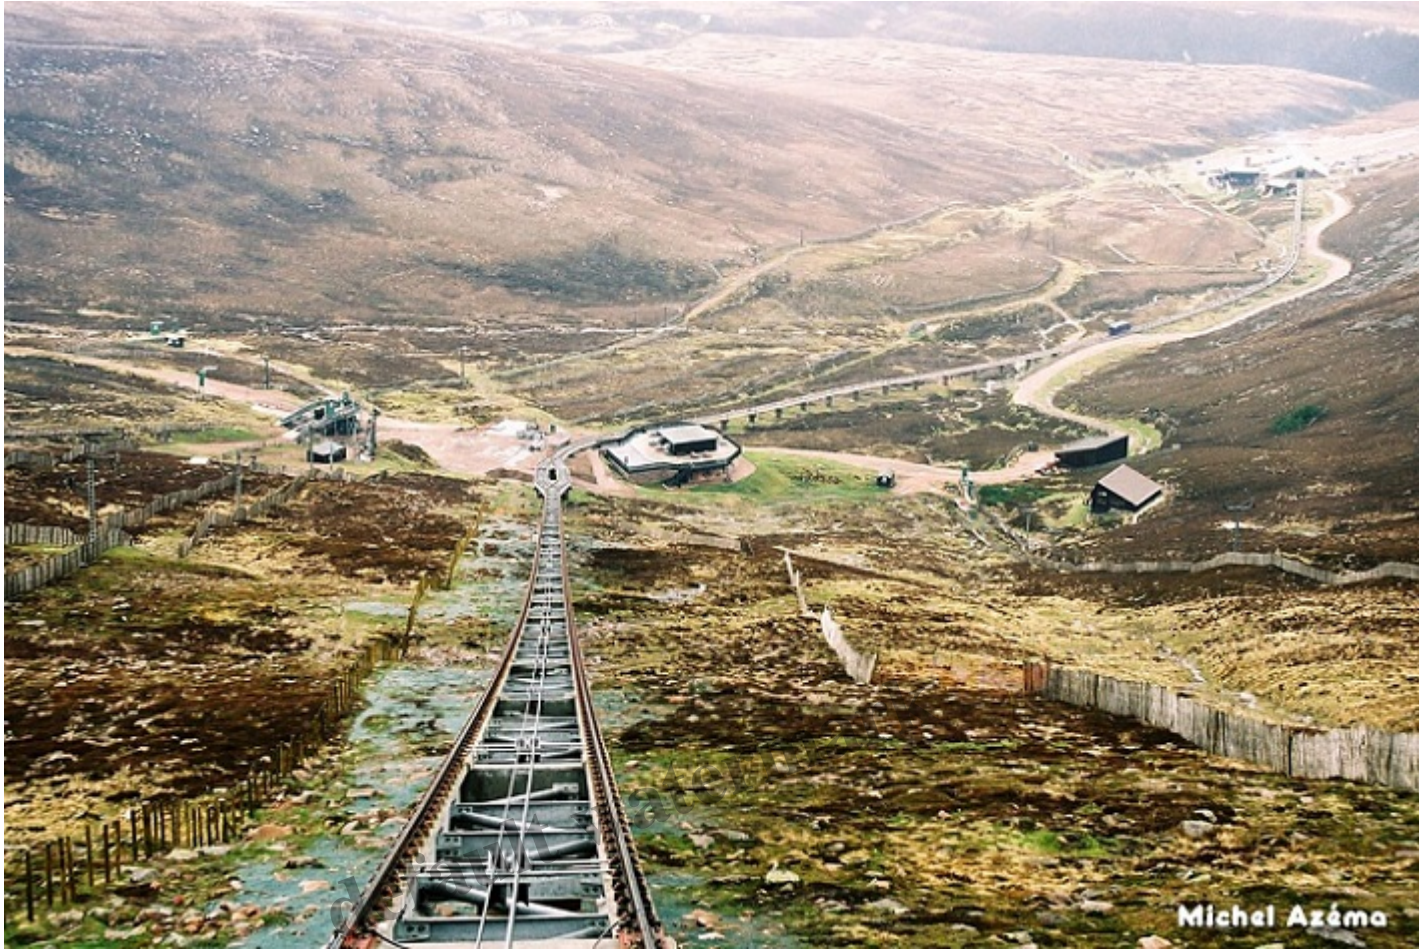
This was missing from much of the funicular (see photo from the Funimag below) but was in place at others (eg Pier 53 in photo above). Its removal was reported to the Health and Safety Executive and it appears thanks to their intervention a walkway has now been put in place to ensure the safety of CM(S)L inspection/ maintenance crew working on the structure.

Photo courtesy of Michel Azema author of the magazine FUNIMAG.

The absence of large sections of the walkway was a point made several times by ADAC Structures in previous reports into the funicular. It should make the annual inspection by ADAC Structures easier, more comprehensive and therefore more accurate.

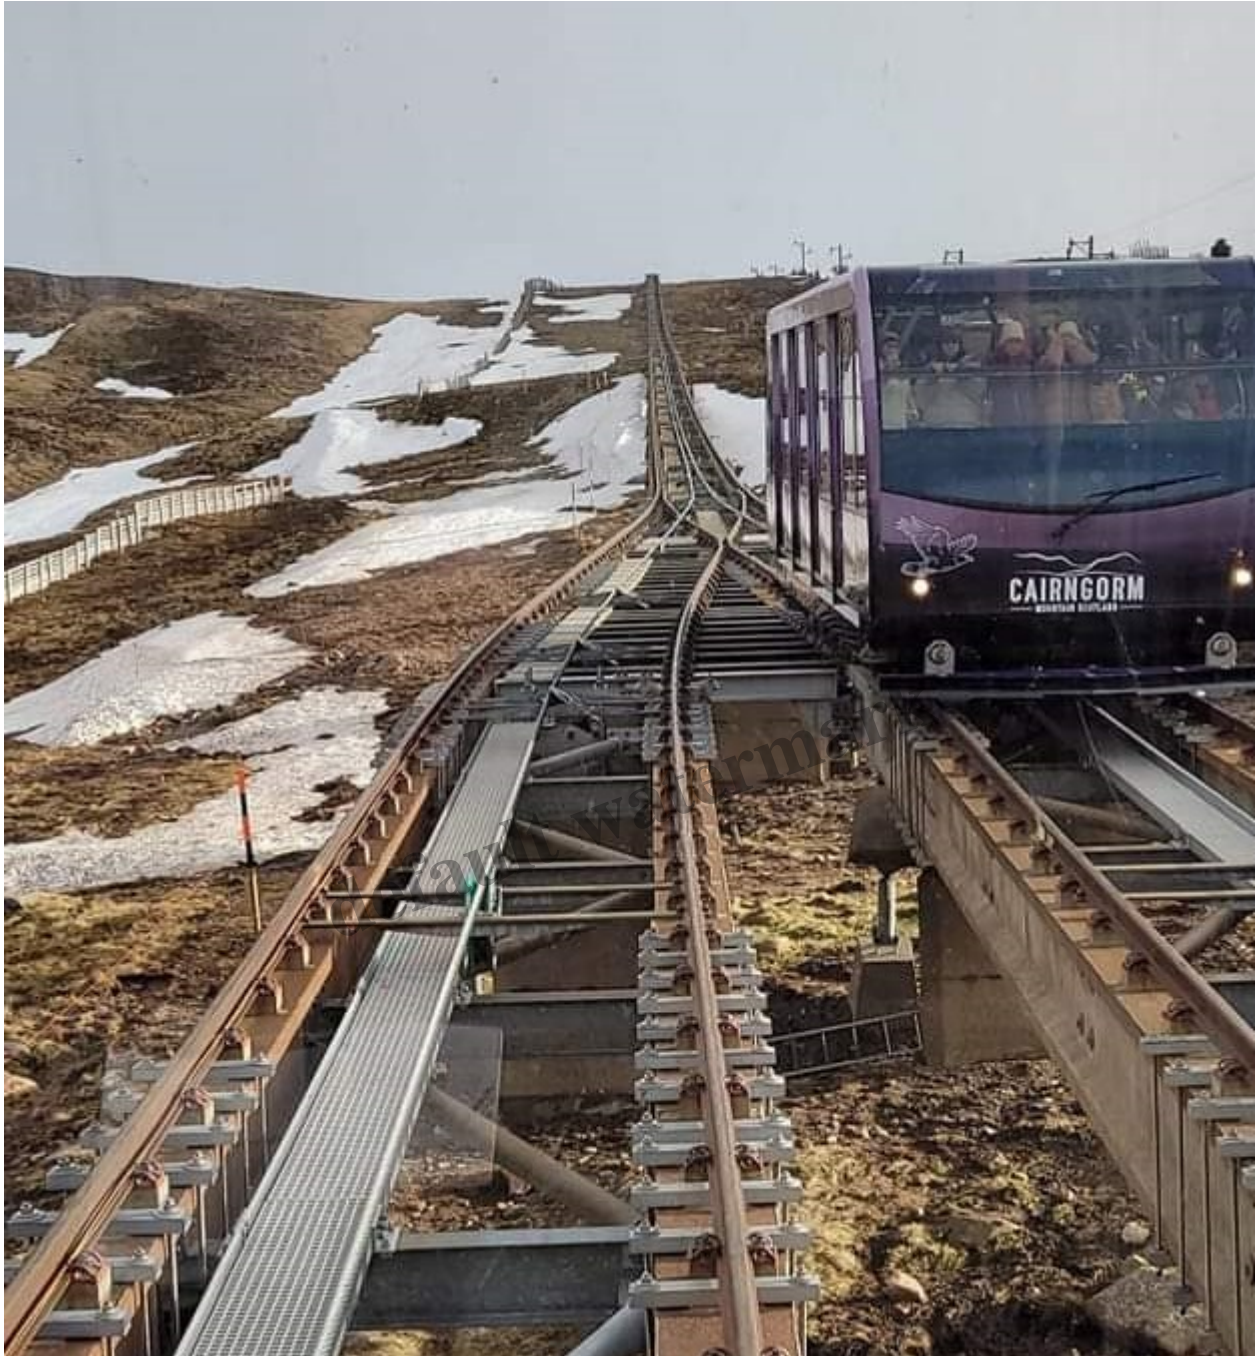
The new walkway and lots of metal brackets. Incidentally, note the state of the ground below! Photo from FB

As far as I can tell this is a completely new walkway, which begs the question if it is, “What happened to the previous steel walkway sections of which were left lying on the ground for years”? Who got the scrap money for that? Another charity?!

In my opinion there is now a new safety risk for inspectors and people working by the funicular which also shows poor work practices and that is the length of studding/ threaded bar, holding the brackets

together, protruding from (a) the sides and (b) up into the air.

(a) The excess steel-work protruding outwards from the brackets will hinder staff clearing snow away from the track and could cause injury, and,

(b) The extra lengths especially in the middle of the walkway, are a tripping hazard for staff working on it, from which someone could be seriously injured or even worse!

Why were the excess lengths not removed to make the work more presentable and safer?

Where are the safety markers that should be placed near those brackets? Even a coat of red paint would make them more obvious!

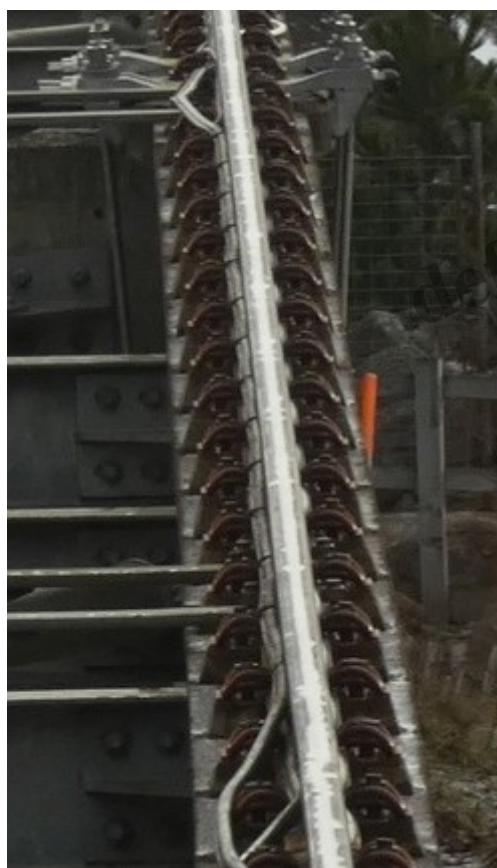
This is easier to see from another photo taken from the same social media page showing the right hand track as it leaves the base station:-

The photo shows that the track did not have a surface grind before rail operations recommenced. The shiny mid- section is where the bogie wheels are touching the centre of the rail with lateral shiny bits where the wheels touch now and again. These are high spots on the rails known in the rail world as “corrugations” and are a major cause of vibration which damages the concrete structure of the system ( [see here](#) for my fuller explanation of the importance of grinding and the impact of vibration).

After **FOUR** years of inactivity and the track rusting a rail grind was one of those jobs that should have

been a major part of the repair/ strengthening works and shows how both CM(S)L and HIE have a lackadaisical approach to health and safety. Nothing appears to have changed since the COWI report in 2018 (page 311) stated:

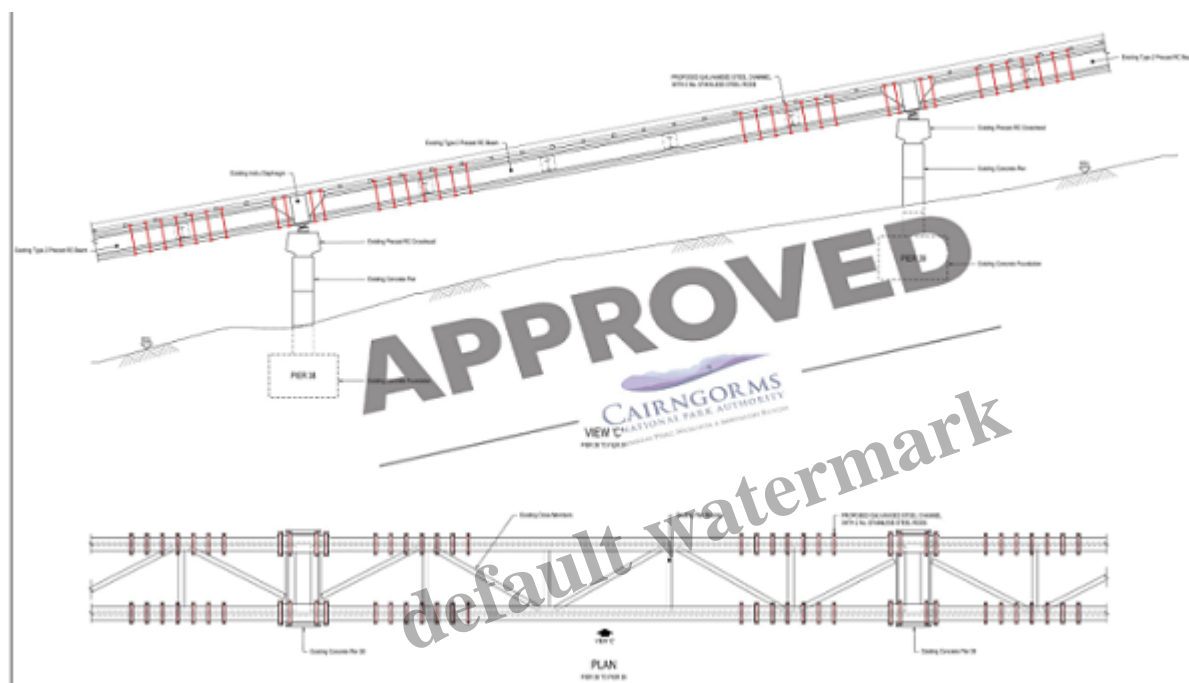
(4) The work is different to what was shown in the planning application

Note that the two brackets on the insitu blocks are not shown! A later addition?
