## The Strengthening Works on the funicular railway.

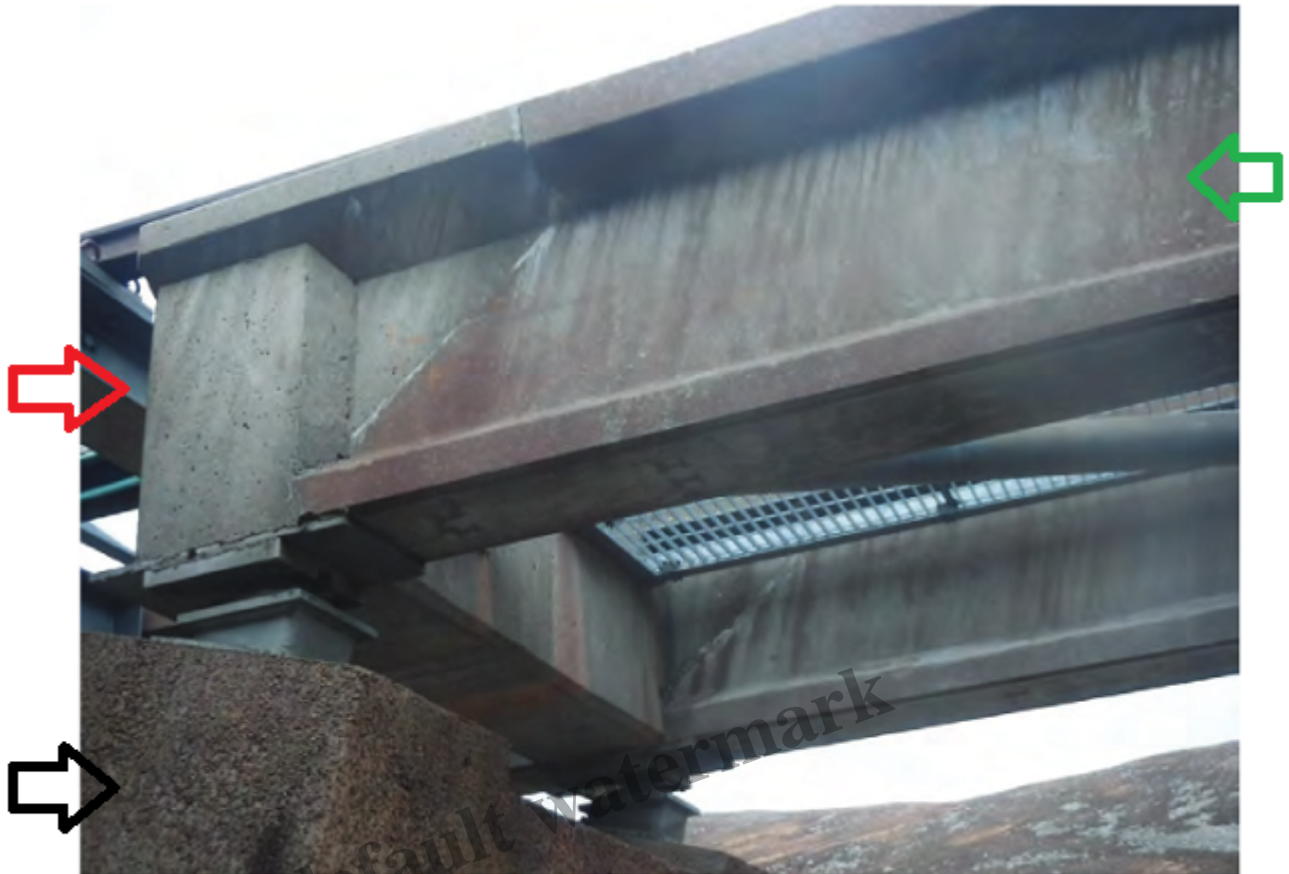
**Plate 24 - General view of surface markings to Pier 53 Right Beam, left support up.**

Green = "I" beam; Red = insitu block; Black = cross head.

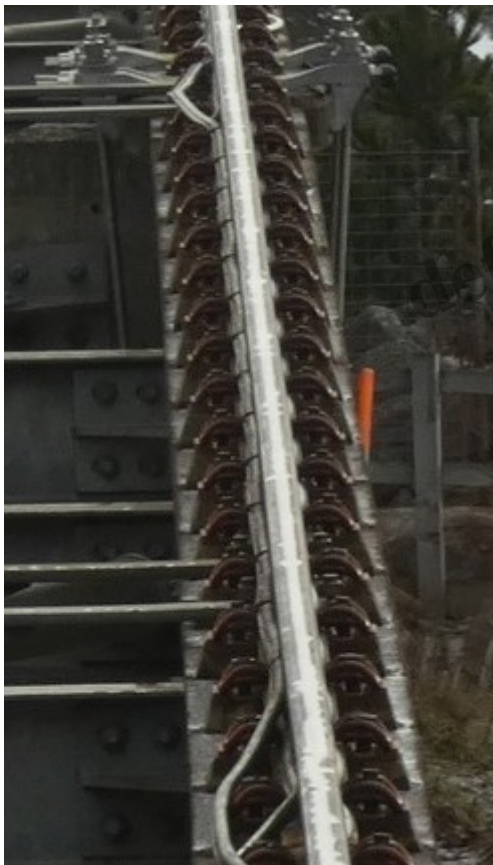
This is easier to see from another photo taken from the same social media page showing the right hand track as it leaves the base station:-

The photo shows that the track did not have a surface grind before rail operations recommenced. The shiny mid- section is where the bogie wheels are touching the centre of the rail with lateral shiny bits where the wheels touch now and again. These are high spots on the rails known in the rail world as “corrugations” and are a major cause of vibration which damages the concrete structure of the system ( [see here](#) for my fuller explanation of the importance of grinding and the impact of vibration).

After **FOUR** years of inactivity and the track rusting a rail grind was one of those jobs that should have

been a major part of the repair/ strengthening works and shows how both CM(S)L and HIE have a lackadaisical approach to health and safety. Nothing appears to have changed since the COWI report in 2018 (page 311) stated:

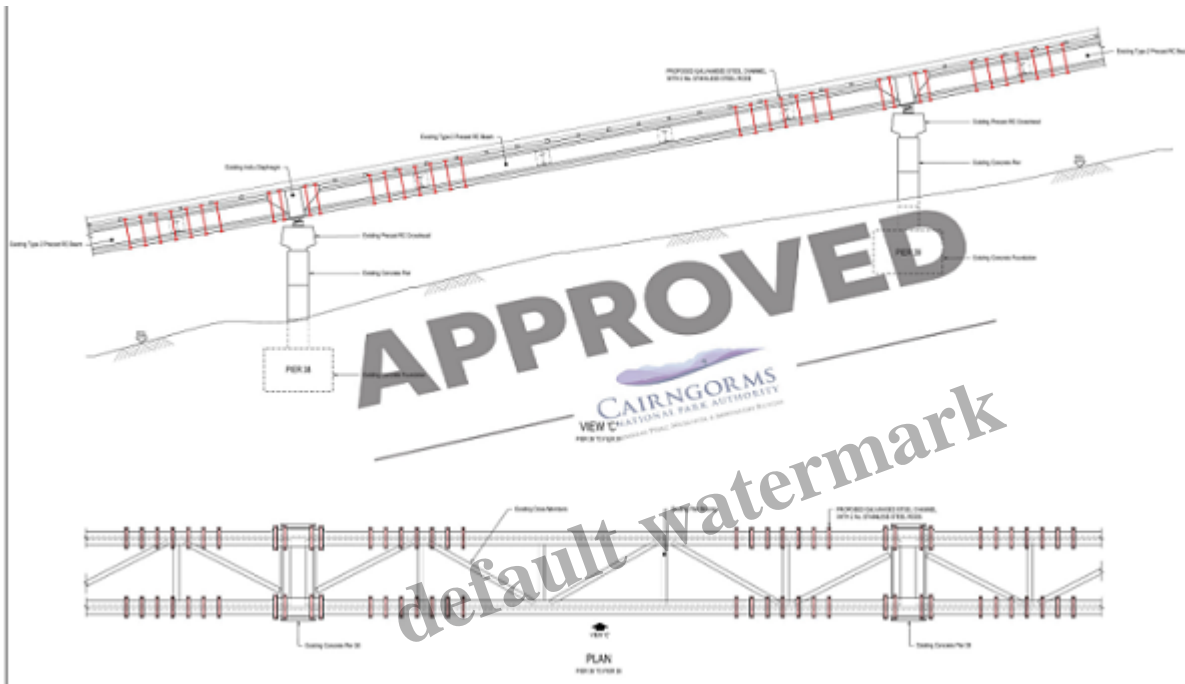
(4) The work is different to what was shown in the planning application

Note that the two brackets on the insitu blocks are not shown! A later addition?
