## The Strengthening Works on the funicular railway.

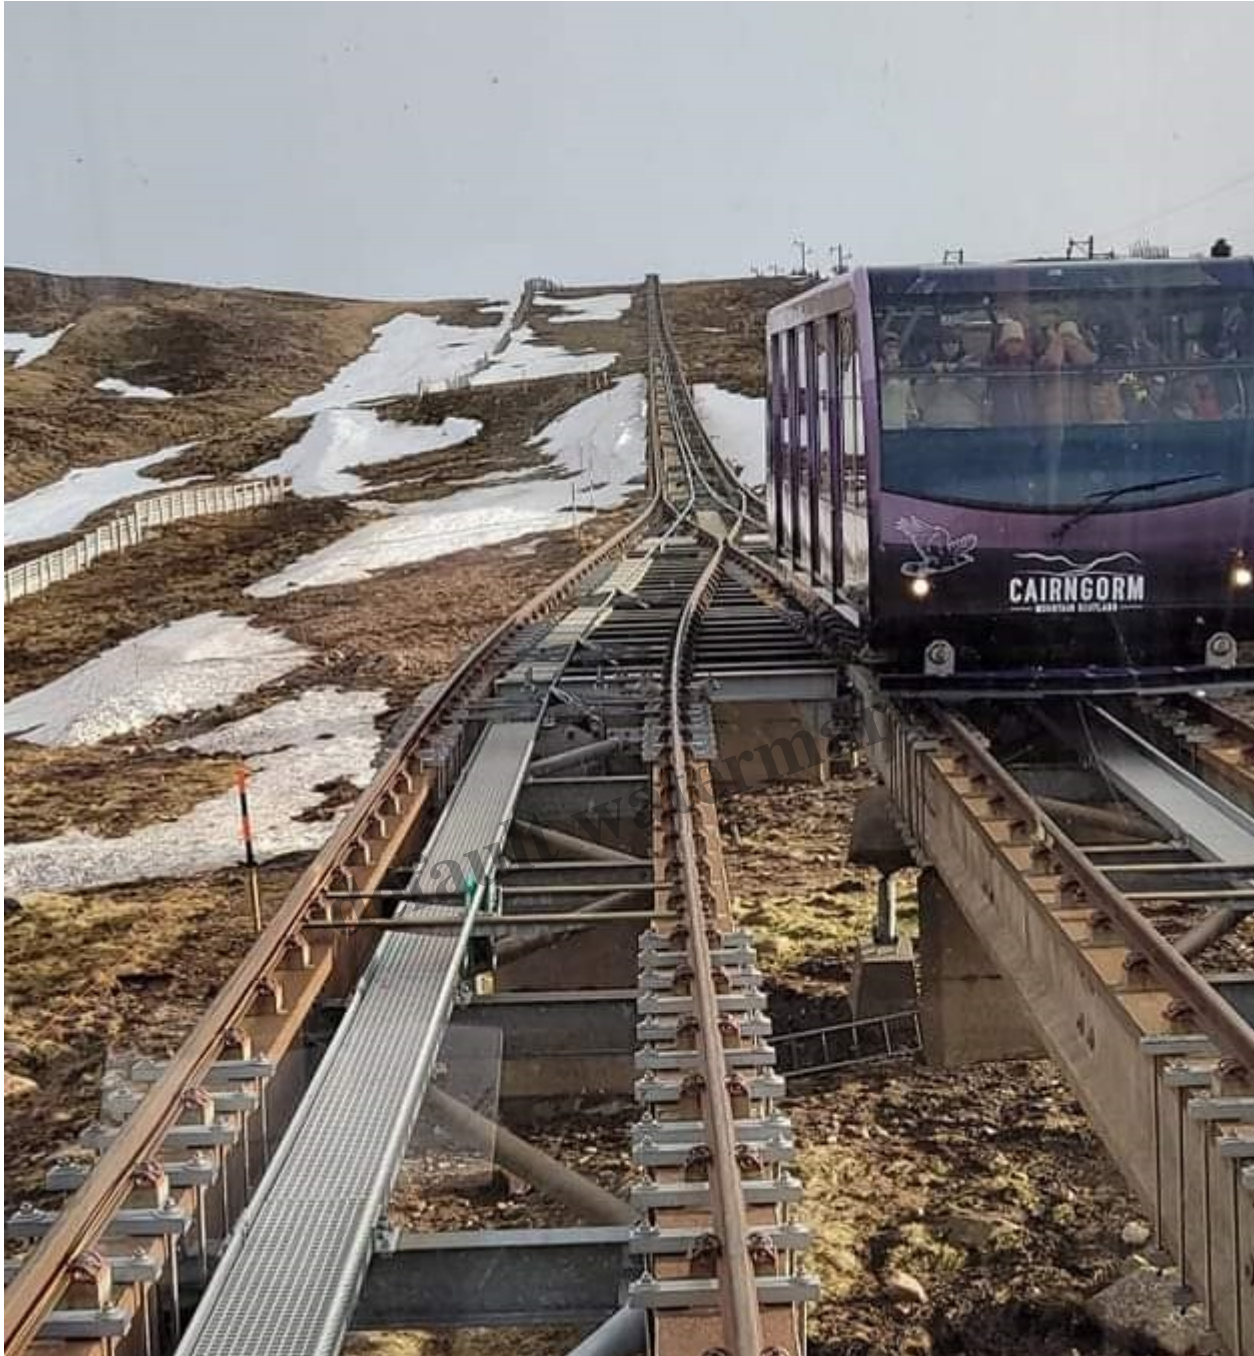
The new walkway and lots of metal brackets. Incidentally, note the state of the ground below! Photo from FB

As far as I can tell this is a completely new walkway, which begs the question if it is, “What happened to the previous steel walkway sections of which were left lying on the ground for years”? Who got the scrap money for that? Another charity?!

In my opinion there is now a new safety risk for inspectors and people working by the funicular which also shows poor work practices and that is the length of studding/ threaded bar, holding the brackets

together, protruding from (a) the sides and (b) up into the air.

(a) The excess steel-work protruding outwards from the brackets will hinder staff clearing snow away from the track and could cause injury, and,

(b) The extra lengths especially in the middle of the walkway, are a tripping hazard for staff working on it, from which someone could be seriously injured or even worse!

Why were the excess lengths not removed to make the work more presentable and safer?

Where are the safety markers that should be placed near those brackets? Even a coat of red paint would make them more obvious!

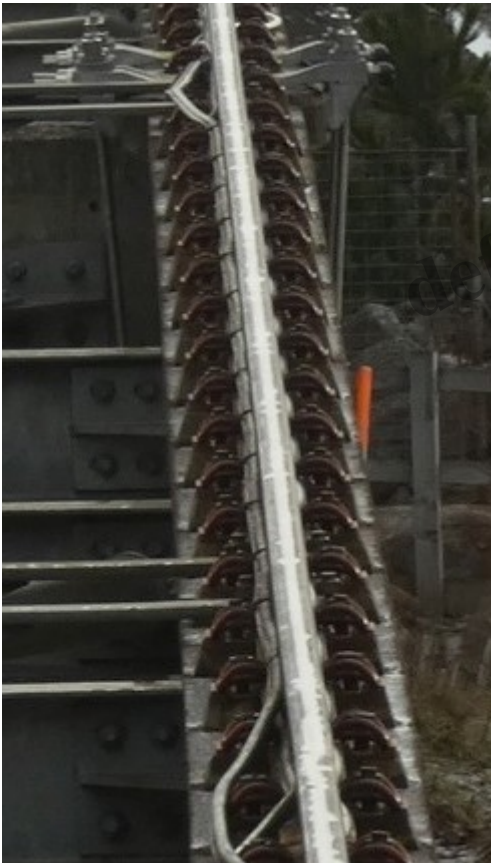
The photo shows that the track did not have a surface grind before rail operations recommenced. The shiny mid-section is where the bogie wheels are touching the centre of the rail with lateral shiny bits where the wheels touch now and again. These are high spots on the rails known in the rail world as “corrugations” and are a major cause of vibration which damages the concrete structure of the system ( [see here](#) for my fuller explanation of the importance of grinding and the impact of vibration).

After **FOUR** years of inactivity and the track rusting a rail grind was one of those jobs that should have

been a major part of the repair/ strengthening works and shows how both CM(S)L and HIE have a lackadaisical approach to health and safety. Nothing appears to have changed since the COWI report in 2018 (page 311) stated:
