## The Strengthening Works on the funicular railway.

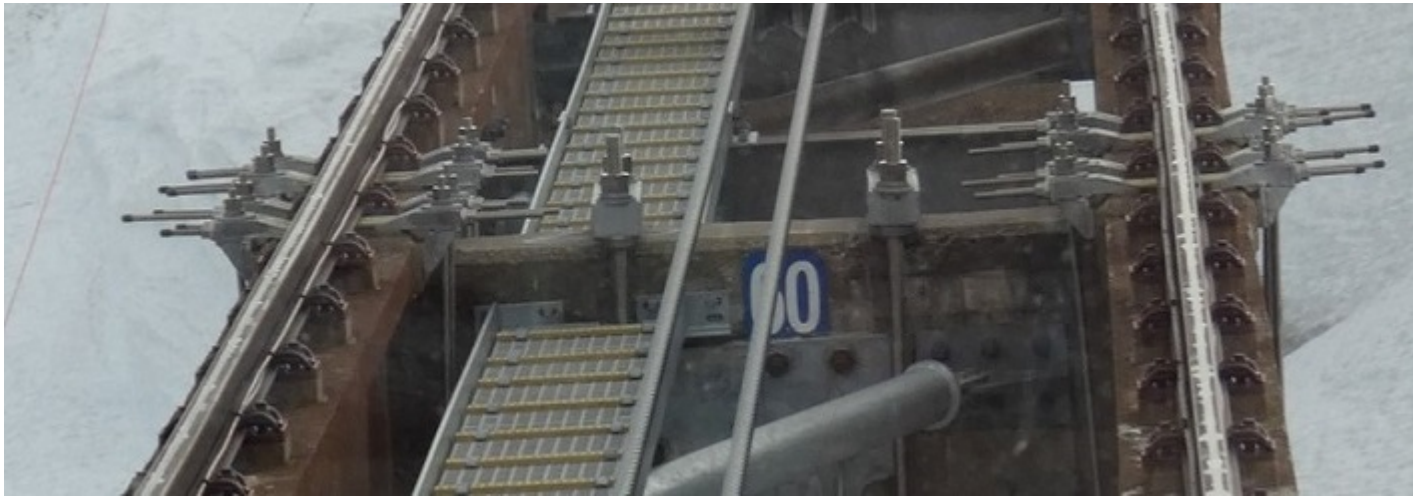
When I commented on this picture in my second post on the funicular court cases ([see here](#)) I had not realised that there are two different types of brackets holding the beams together. The second type can just be seen at the very edge of the left hand side, but, is better seen in this picture of pier 60 which appeared on social media last Saturday:-

The outer and inner brackets

The four outer brackets which are clamping the insitu blocks to the  $\hat{??}l\hat{?}$  beams are more complex than the two inner brackets around the insitu block. This indicates that there is a major problem at those joints, something that I have suggested and commented on before ([see here](#)) and ([here](#)), including the following screenshot which shows the  $\hat{??}l\hat{?}$  beams and in-situ joints:-

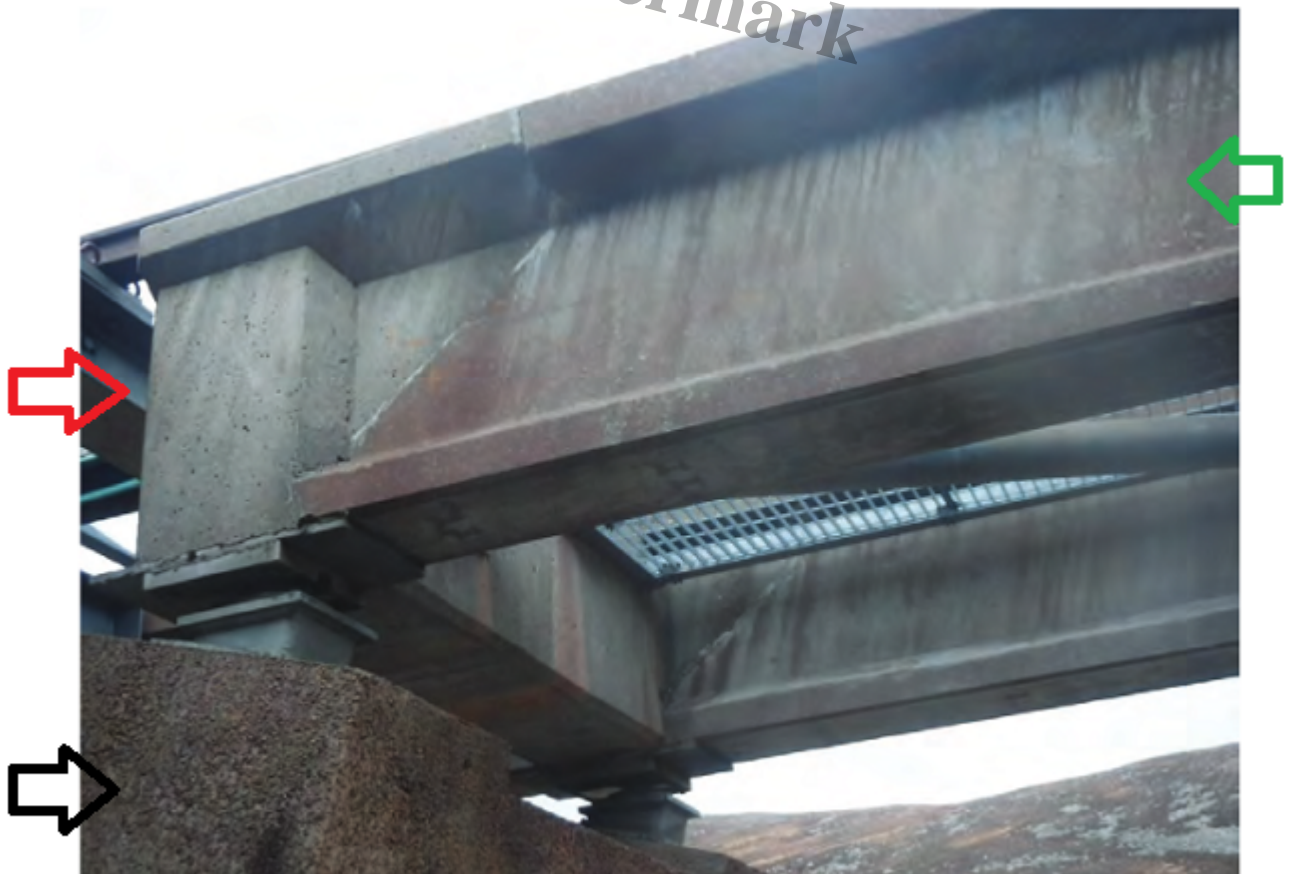
**Plate 24 - General view of surface markings to Pier 53 Right Beam, left support up.**

Green =  $\hat{??}l\hat{?}$  beam; Red = insitu block; Black = cross head.

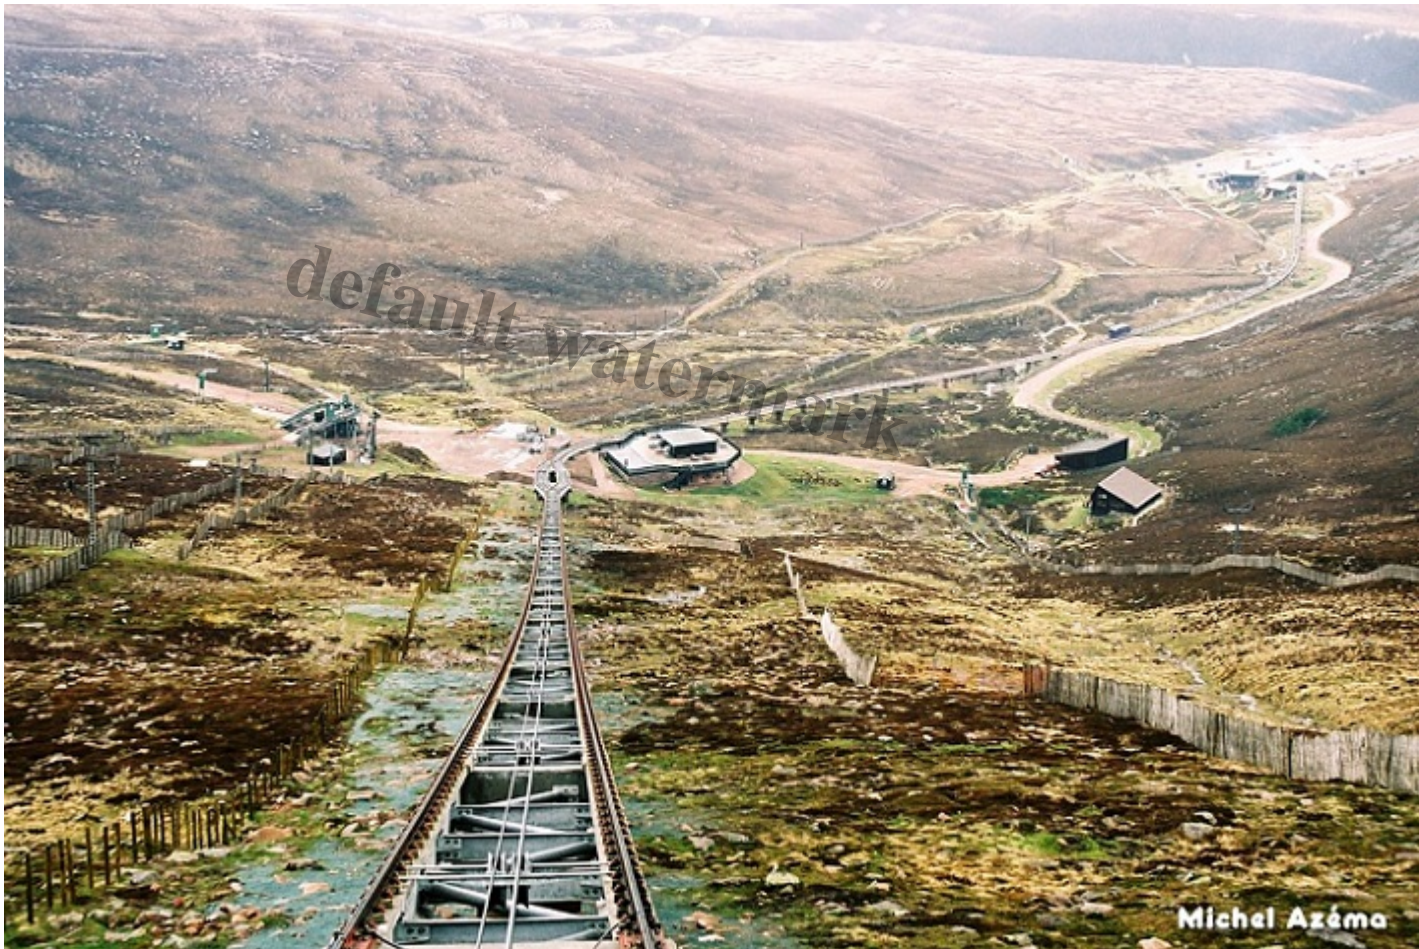
This was missing from much of the funicular (see photo from the Funimag below) but was in place at others (eg Pier 53 in photo above). Its removal was reported to the Health and Safety Executive and it appears thanks to their intervention a walkway has now been put in place to ensure the safety of CM(S)L inspection/ maintenance crew working on the structure.

The absence of large sections of the walkway was a point made several times by ADAC Structures in previous reports into the funicular. It should make the annual inspection by ADAC Structures easier, more comprehensive and therefore more accurate.

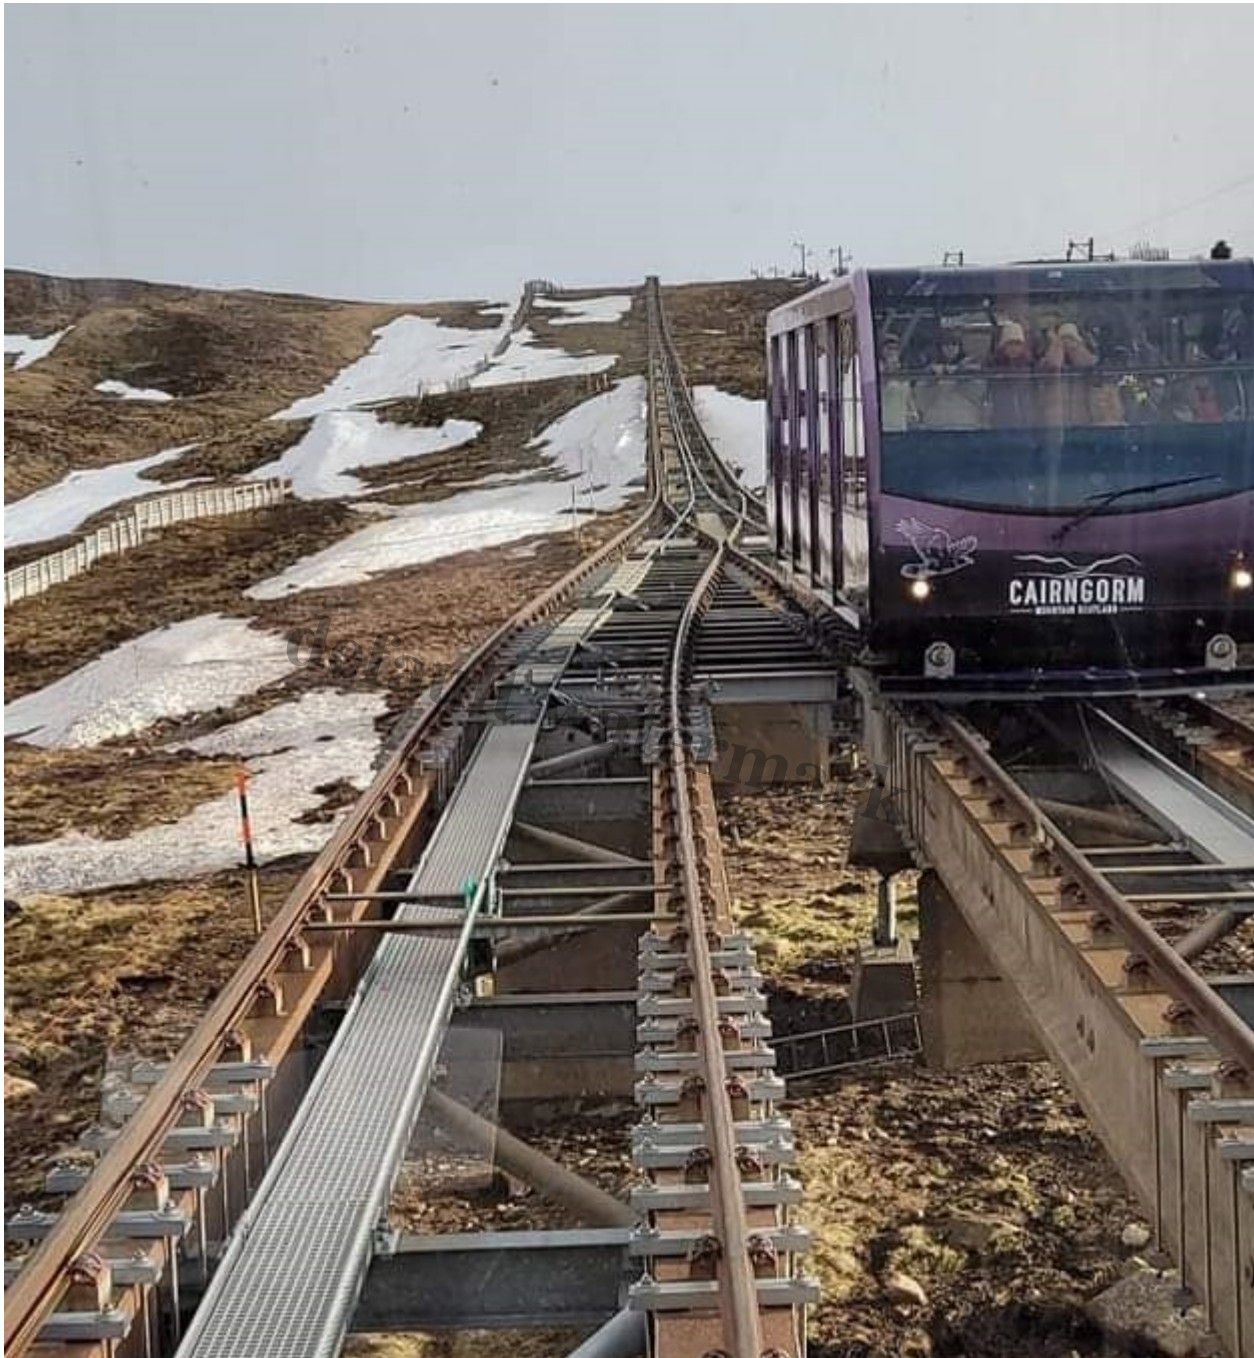
The new walkway and lots of metal brackets. Incidentally, note the state of the ground below! Photo from FB

In my opinion there is now a new safety risk for inspectors and people working by the funicular which also shows poor work practices and that is the length of studding/ threaded bar, holding the brackets together, protruding from (a) the sides and (b) up into the air.

(a) The excess steel-work protruding outwards from the brackets will hinder staff clearing snow away from the track and could cause injury, and,

(b) The extra lengths especially in the middle of the walkway, are a tripping hazard for staff working on it, from which someone could be seriously injured or even worse!

Why were the excess lengths not removed to make the work more presentable and safer?

Where are the safety markers that should be placed near those brackets? Even a coat of red paint would make them more obvious!

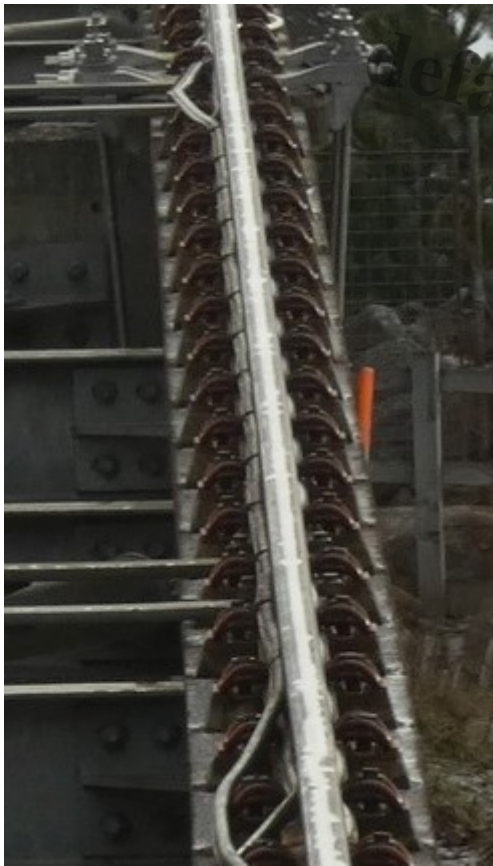
The photo shows that the track did not have a surface grind before rail operations recommenced. The shiny mid- section is where the bogie wheels are touching the centre of the rail with lateral shiny bits where the wheels touch now and again. These are high spots on the rails known in the rail world as 'corrugations' and are a major cause of vibration which damages the concrete structure of the system ([see here](#) for my fuller explanation of the importance of grinding and the impact of vibration).

After **FOUR** years of inactivity and the track rusting a rail grind was one of those jobs that should have been a major part of the repair/ strengthening works and shows how both CM(S)L and HIE have a lackadaisical approach to health and safety. Nothing appears to have changed since the COWI report

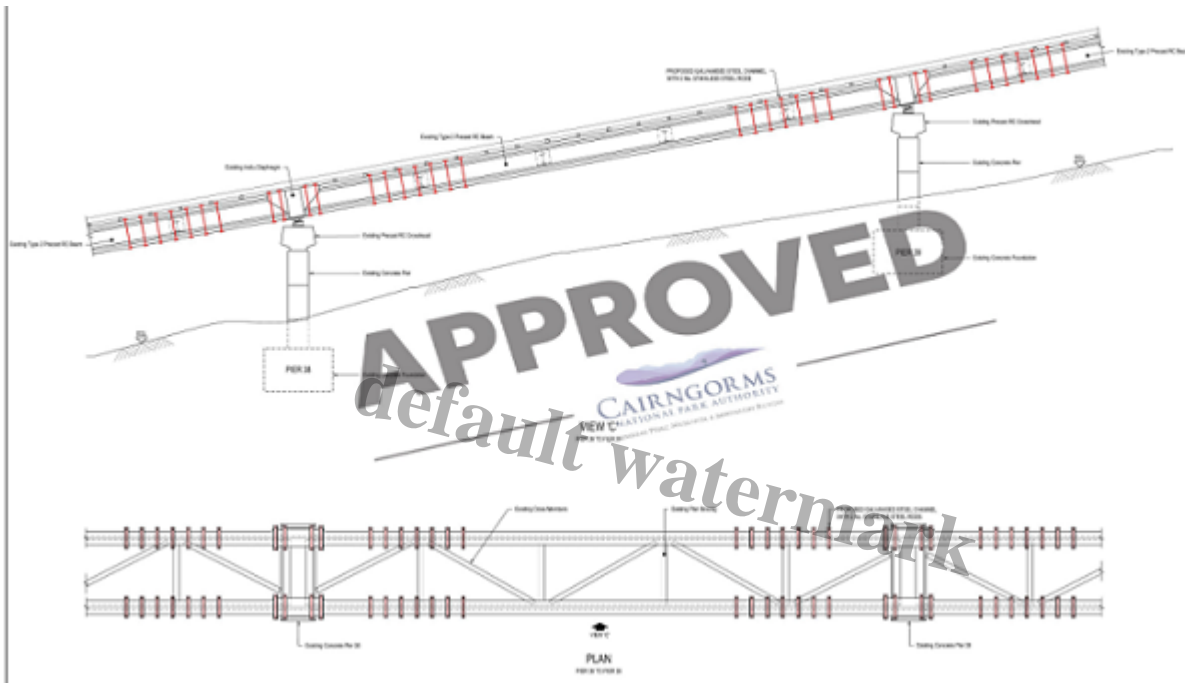
(4) The work is different to what was shown in the planning application

Note that the two brackets on the insitu blocks are not shown! A later addition?
