And still the silt flows on the Pitmain Estate – what is the point of the Cairngorms National Park Planning Authority?

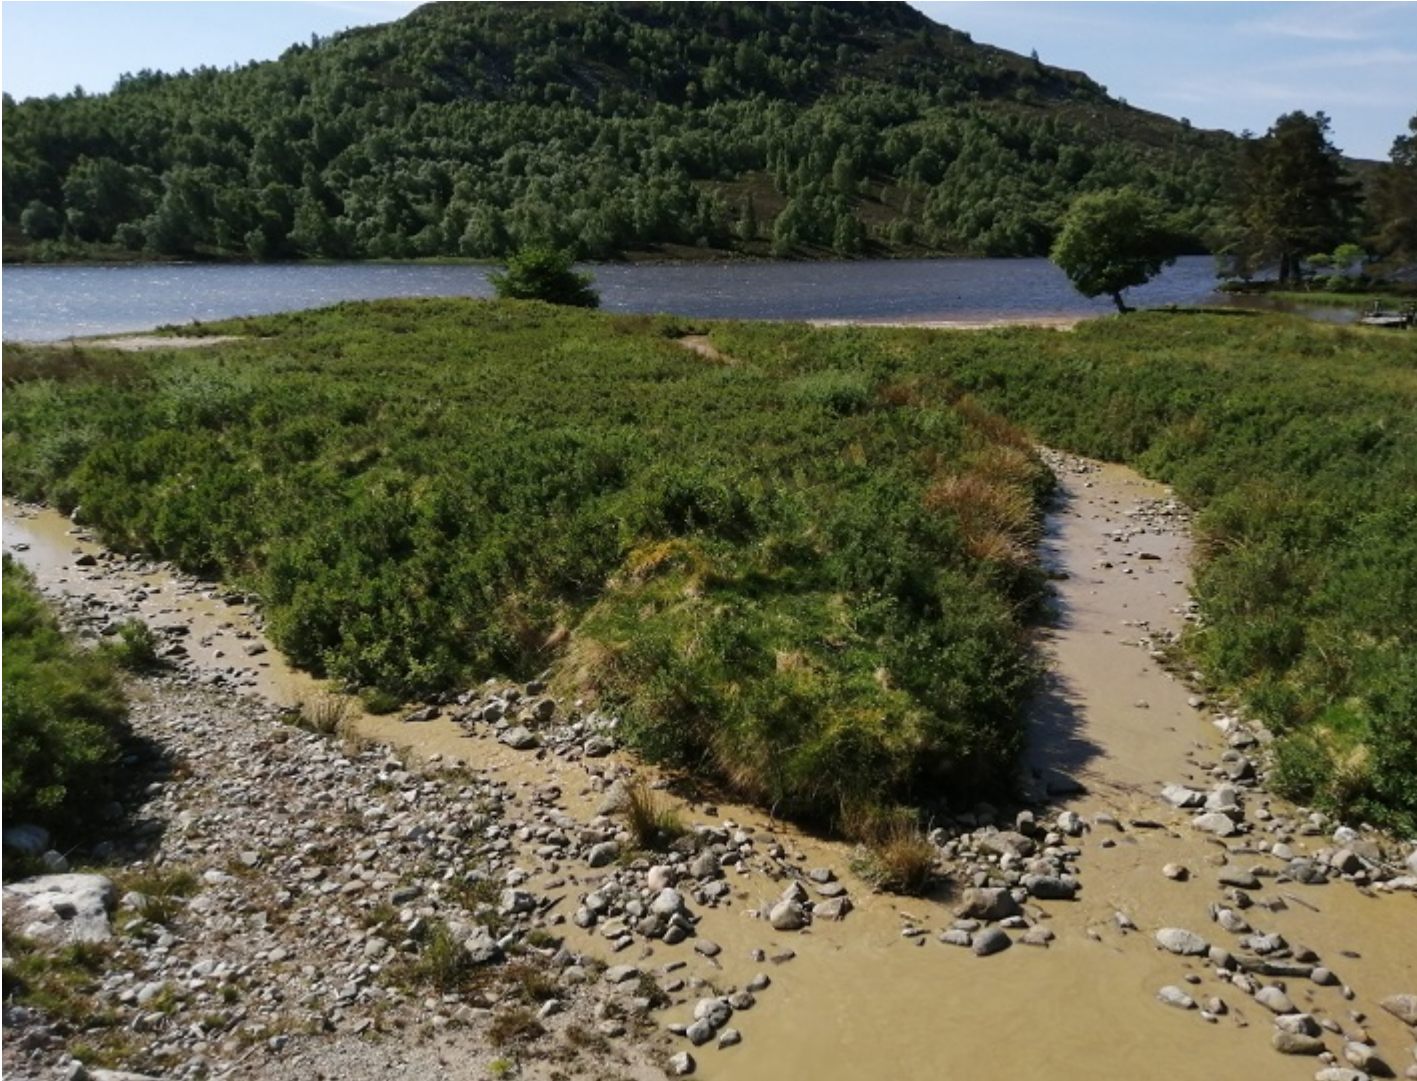
Outflow of Gynack overflow channel 9th June where it flows into Loch Gynack. Photo credit Parkswatch reader

There is no doubt, however, that the silt that was being washed into Loch Gynack yesterday was

flowing the overflow channel which is currently being “repaired” after it failed soon after construction ([see here](#)). The silt is therefore a planning enforcement matter.

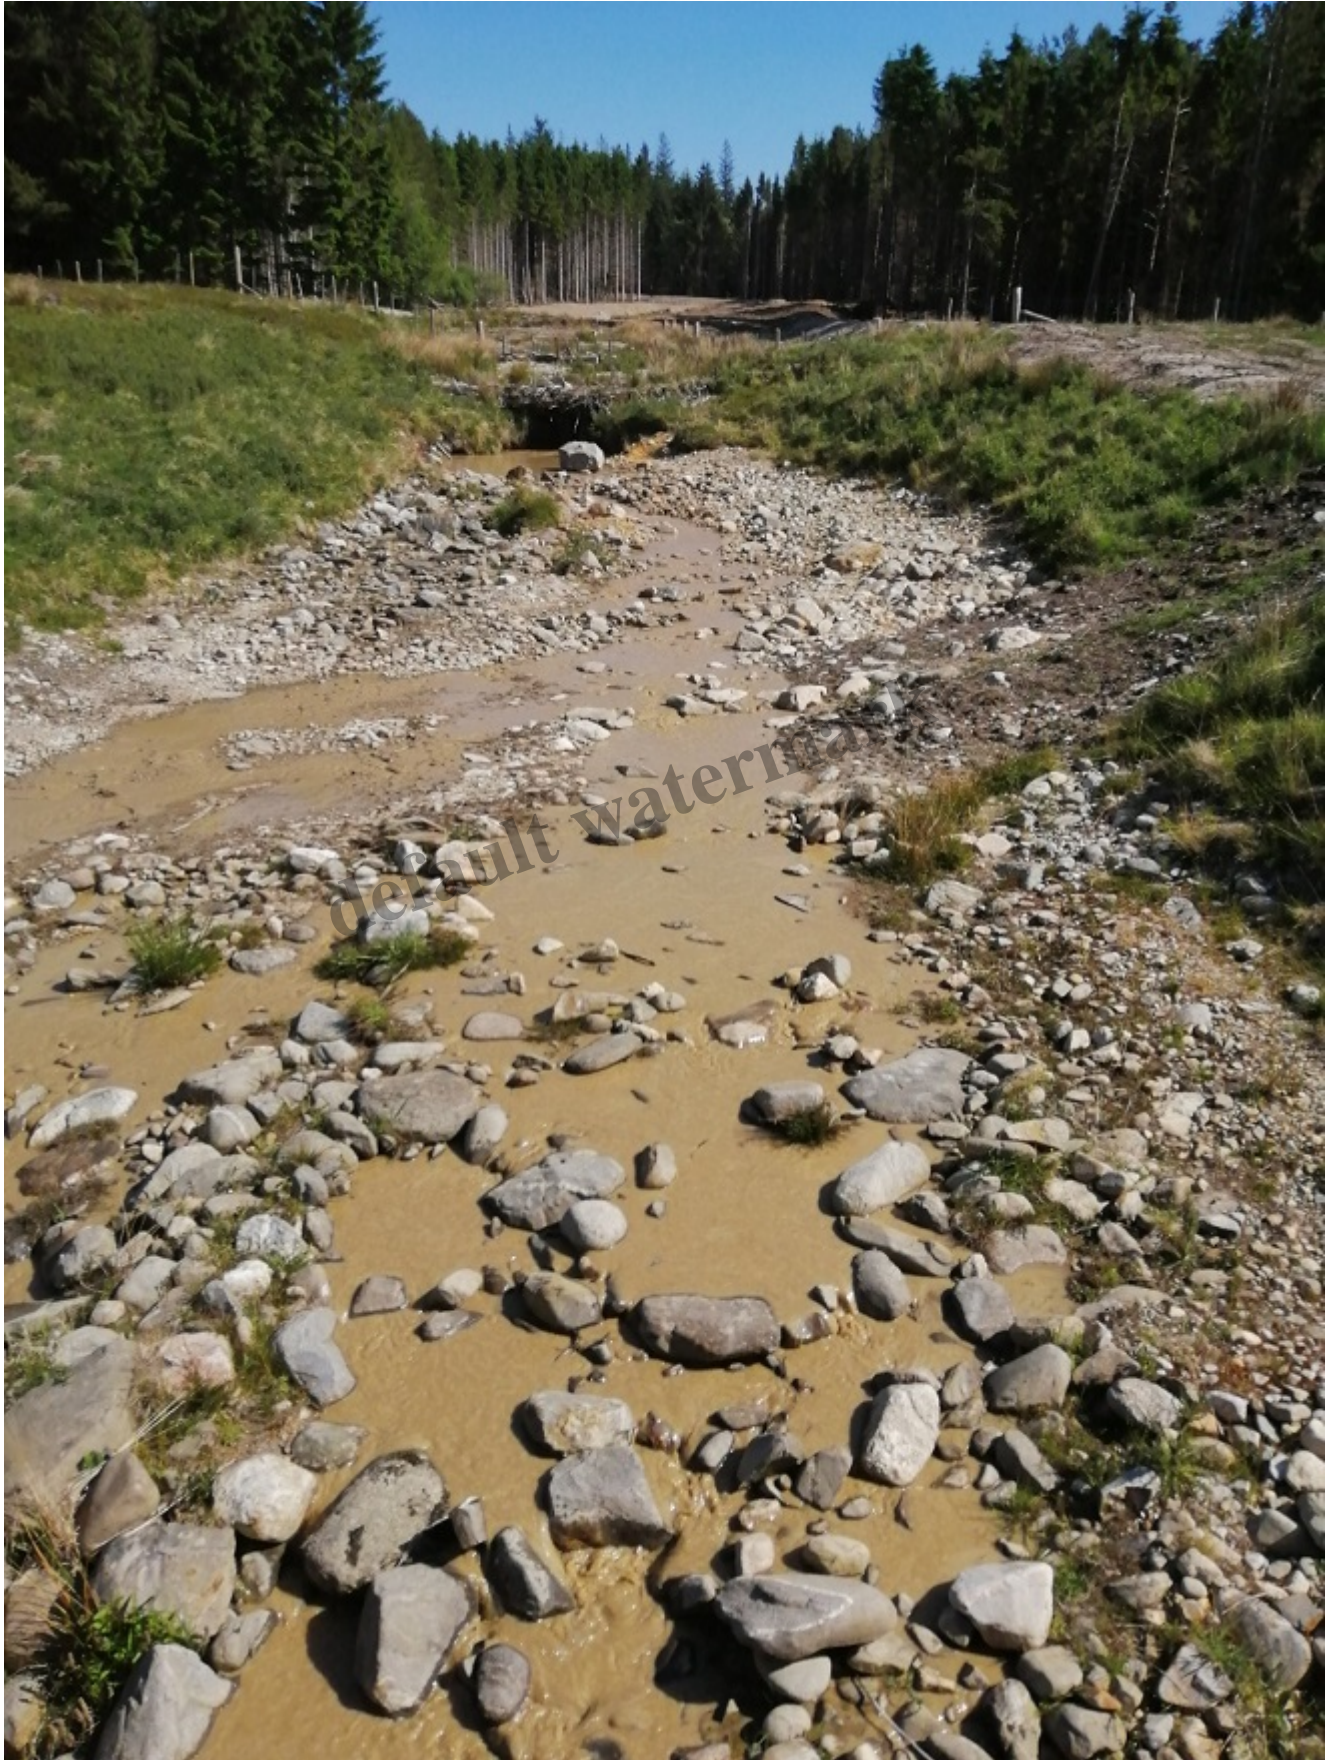
The silt sedimentation pond was shown on the original plans as being situated just above

the fence in the photo – yesterday it was clearly not working

The photos from 9th June suggest that neither the diversion culverts nor the sedimentation pond, as proposed in the original plans, have been operating properly during the repairs works. So why, six weeks later, have neither the CNPA or SEPA done anything to rectify this and prevent the flow of silt into the river system?

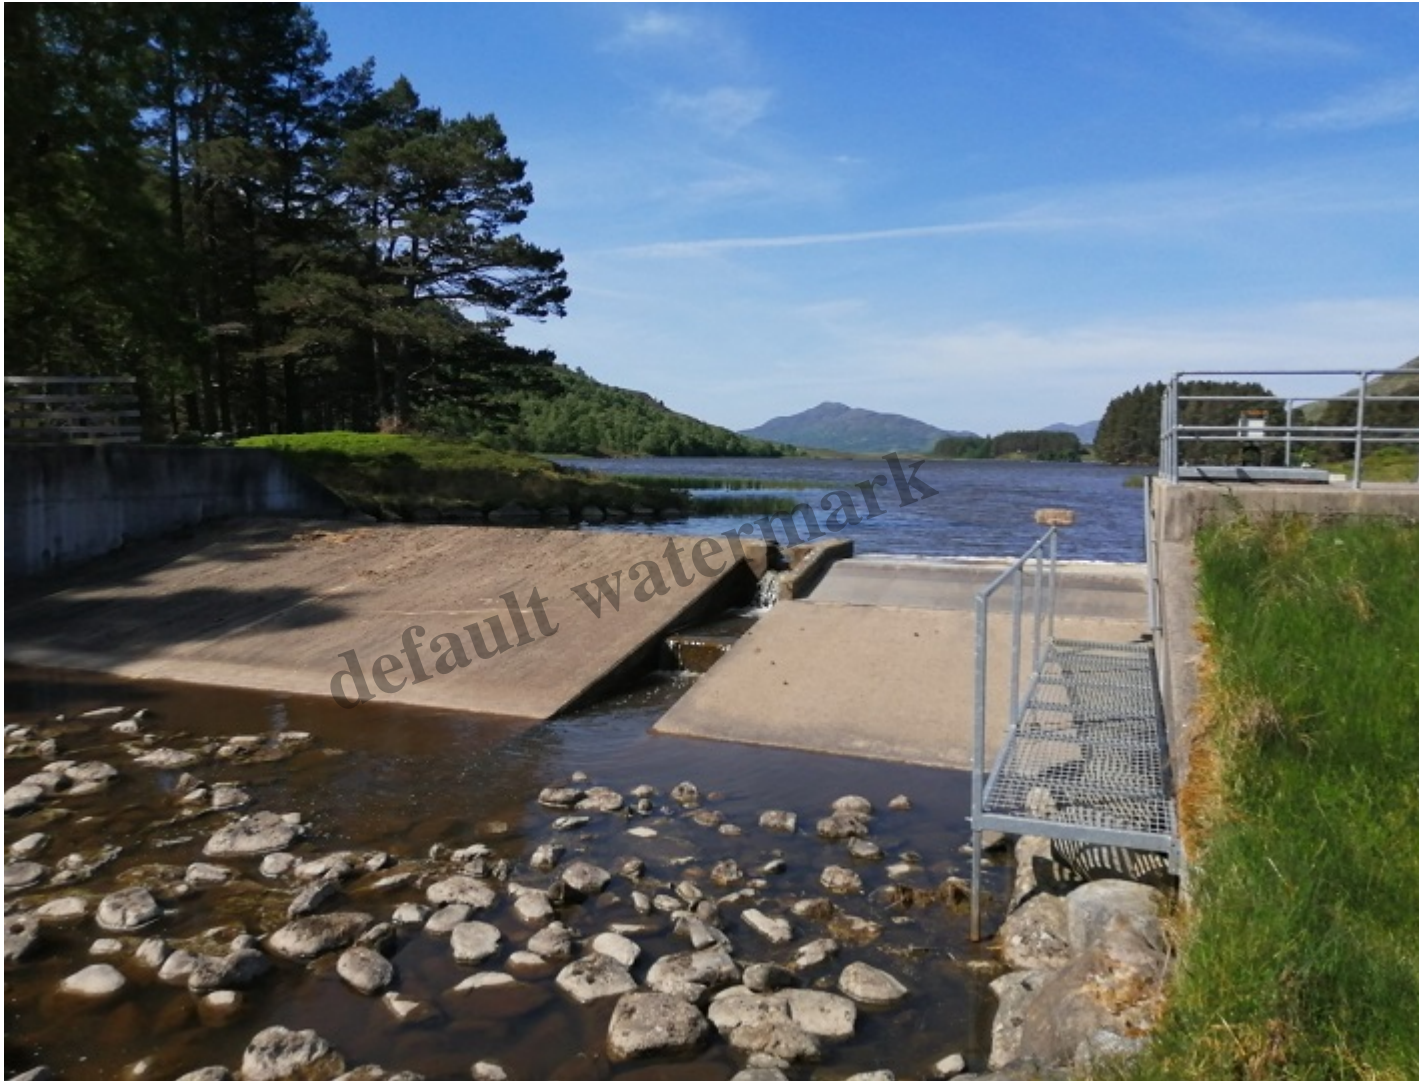
The Loch Gynack outflow, which now also serves as a hydro intake. The water on 9th June appeared slightly murky. Photo credit Parkswatch reader.

Loch Gynack, itself, acts like a giant sedimentation pond for the silt flowing down the overflow, however that has not been sufficient to stop some of the silt flowing out and down into the River Spey Special Area of Conservation below. NatureScot, the agency responsible for these protected areas, should also be up in arms.

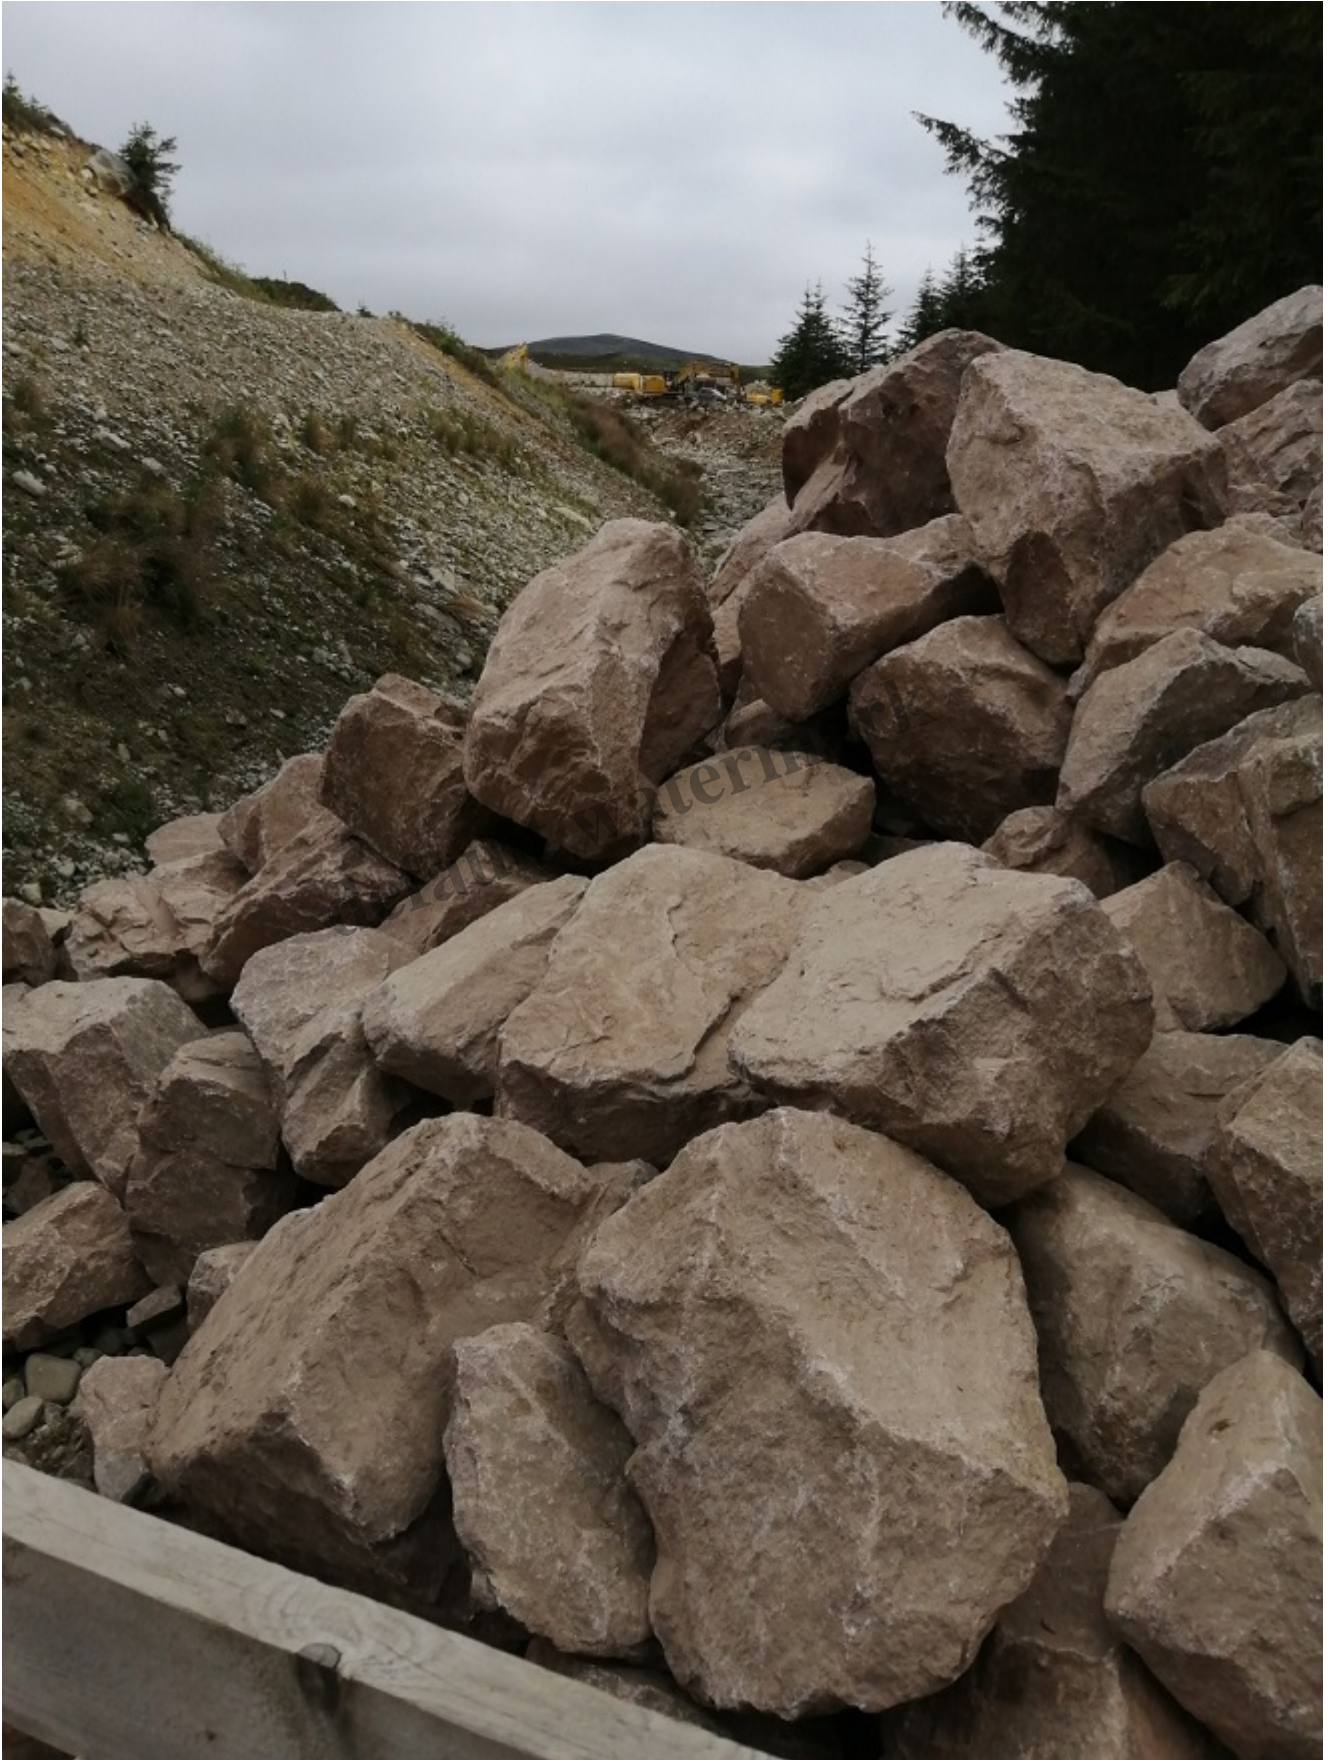
View from the bridge over the overflow channel, with the intake to the diversion scheme

visible on the near horizon. Photo credit Parkswatch reader.

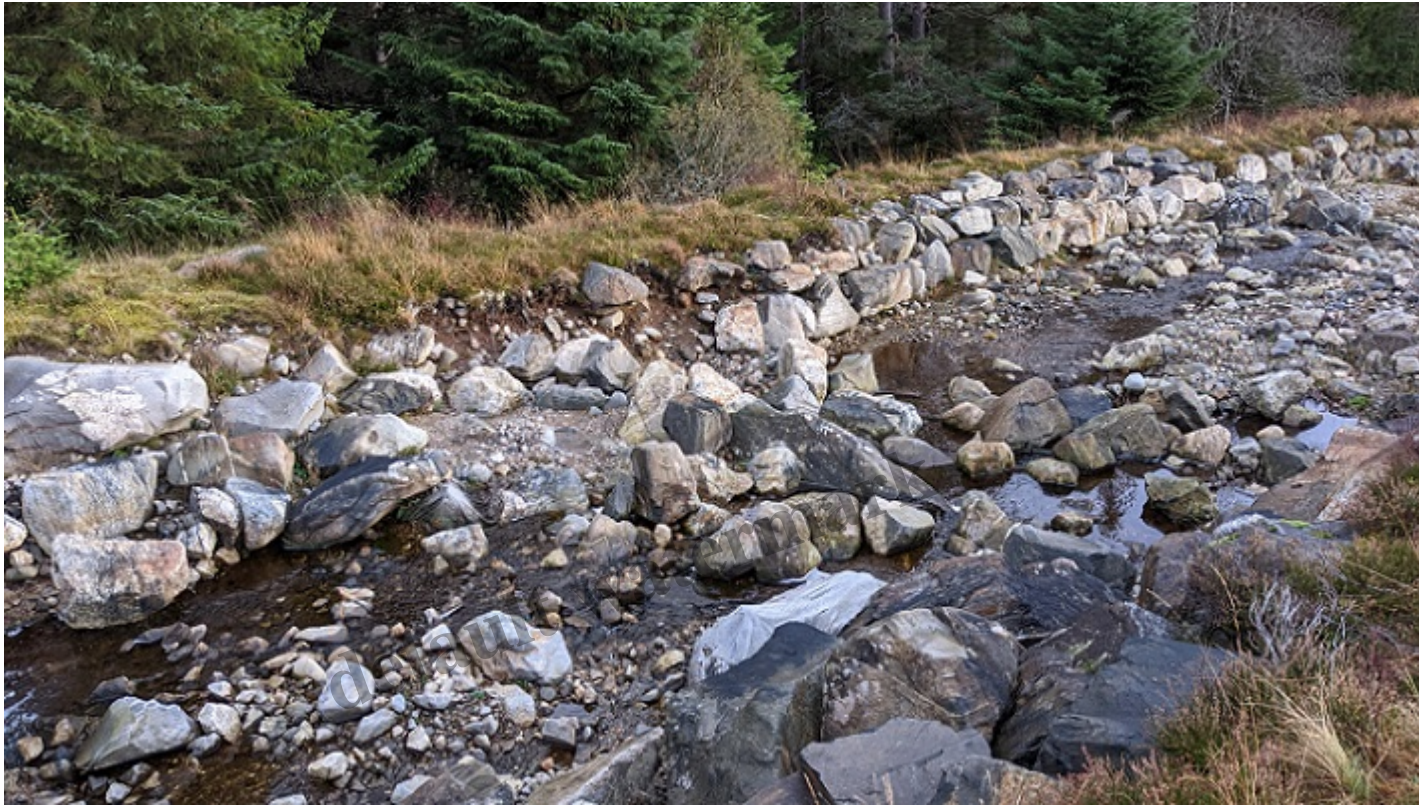
Photo 2022.

Meantime other recent photos suggest that large amounts of rock re-inforcement has been brought in to Pitmain to reinforce the sides of the overflow channel. Whether this will work is a moot point as some of the rip rap bouldering used to line the channel previously was washed away soon after it was first used:

Judging by a comparison of the size of the boulders in the two photos, the idea appears to be that enormous rocks – rumoured to have come from a quarry near Nairn – will contain flood water where smaller ones didn't.

There are reasons to doubt that, given the force that flood water will be forced through the boulders and the size of the bank behind, but perhaps the current plan is to embed the new boulders in concrete? That surely should require a fresh planning application. Unfortunately, without any plans there is no way for anyone to evaluate the current repair work, either whether it will work or the environmental costs.
