HIE's decision to close the Cairn Gorm funicular again! (2) What's happening?

The repairs to the concrete support beams and current “snagging” issues at Cairn Gorm

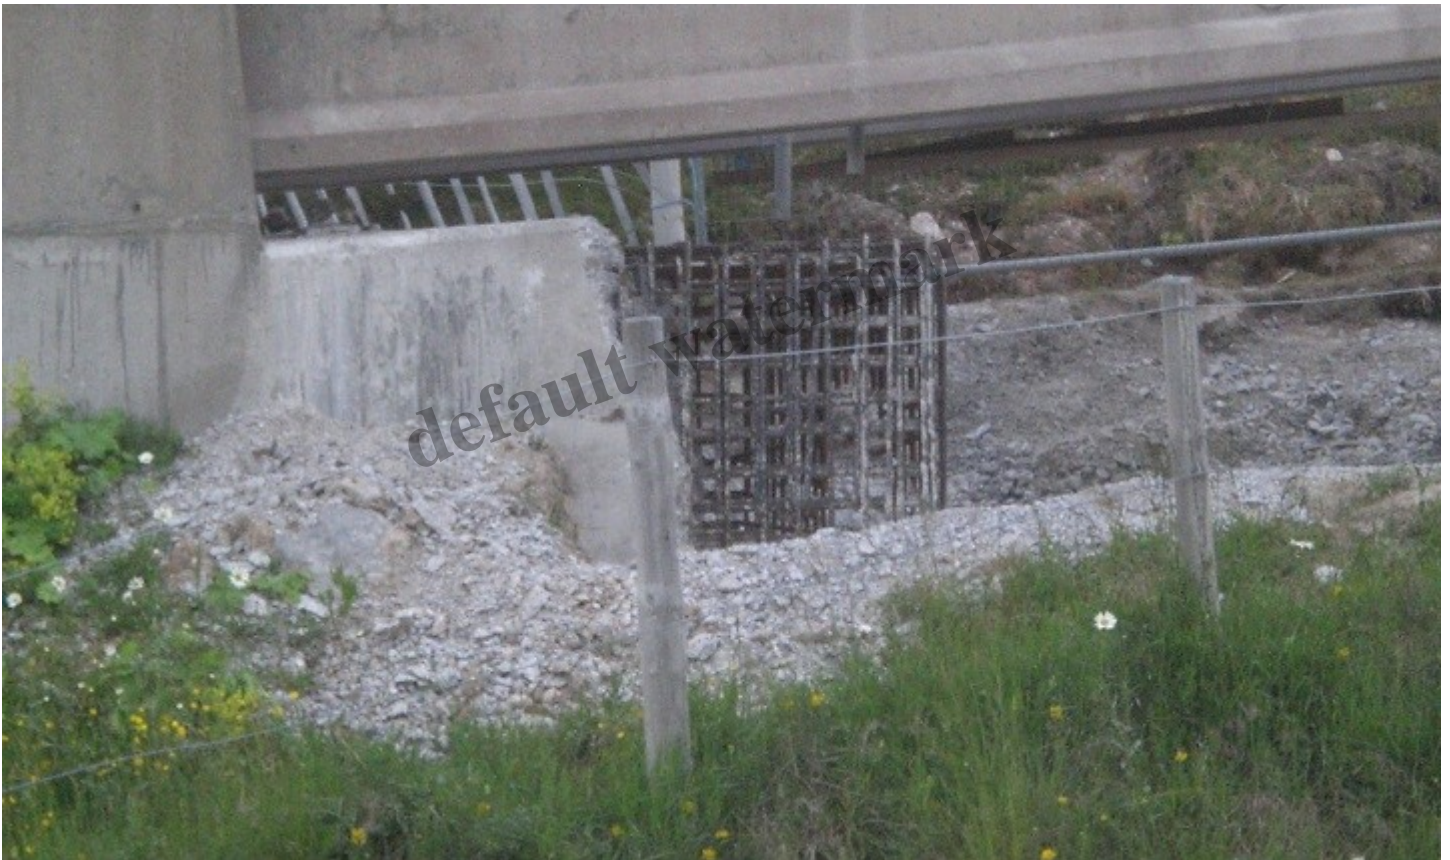
The bottom anchor block (photo above) – which is designed to stop the section of railway above moving downhill – and a few piers (photo below) have been reinforced but this is the exception, not the rule, and the explanation for why this was needed in these cases is unclear.

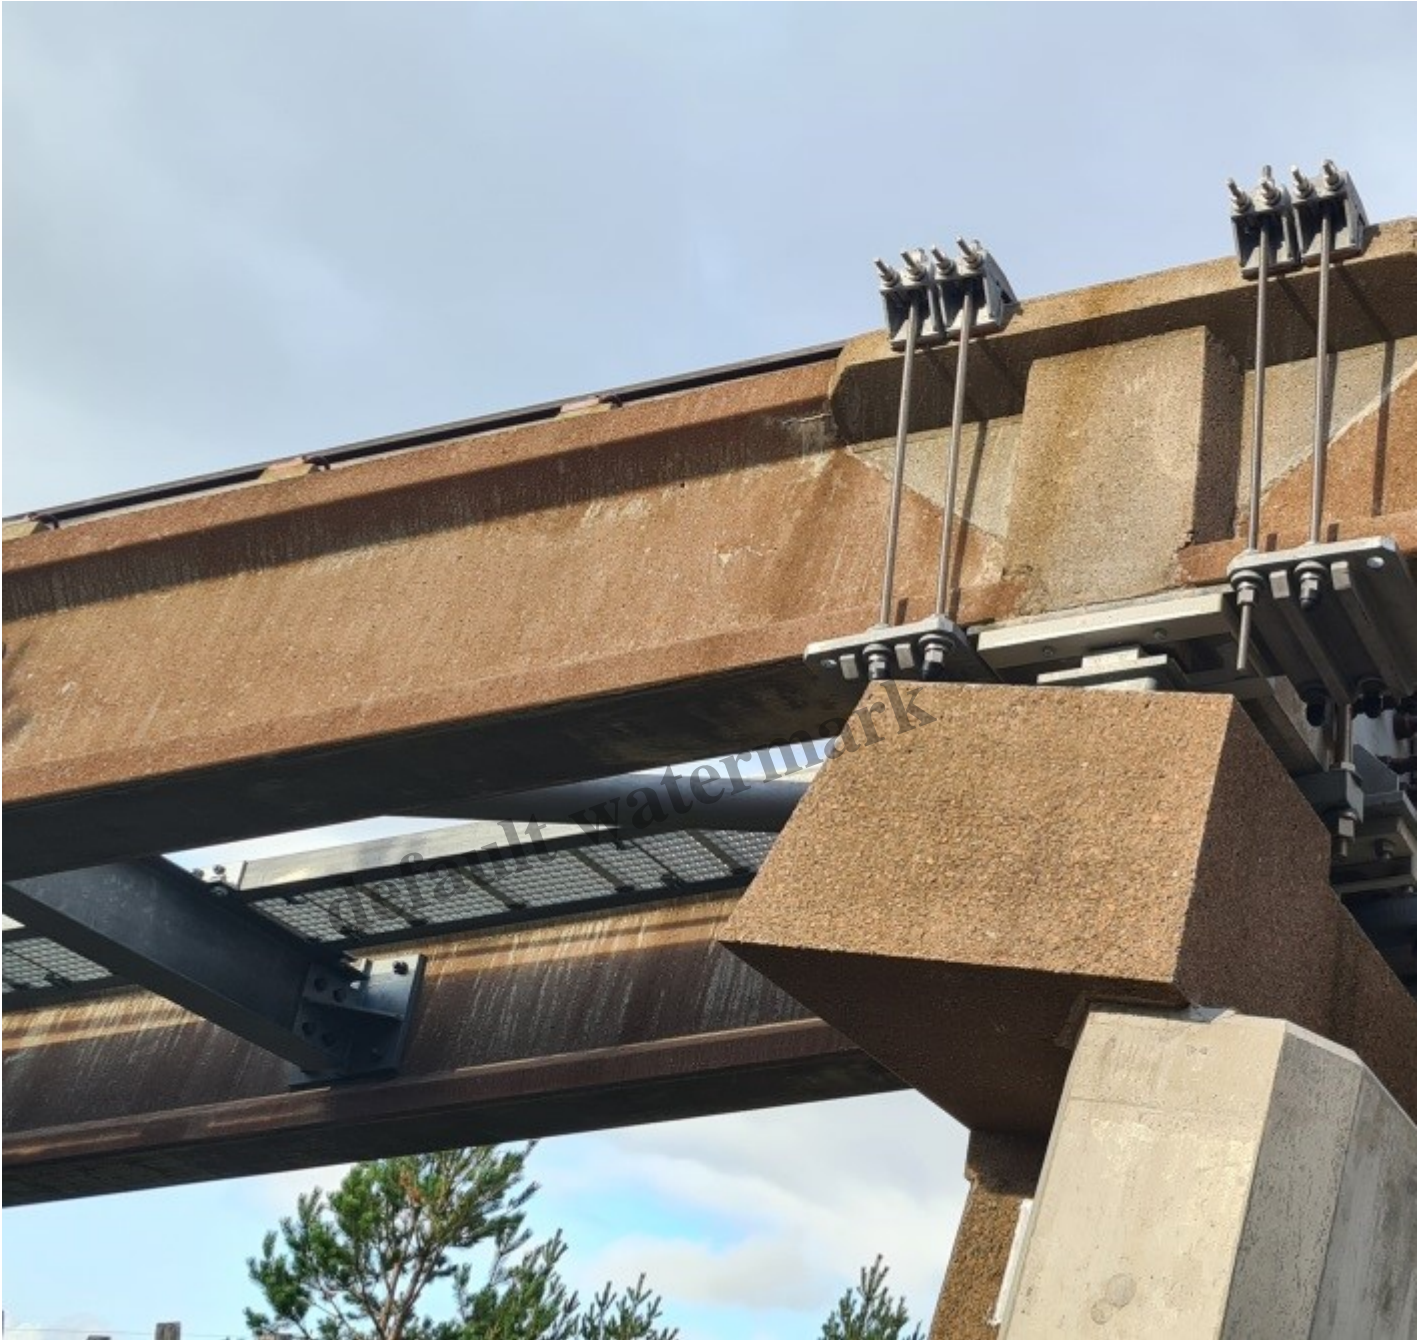
This photo shows how the scarf joints (where the “I” beams meet the in-situ blocks) have been strengthened. The “I” beams in this picture appear to be sound with no brackets holding them together but ingress into the joint

The real problem with more than tripling the weight of the beams was that their span meant they were too large to support their own weight given their intended use. It is for that reason that brackets have been added to strengthen the thinnest section of the beams on either side of each scarf joint as in the photo above.

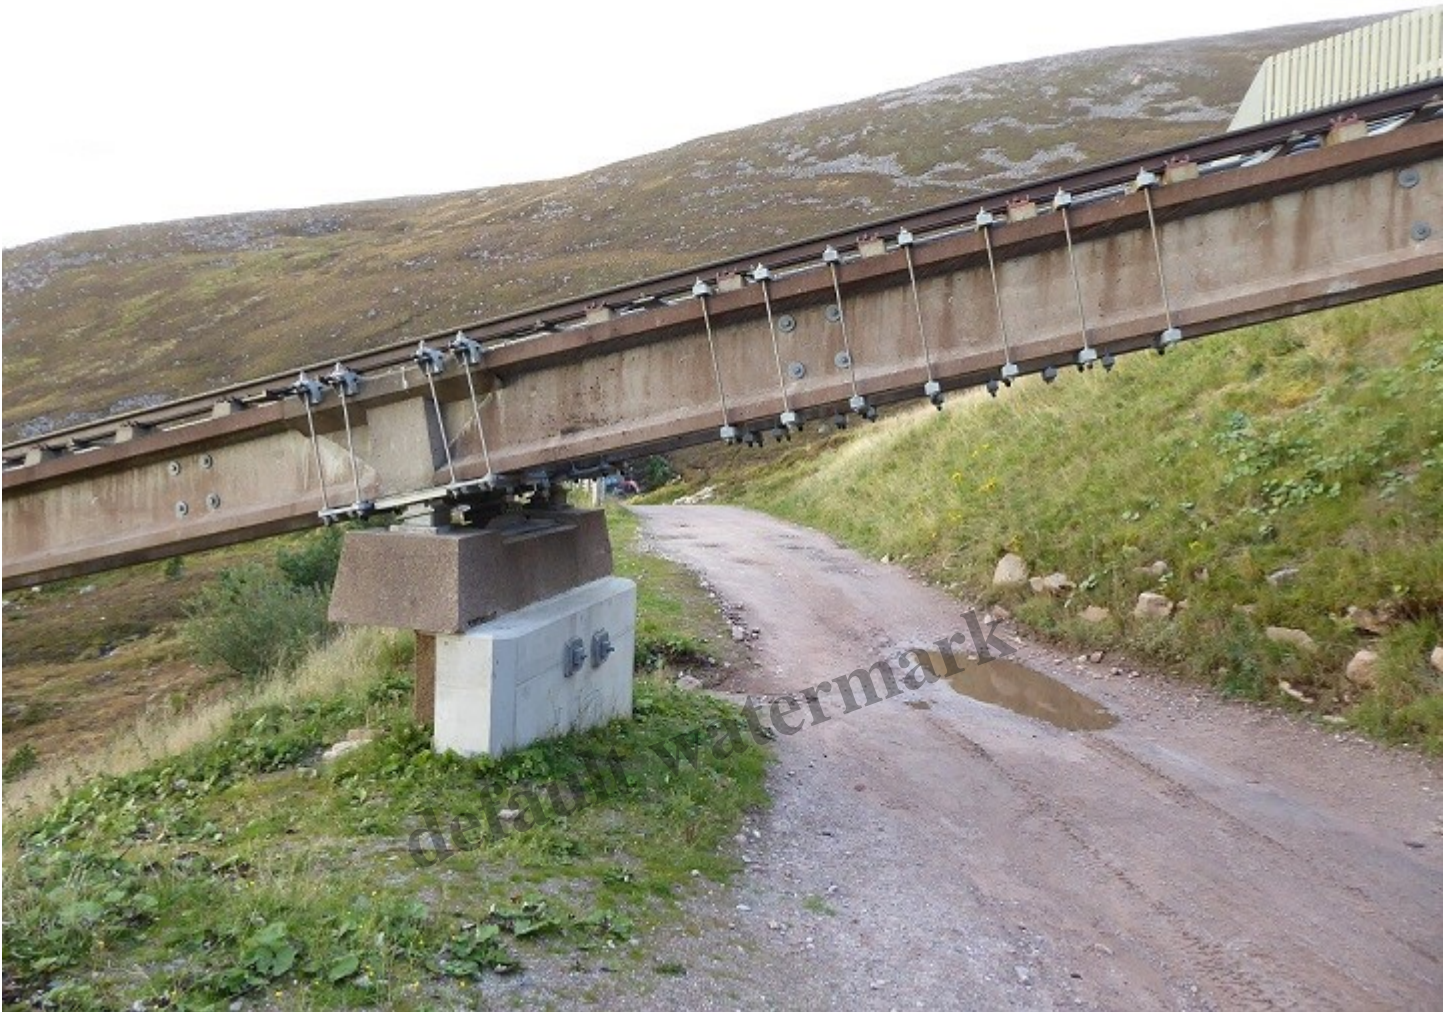
On many other beams, however, further brackets have been added to the strengthen the main section. This indicates the beams were at risk of breaking up.

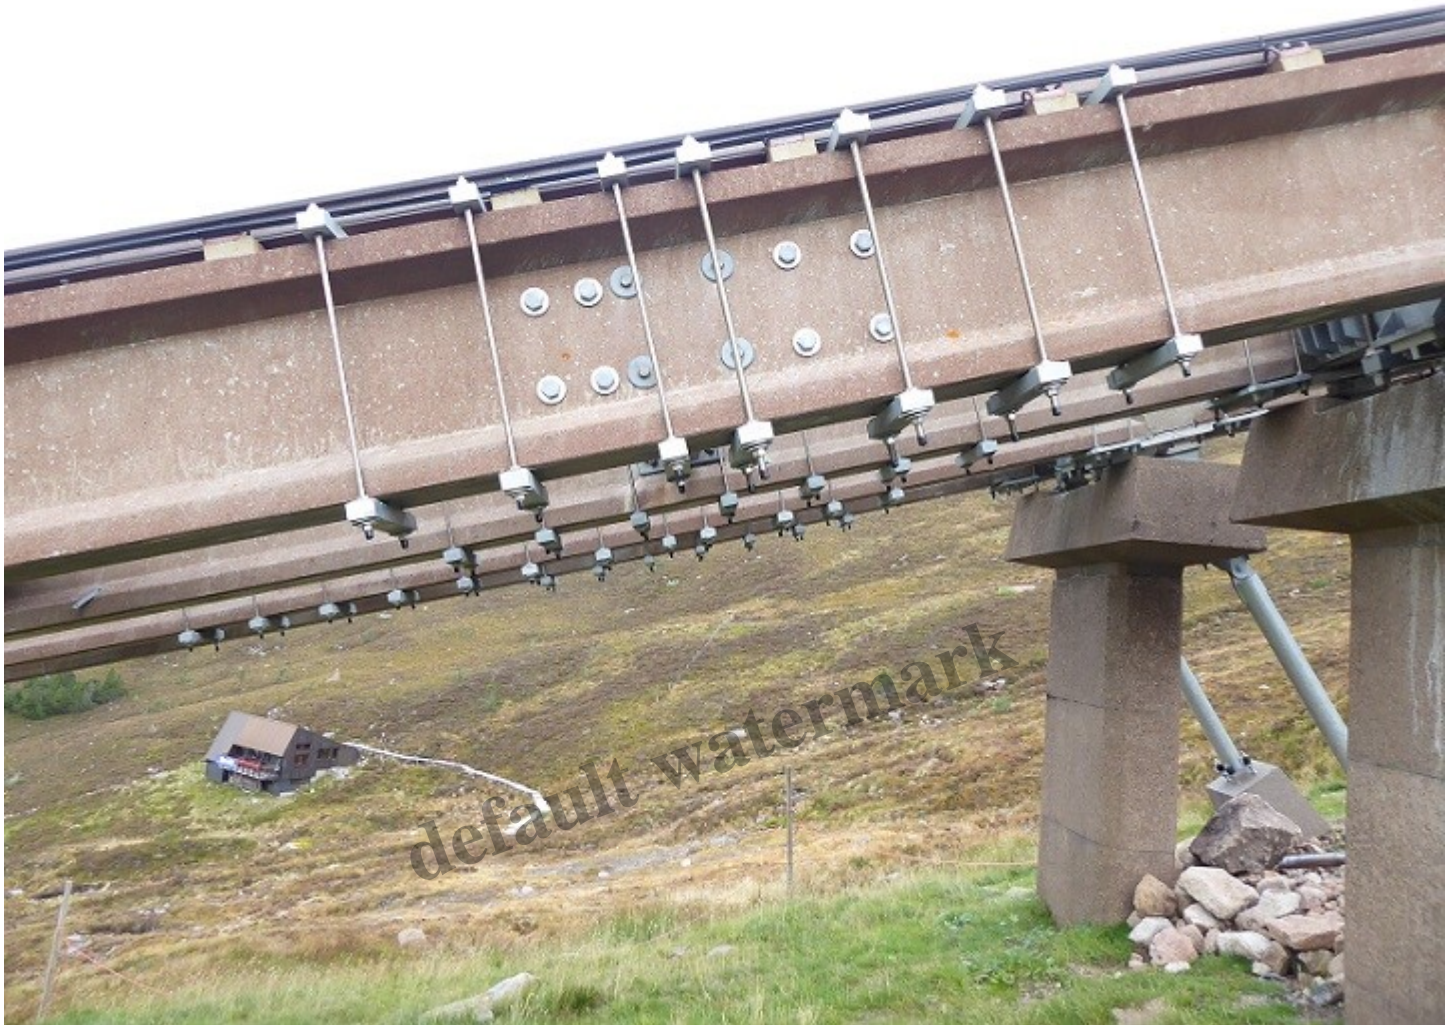
The numbers of brackets used to reinforce the concrete beams varies, as you can see from the photo above. This suggests that the risk of beams breaking up varied and when to use them was a finely judged exercise (easy to get wrong)

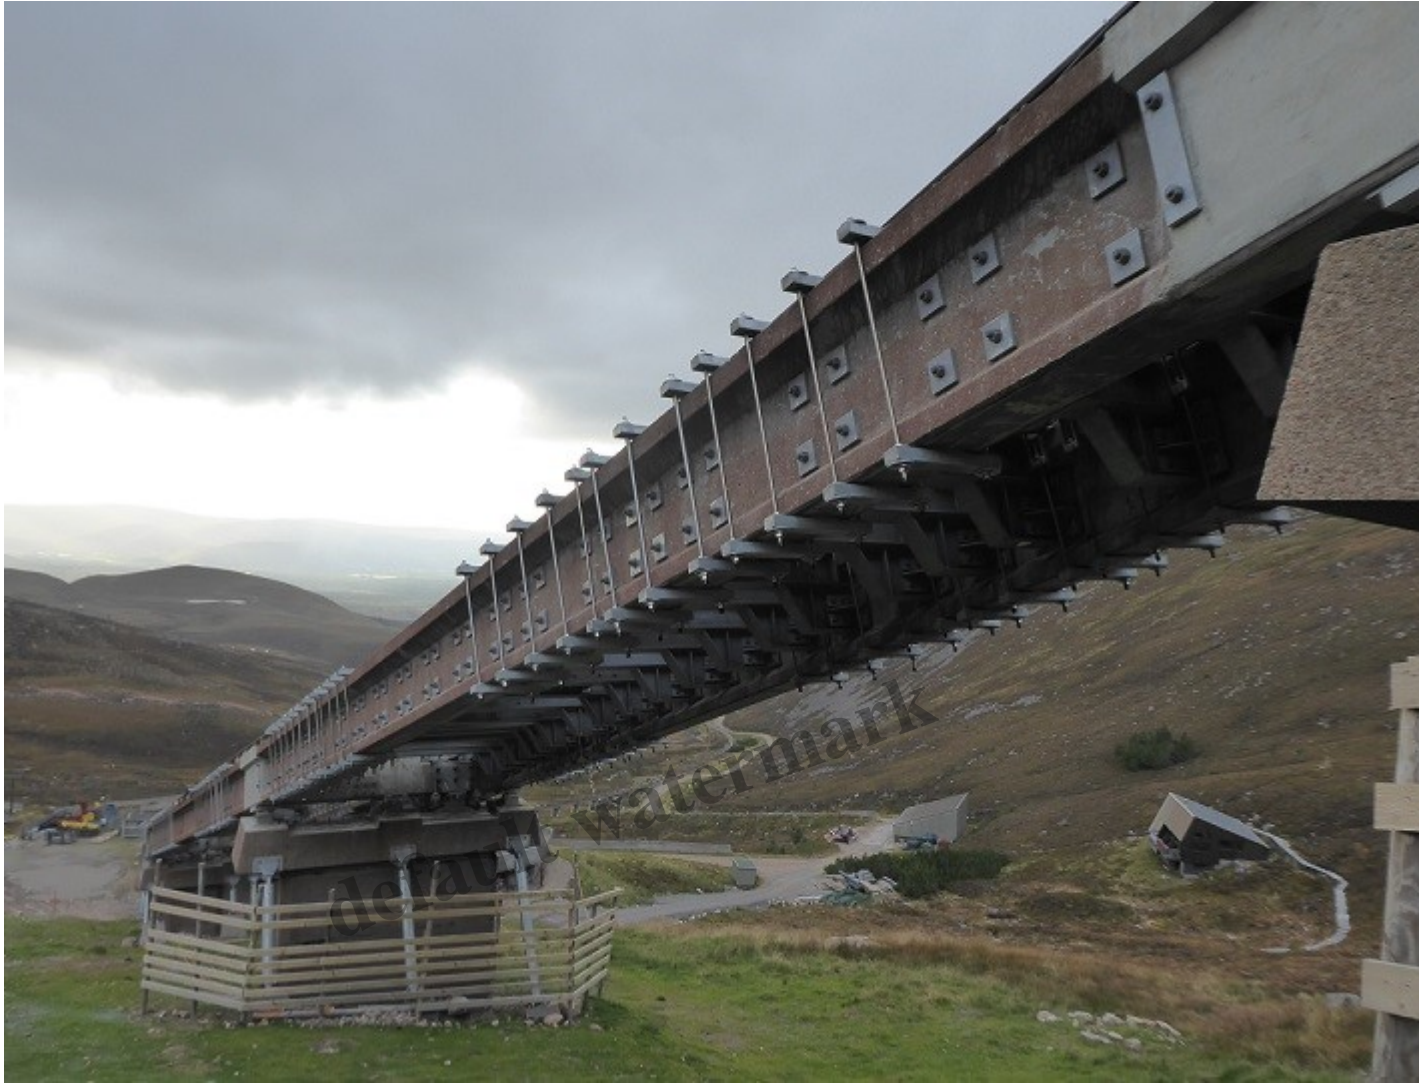
Photo showing the extensive use of metal reinforcing brackets by the mid-station

Some of the beams with brackets are at points which could have suffered higher stresses from the use of the railway:

- The beam below the exit from the tunnel at the top of the funicular;
- The beams immediately below the anchor blocks at Piers 78 and 65 (these are the only other reinforced beams between the tunnel and the mid-station);
- Around the mid-station;
- And on the curved sections below.

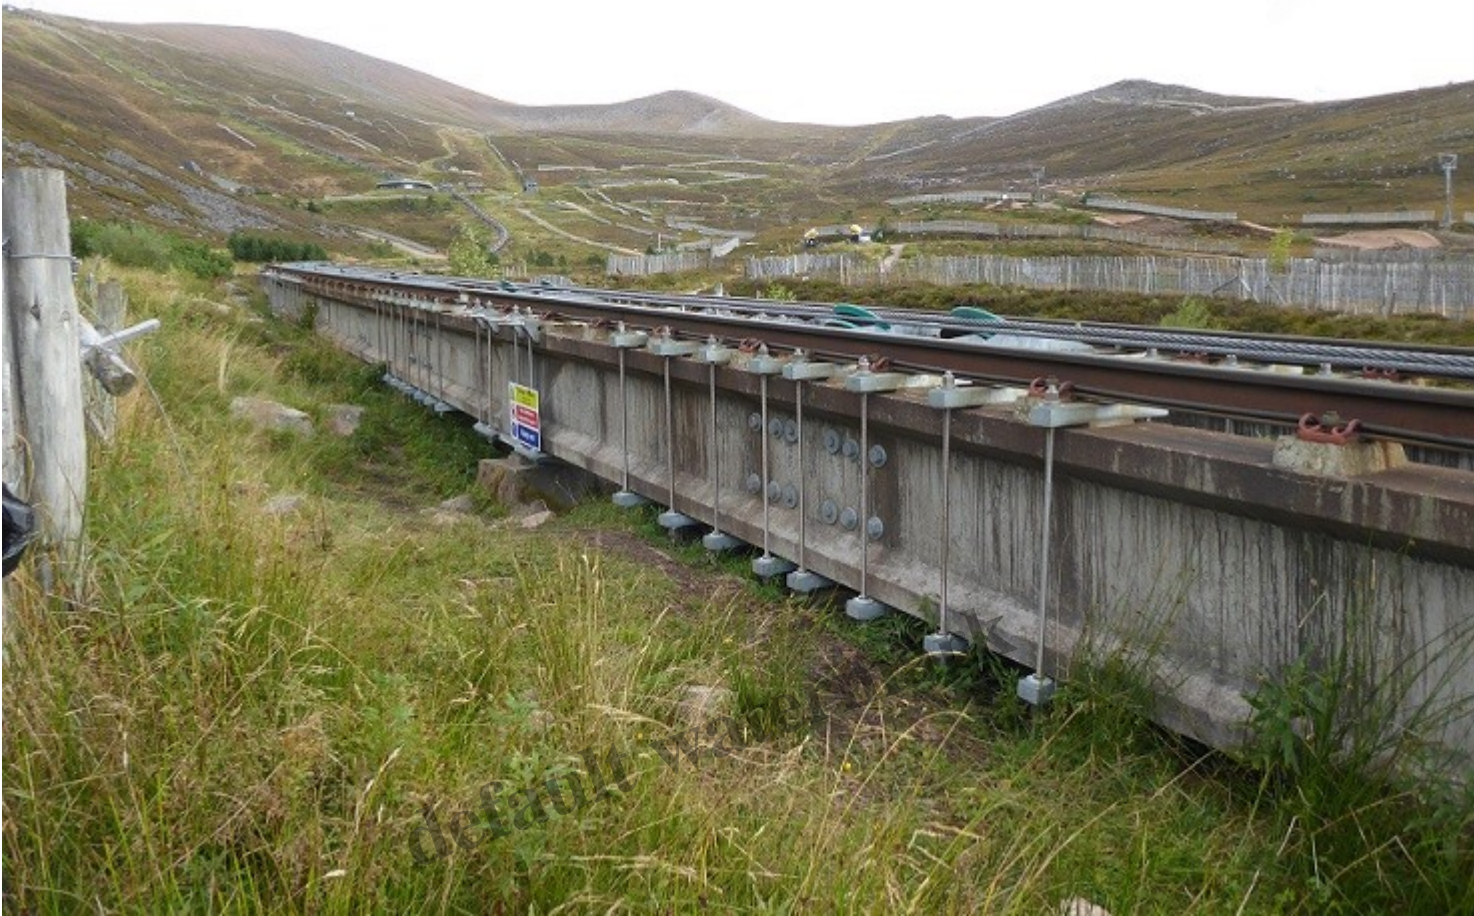
However, there are also brackets around beams on the lower section of straight horizontal track. This suggests that some of the beams may have been breaking up under their own weight.
