HIE's decision to close the Cairn Gorm funicular again! (2) What's happening?

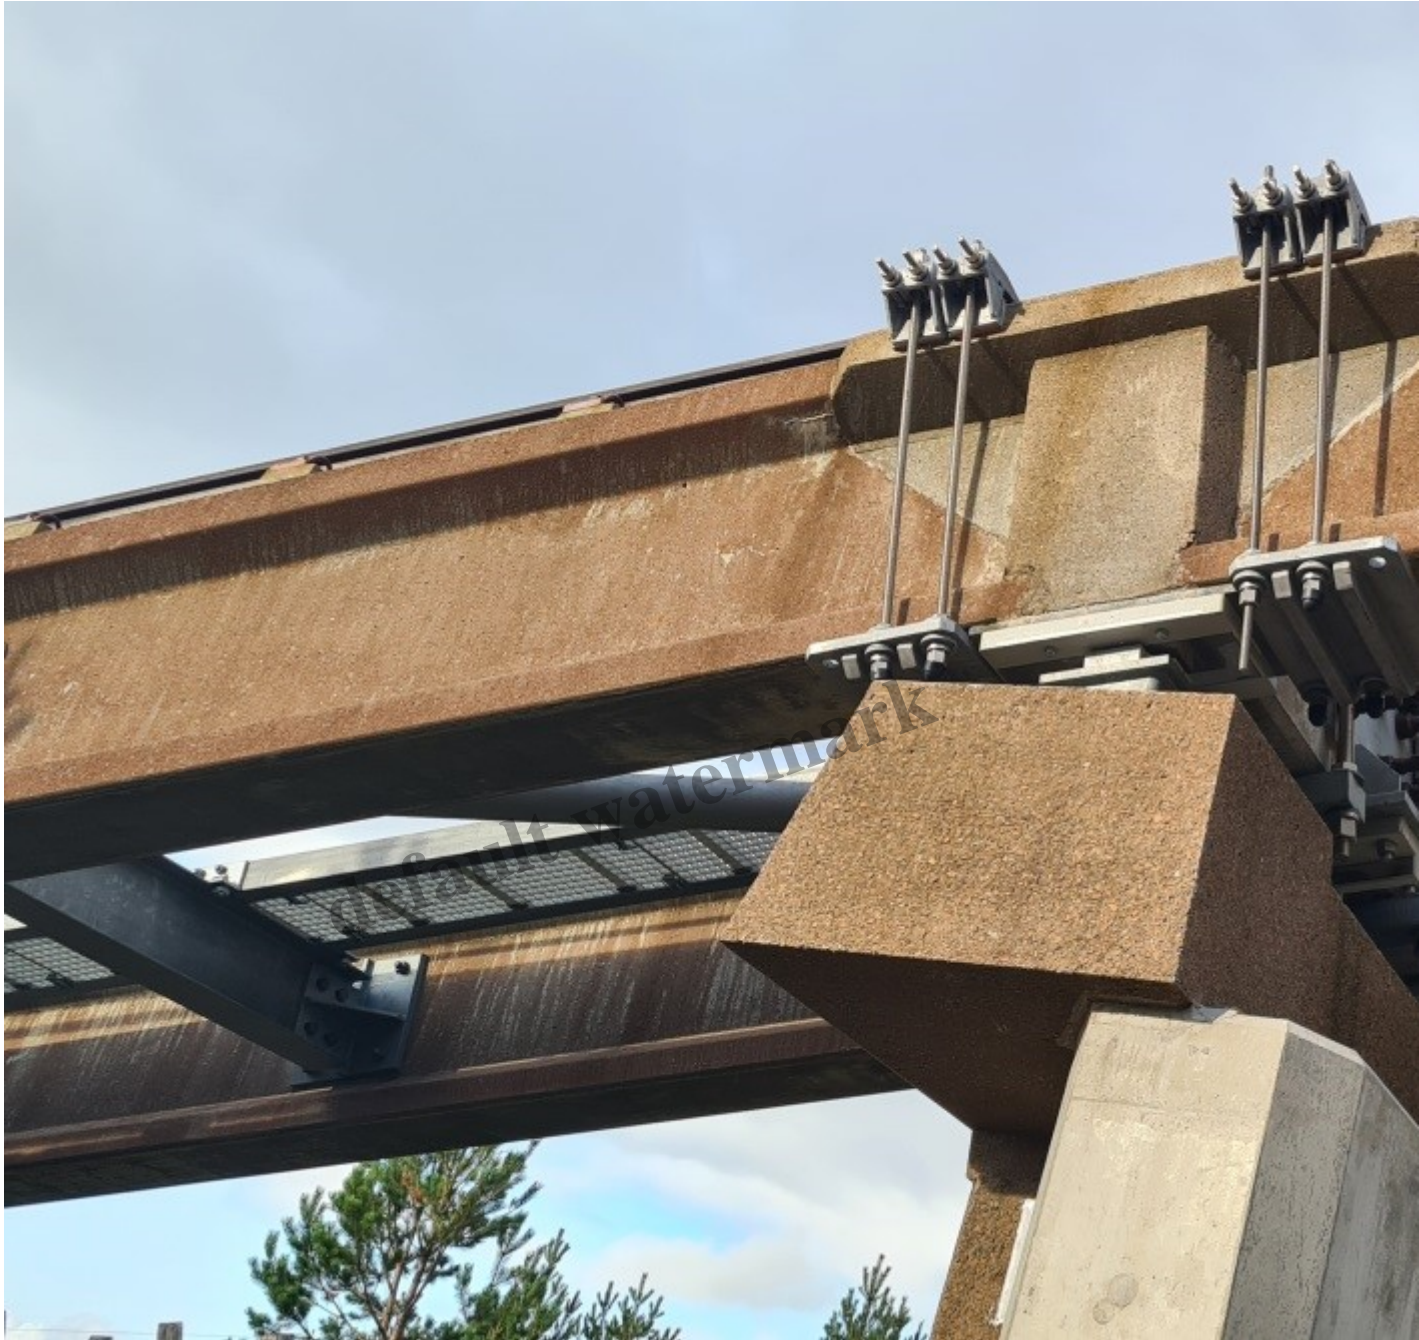
This photo shows how the scarf joints (where the “I” beams meet the in-situ blocks) have been strengthened. The “I” beams in this picture appear to be sound with no brackets holding them together but ingress into the joint

The real problem with more than tripling the weight of the beams was that their span meant they were too large to support their own weight given their intended use. It is for that reason that brackets have been added to strengthen the thinnest section of the beams on either side of each scarf joint as in the photo above.

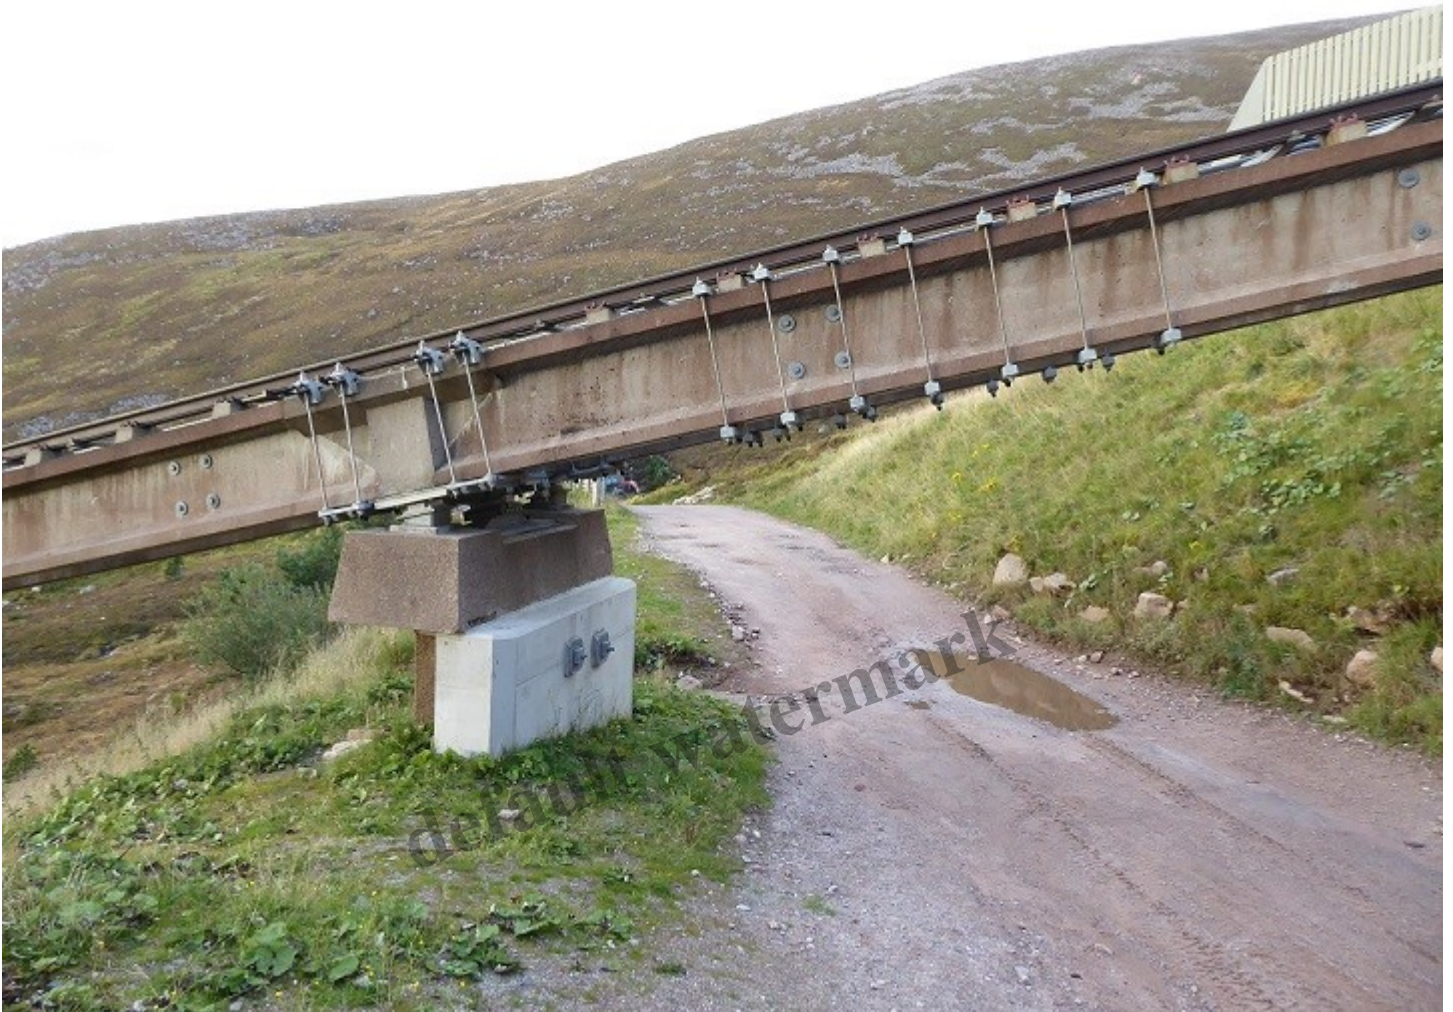
On many other beams, however, further brackets have been added to the strengthen the main section. This indicates the beams were at risk of breaking up.

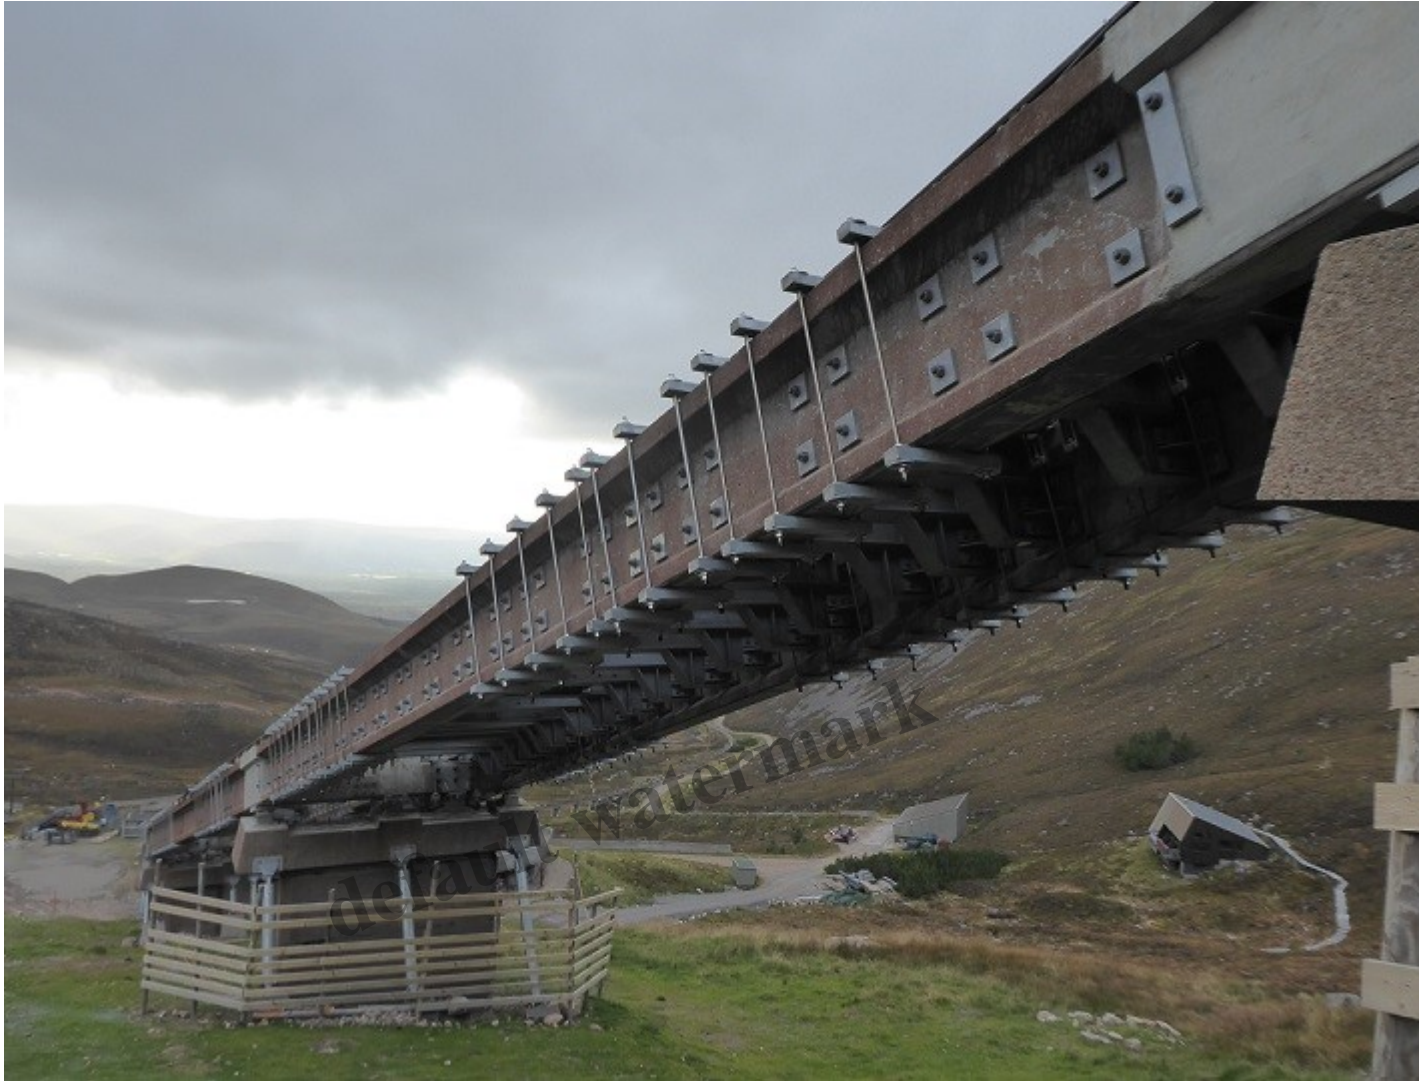
Photo showing the extensive use of metal reinforcing brackets by the mid-station
