HIE's decision to close the Cairn Gorm funicular again! (2) What's happening?

The repairs to the concrete support beams and current ‘snagging’ issues at Cairn Gorm

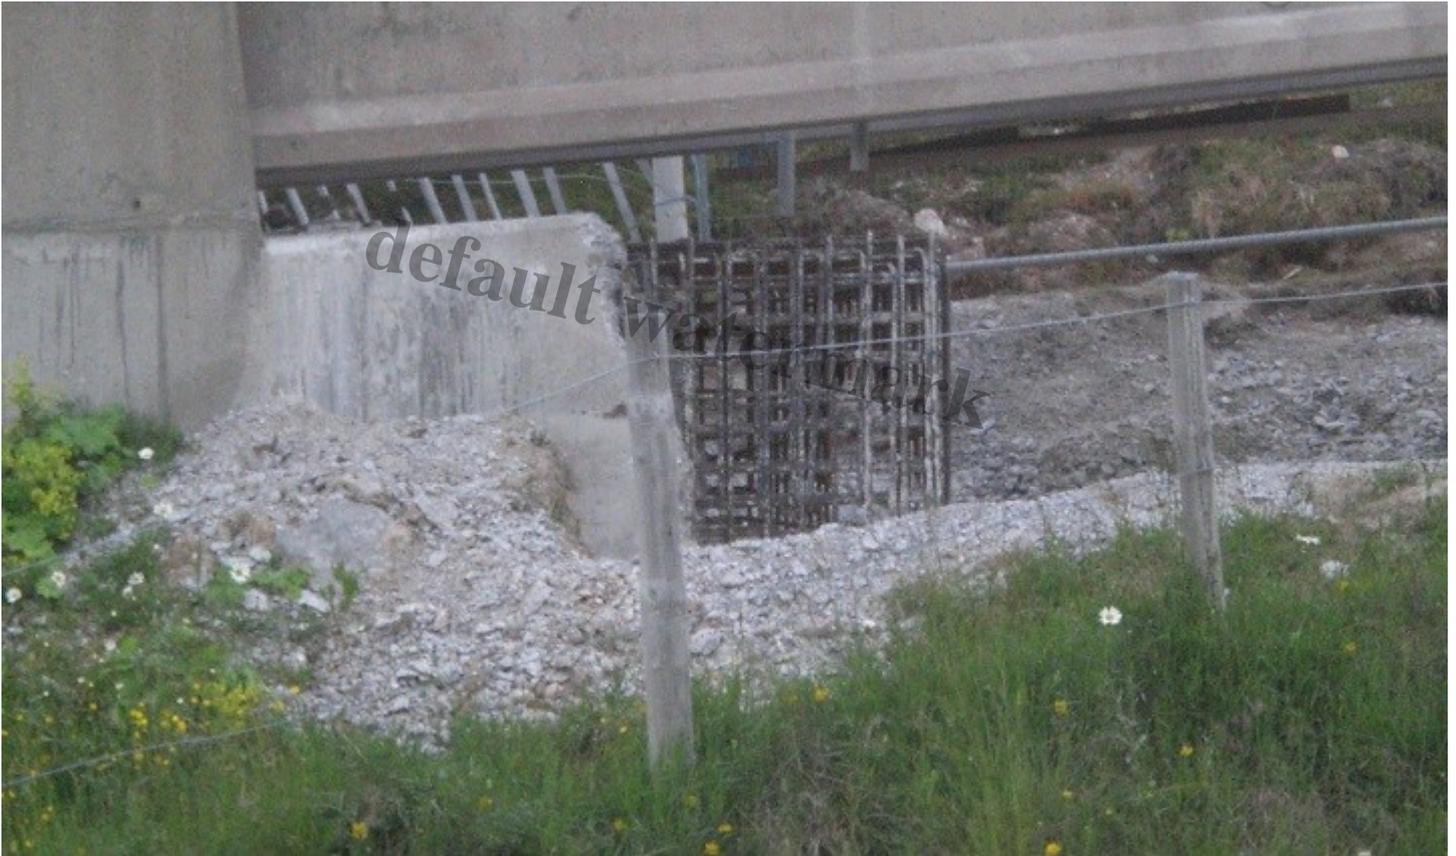
The bottom anchor block (photo above) which is designed to stop the section of railway above moving downhill and a few piers (photo below) have been reinforced but this is the exception, not the rule, and the explanation for why this was needed in these cases is unclear.

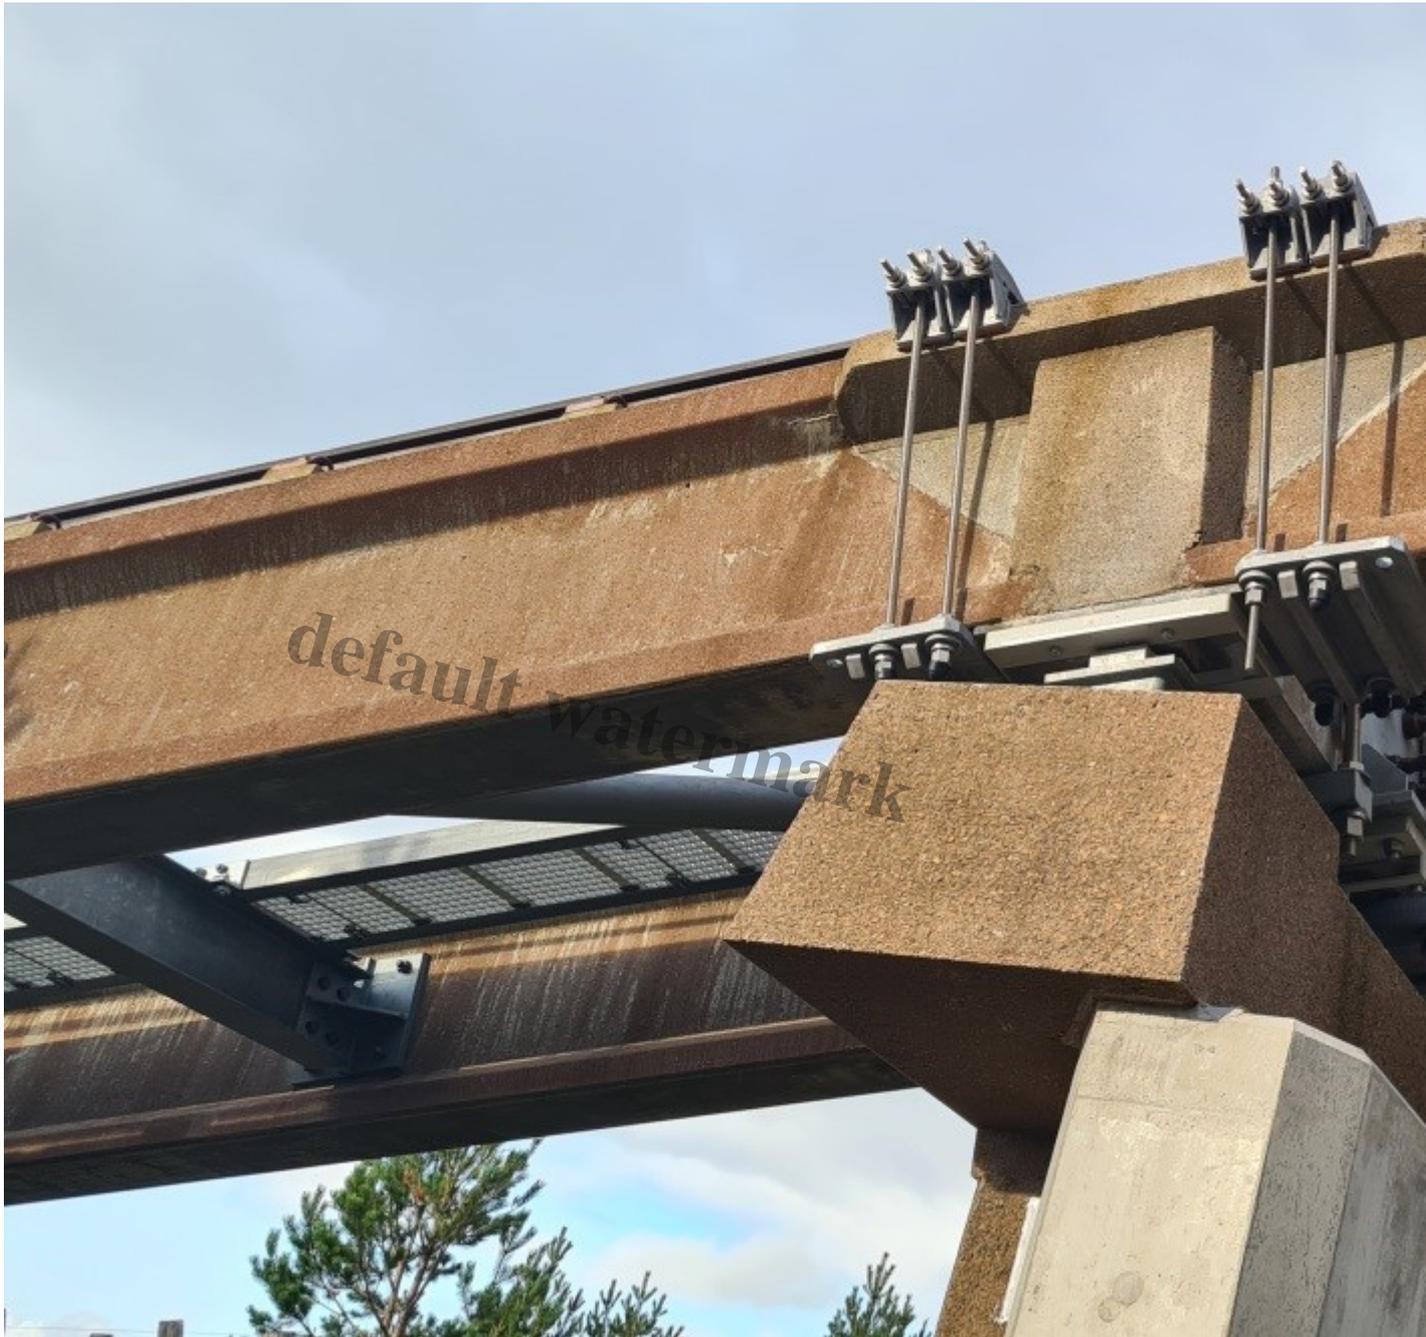
This photo shows how the scarf joints (where the beams meet the in-situ blocks) have been added. The beams in this picture appear to be sound with no brackets holding them together ingress into the joint

The real problem with more than tripling the weight of the beams was that their span meant they were too large to support their own weight given their intended use. It is for that reason that brackets have been added to strengthen the thinnest section of the beams on either side of each scarf joint as in the photo above.

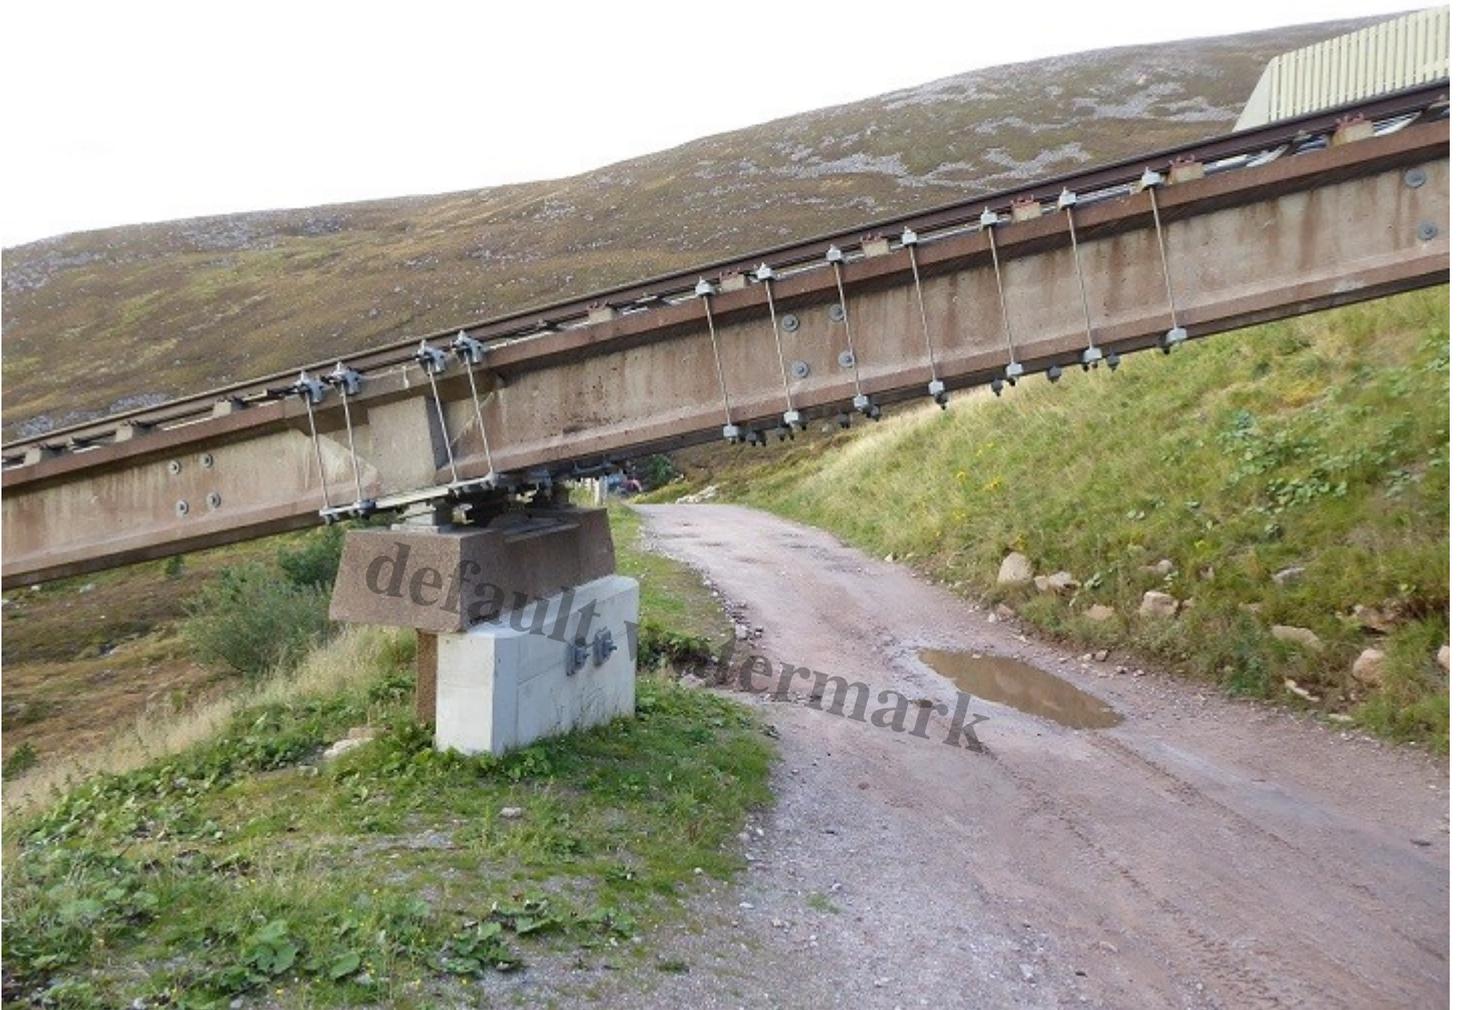
On many other beams, however, further brackets have been added to the strengthen the main section. This indicates the beams were at risk of breaking up.

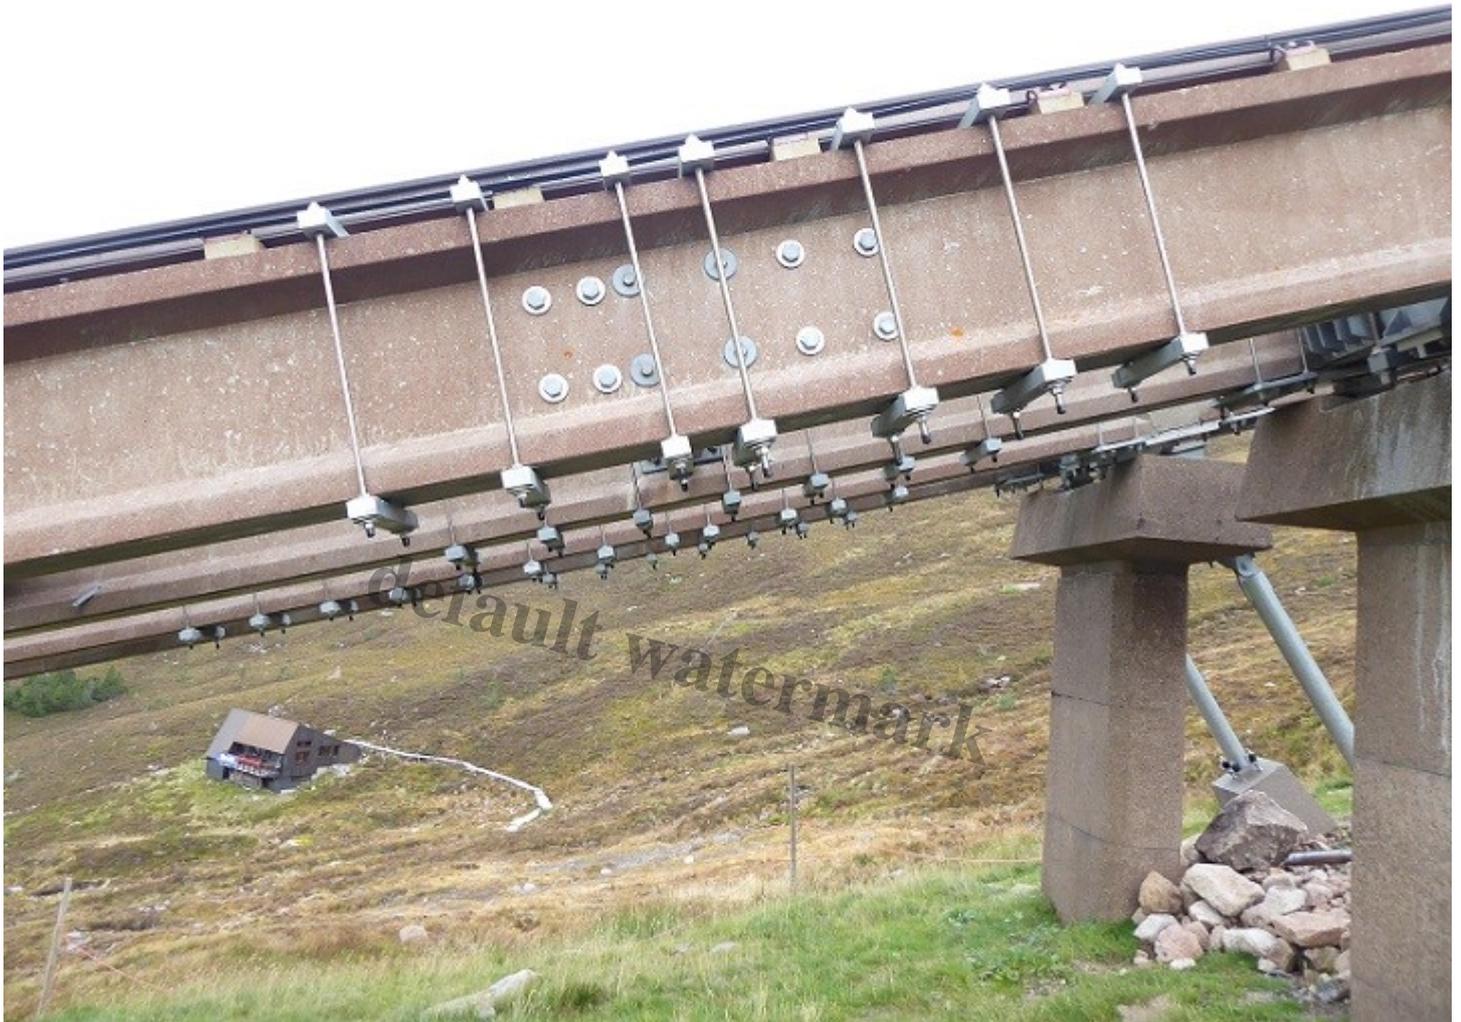
The numbers of brackets used to reinforce the concrete beams varies, as you can see from the photo above. This suggests that the risk of beams breaking up varied and when to use them was a finely judged exercise (easy to get wrong)

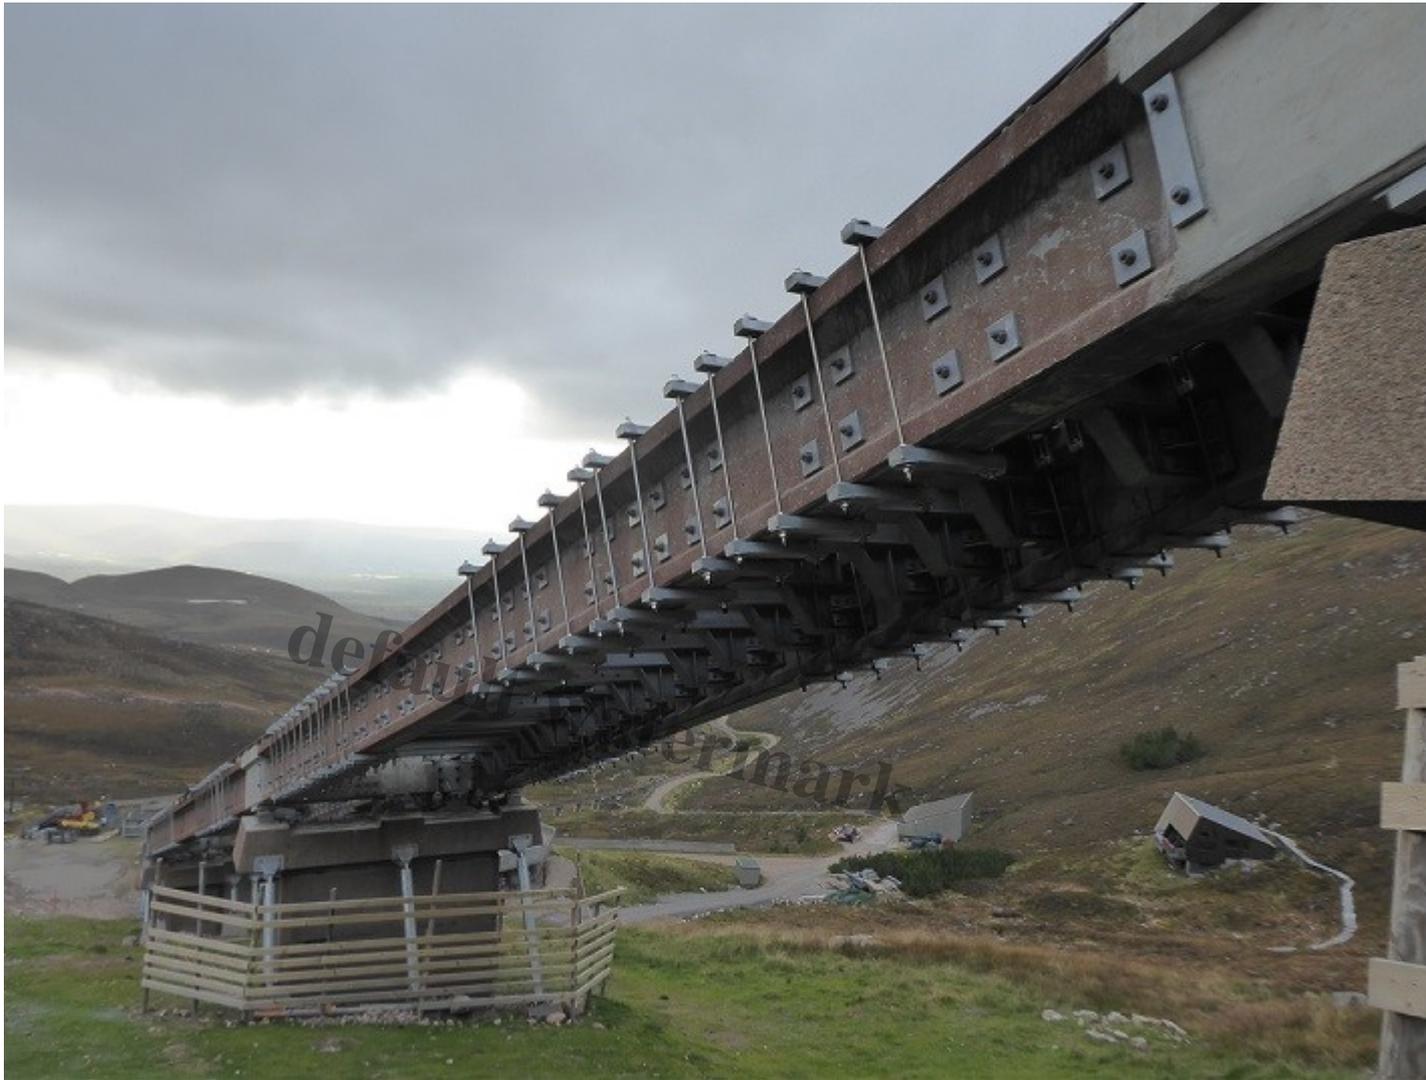
Photo showing the extensive use of metal reinforcing brackets by the mid-station

Some of the beams with brackets are at points which could have suffered higher stresses from the use of the railway:

- The beam below the exit from the tunnel at the top of the funicular;
- The beams immediately below the anchor blocks at Piers 78 and 65 (these are the only other reinforced beams between the tunnel and the mid-station);
- Around the mid-station;
- And on the curved sections below.

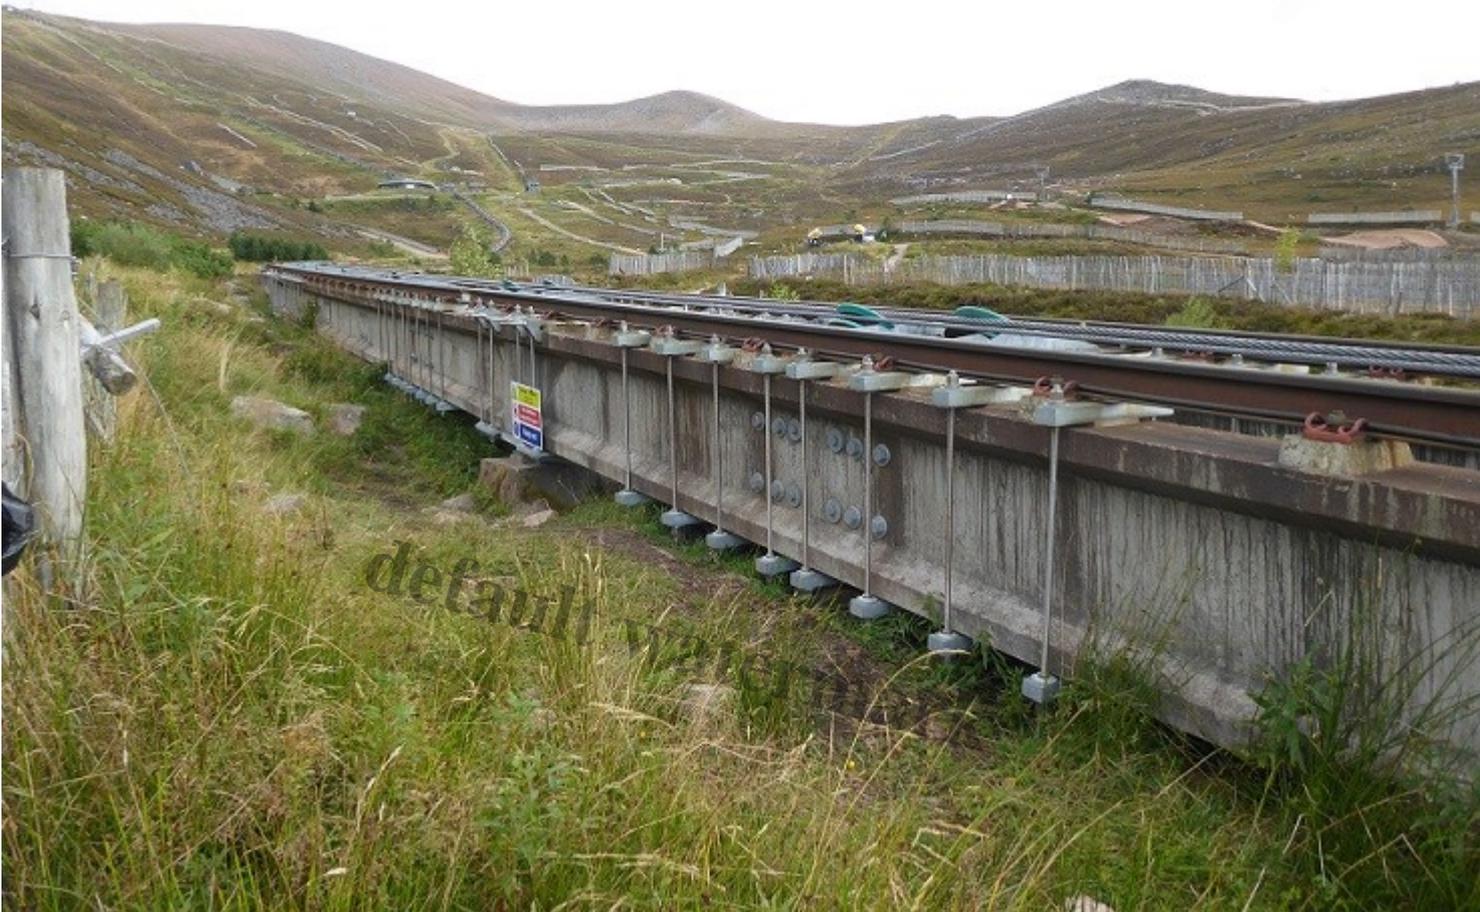
However, there are also brackets around beams on the lower section of straight horizontal track. This suggests that some of the beams may have been breaking up under their own weight.
