## HIE, concrete and the death of Cairn Gorm as a ski resort (2)?

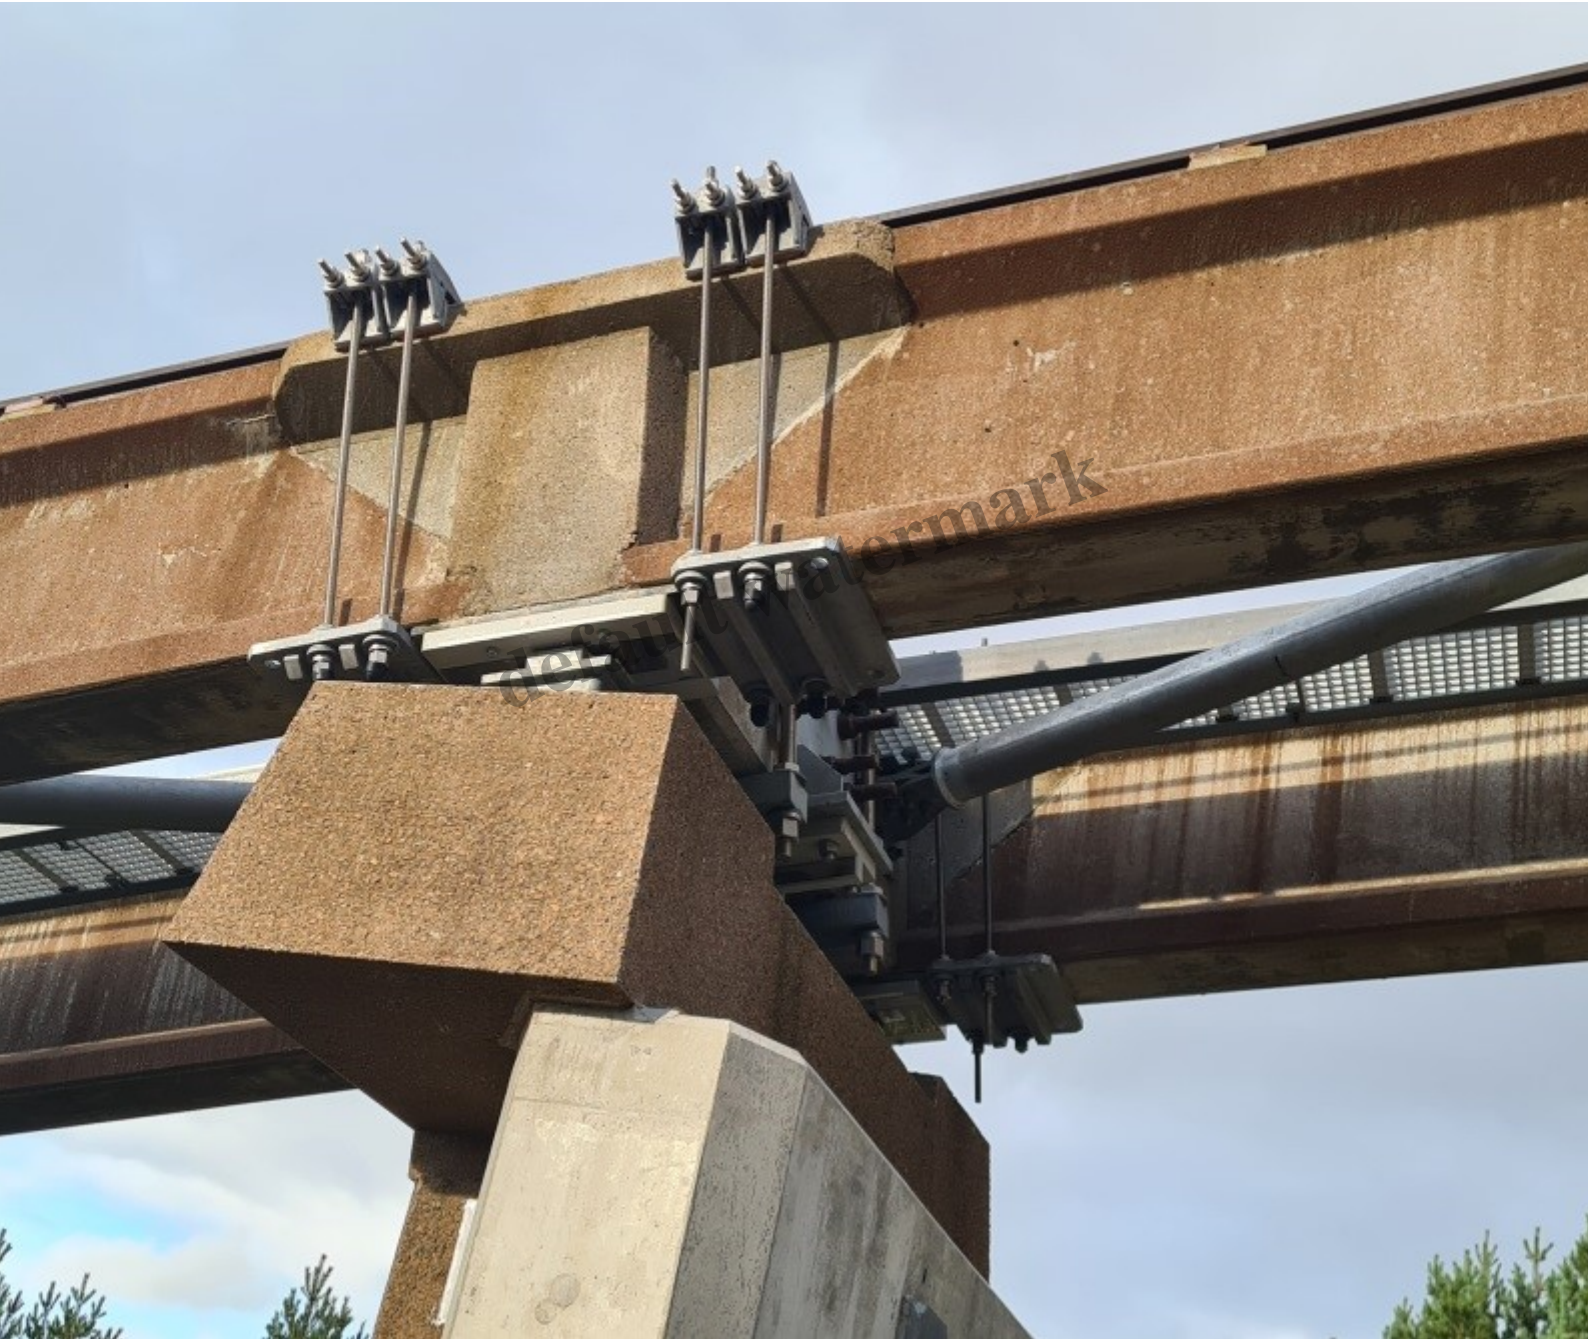
After my last post I had conversations with a couple of people about my conclusions that the insitu stitch/ joints are the wrong way up, i.e. instead of the joint being wedge shaped, as in the picture above, it should be more of a pyramid, as in my drawing below.

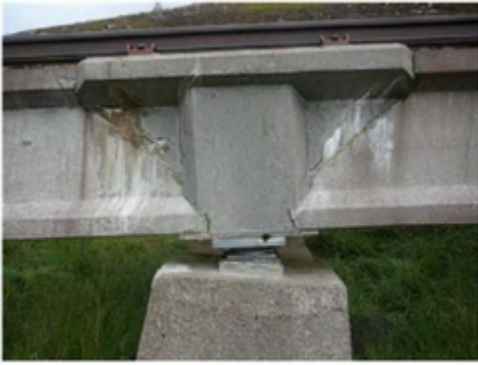
Photo [12] Pier 8, one of the poorer insitu infills. Showing joints opening between Insitu and precast plus cracking within the mass of the Insitu, both inclined and near vertical.

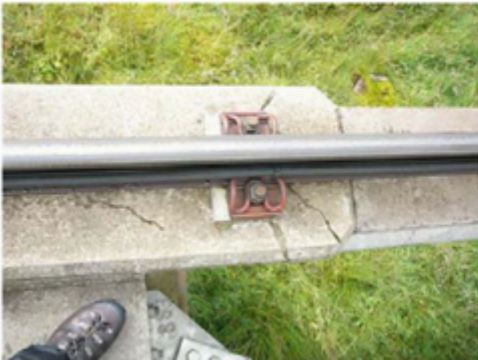
Photo [13] Pier 8 from above.

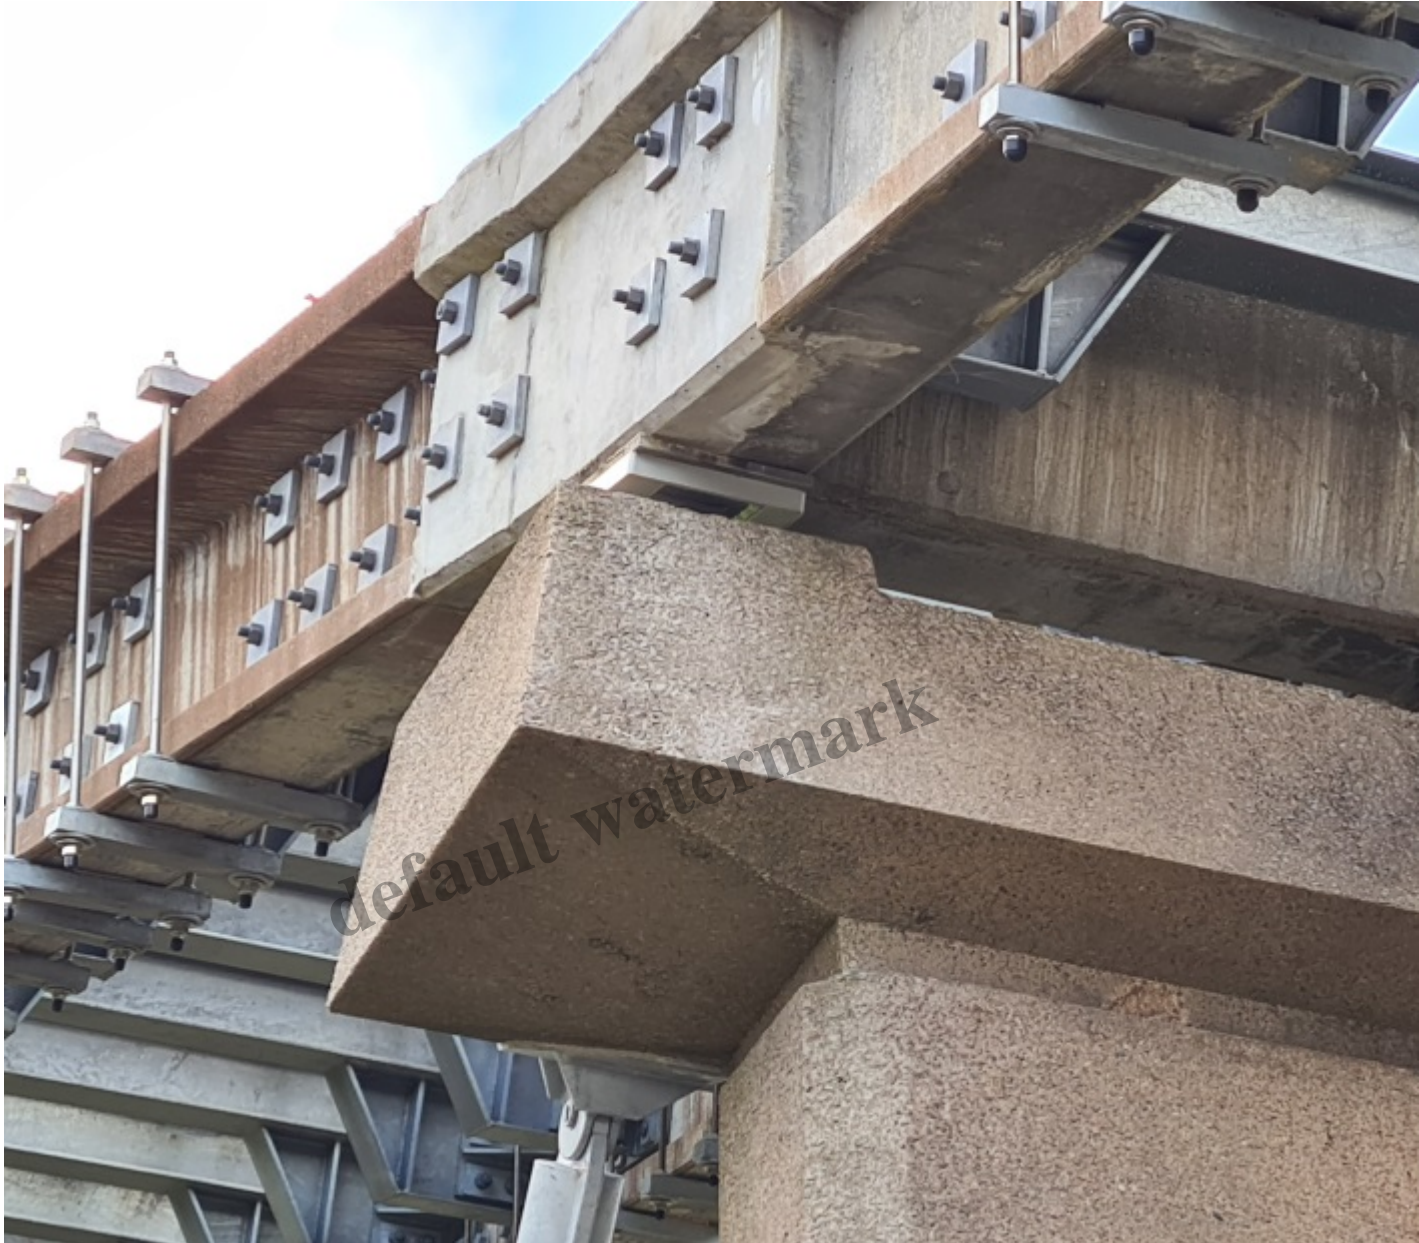
A rectangular insitu joint would have been much easier and cheaper to form than either the wedge or the pyramid and appears to be what Balfour Beatty have done at Pier 51 at the passing loop as shown below.

Notice what appears to be a V shaped calcite bleed near the centre of this insitu joint under the metal

This joint may be not as pleasing visually but probably more effective.

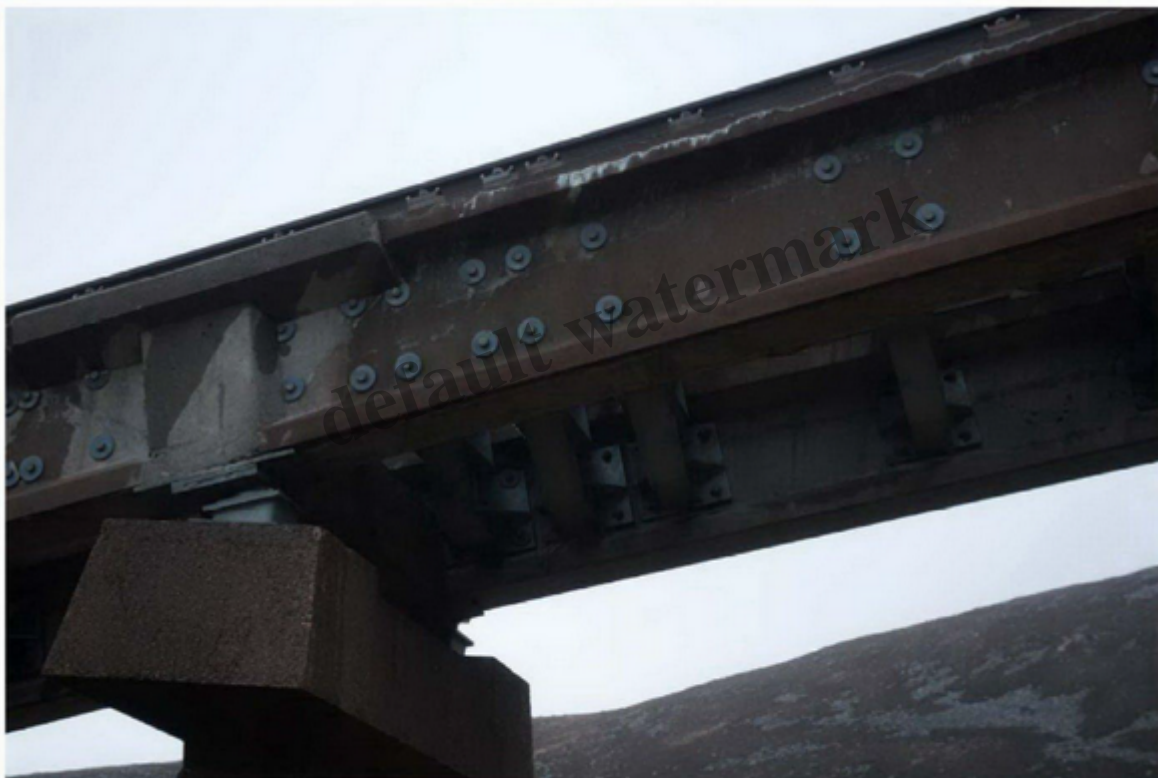
View of side face of Beam 51/R

The beam above Pier 51,see photo below, is an example of how quickly the size of these cracks can become a major problem, increasing from a few centimetres in 2016 to half its length in July 2017.

*5.1 It was concluded that the observed crack were a developing situation, due to the fact that it was only first noticed in 2016 and that the calcite bleed is more developed at one end.*

*5.2 It is thought that the problem is a latent defect within the original fabrication of the beams, most likely due to a cold joint within the concrete pour.*

*5.3 It was concluded that there is no imminent danger of the beams collapsing.*

5.4 If left the beams will continue to deteriorate and stability issues would arise.”

6.1 Having halted train operations whilst this situation was assessed it was recommended that the train could resume operating, but under a reduced scope– until remedial action is taken:

- The maximum number of passengers and luggage allowed in the operating and maintenance manual is 10050kg, or 120 people. This should be reduced to 5000kg or 60 people, evenly distributed through the compartments.
- It is understood that the train operates at 4m/s during the summer months. This should not be exceeded.

6.2 In the short term temporary supports should be installed under the pair of beams above pier 51. These should be braced in both directions. A suitable scaffolding or temporary works contractor should be appointed to carry this out under the guidance of your Engineer. This support will be required both to enable resumption of normal operations and for the period of time when the permanent solution is implemented. This arrangement should be suitable for being left in place through the winter and until next summer when the permanent solution should be implemented.

6.3 During the 2018 summer shut down beam 51/R should be repaired by removing the entire top flange, which will necessitate the removal of all the rail supports; and re-cast using a suitable product. These works should be planned ahead and suitable contractors appointed ahead of time to enable them to guarantee their availability come the time.

6.4 The beam should be inspected on a regular basis, including particular daily observations, for any deterioration in its condition or negative impacts on the plinths.

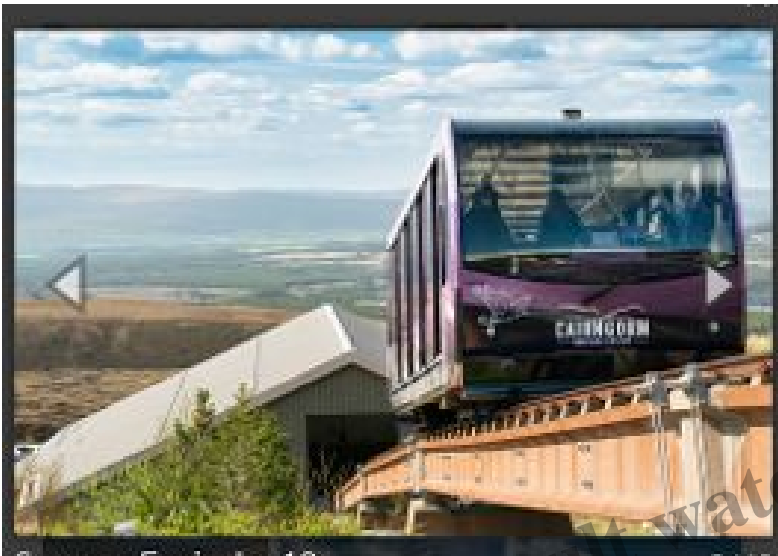
A crack in the vertical plane of one of the concrete “I” beams is unlikely to be noticed and could cause an instant and catastrophic failure of the beam as a carriage crosses it, the result of which you can imagine! Is this next picture of a beam about to collapse? Unless it is an optical illusion that beam has dropped as the train went onto it.
