HIE, concrete and the death of Cairn Gorm as a ski resort (2)?

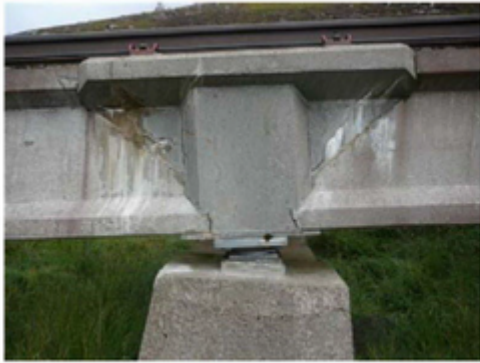
Photo [12] Pier 8, one of the poorer insitu infills. Showing joints opening between Insitu and precast plus cracking within the mass of the Insitu, both inclined and near vertical.

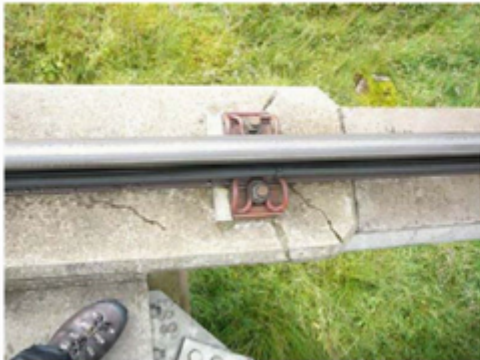
Photo [13] Pier 8 from above.

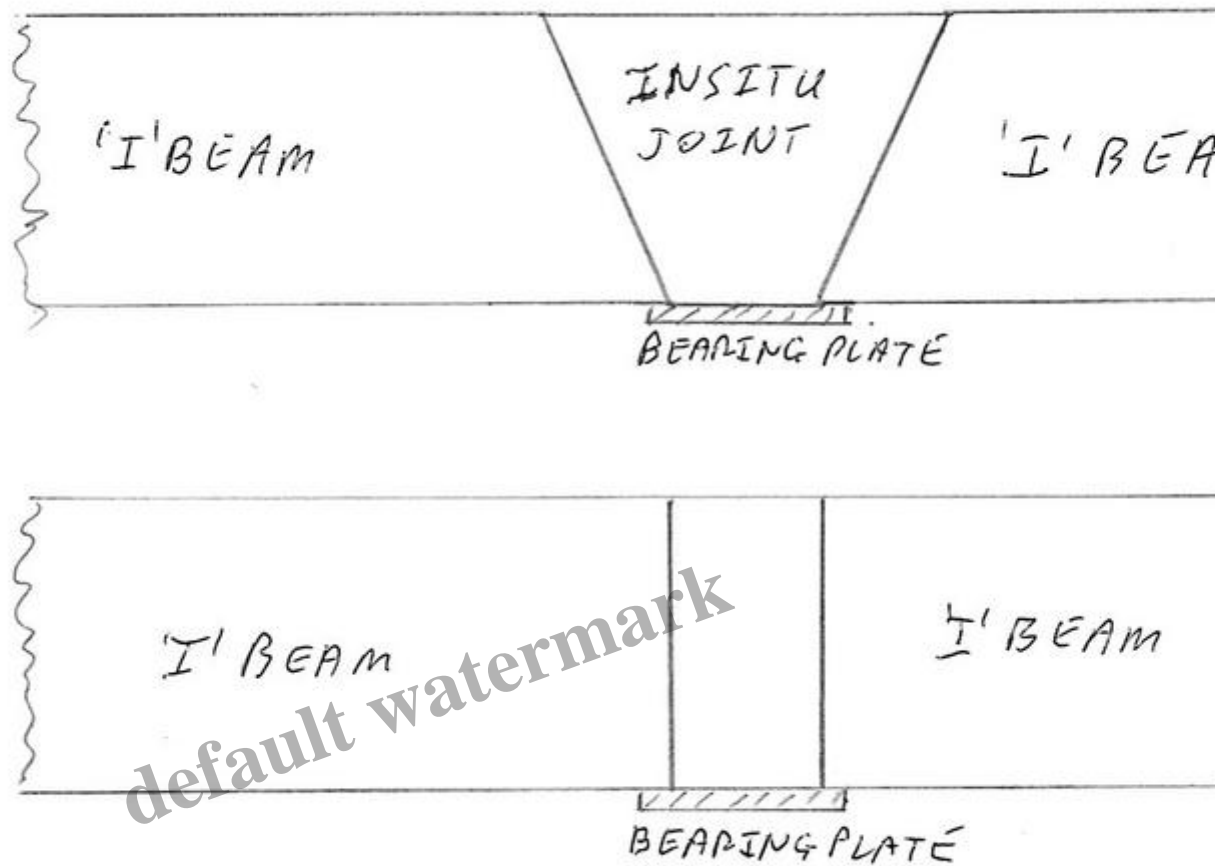
Having said that, there is a third option, the beams could have been made with straight, vertical ends, as shown below,

The bearing plate is the same length but supporting the whole end of each beam. A better design would be longer

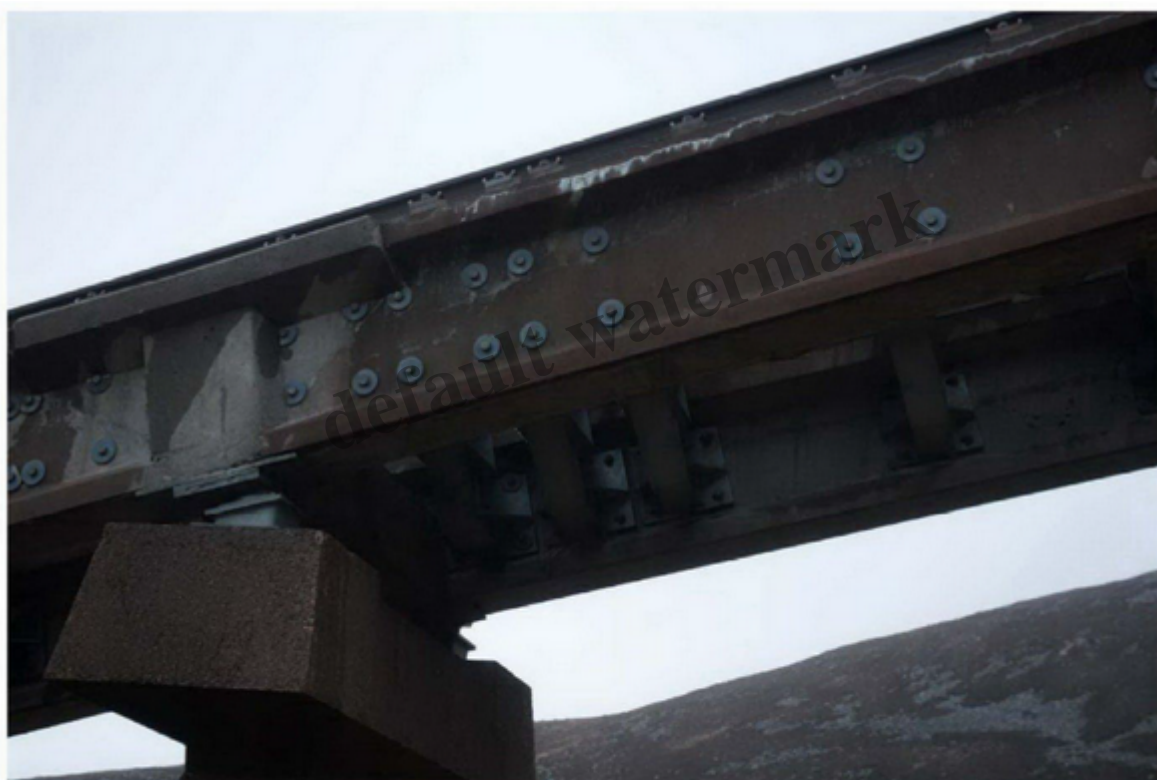
View of side face of Beam 51/R

The beam above Pier 51,see photo below, is an example of how quickly the size of these cracks can become a major problem, increasing from a few centimetres in 2016 to half its length in July 2017.

5.1 It was concluded that the observed crack were a developing situation, due to the fact that it was only first noticed in 2016 and that the calcite bleed is more developed at one end.

5.2 It is thought that the problem is a latent defect within the original fabrication of the beams, most likely due to a cold joint within the concrete pour.

5.3 It was concluded that there is no imminent danger of the beams collapsing.

5.4 If left the beams will continue to deteriorate and stability issues would arise.”

6.1 Having halted train operations whilst this situation was assessed it was recommended that the train could resume operating, but under a reduced scope– until remedial action is taken:

- The maximum number of passengers and luggage allowed in the operating and maintenance manual is 10050kg, or 120 people. This should be reduced to 5000kg or 60 people, evenly distributed through the compartments.
- It is understood that the train operates at 4m/s during the summer months. This should not be exceeded.

6.2 In the short term temporary supports should be installed under the pair of beams above pier 51. These should be braced in both directions. A suitable scaffolding or temporary works contractor should be appointed to carry this out under the guidance of your Engineer. This support will be required both to enable resumption of normal operations and for the period of time when the permanent solution is implemented. This arrangement should be suitable for being left in place through the winter and until next summer when the permanent solution should be implemented.

6.3 During the 2018 summer shut down beam 51/R should be repaired by removing the entire top flange, which will necessitate the removal of all the rail supports, and re-cast using a suitable product. These works should be planned ahead and suitable contractors appointed ahead of time to enable them to guarantee their availability come the time.

6.4 The beam should be inspected on a regular basis, including particular daily observations, for any deterioration in its condition or negative impacts on the plinths.

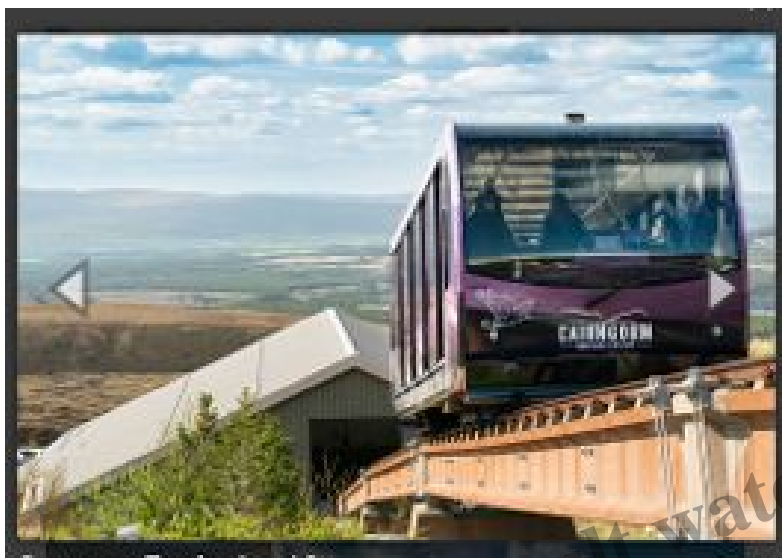
A crack in the vertical plane of one of the concrete “I” beams is unlikely to be noticed and could cause an instant and catastrophic failure of the beam as a carriage crosses it, the result of which you can imagine! Is this next picture of a beam about to collapse? Unless it is an optical illusion that beam has dropped as the train went onto it.
