HIE, concrete and the death of Cairn Gorm as a ski resort (2)?

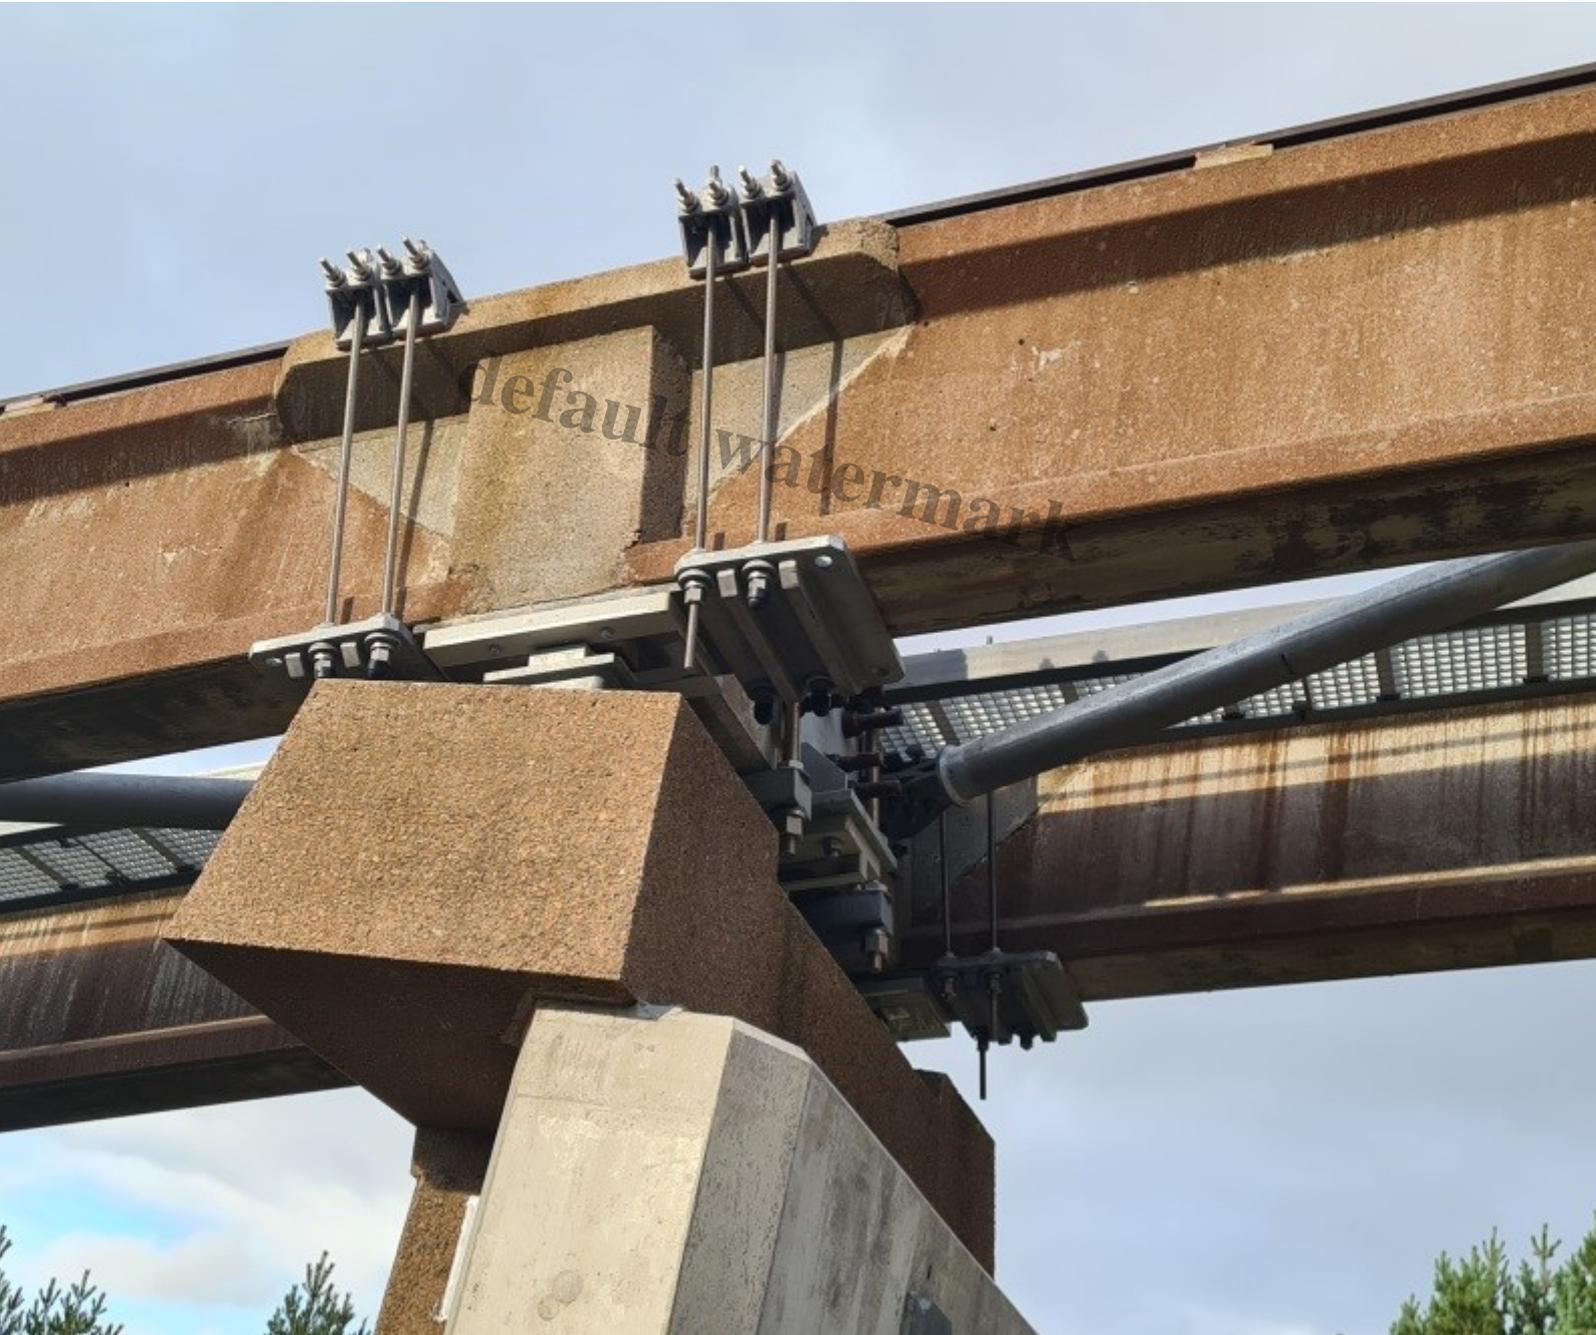
After my last post I had conversations with a couple of people about my conclusions that the insitu stitch/ joints are the wrong way up, i.e. instead of the joint being wedge shaped, as in the picture above, it should be more of a pyramid, as in my drawing below.

The majority of precast beams have slightly larger cracks at their junction with the insitu concrete of the crossheads. Usually the cracks are larger at the upper flange, tapering to zero by midweb. Typical crack widths vary upto 1.0mm, with an average of 0.5mm. In a significant number of cases, these cracks are associated with rust coloured deposits on the surface of the precast concrete web, indicating that some corrosion has occurred of the reinforcing steel which originally protruded from the precast beam prior to being surrounded by insitu concrete.

BS 8110 section 3 clause 3.2.4.2 states that to prevent corrosion in aggressive environments the crack width should not exceed 0.3mm. There are many instances where this limit is exceeded and it is no surprise that rust staining is being seen.

A detailed assessment of what has caused this cracking has not been carried out, but it seems likely that there is more than one cause.

The possibility of ongoing corrosion of the reinforcing steel should be considered, together with the long term consequences of this, should it be left uncorrected. It is recommended that measures should be taken to seal any cracks where rust staining is apparent, so as to eliminate oxygen and water ingress.

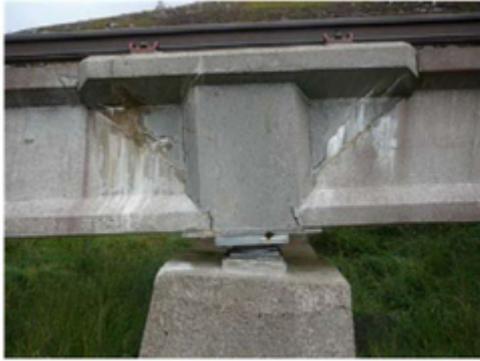
Photo [12] Pier 8, one of the poorer insitu infills. Showing joints opening between Insitu and precast plus cracking within the mass of the Insitu, both inclined and near vertical.

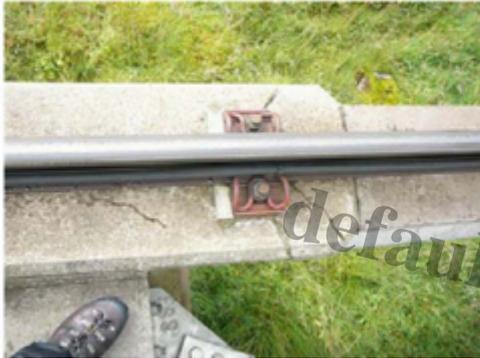
Photo [13] Pier 8 from above.

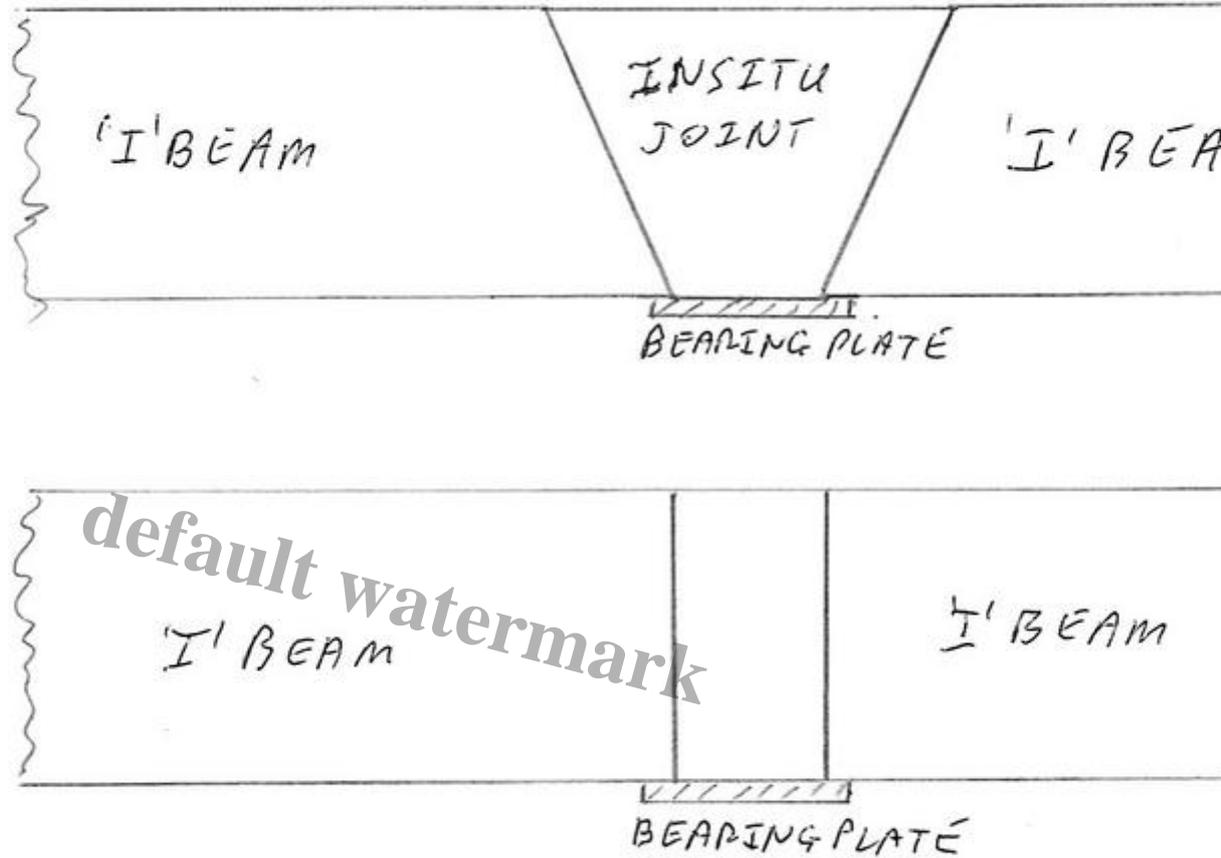
Having said that, there is a third option, the beams could have been made with straight, vertical ends, as shown below,

The bearing plate is the same length but supporting the whole end of each beam. A better design would be longer

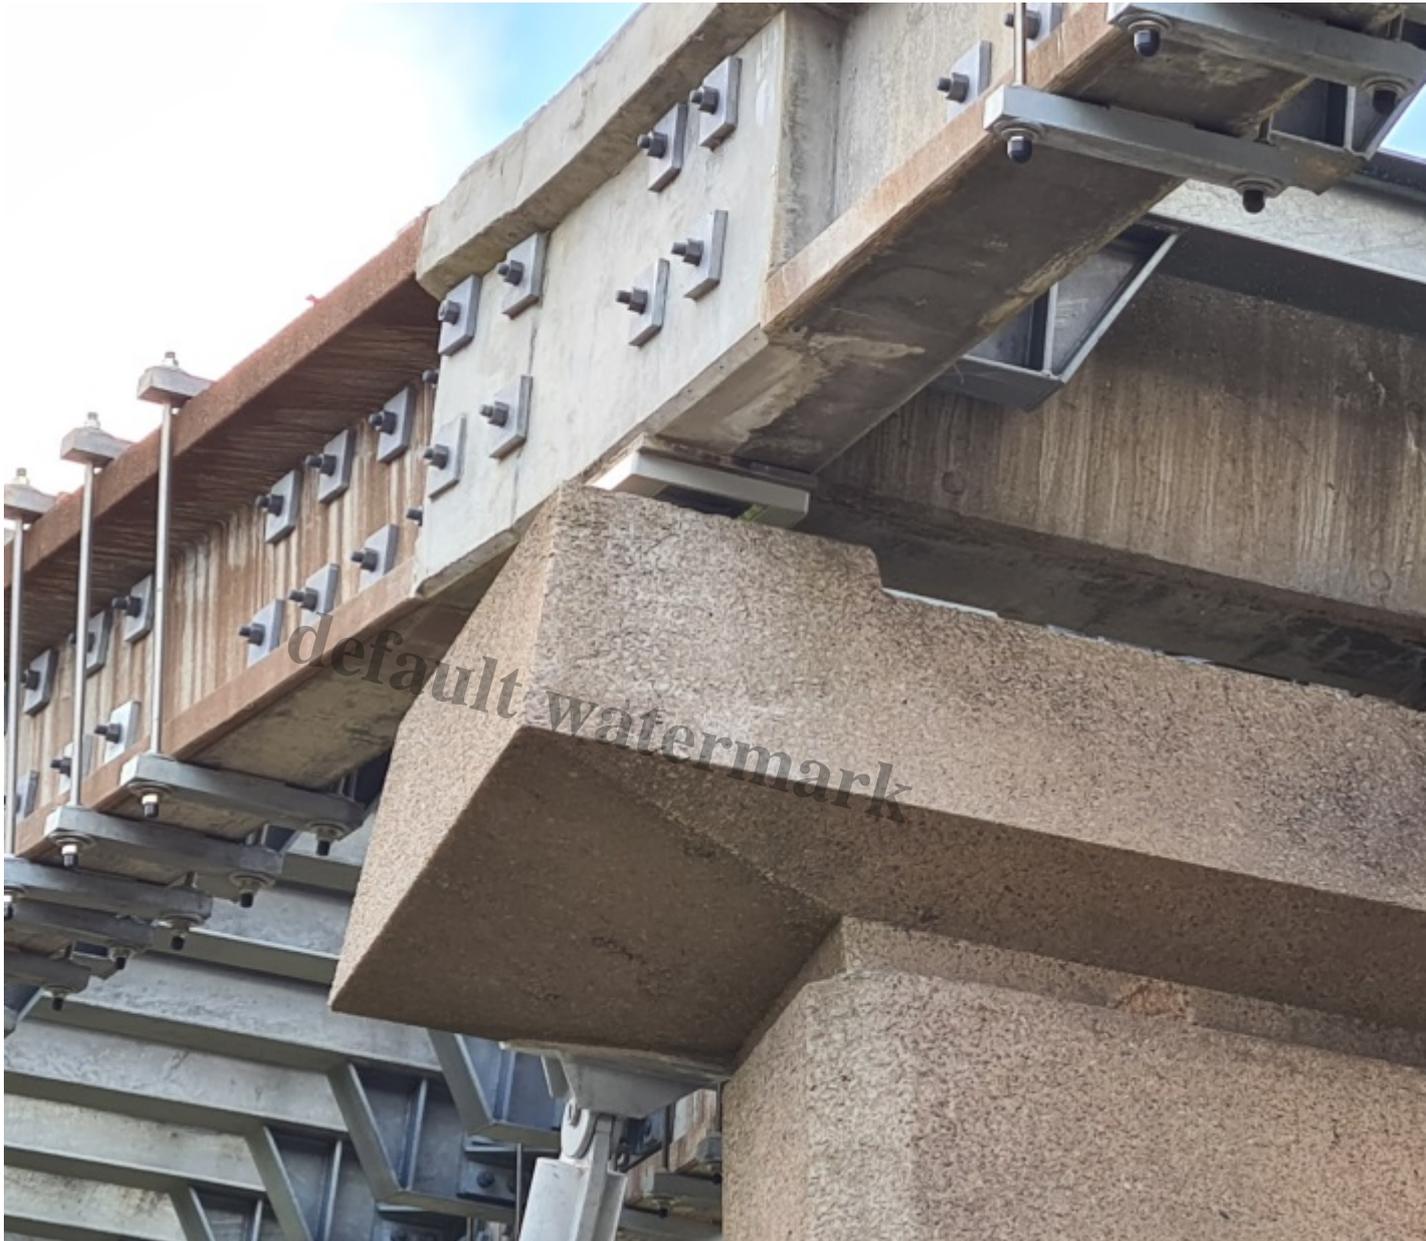
A rectangular insitu joint would have been much easier and cheaper to form than either the wedge or the pyramid and appears to be what Balfour Beatty have done at Pier 51 at the passing loop as shown below.

Notice what appears to be a V shaped calcite bleed near the centre of this insitu joint under the metal

This joint may be not as pleasing visually but probably more effective.

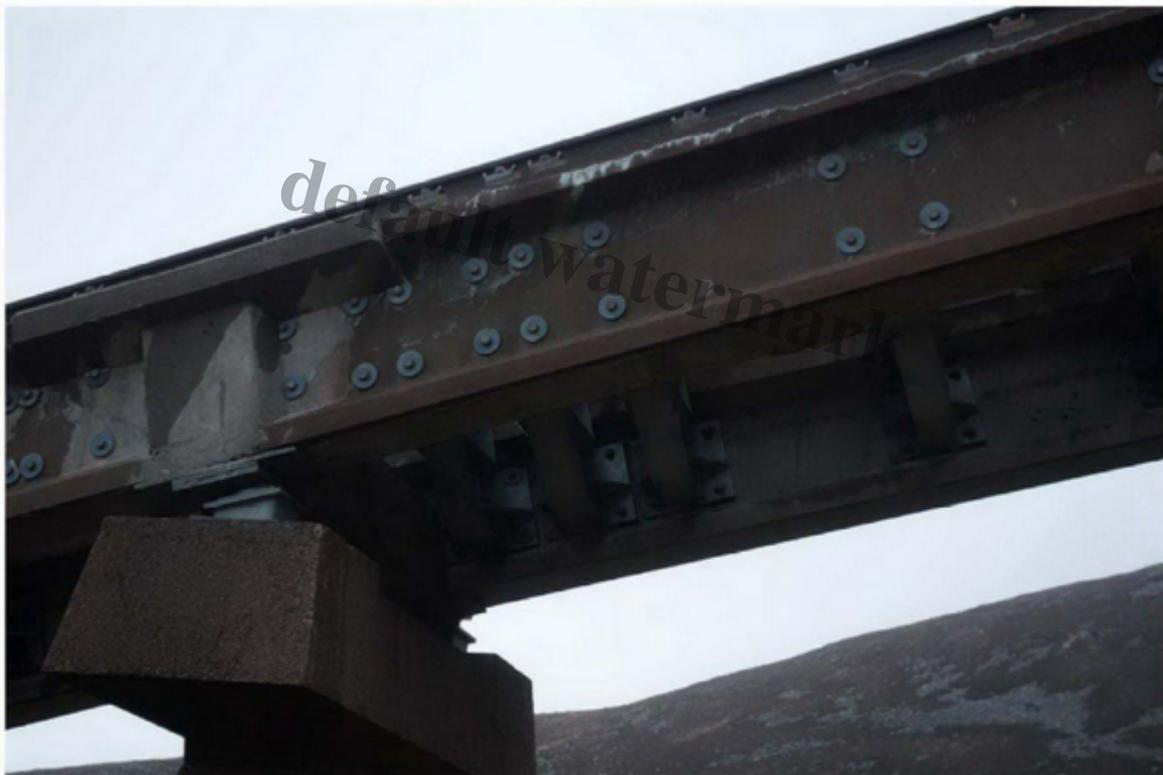
View of side face of Beam 51/R

The beam above Pier 51,see photo below, is an example of how quickly the size of these cracks can become a major problem, increasing from a few centimetres in 2016 to half its length in July 2017.

5.1 It was concluded that the observed crack were a developing situation, due to the fact that it was only first noticed in 2016 and that the calcite bleed is more developed at one end.

5.2 It is thought that the problem is a latent defect within the original fabrication of the beams, most likely due to a cold joint within the concrete pour.

5.3 It was concluded that there is no imminent danger of the beams collapsing.

5.4 If left the beams will continue to deteriorate and stability issues would arise.

6.1 Having halted train operations whilst this situation was assessed it was recommended that the train could resume operating, but under a reduced scope– until remedial action is taken:

- The maximum number of passengers and luggage allowed in the operating and maintenance manual is 10050kg, or 120 people. This should be reduced to 5000kg or 60 people, evenly distributed through the compartments.
- It is understood that the train operates at 4m/s during the summer months. This should not be exceeded.

6.2 In the short term temporary supports should be installed under the pair of beams above pier 51. These should be braced in both directions. A suitable scaffolding or temporary works contractor should be appointed to carry this out under the guidance of your Engineer. This support will be required both to enable resumption of normal operations and for the period of time when the permanent solution is implemented. This arrangement should be suitable for being left in place through the winter and until next summer when the permanent solution should be implemented.

6.3 During the 2018 summer shut down beam 51/R should be repaired by removing the entire top flange, which will necessitate the removal of all the rail supports, and re-cast using a suitable product. These works should be planned ahead and suitable contractors appointed ahead of time to enable them to guarantee their availability come the time.

6.4 The beam should be inspected on a regular basis, including particular daily observations, for any deterioration in its condition or negative impacts on the plinths.

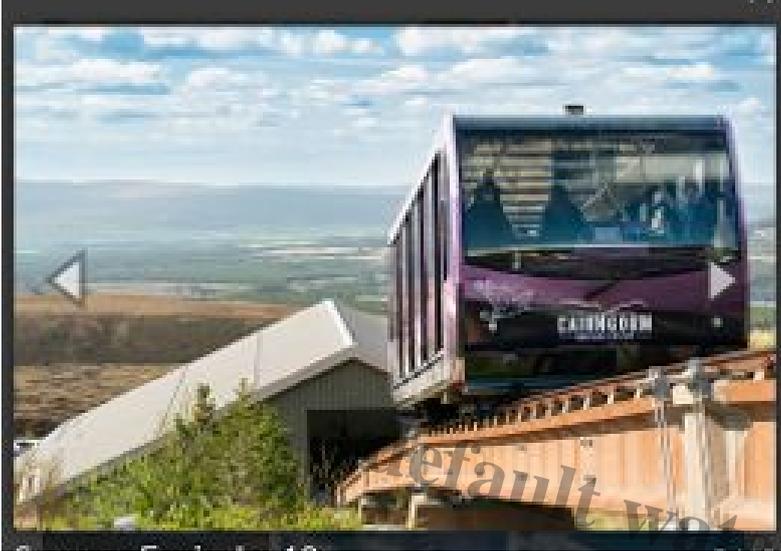
A crack in the vertical plane of one of the concrete beams is unlikely to be noticed and could cause an instant and catastrophic failure of the beam as a carriage crosses it, the result of which you can imagine! Is this next picture of a beam about to collapse? Unless it is an optical illusion that beam has dropped as the train went onto it.
