Flood prevention failure in the Cairngorms – the River Gynack overflow channel

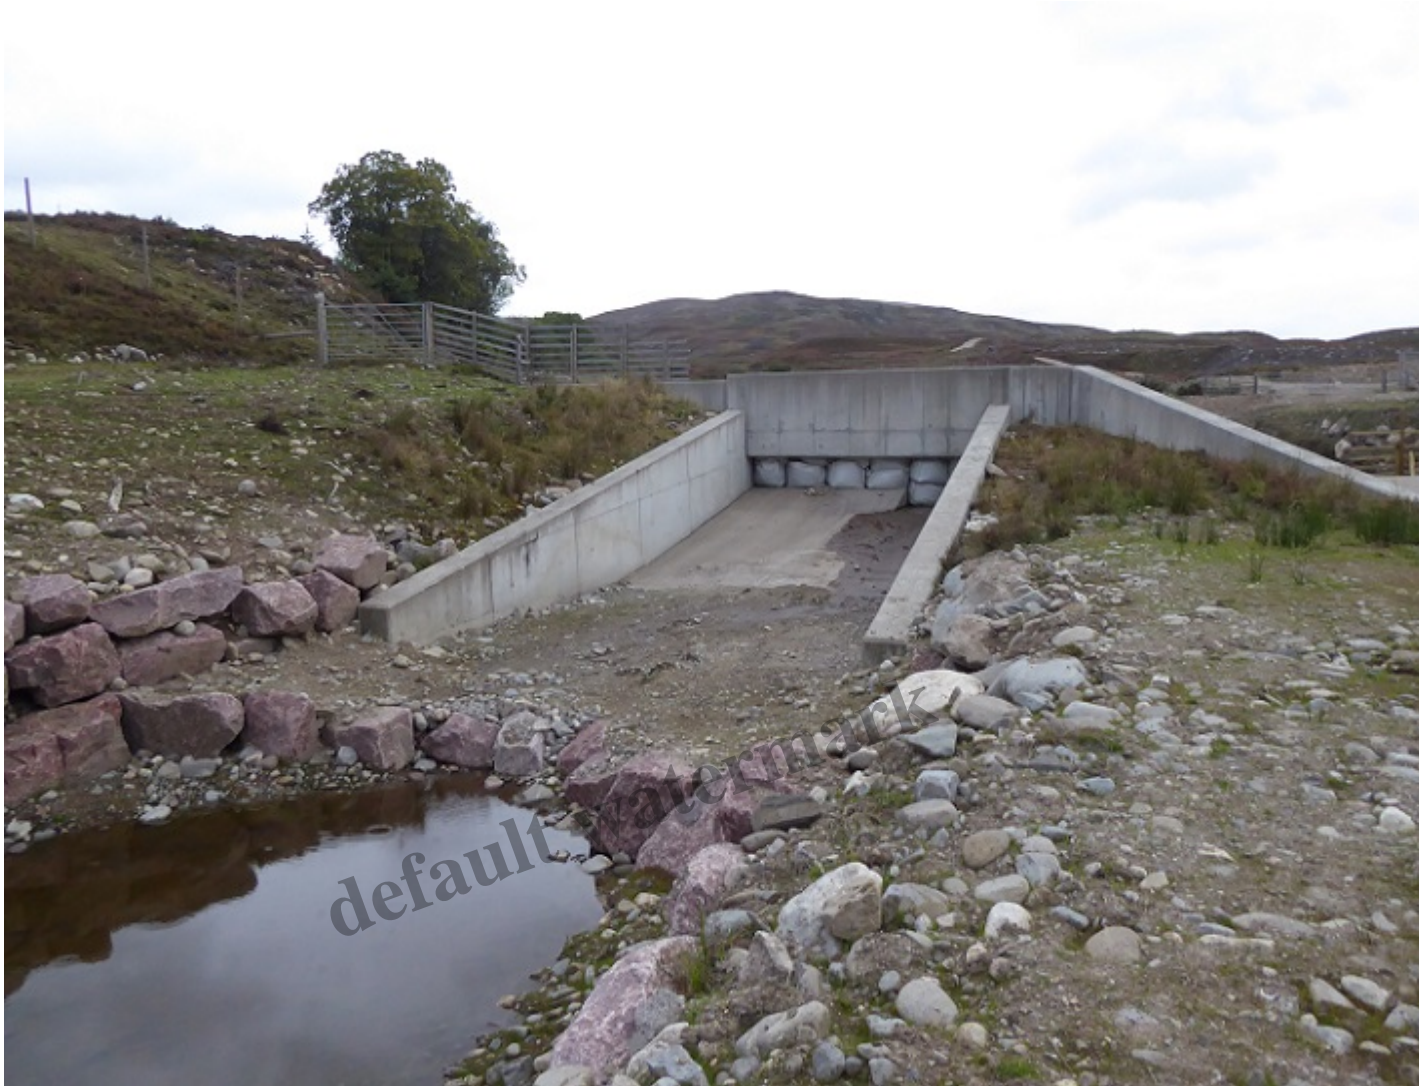
The start of the blocked overflow channel from the west September 2023

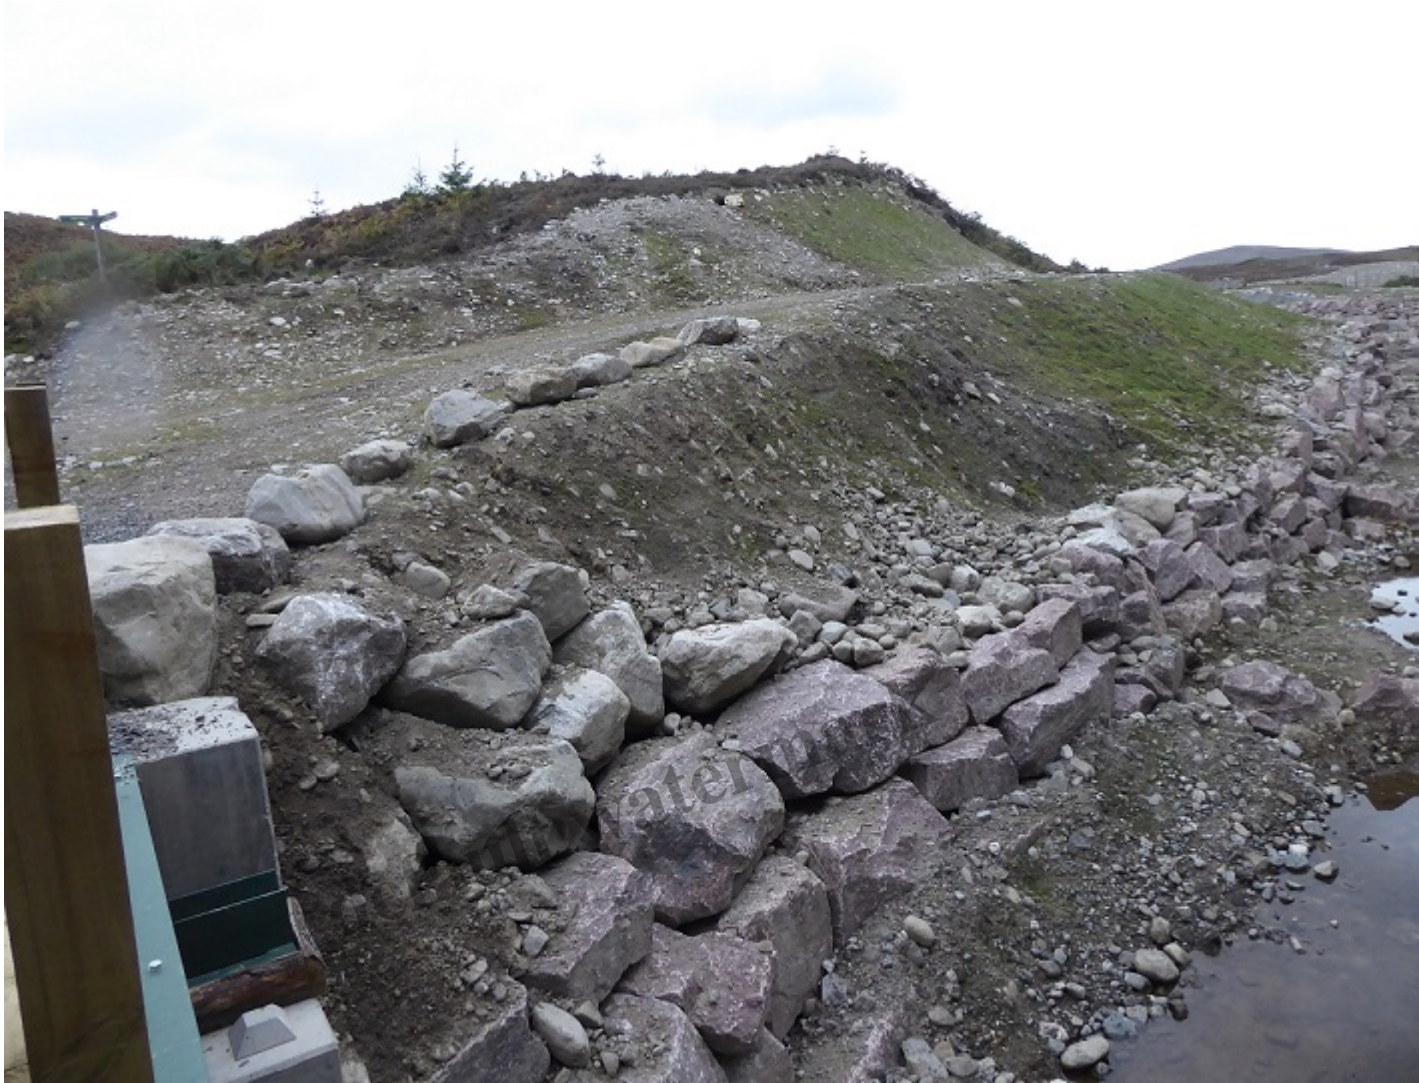
The view from the bridge above Pitmain lodge. The banks on the right have been re-seeded, whereas those in the centre have not and continue to erode.

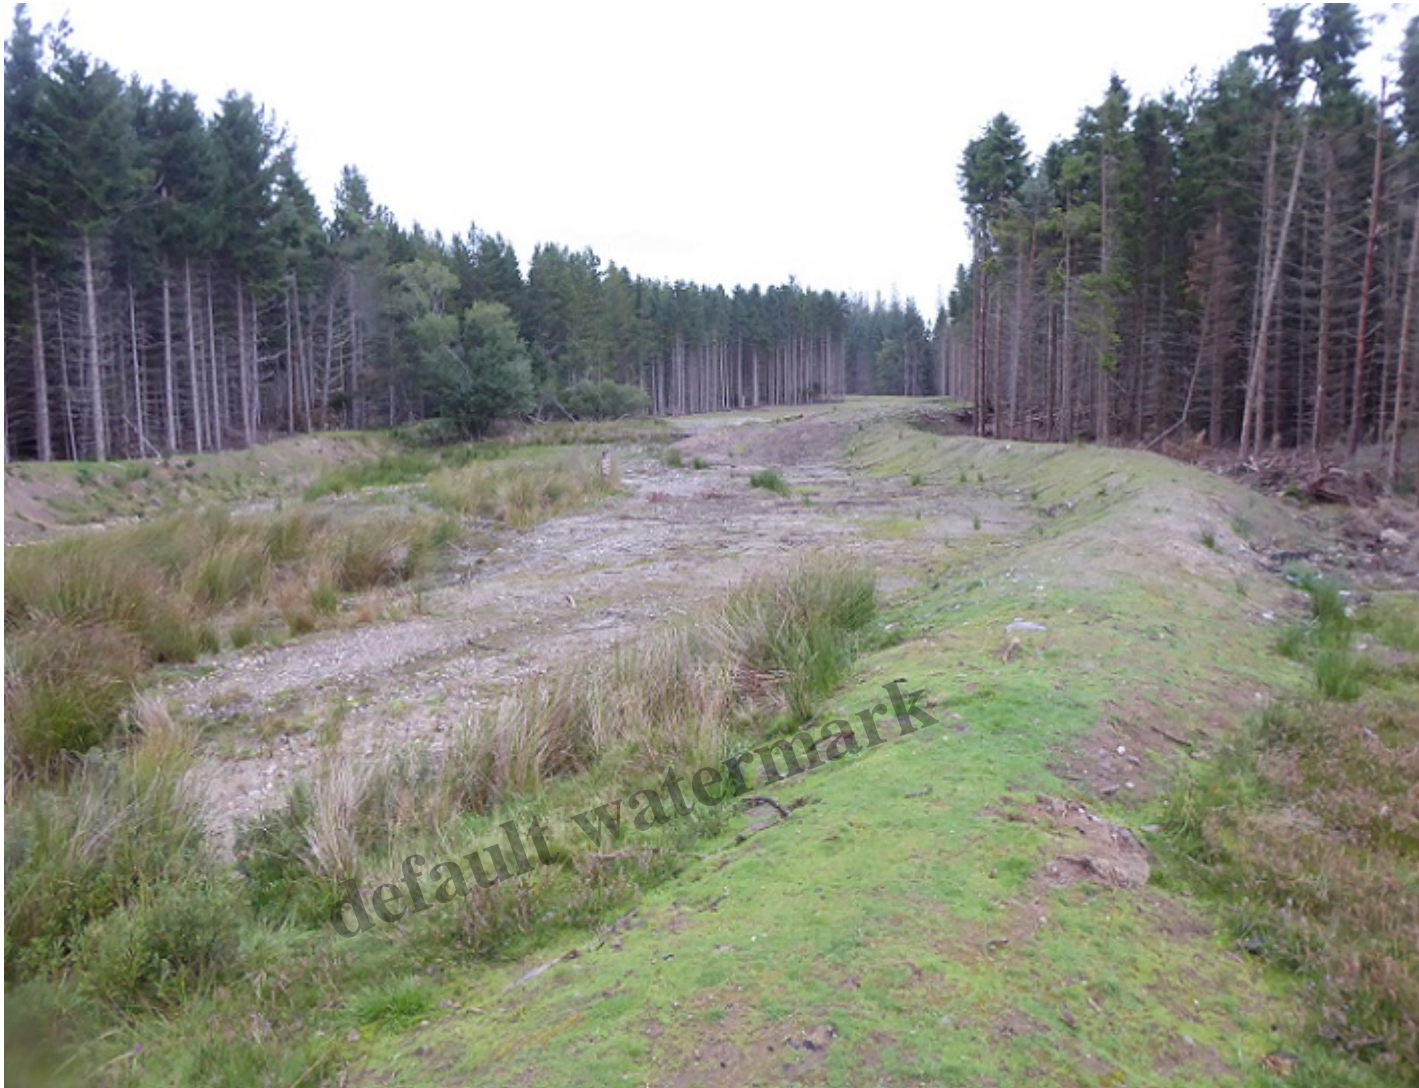
Looking up the lower section of the overflow. The earth banks are revegetating slowly but were still in September 2023 very vulnerable to erosion.

One lesson appears to have been learned from the previous failure, the earth banks are being allowed to re-vegetate before being re-opened. Hence why the overflow channel was still closed during the flooding that took place in early October. Just when the channel will re-open is unclear but let's hope it won't be like the funicular repairs, which the CNPA did actually approve, fundamentally flawed!

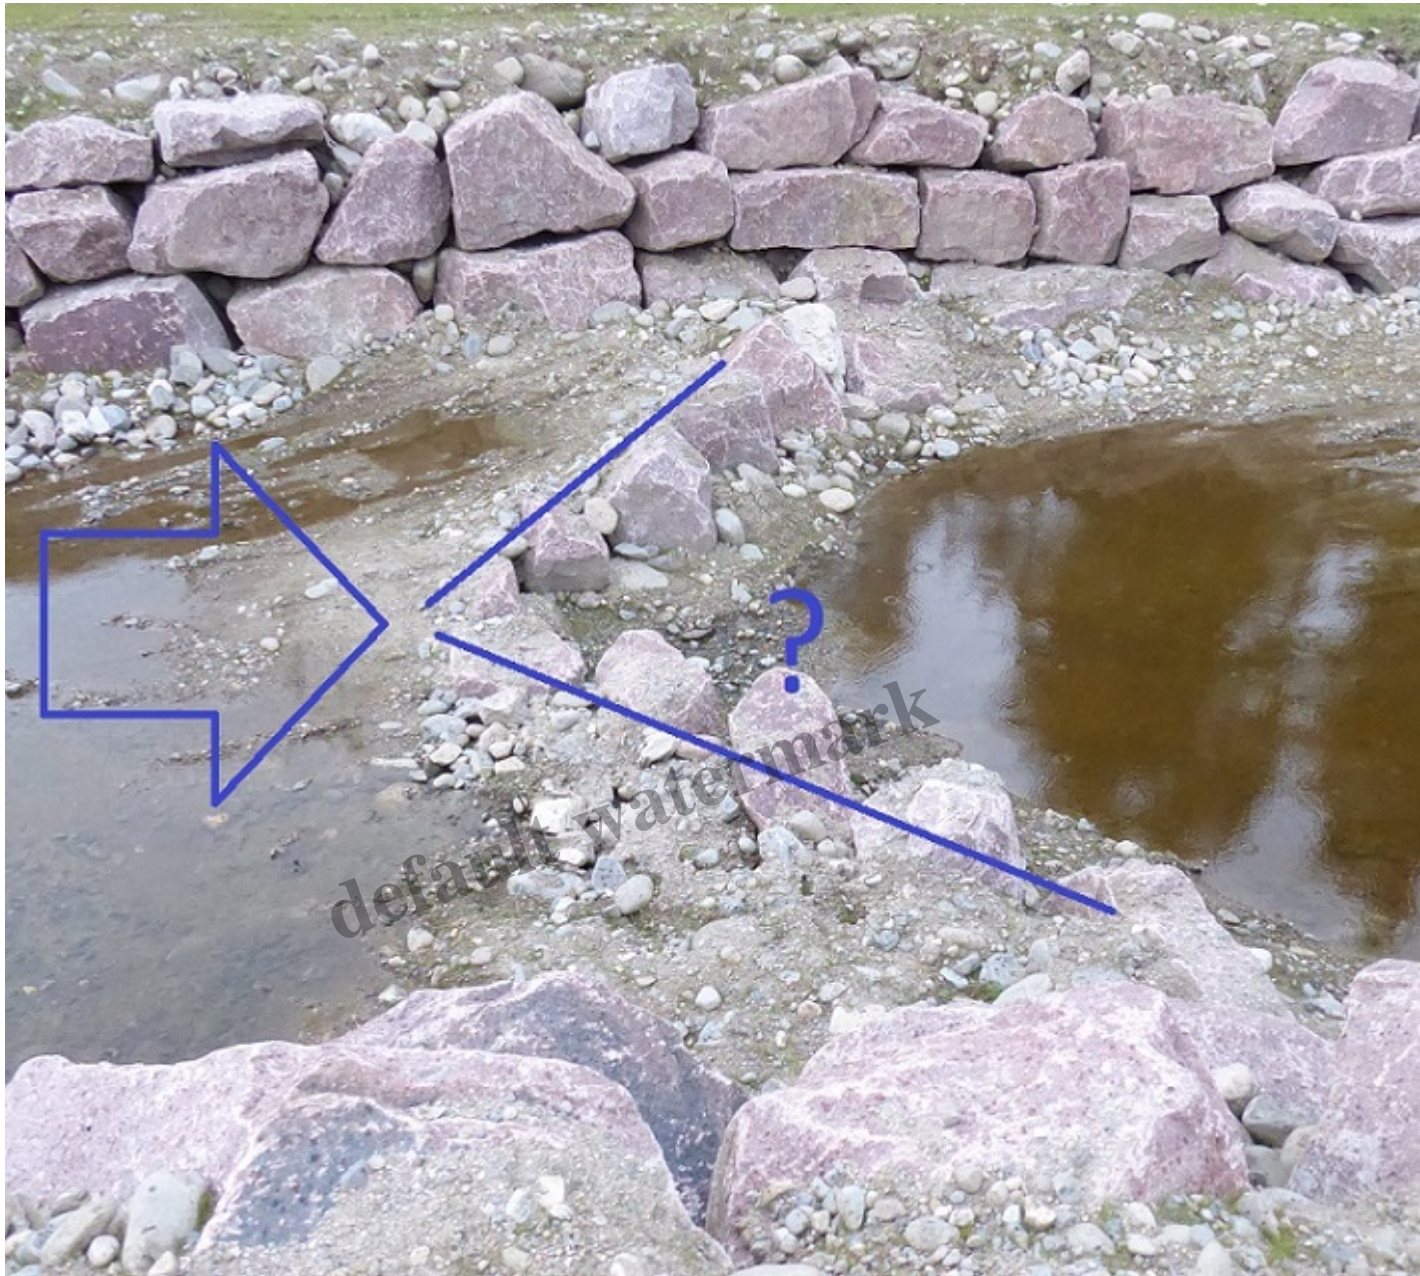
Each stone is resting on the one downstream, like a horizontal arch. Is it well enough constructed to survive a flood?

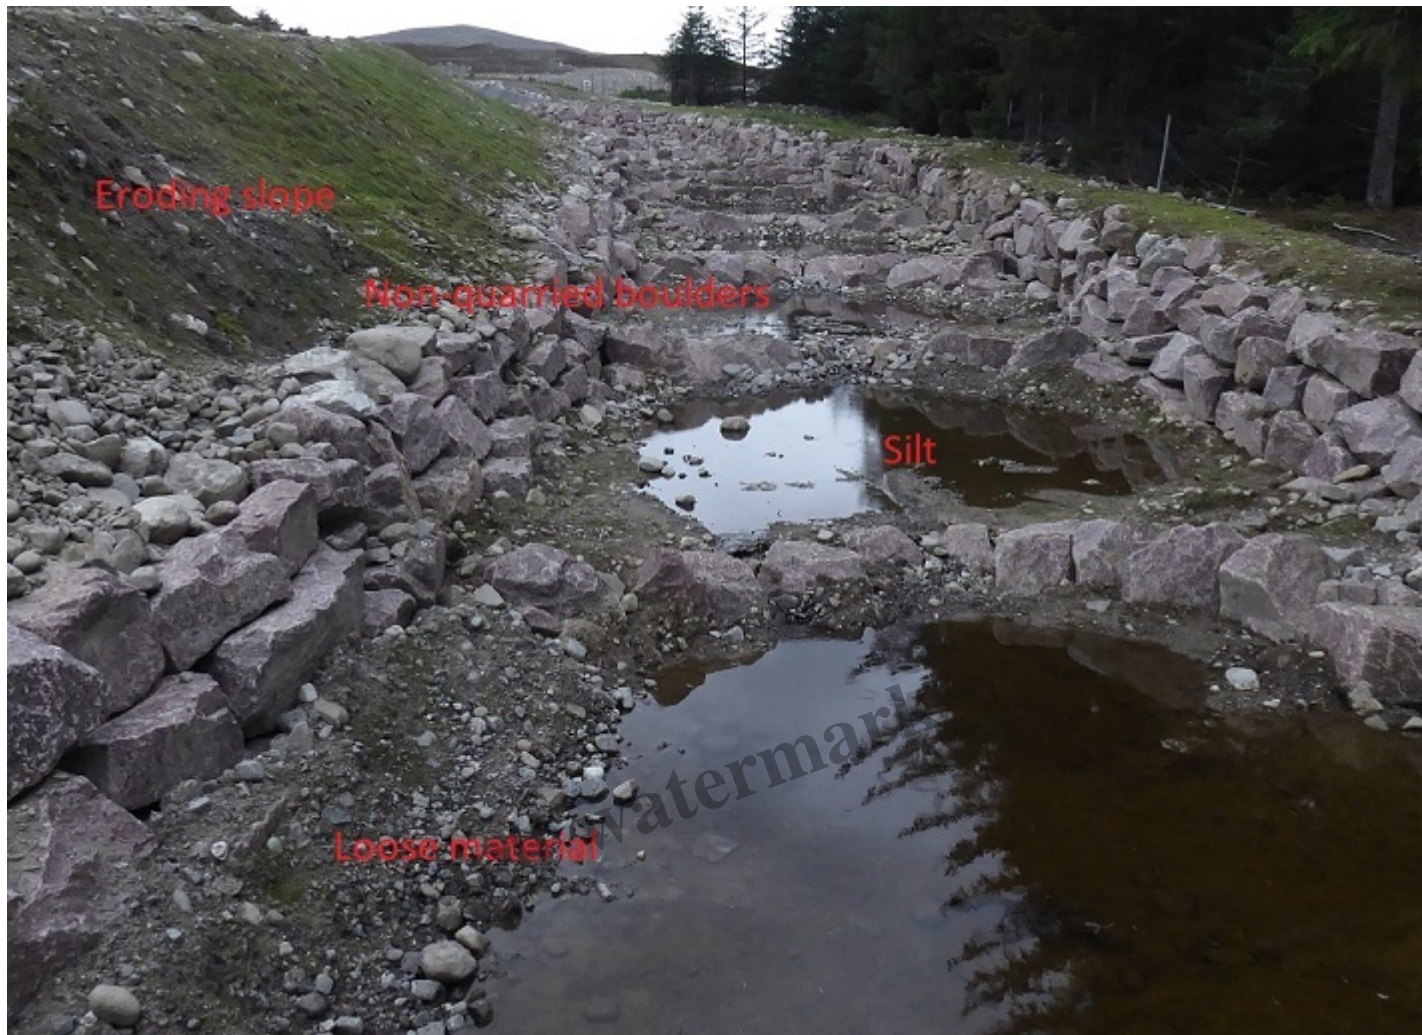
Note the short section of “non-quarried boulders” on the left of the second pool

In the first section of the overflow there is plenty of “loose material ” (front left), extensive silt and, once that is washed away, further material from the eroding slope above to replace it. It does not look very good habitat for wildlife. Whatever the intention, it appears that some of the rip rap bouldering and rock barriers are also vulnerable to being swept away.

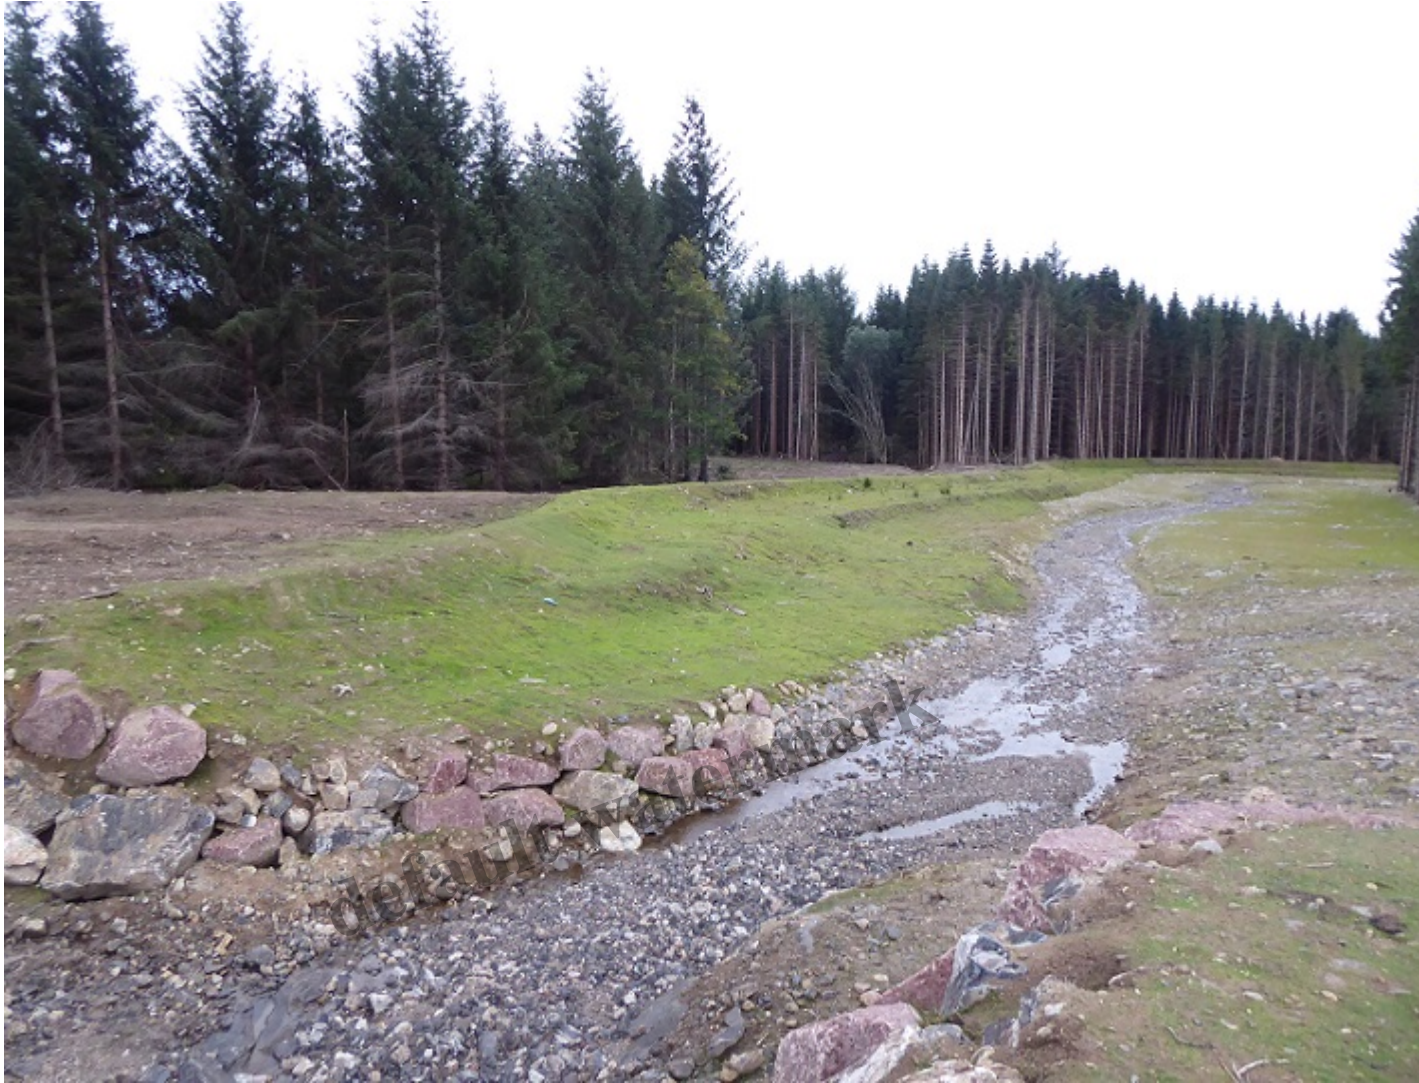
The final section of rip rap bouldering before the re-designed overflow channel broadens out.. Note the stepped banks on the left.

The lower section of the overflow channel appears more likely to work. Except where undercut, grass covered earth banks are generally quite resistant to floods, shedding the water. The reason the banks failed previously was not just that they were bare, they were also formed out of light peaty soil, an unsuitable growing medium, and placed far too close together.

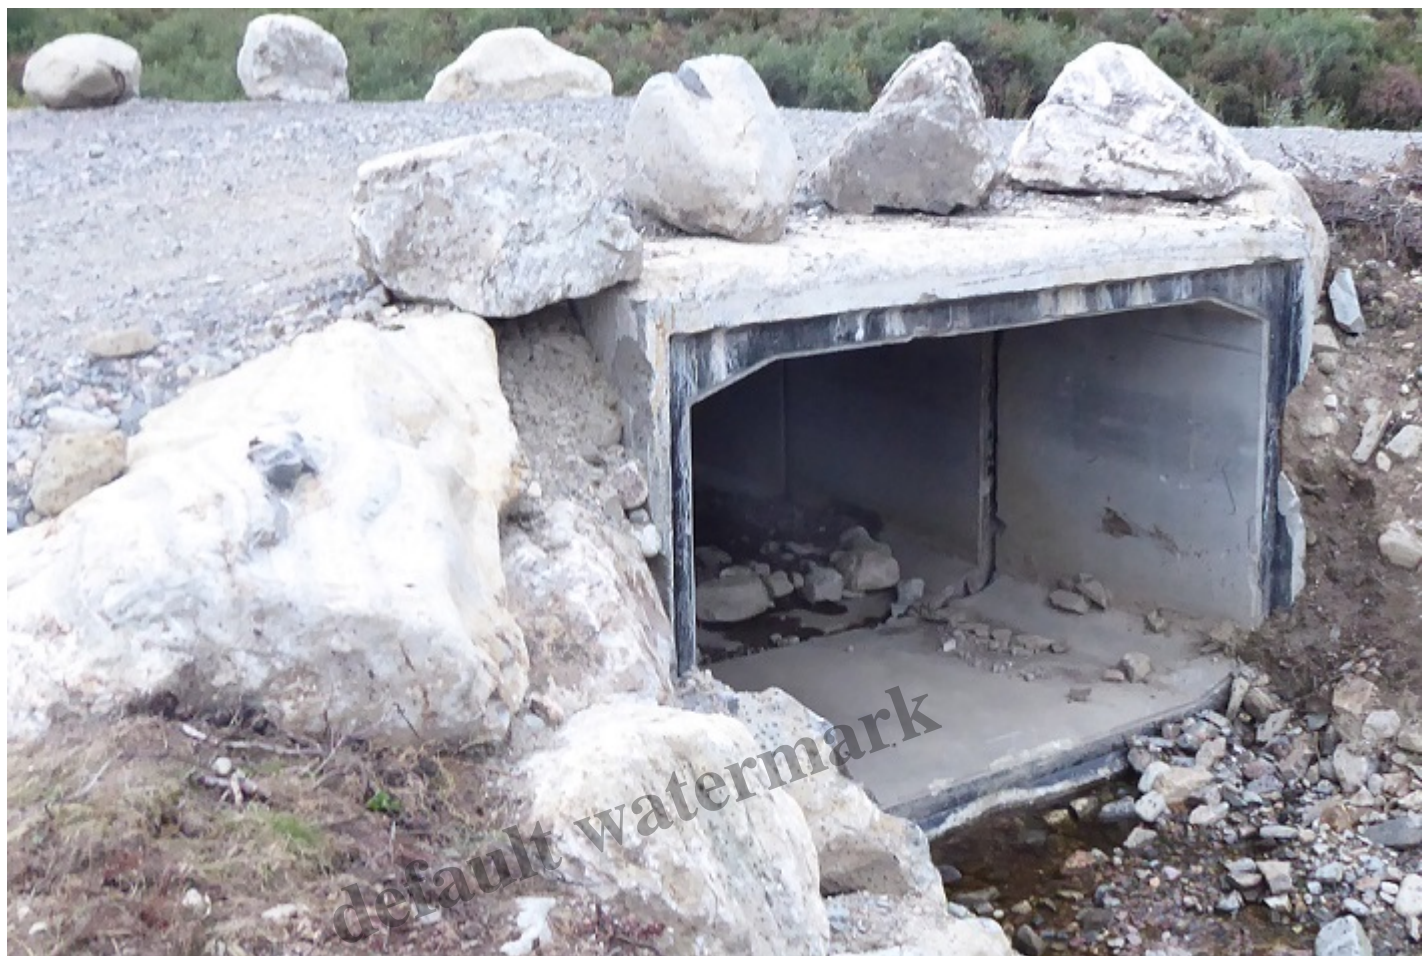
The culvert under the track between Pitmain Lodge and Loch Gynack has been designed to take a considerable volume of water. Note the poor finishing on the left.
