## Flood prevention failure in the Cairngorms – the River Gynack overflow channel

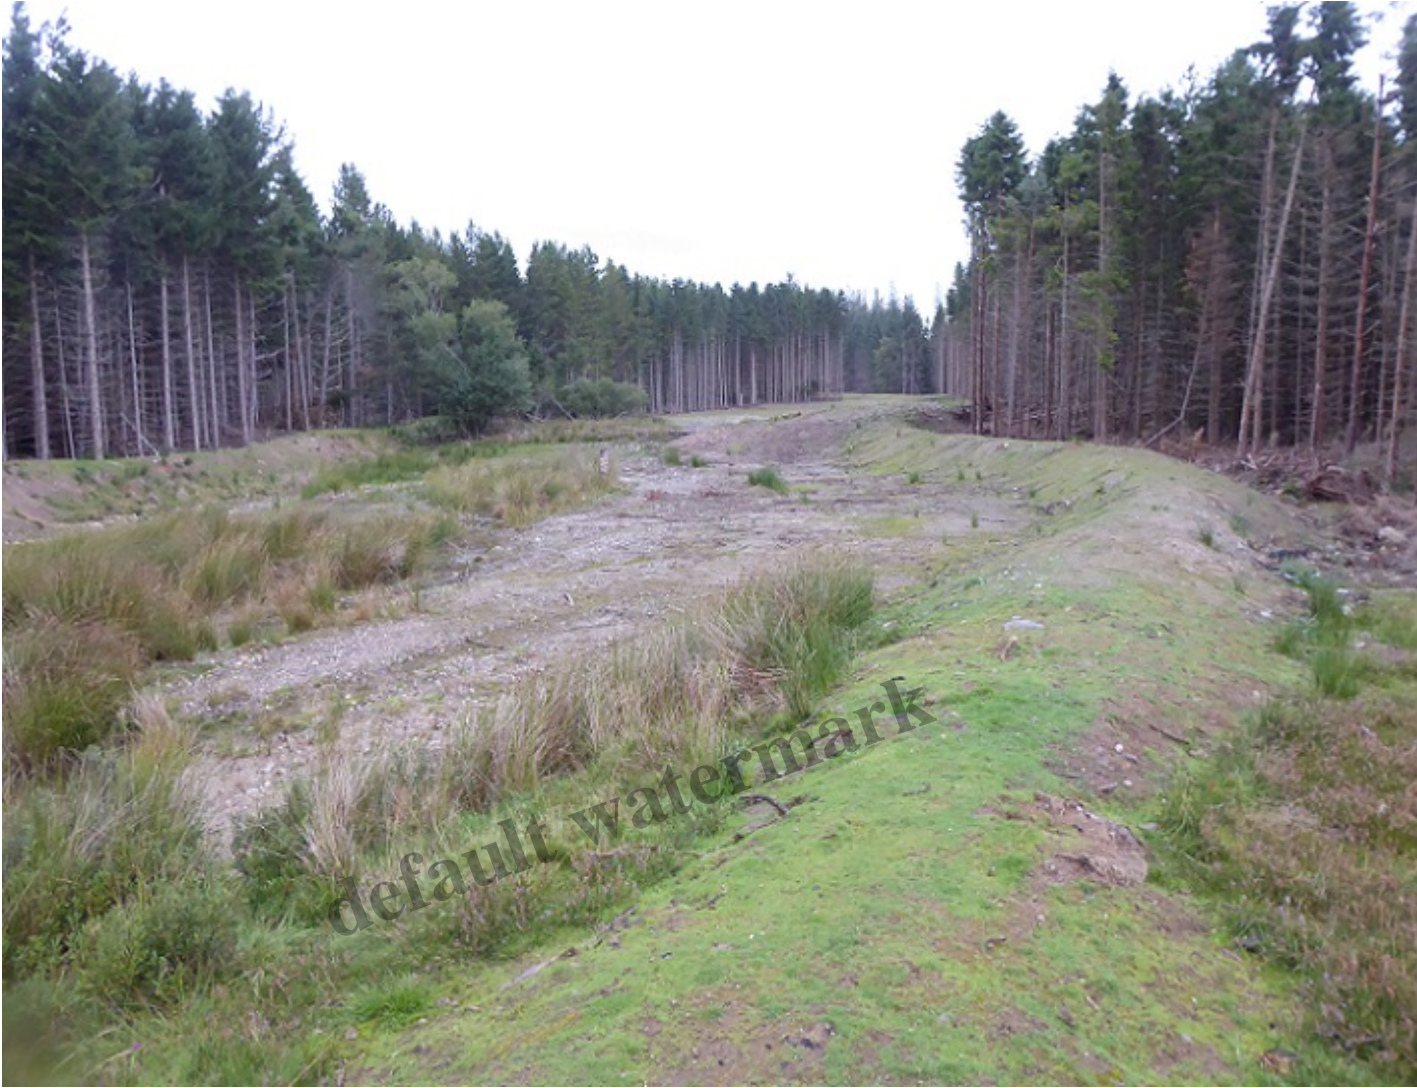
Looking up the lower section of the overflow. The earth banks are revegetating slowly but were still in September 2023 very vulnerable to erosion.

One lesson appears to have been learned from the previous failure, the earth banks are being allowed to re-vegetate before being re-opened. Hence why the overflow channel was still closed during the flooding that took place in early October. Just when the channel will re-open is unclear but let's hope it won't be like the funicular repairs, which the CNPA did actually approve, fundamentally flawed!
