## Flood prevention failure in the Cairngorms – the River Gynack overflow channel

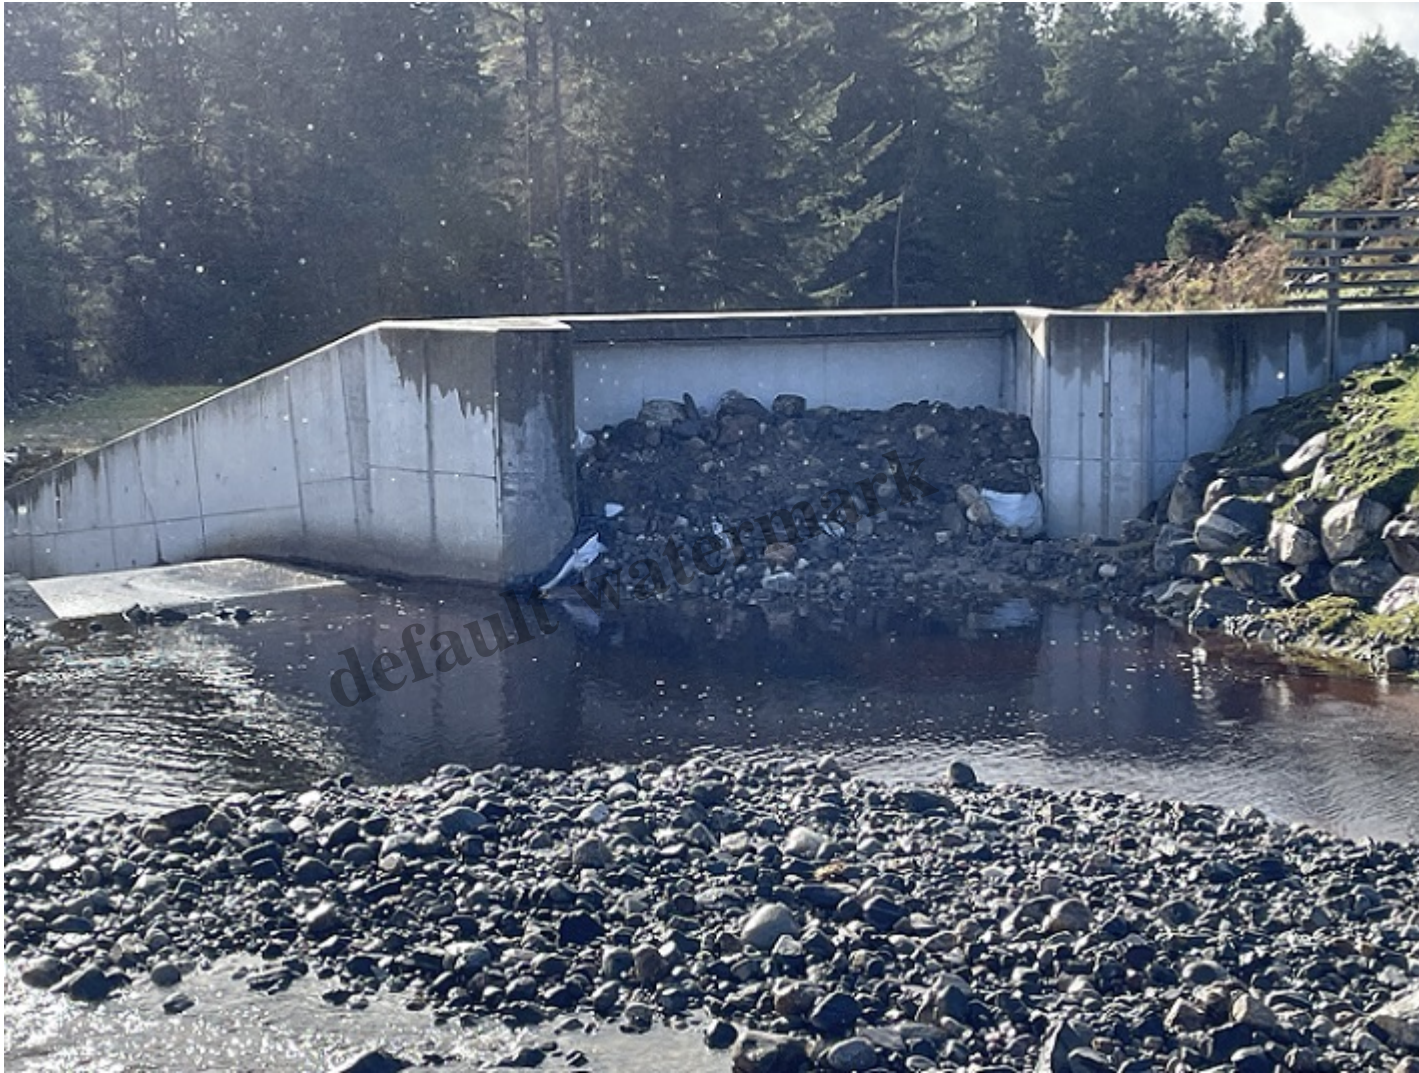
Blocked off entrance to overflow mid-October, after the floods, constructed without any regard for the landscape. The main course of the River Gynack flows to the left. Photo credit Parkswatch reader.

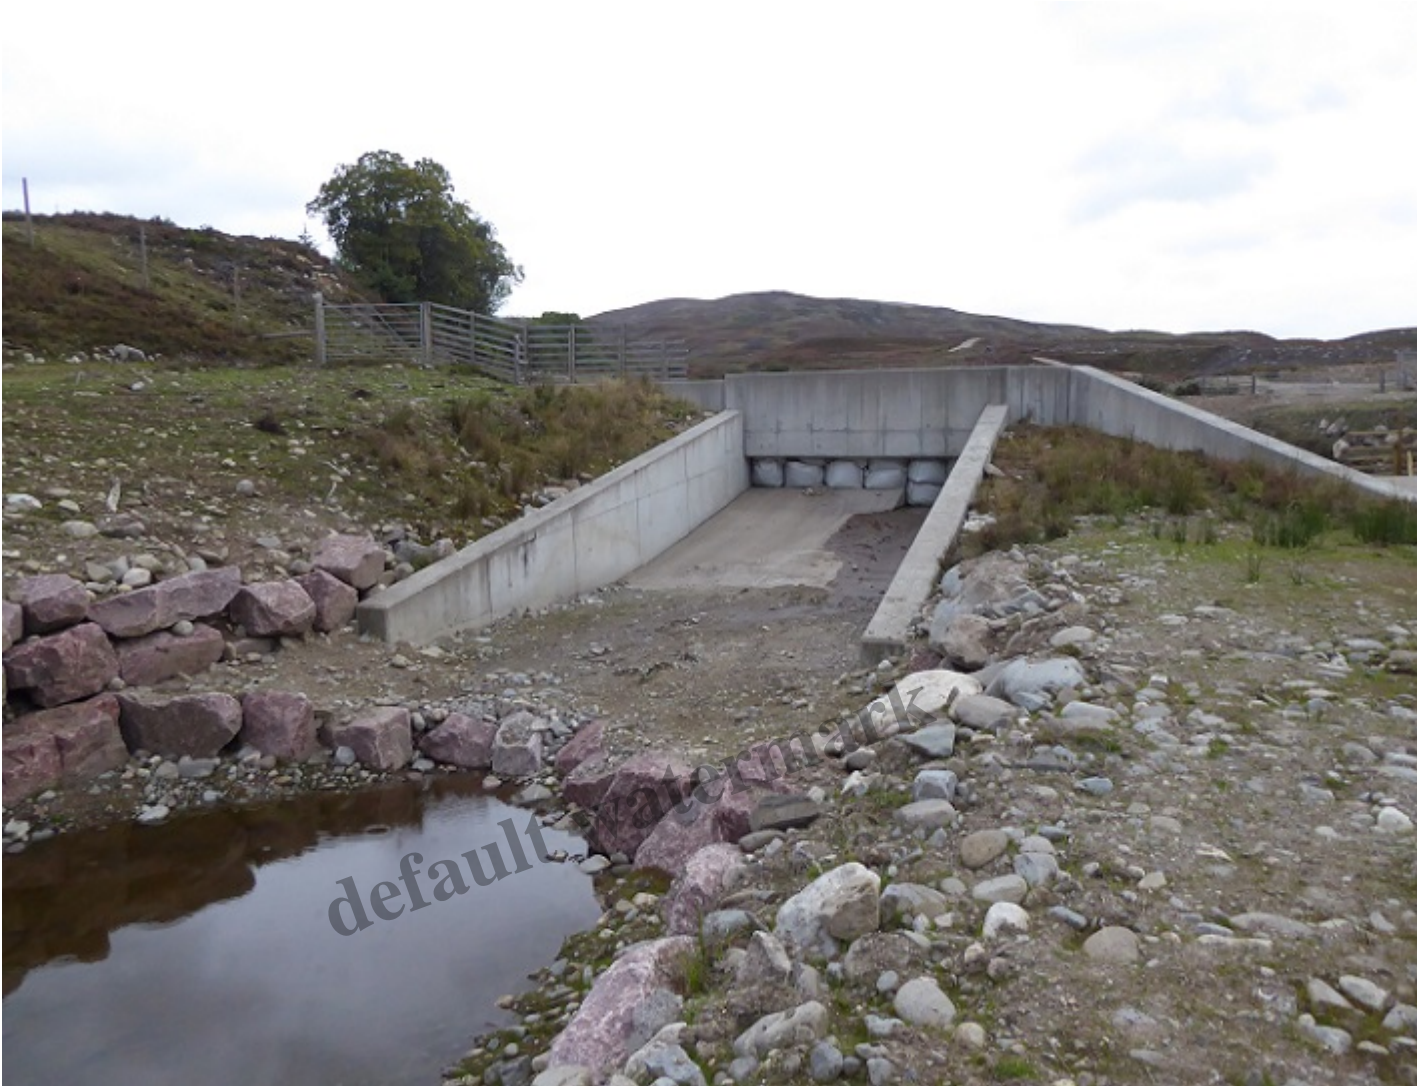
The start of the blocked overflow channel from the west September 2023

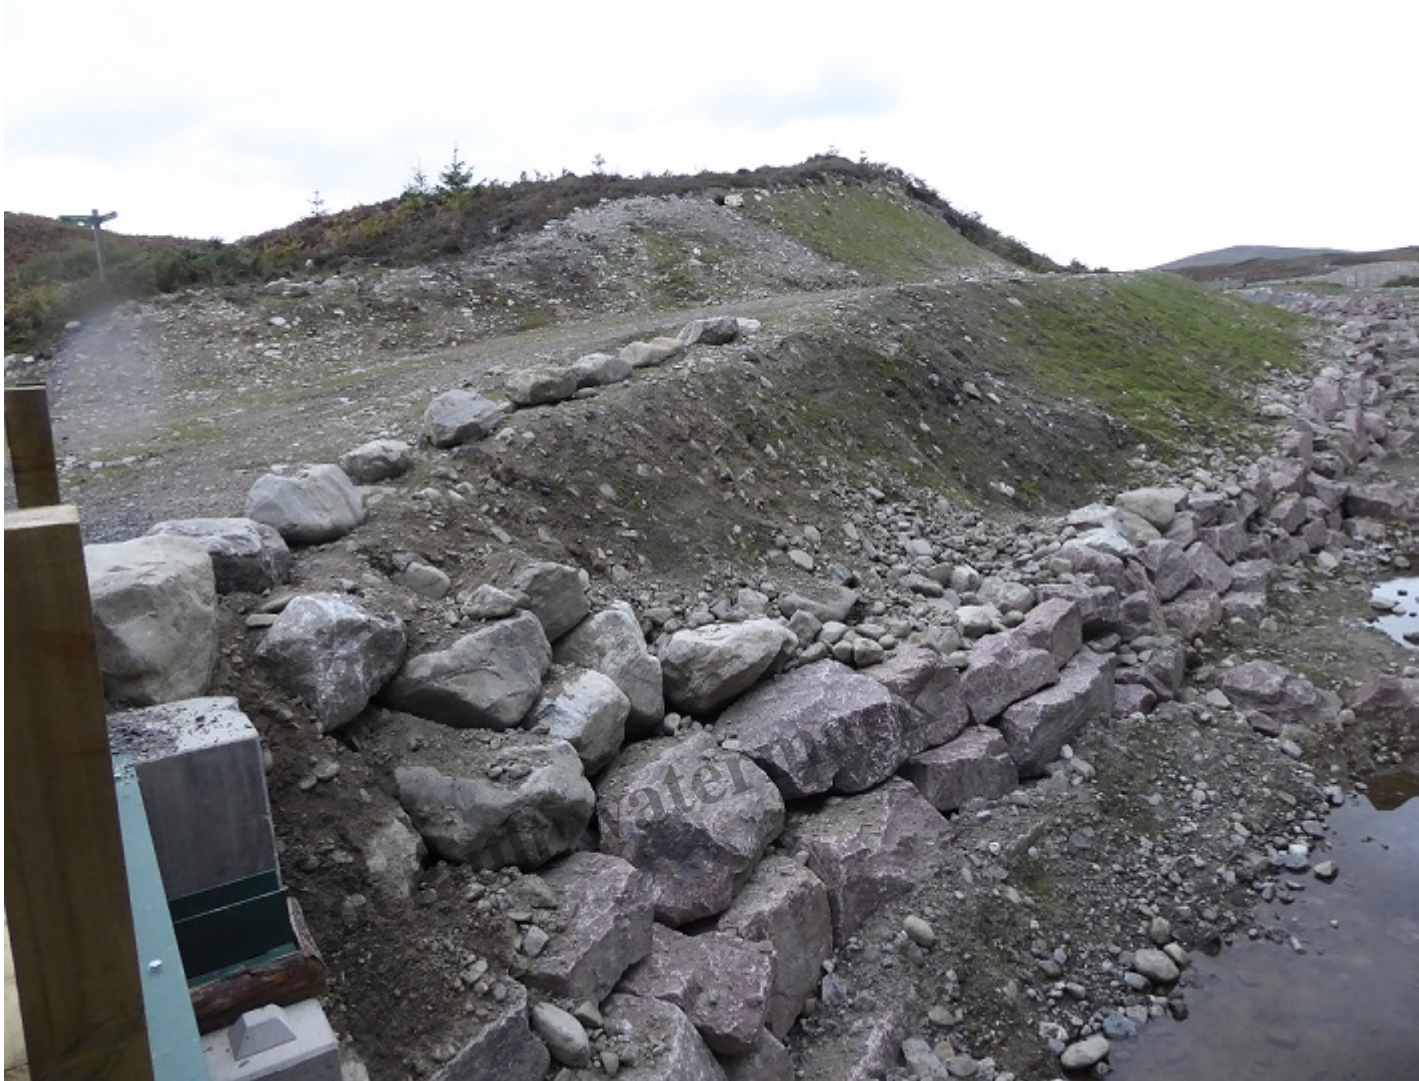
The view from the bridge above Pitmain lodge. The banks on the right have been re-seeded, whereas those in the centre have not and continue to erode.

The basic design of the new overflow appears, from three site visits, to be little different than the previous one. The banks of the top section of the flood channel are protected by rip-rap bouldering while those lower down are still of earth. The main differences are that the floor of the top section of the channel has been reinforced while the lower section is far far wider with stepped banks which will enable flood water to spread out and dissipate its force.

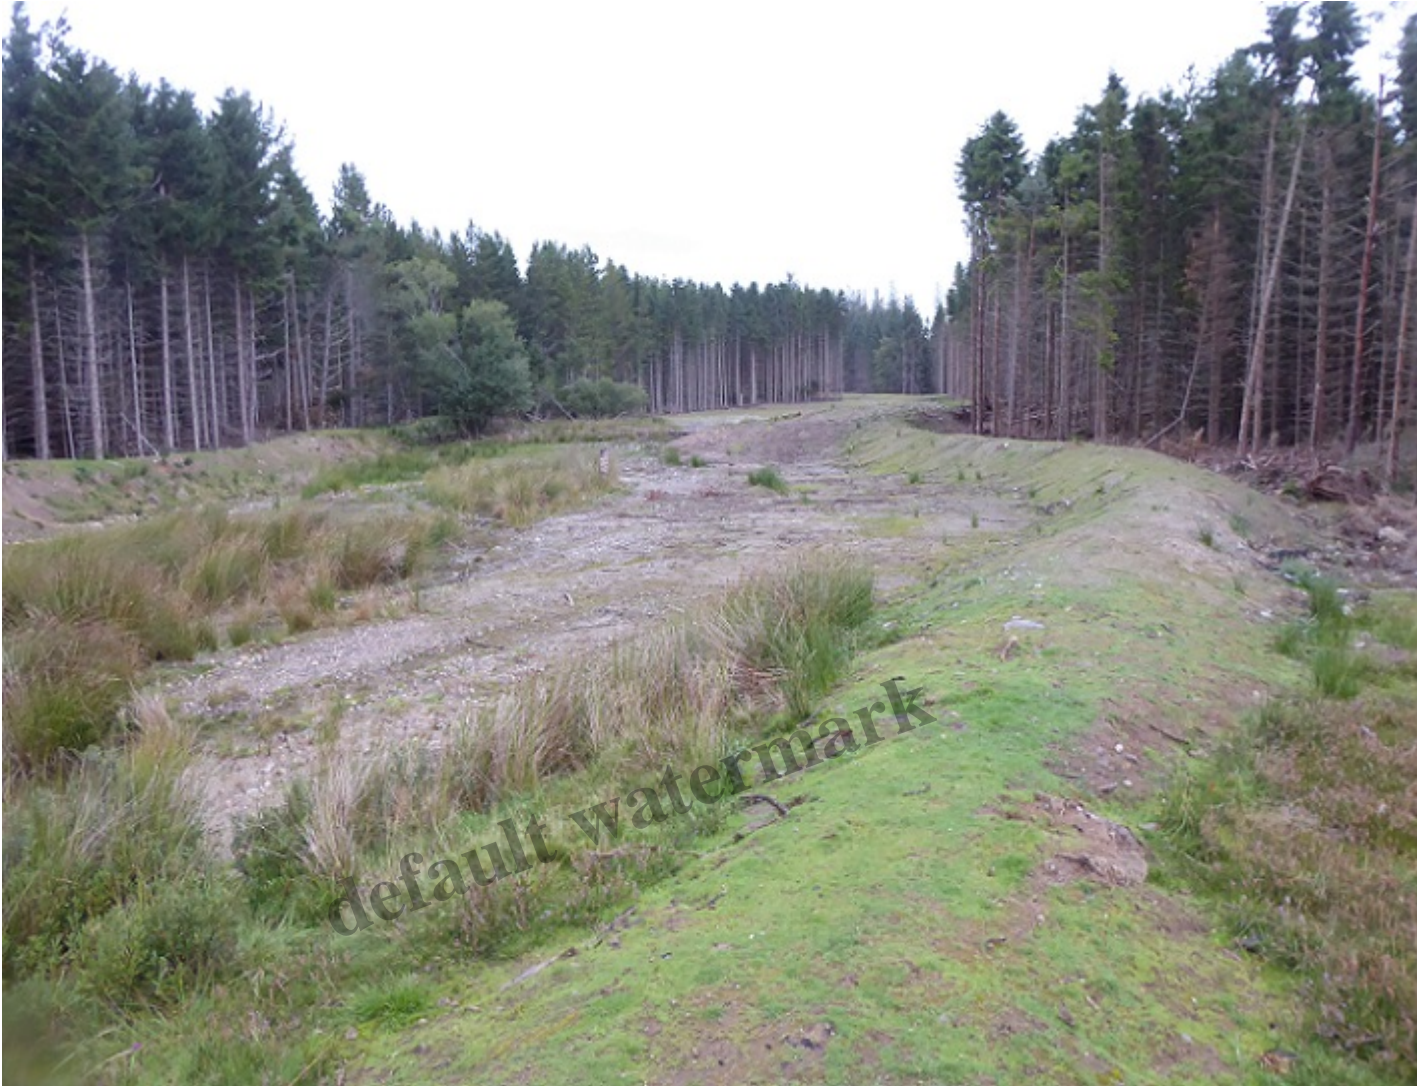
Looking up the lower section of the overflow. The earth banks are revegetating slowly but were still in September 2023 very vulnerable to erosion.

One lesson appears to have been learned from the previous failure, the earth banks are being allowed to re-vegetate before being re-opened. Hence why the overflow channel was still closed during the flooding that took place in early October. Just when the channel will re-open is unclear but let's hope it won't be like the funicular repairs, which the CNPA did actually approve, fundamentally flawed!

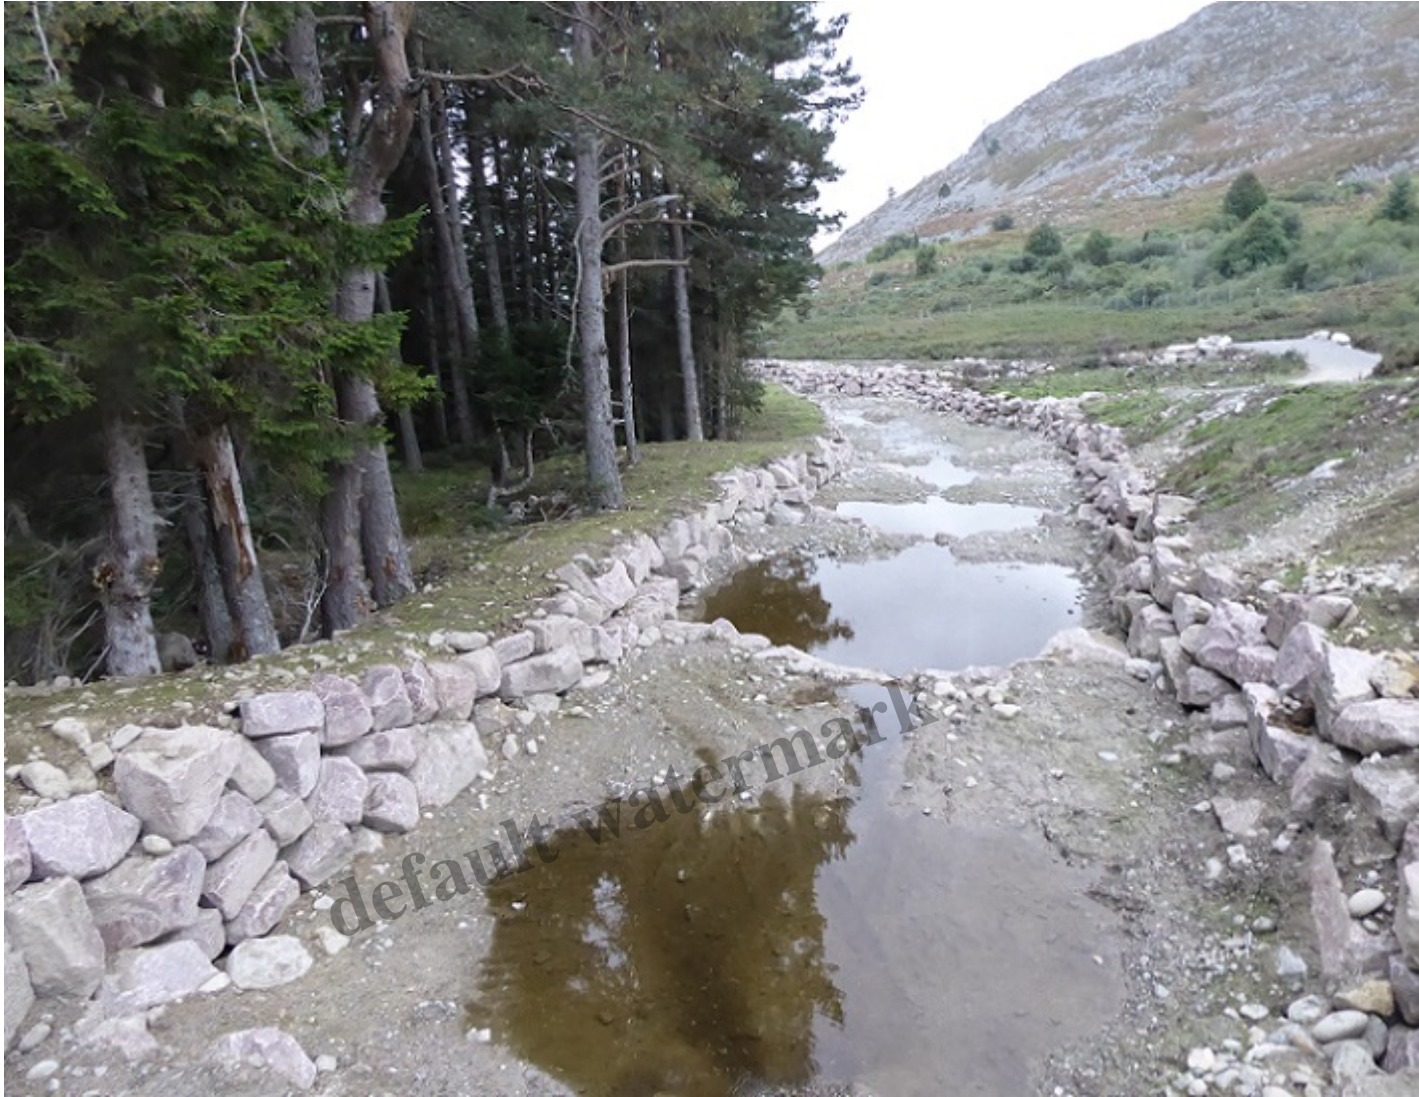
The view downstream from the bridge

The locally sourced stones used for the rip-rap bouldering in the first version have been replaced by imported quarried stone, brought in at significant cost and not reflecting the local geology. By allowing the repairs to proceed without planning permission CNPA board members have been denied the opportunity to consider either the landscape or the carbon issues.

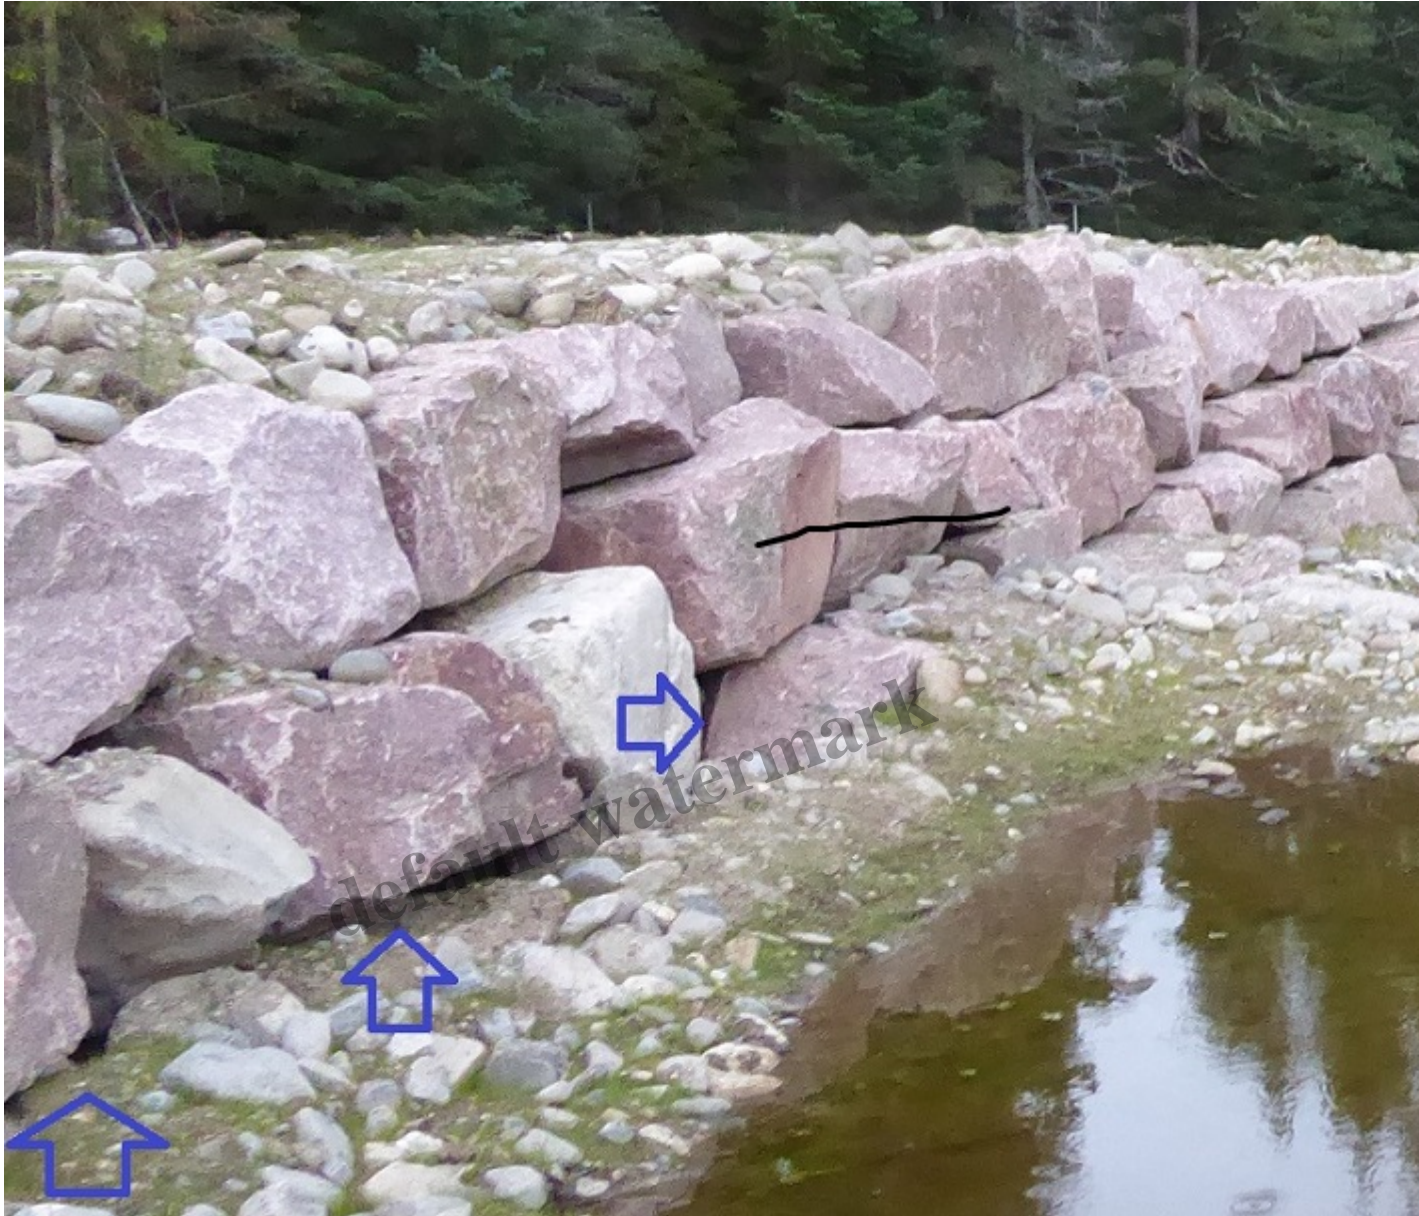
Plenty of places for flood water to be forced under the boulders – are they heavy enough to withstand it?

To me the rip-rap bouldering looks not that different to before and, without sight of the civil engineers' drawing and justification, it is not clear why flood water shouldn't prise the new boulders from the banks just as they did before. It appears that CNPA officers are prepared to wait and see but should the rip-rap bouldering fail that should put both themselves and the National Park in a very difficult position.

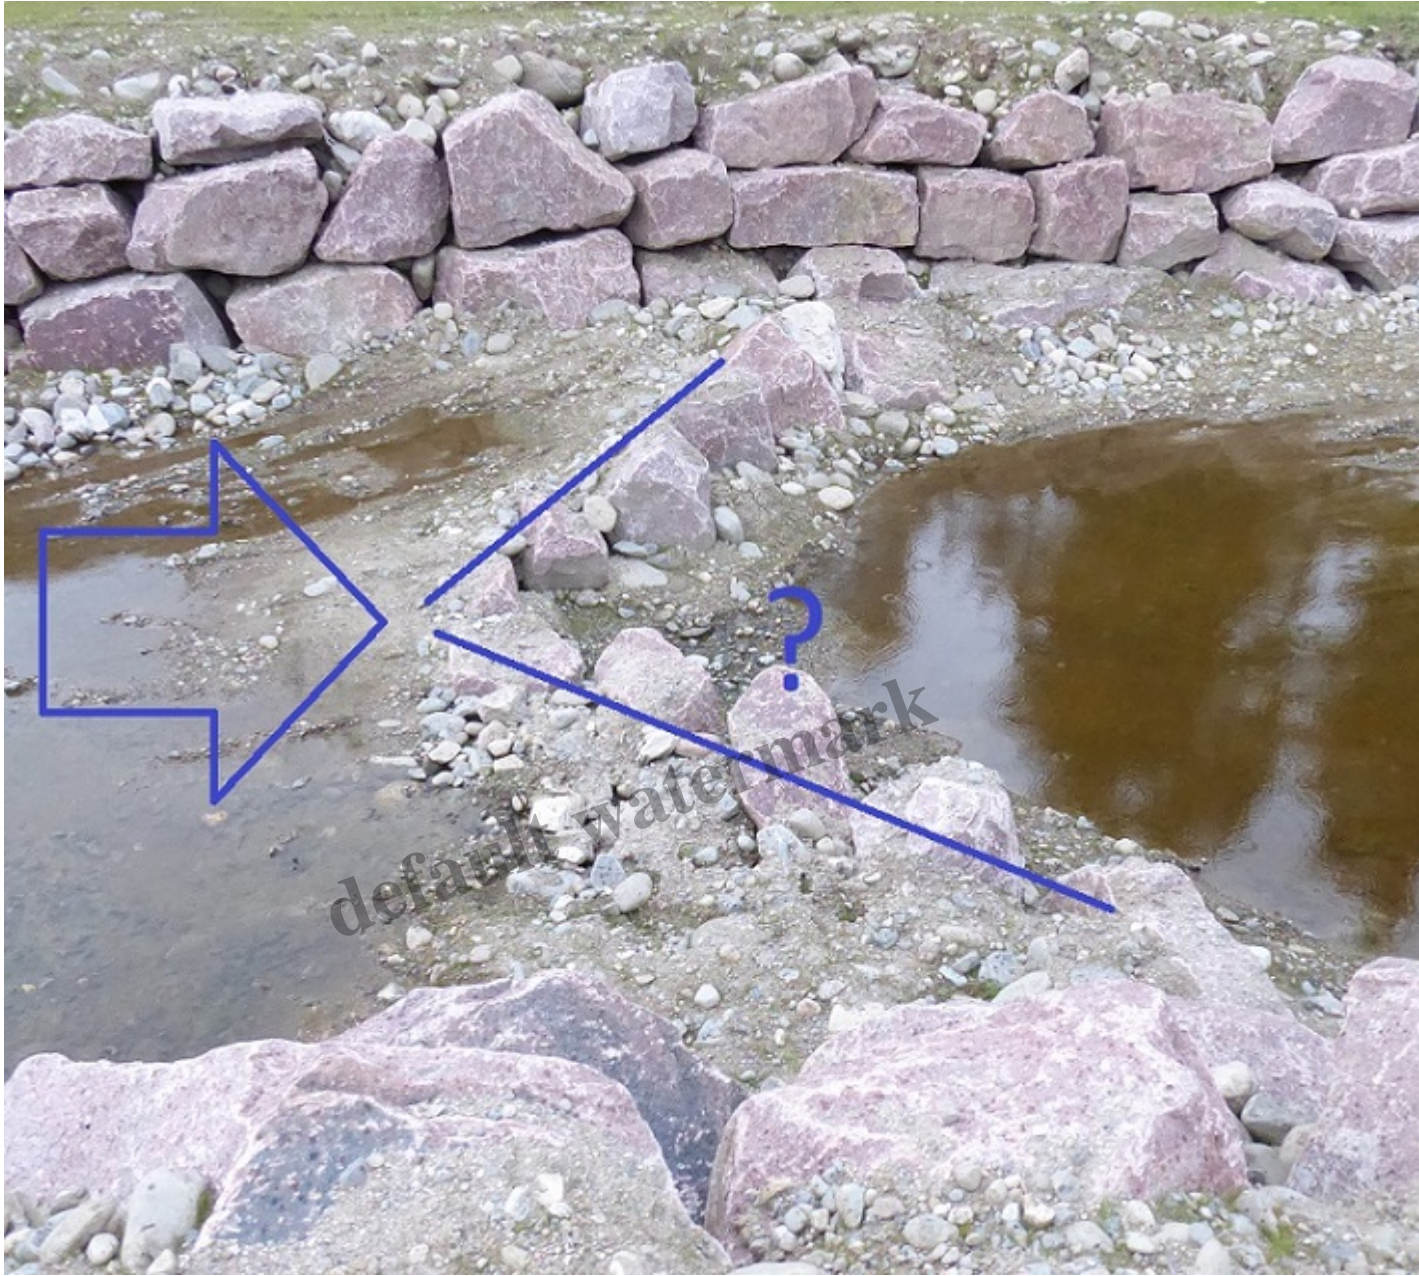
Each stone is resting on the one downstream, like a horizontal arch. Is it well enough constructed to survive a flood?

The floor of the first version of the channel quickly eroded and the rock was swept bare in places. The rationale for the new v-shaped rock barriers may be an attempt to prevent this but if so the rationale has not been explained. Alternatively, the idea may be to retain pools of water for aquatic life when the upper section of the channel is not working (lower down the overflow is fed by a burn).

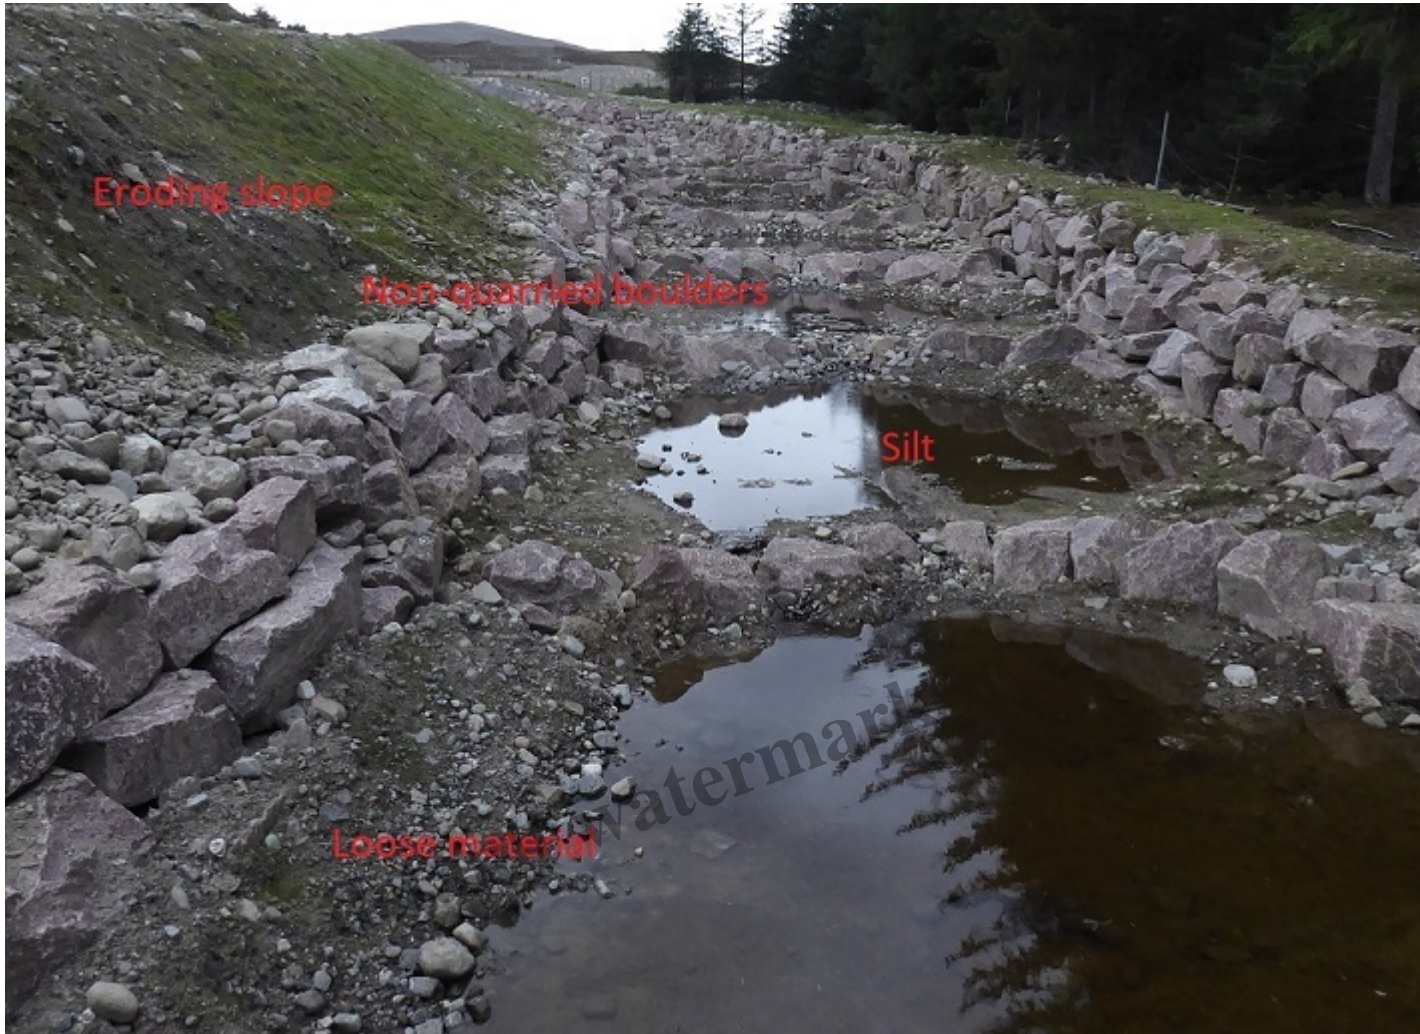
Note the short section of “non-quarried boulders” on the left of the second pool

In the first section of the overflow there is plenty of “loose material ” (front left), extensive silt and, once that is washed away, further material from the eroding slope above to replace it. It does not look very good habitat for wildlife. Whatever the intention, it appears that some of the rip rap bouldering and rock barriers are also vulnerable to being swept away.

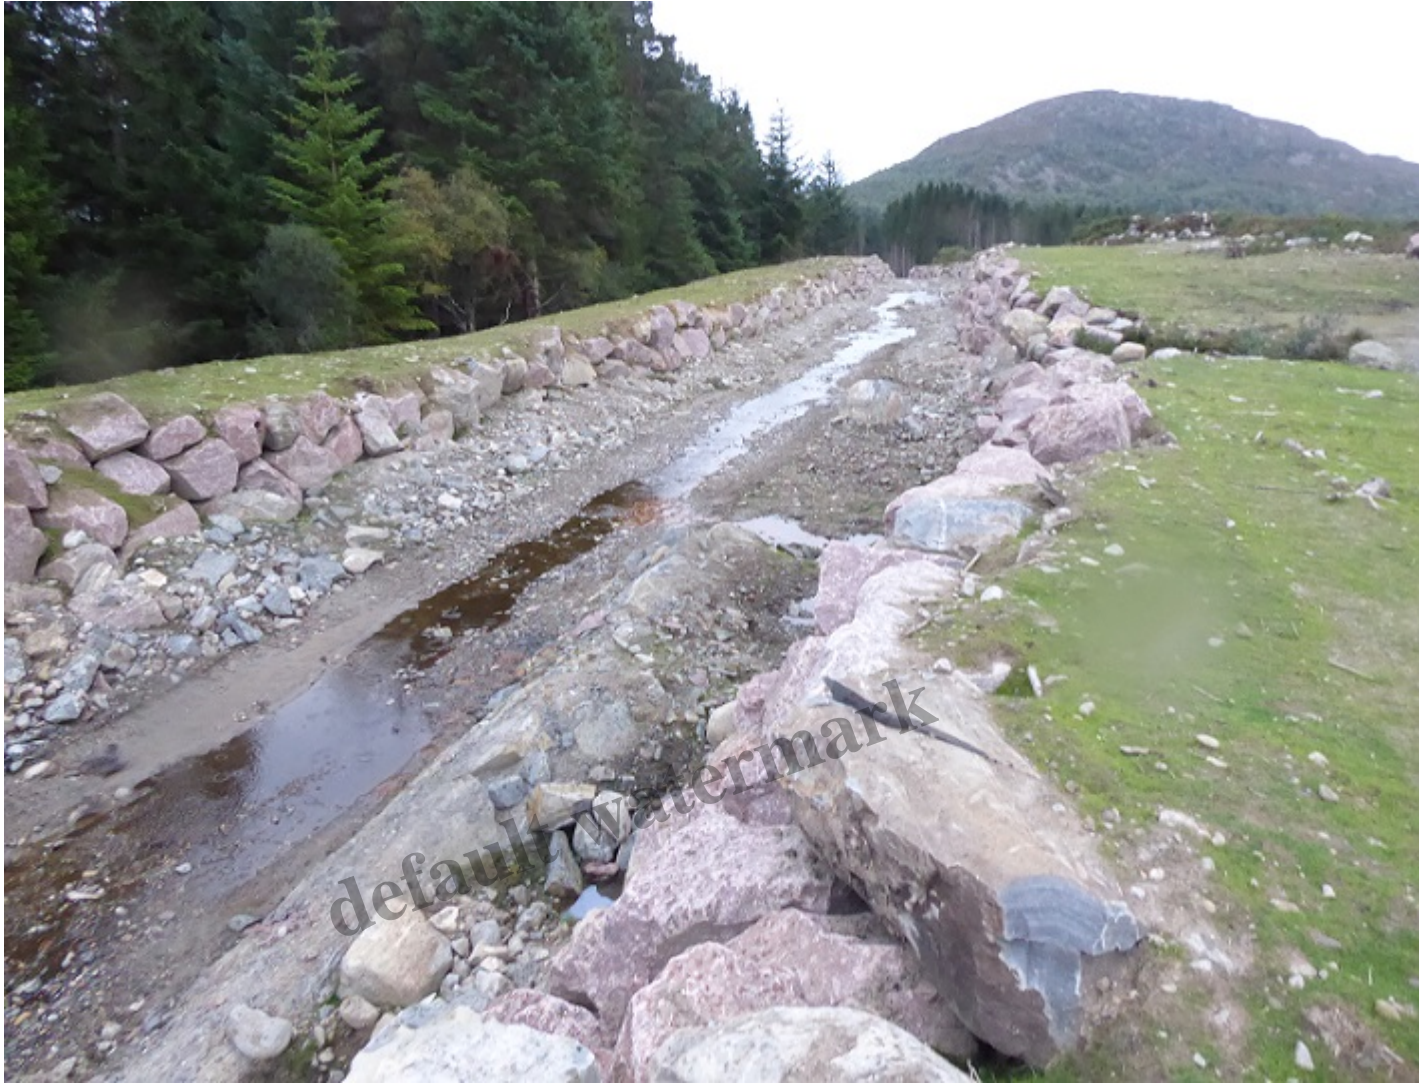
The channel below where a burn enters it from the north. Note the large area of flattened ground on the right, a consequence of the repair work not the original construction

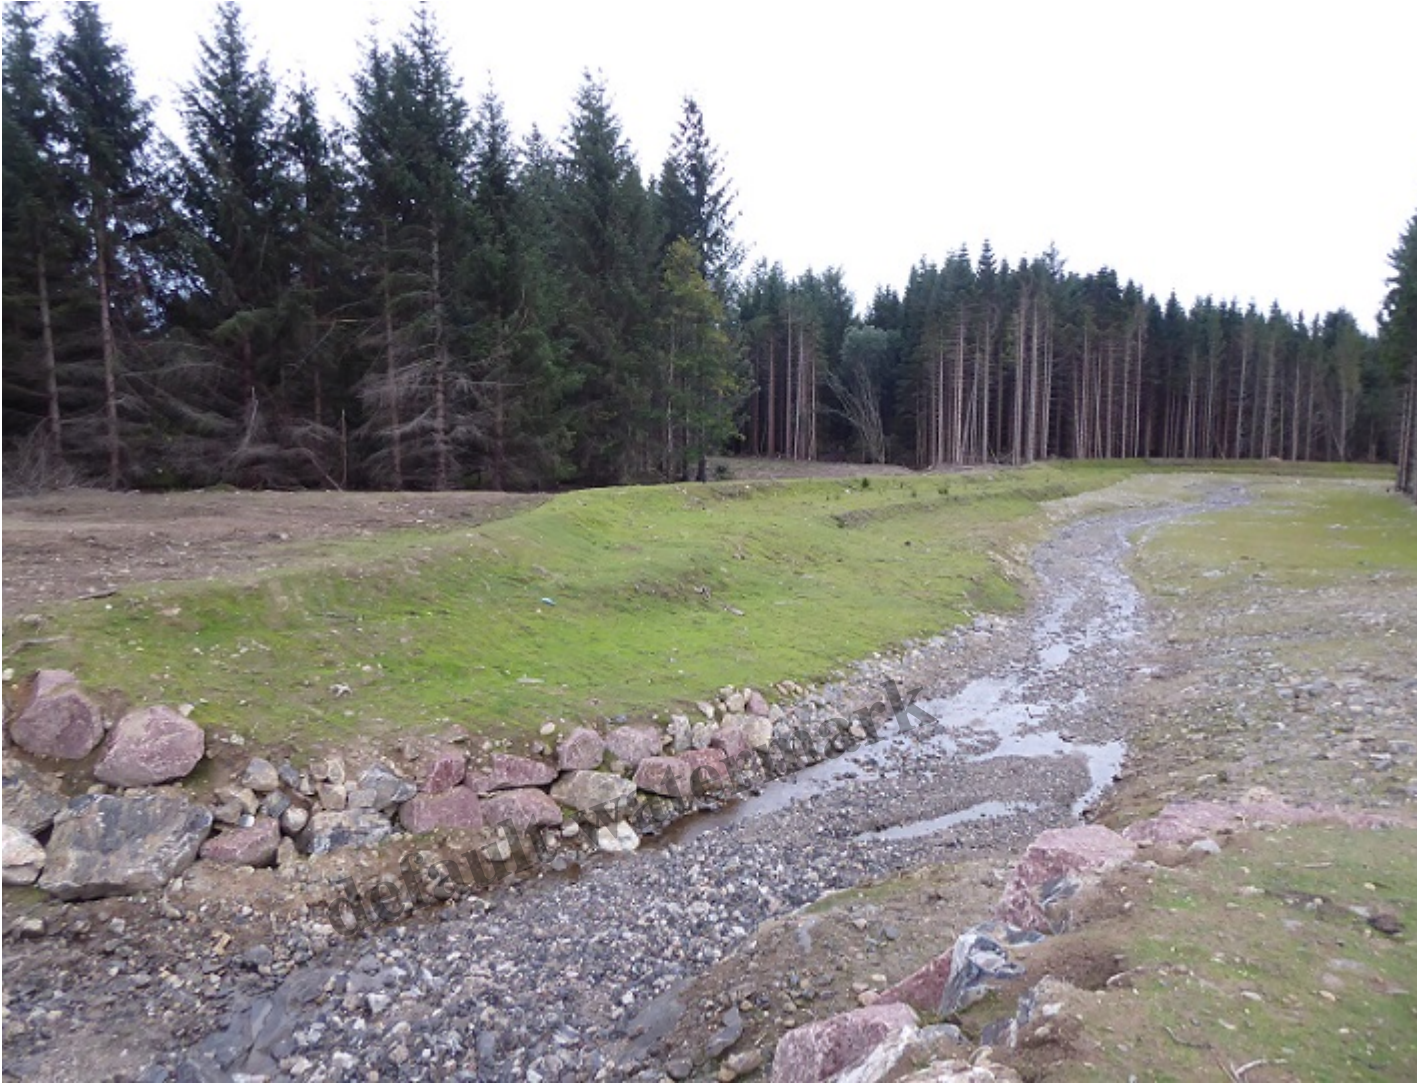
The final section of rip rap bouldering before the re-designed overflow channel broadens out.. Note the stepped banks on the left.

The lower section of the overflow channel appears more likely to work. Except where undercut, grass covered earth banks are generally quite resistant to floods, shedding the water. The reason the banks failed previously was not just that they were bare, they were also formed out of light peaty soil, an unsuitable growing medium, and placed far too close together.

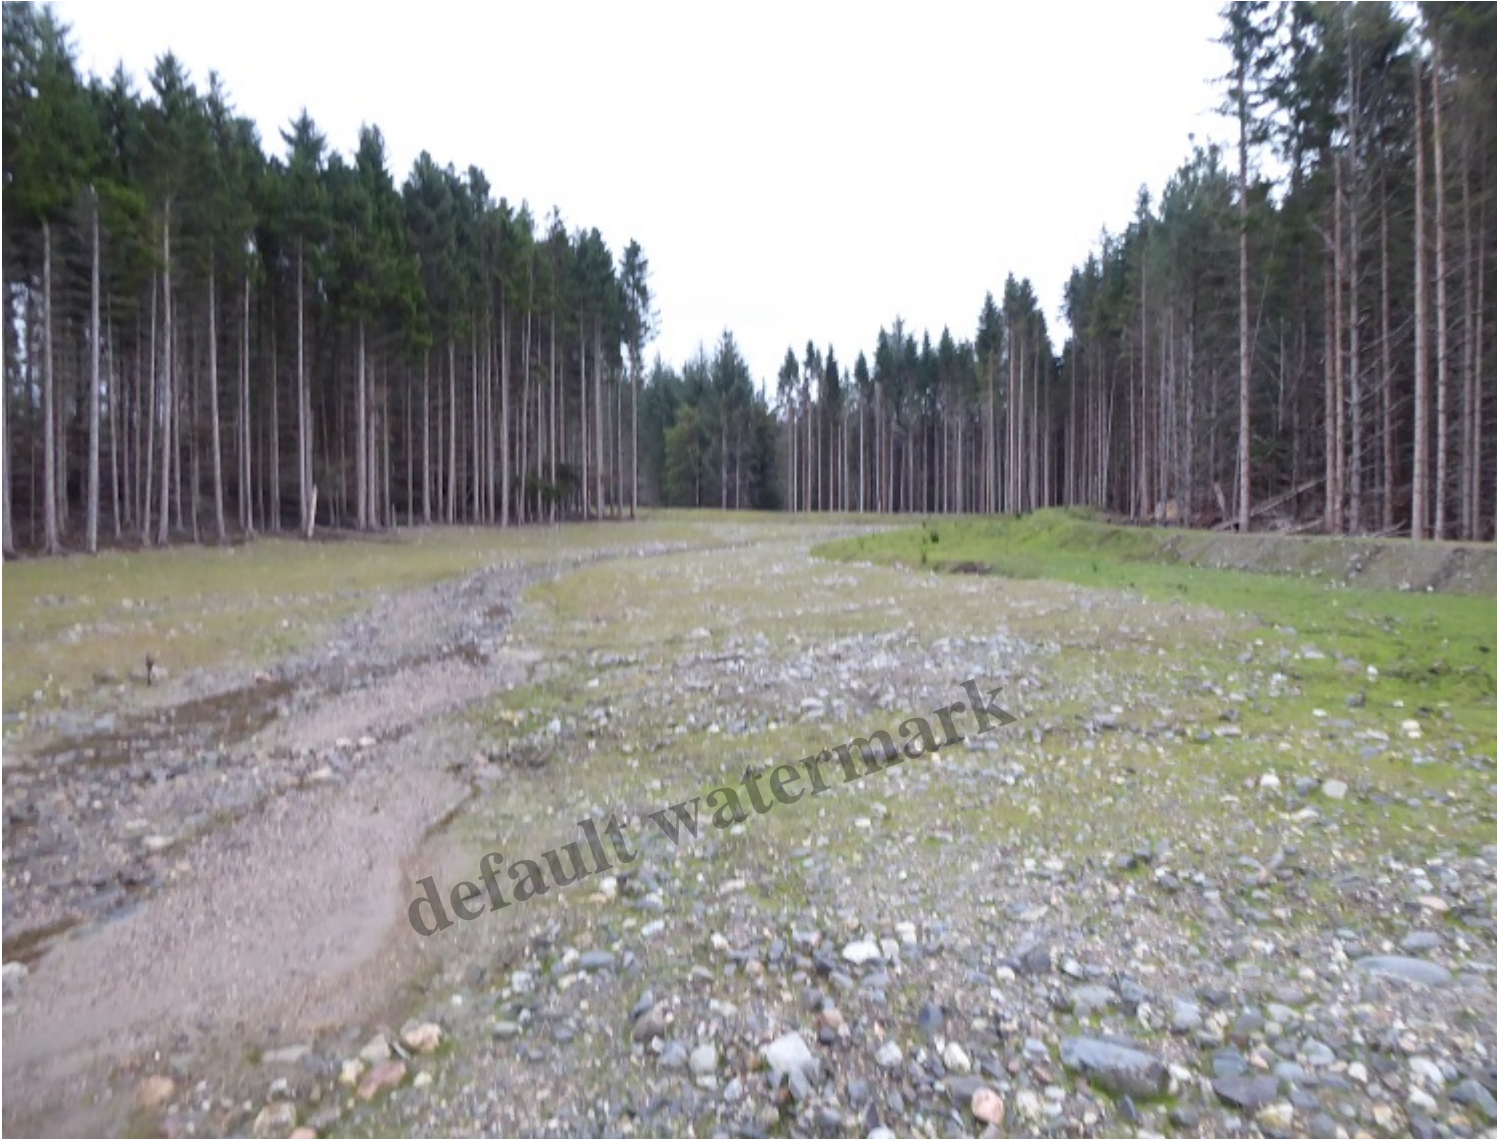
Whether the widely spaced earth banks will work depends on the volume of water that gets into the channel. While the intake from the Gynack is limited in size, the first burn that flows into the overflow can be sizeable in flood:

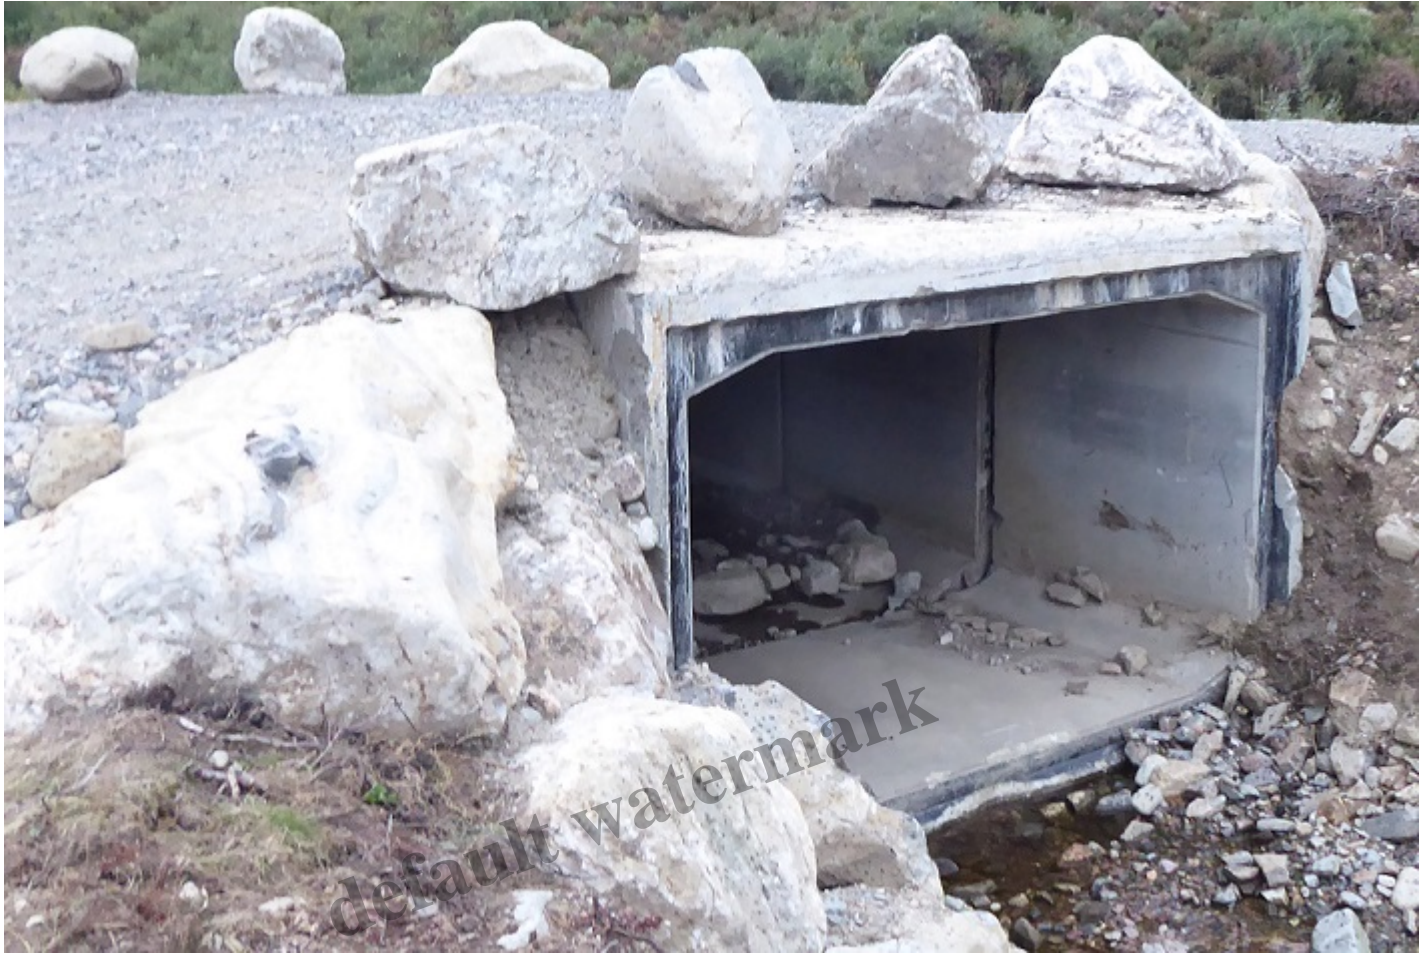
The culvert under the track between Pitmain Lodge and Loch Gynack has been designed to take a considerable volume of water. Note the poor finishing on the left.

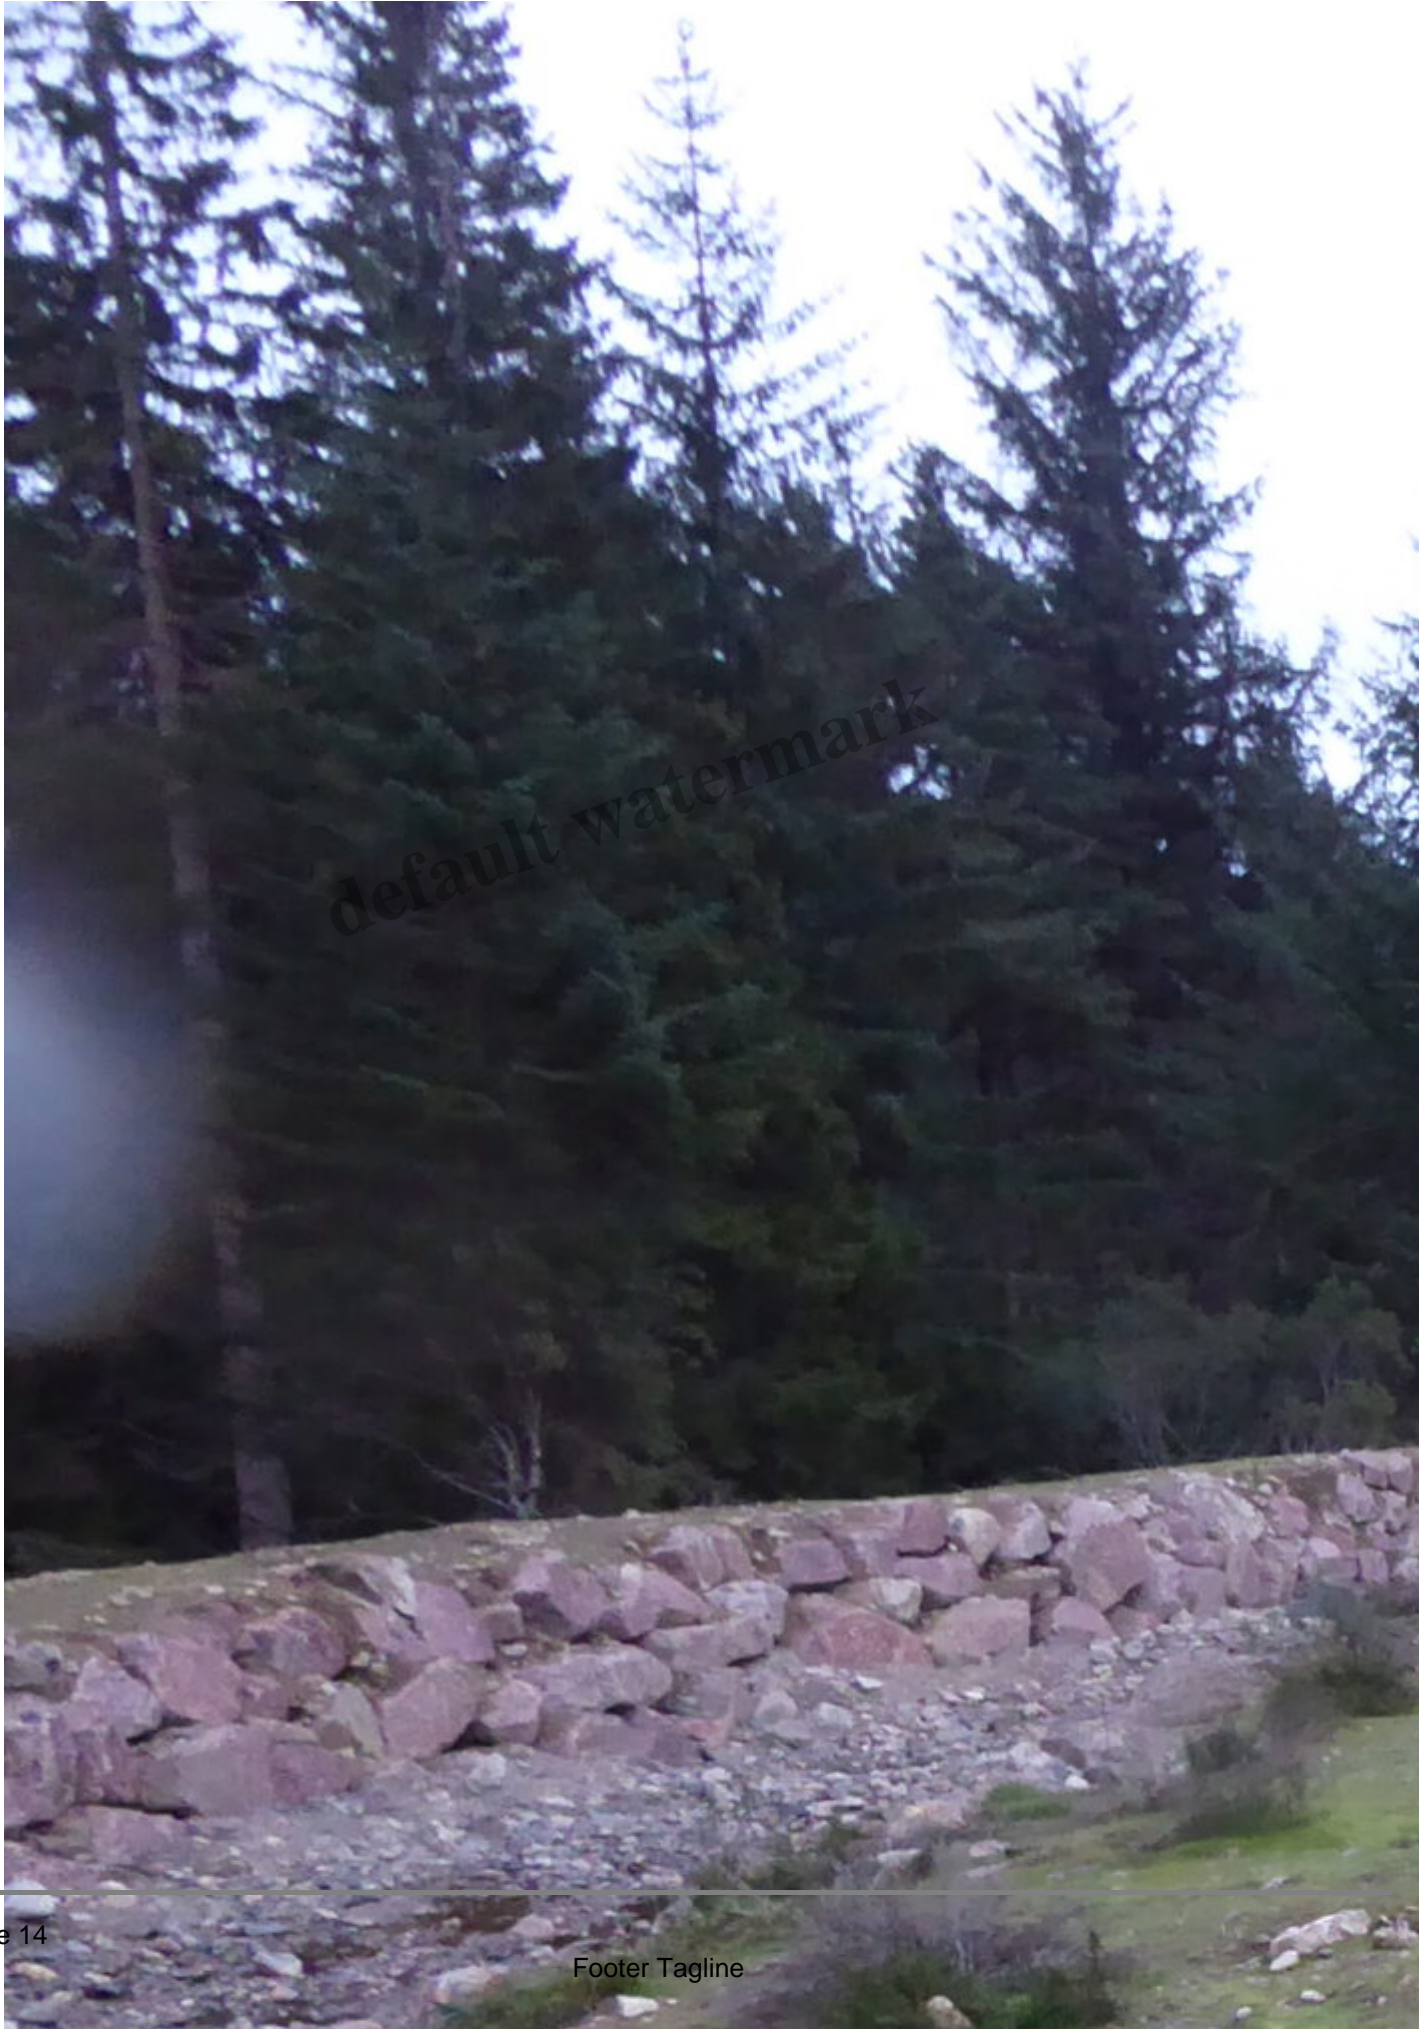
Ground that has been extensively modified by the “repair” work
