Flood prevention failure in the Cairngorms â?? the River Gynack overflow channel

November 22, 2023

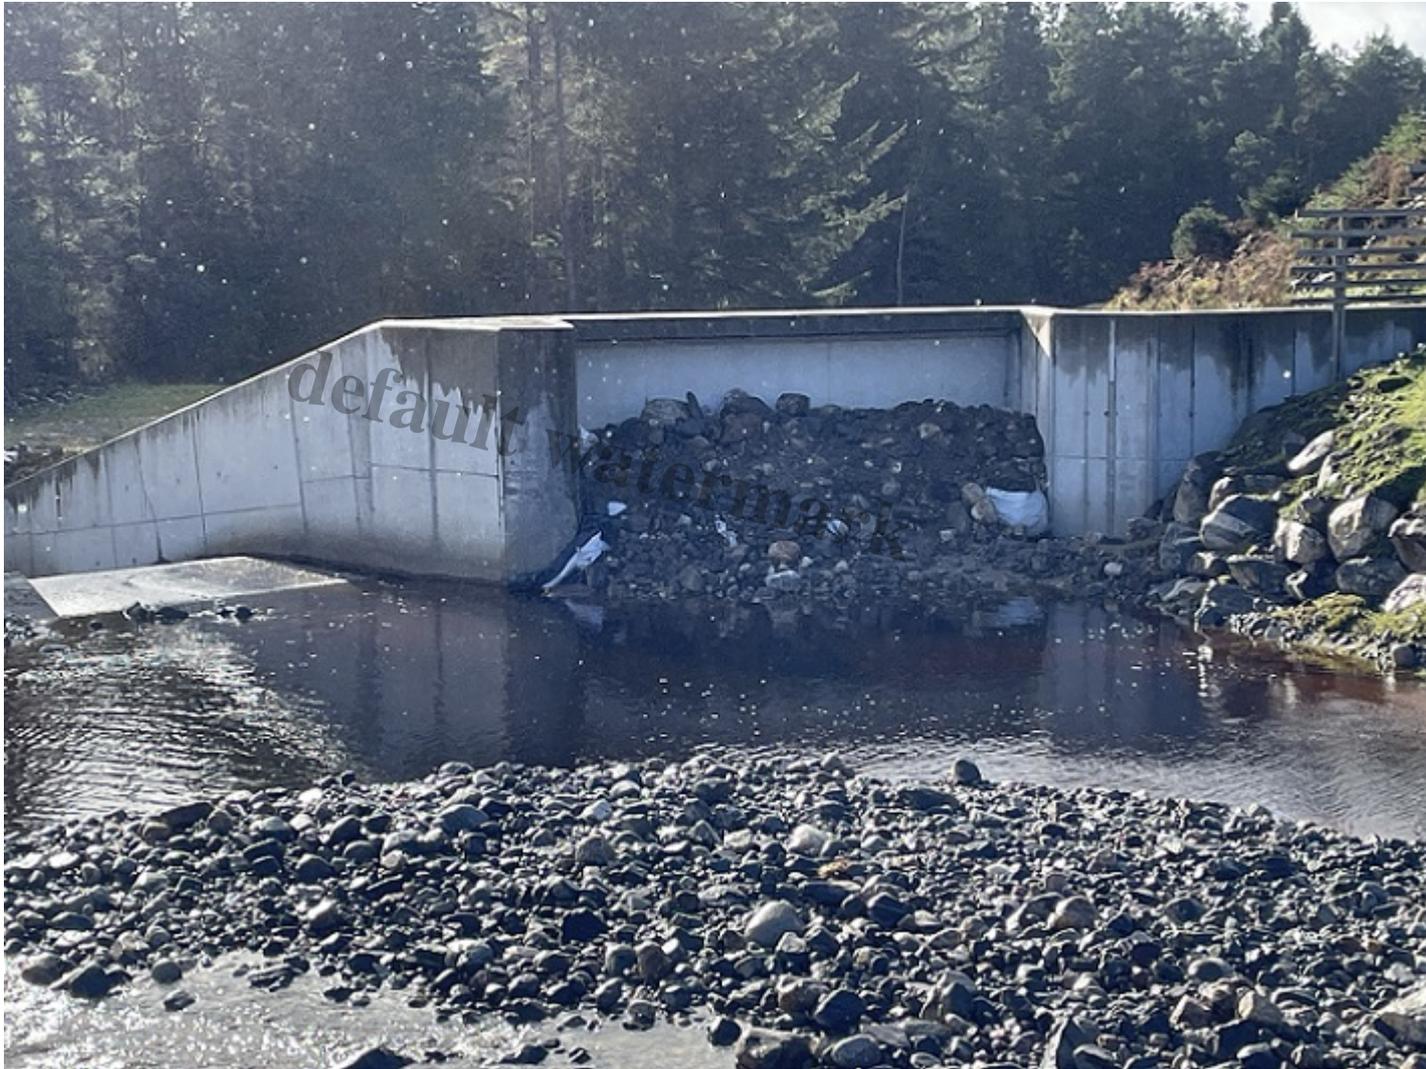
Blocked off entrance to overflow mid-October, after the floods, constructed without any regard for the landscape. The main course of the River Gynack flows to the left. Photo credit Parkswatch reader.

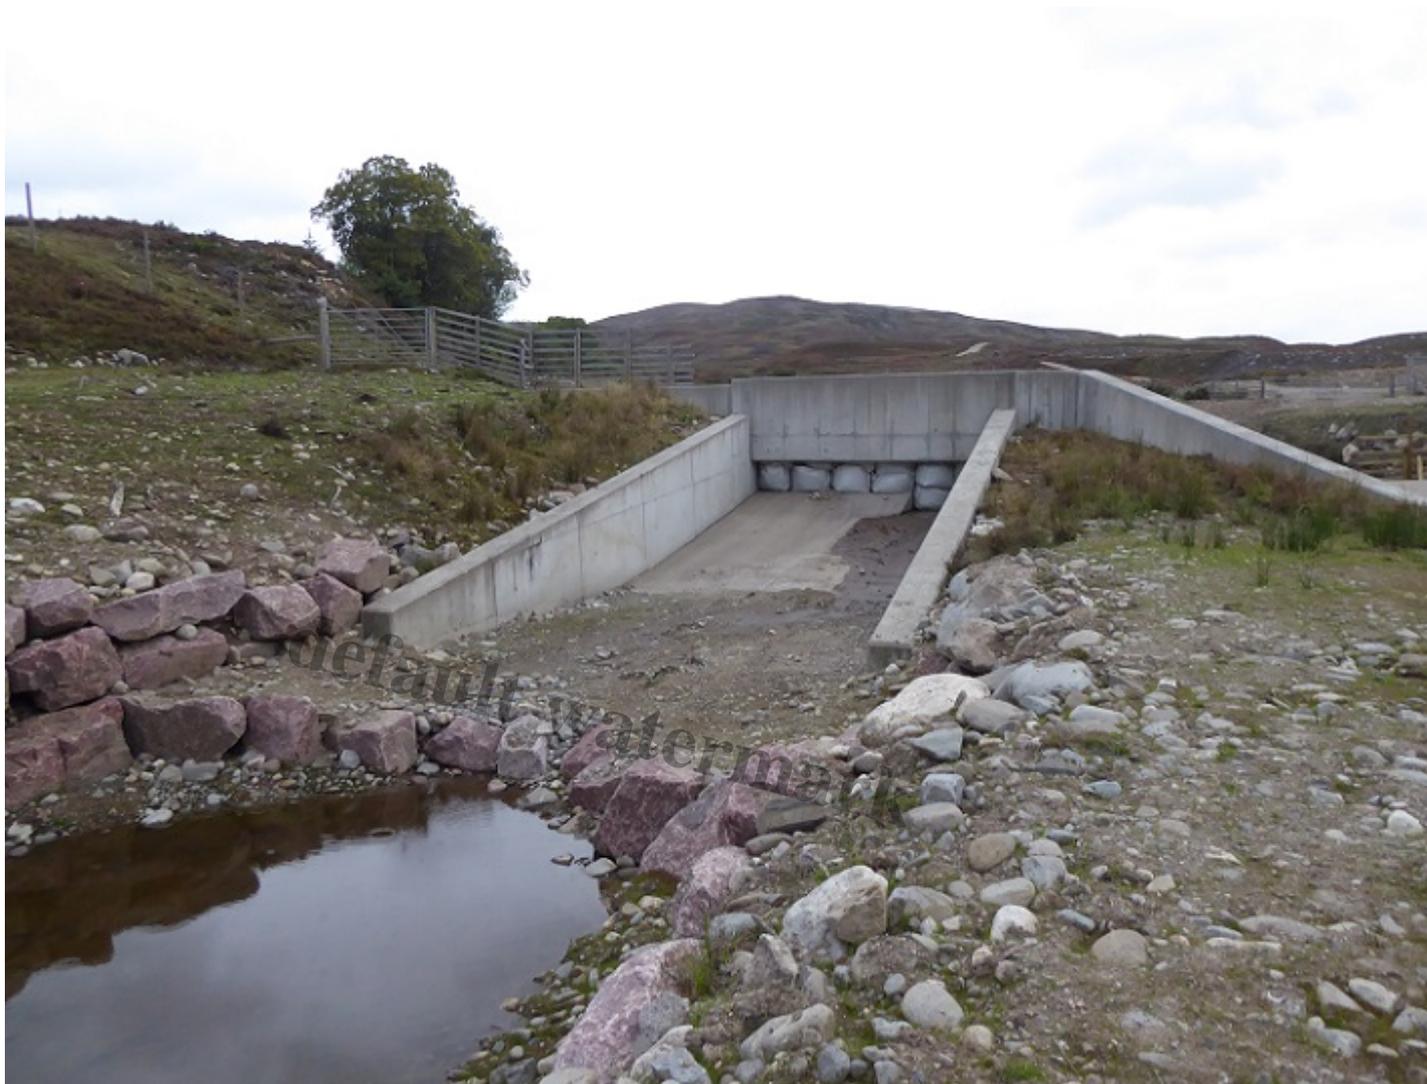
The start of the blocked overflow channel from the west September 2023

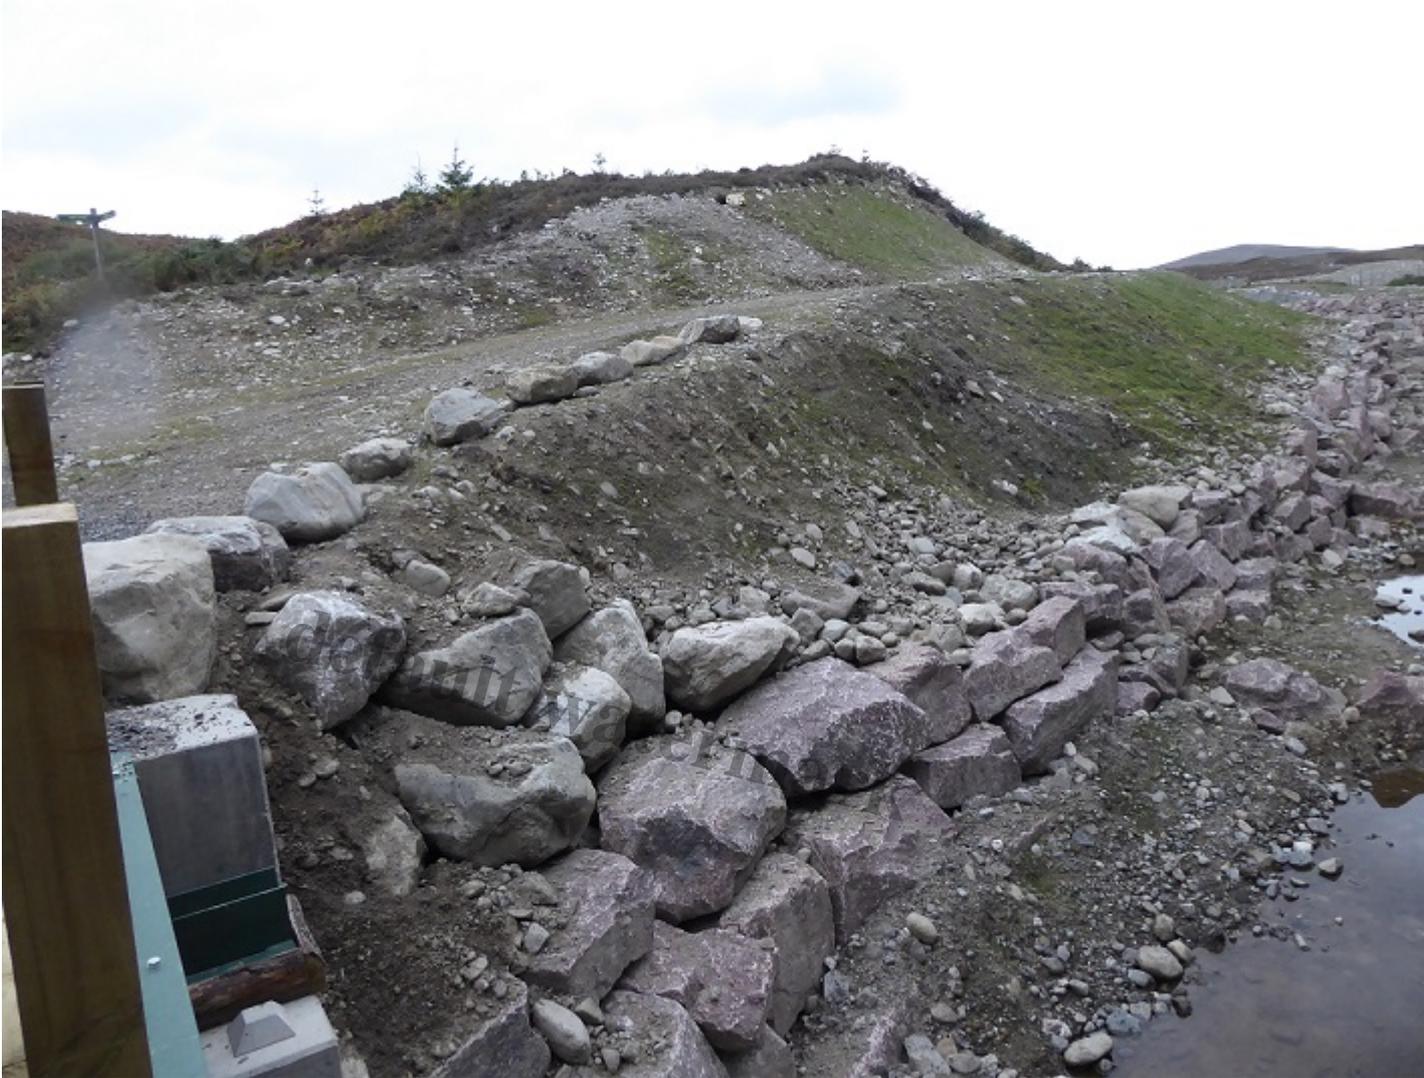
The view from the bridge above Pitmain lodge. The banks on the right have been re-seeded, whereas those in the centre have not and continue to erode.

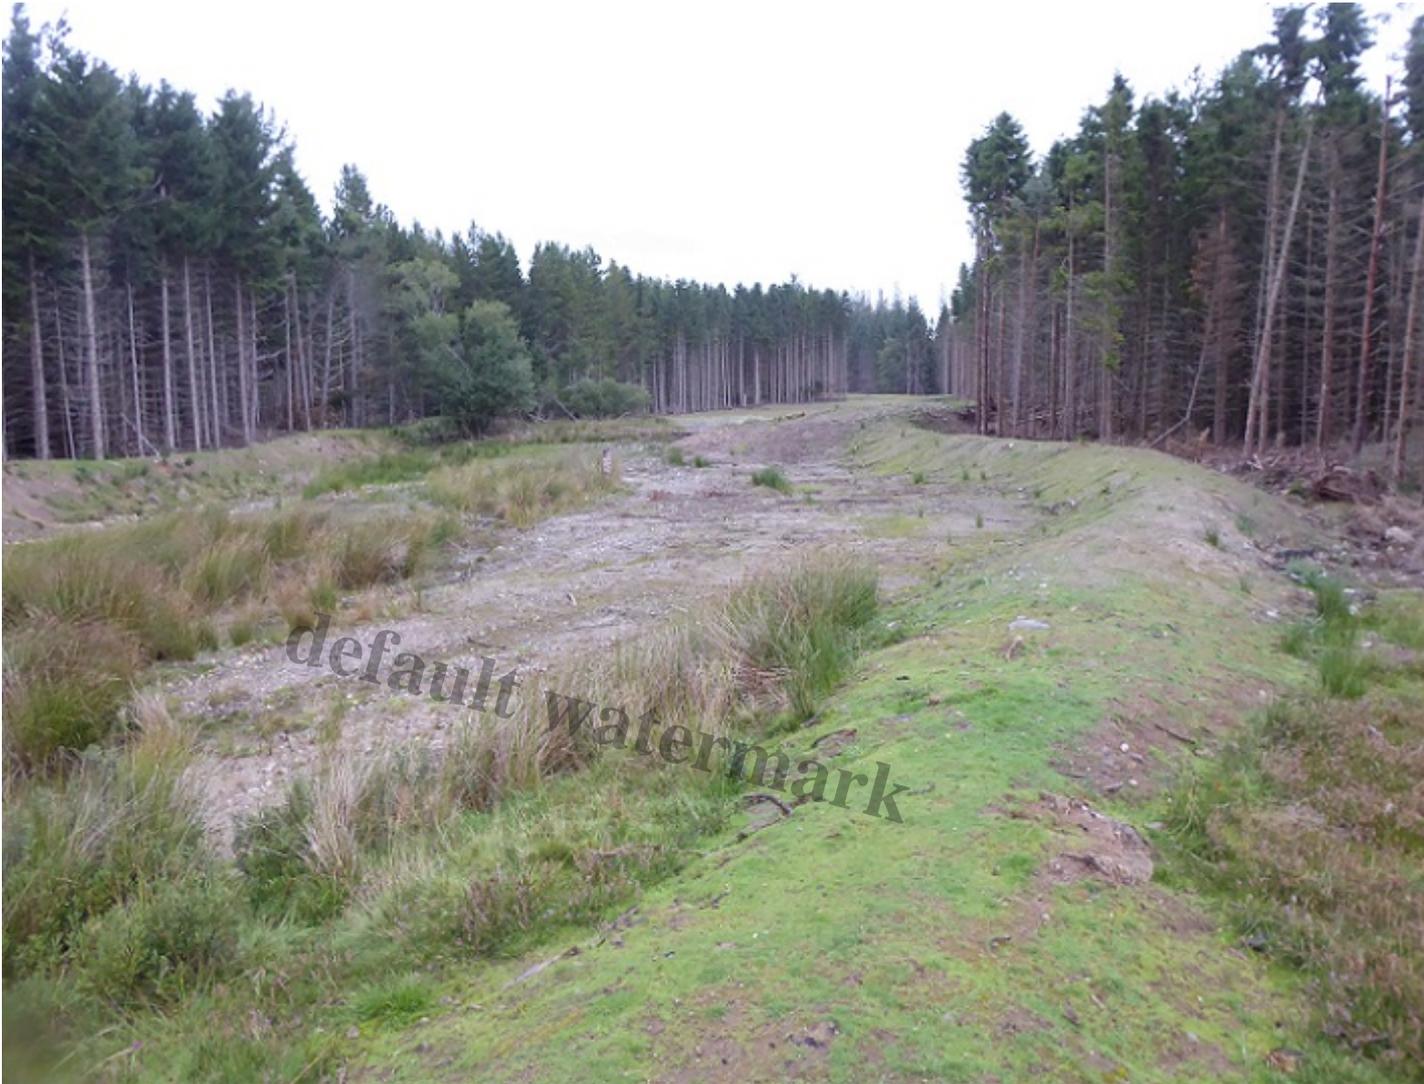
Looking up the lower section of the overflow. The earth banks are revegetating slowly but were still in September 2023 very vulnerable to erosion.

One lesson appears to have been learned from the previous failure, the earth banks are being allowed to re-vegetate before being re-opened. Hence why the overflow channel was still closed during the flooding that took place in early October. Just when the channel will re-open is unclear but let's hope it won't be like the funicular repairs, which the CNPA did actually approve, fundamentally flawed!

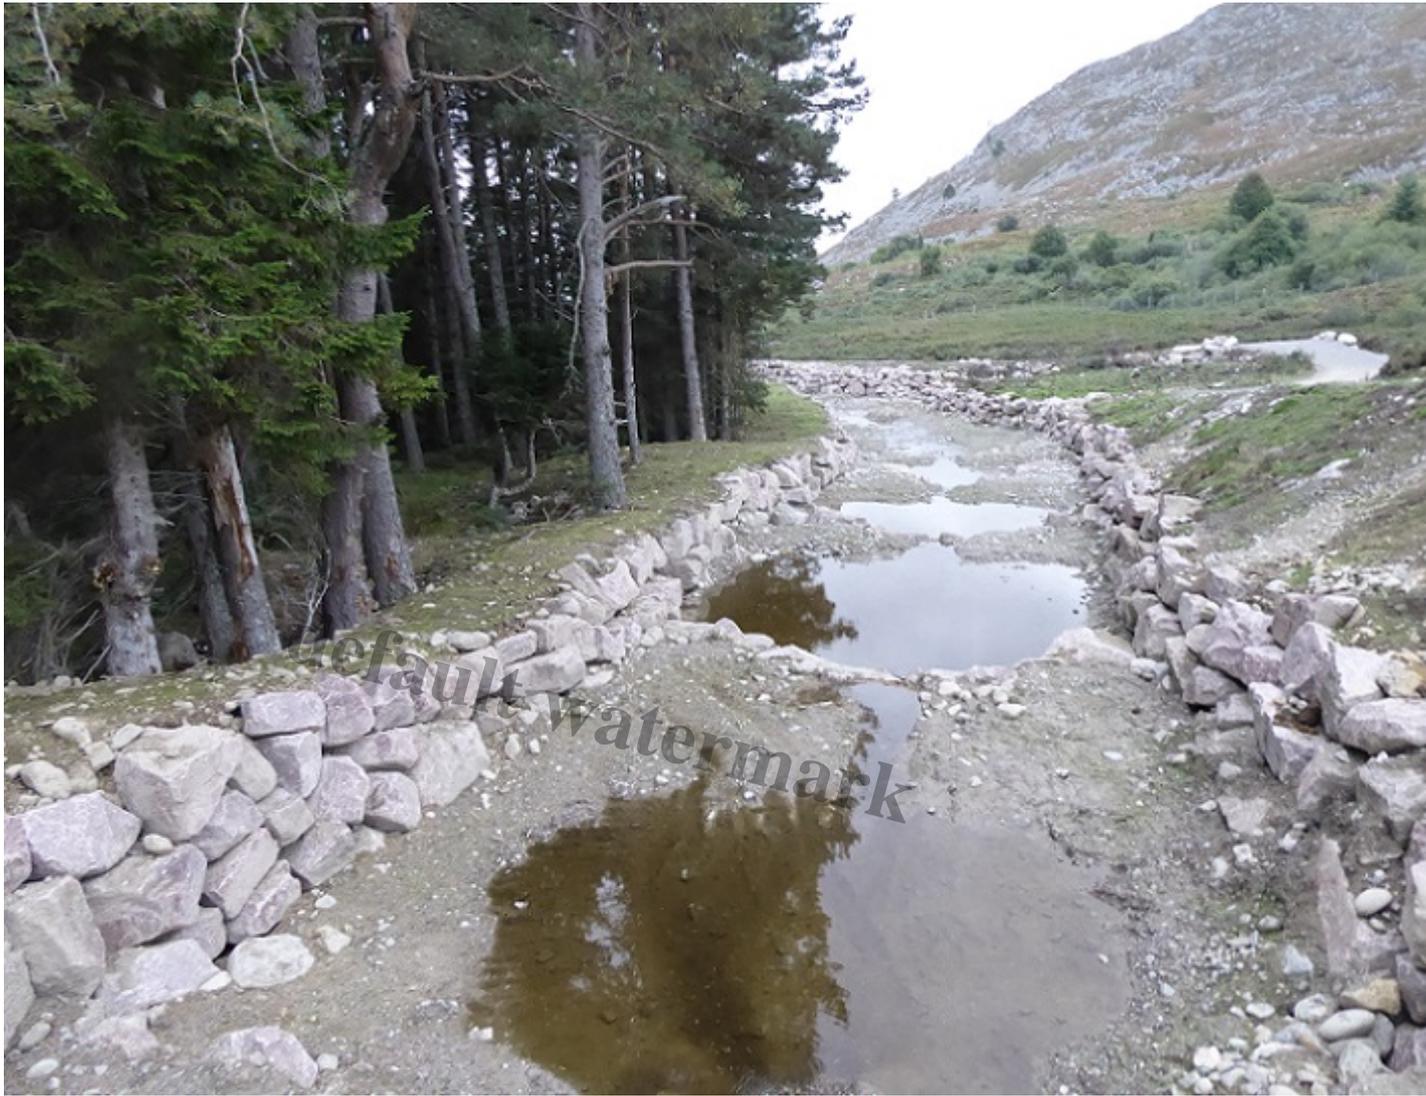
The view downstream from the bridge

The locally sourced stones used for the rip-rap bouldering in the first version have been replaced by imported quarried stone, brought in at significant cost and not reflecting the local geology. By allowing the repairs to proceed without planning permission CNPA board members have been denied the opportunity to consider either the landscape or the carbon issues.

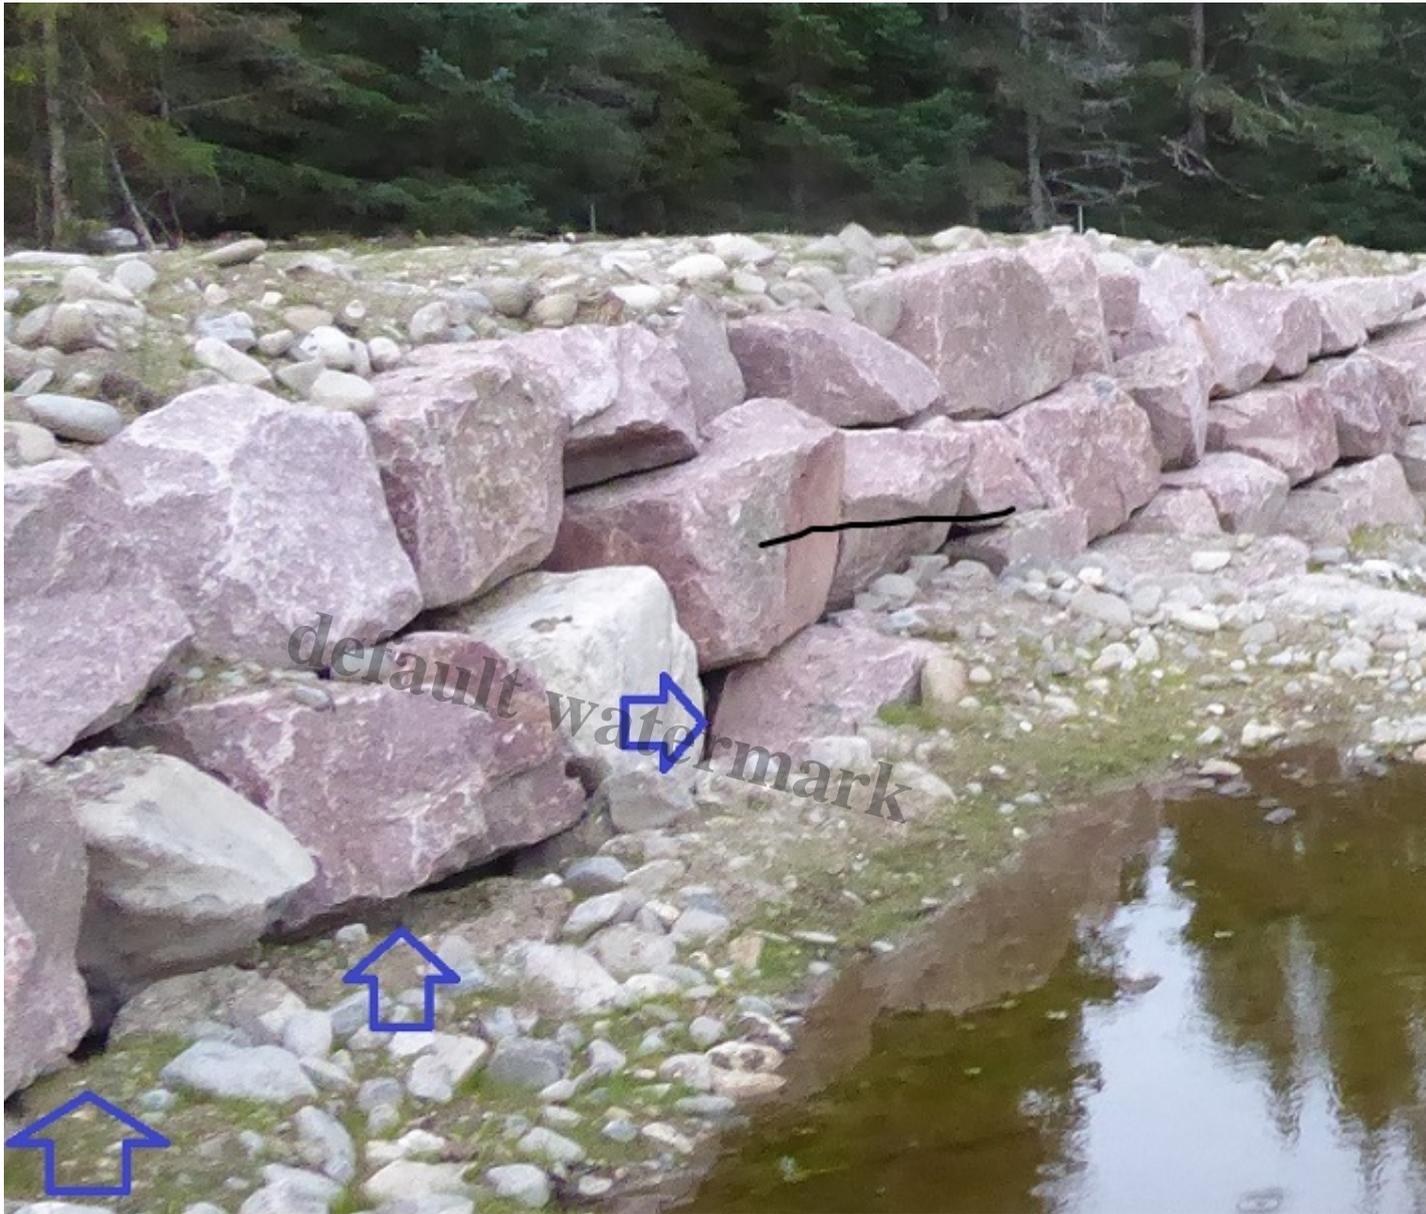
Plenty of places for flood water to be forced under the boulders â?? are they heavy enough to withstand it?

To me the rip-rap bouldering looks not that different to before and, without sight of the civil engineersâ?? drawing and justification, it is not clear why flood water shouldnâ??t prise the new boulders from the banks just as they did before. It appears that CNPA officers are prepared to wait and see but should the rip-rap bouldering fail that should put both themselves and the National Park in a very difficult position.

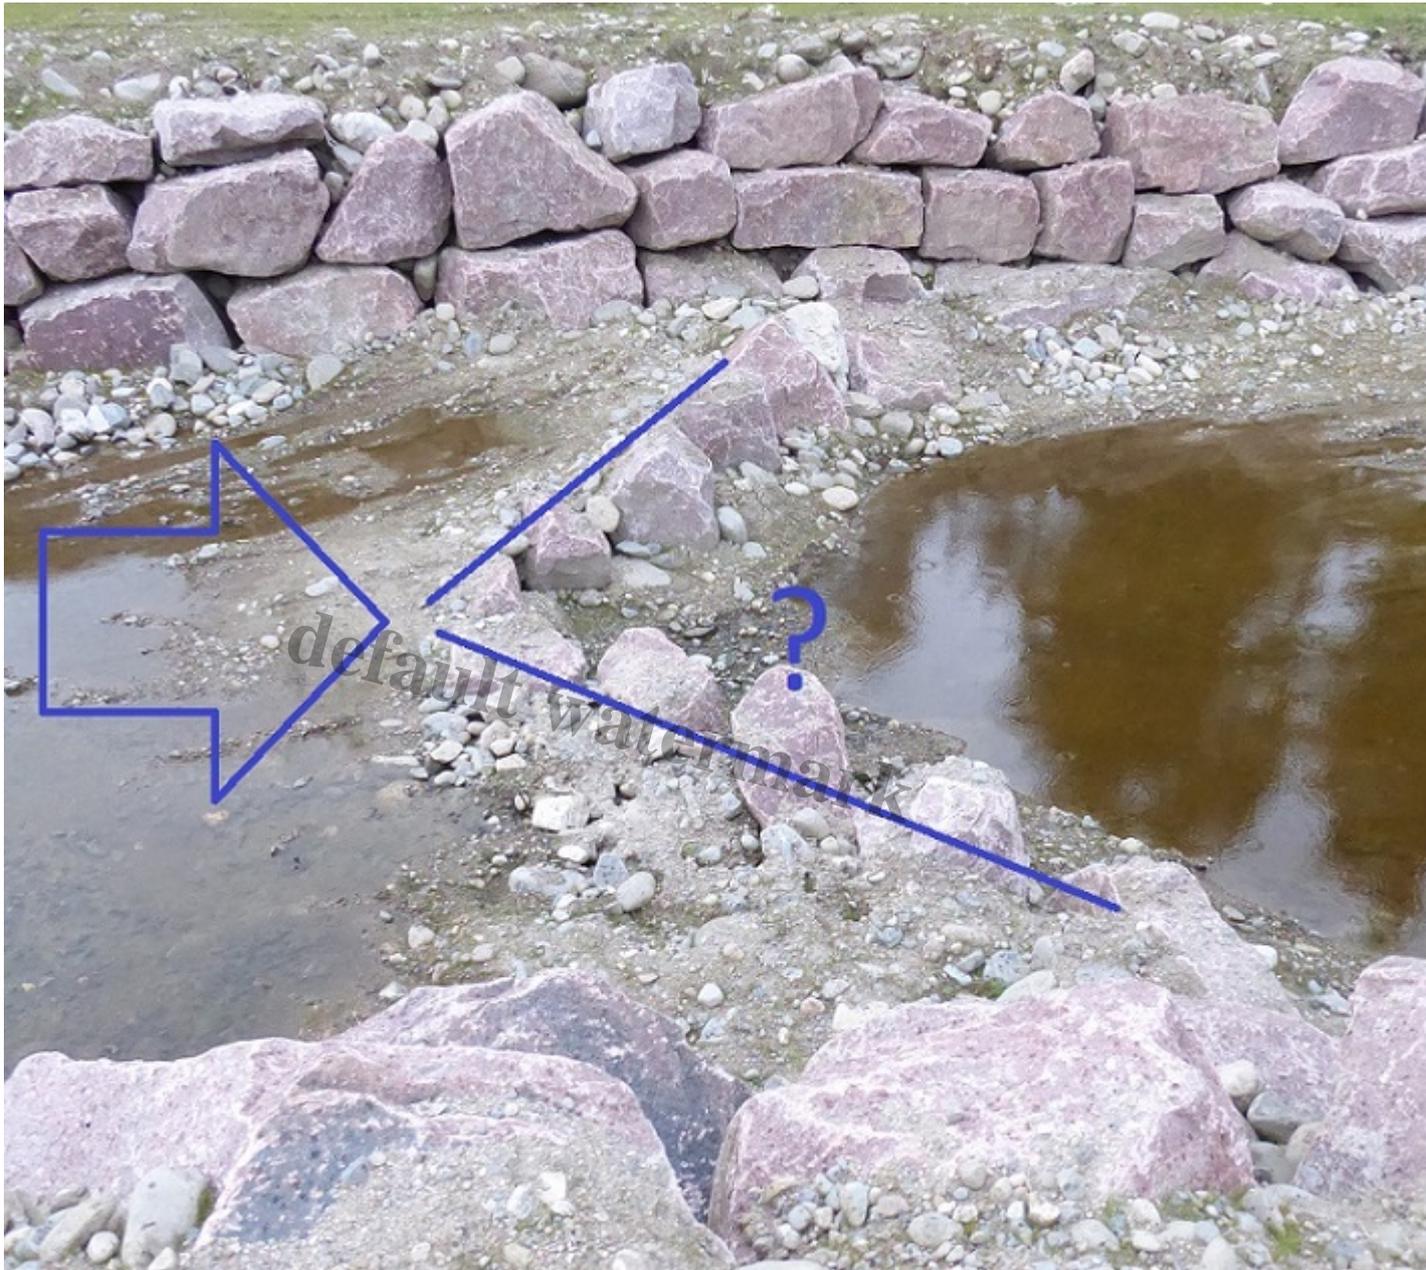
Each stone is resting on the one downstream, like a horizontal arch. Is it well enough constructed to survive a flood?

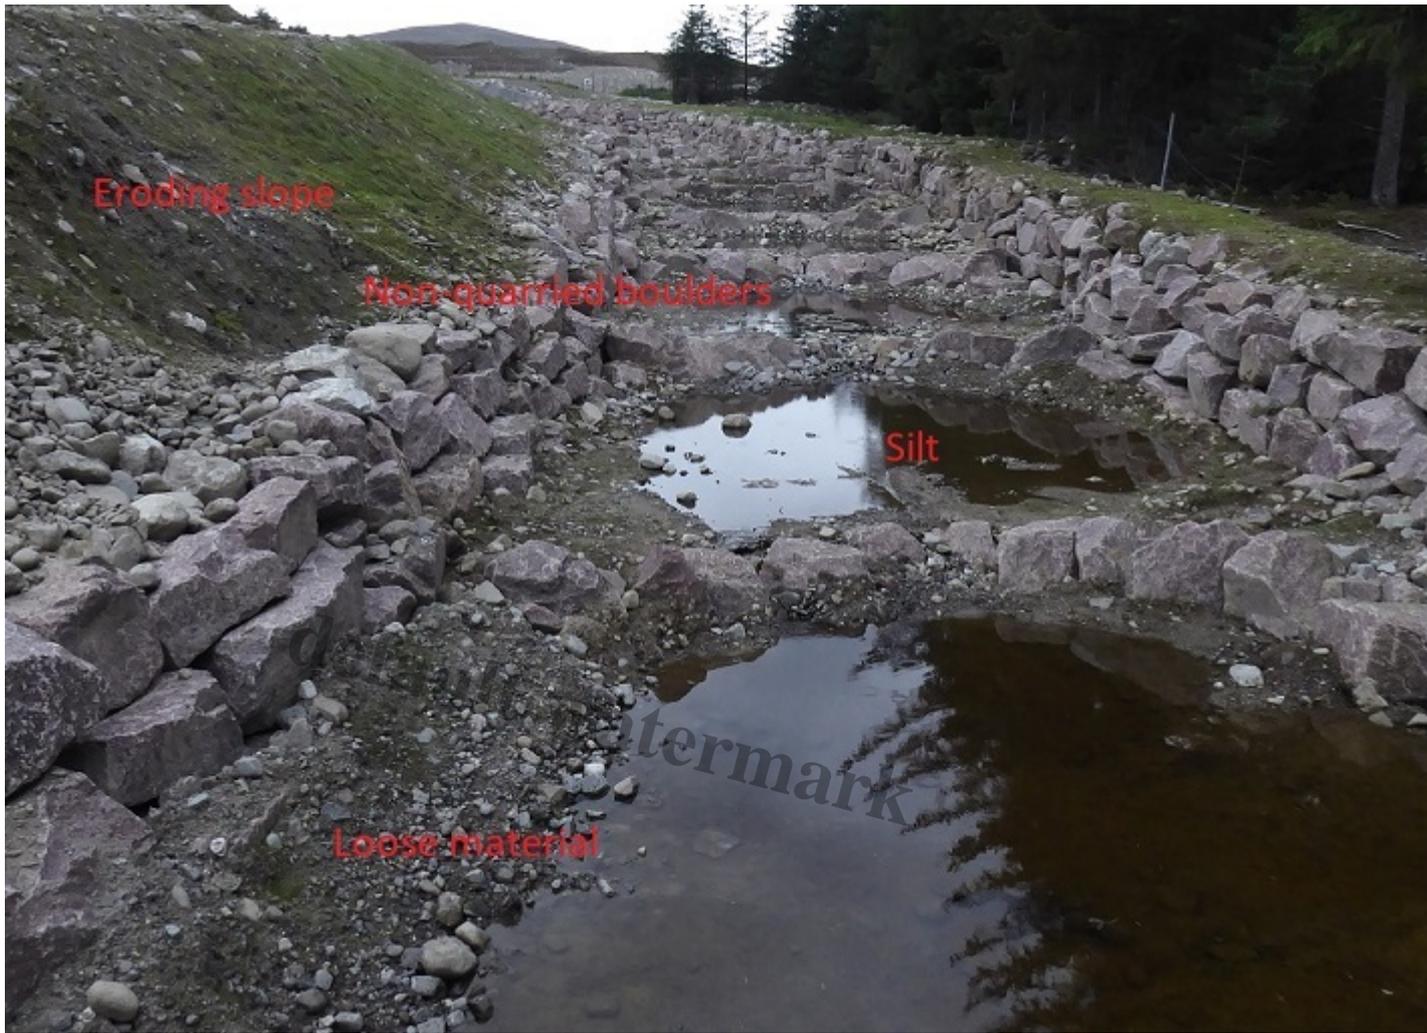
Note the short section of “non-quarried boulders” on the left of the second pool

In the first section of the overflow there is plenty of “loose material” (front left), extensive silt and, once that is washed away, further material from the eroding slope above to replace it. It does not look very good habitat for wildlife. Whatever the intention, it appears that some of the rip rap bouldering and rock barriers are also vulnerable to being swept away.

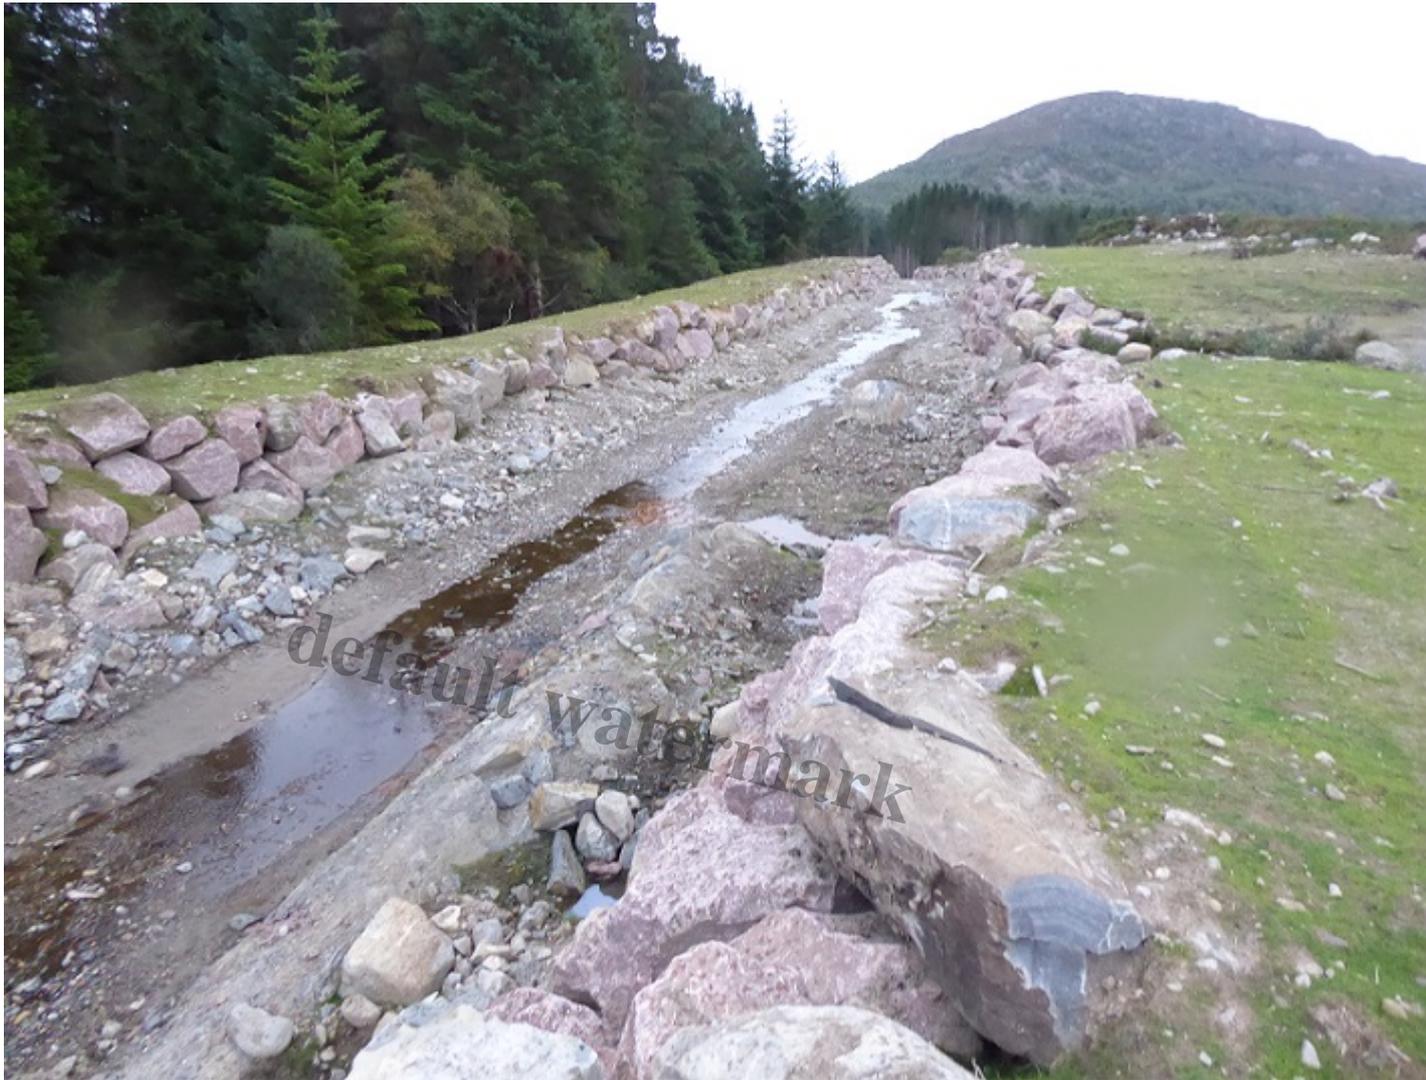
The channel below where a burn enters it from the north. Note the large area of flattened ground on the right, a consequence of the repair work not the original construction

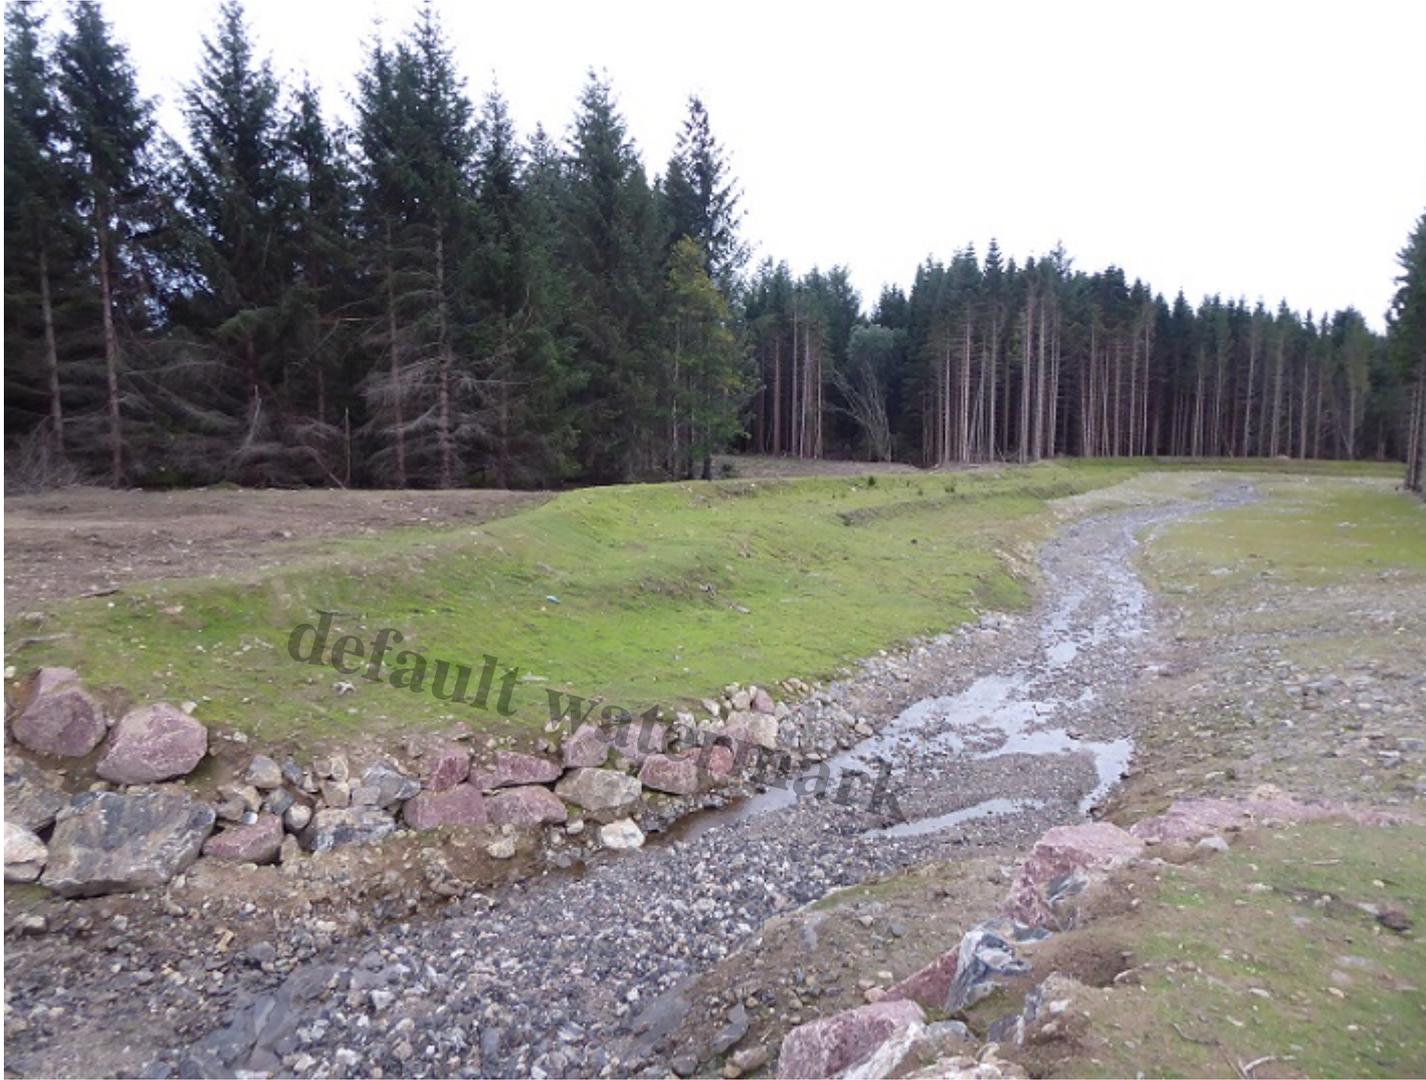
The final section of rip rap bouldering before the re-designed overflow channel broadens out.. Note the stepped banks on the left.

The lower section of the overflow channel appears more likely to work. Except where undercut, grass covered earth banks are generally quite resistant to floods, shedding the water. The reason the banks failed previously was not just that they were bare, they were also formed out of light peaty soil, an unsuitable growing medium, and placed far too close together.

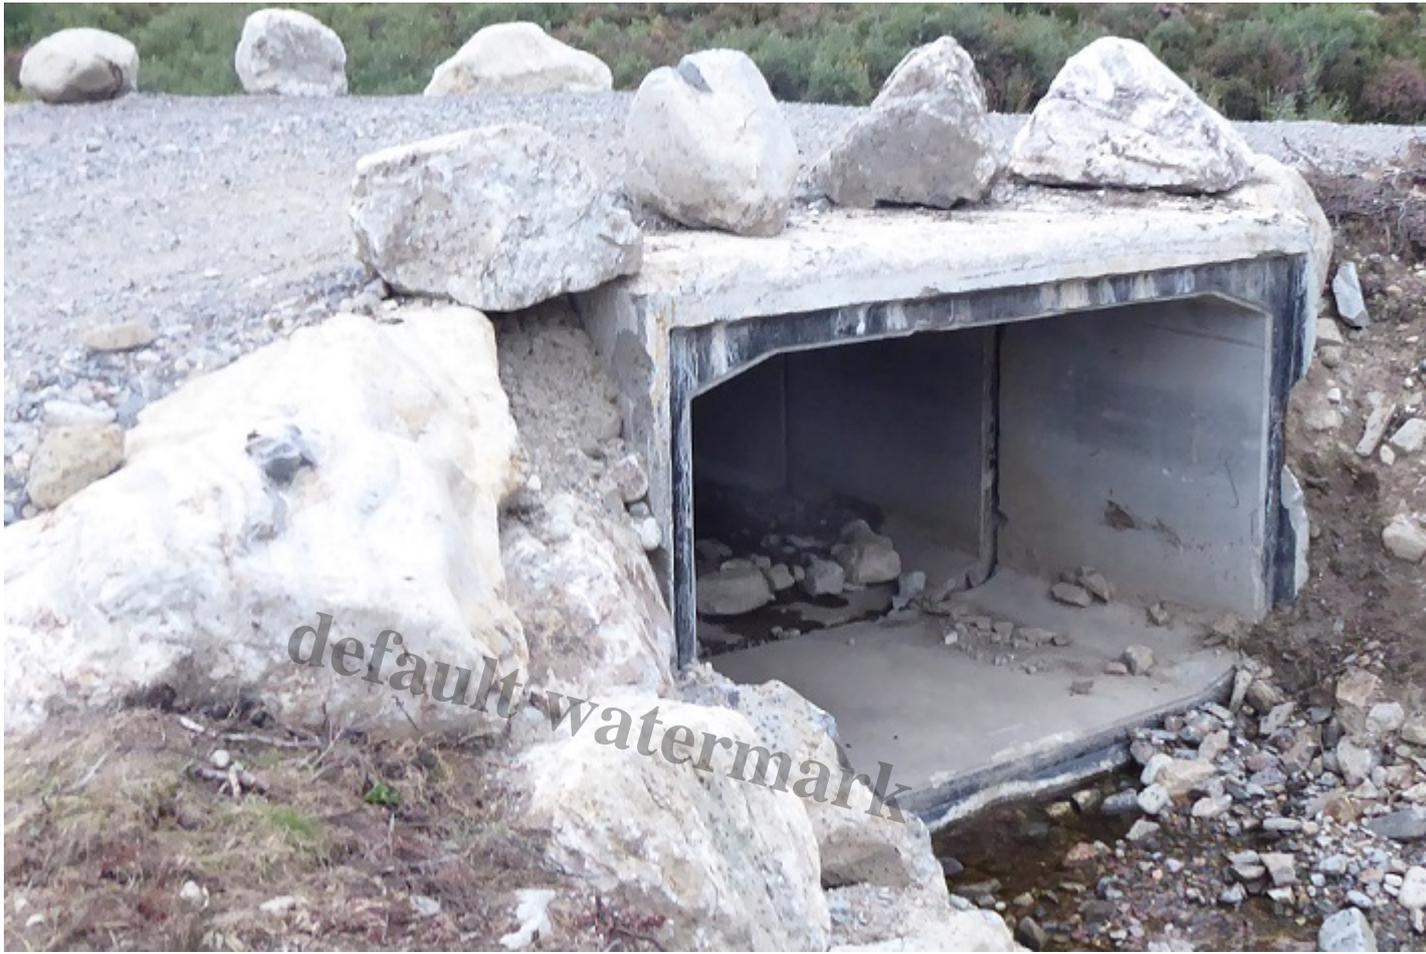
The culvert under the track between Pitmain Lodge and Loch Gynack has been designed to take a considerable volume of water. Note the poor finishing on the left.

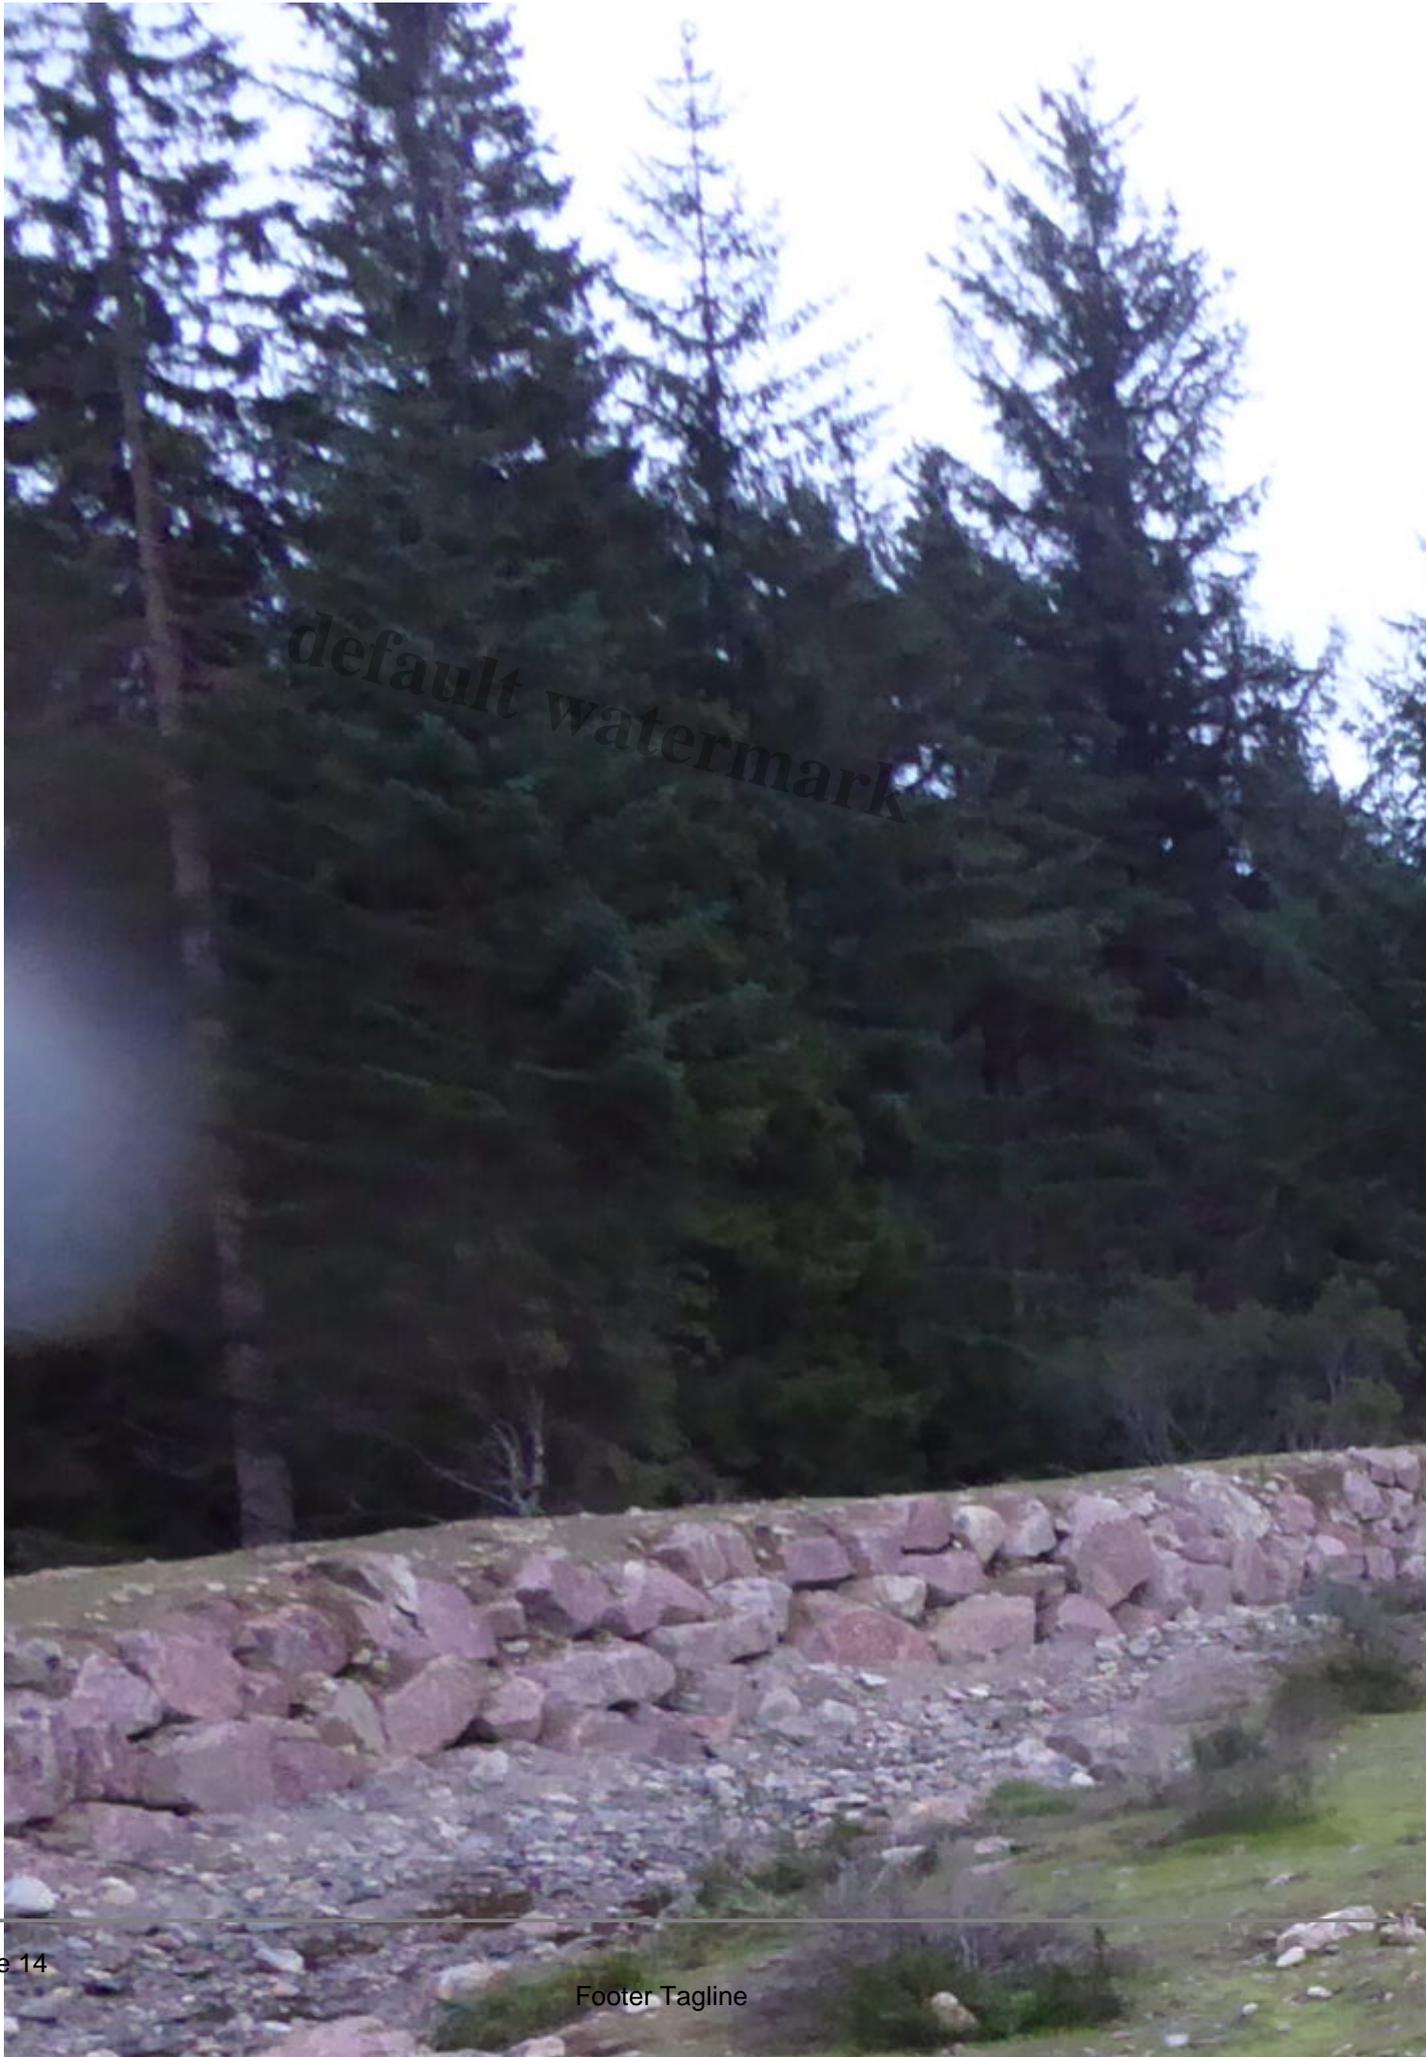
Ground that has been extensively modified by the "repair" work
