HIE's decision to close the Cairn Gorm funicular again (3)

### (A) The steel strengthening brackets

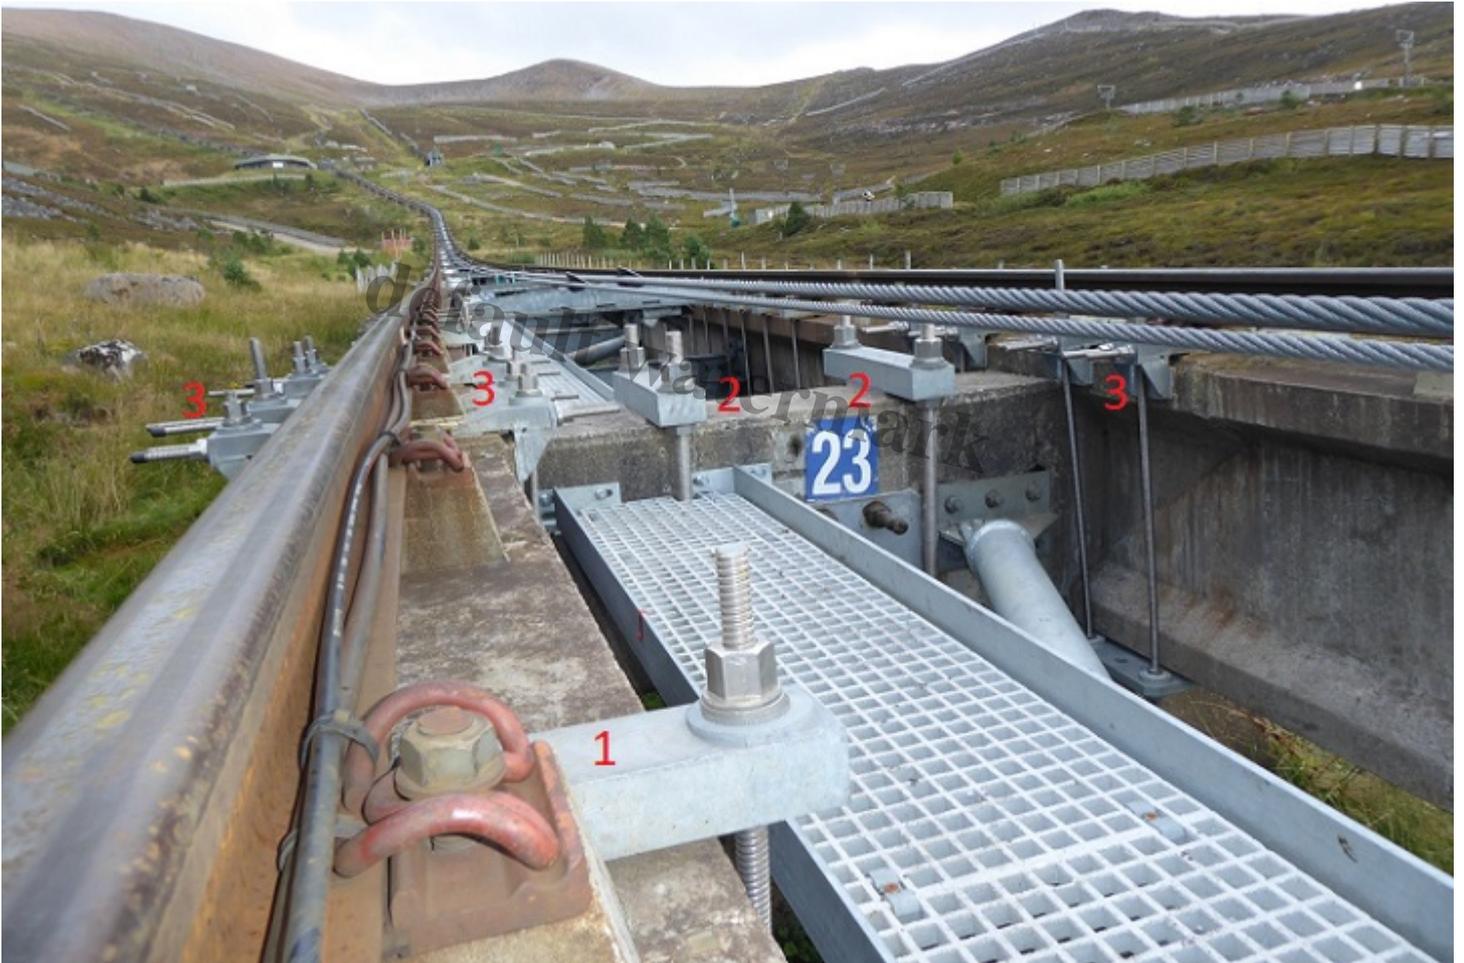
This picture shows the three different types of bracket used in the strengthening works.

Type 1. The bracket in the foreground (used in the central section of the beam)

Type 2. The brackets around the insitu block either side of the number 23

Type 3. The brackets around the scarf joint, more clearly seen on the right of the next picture.

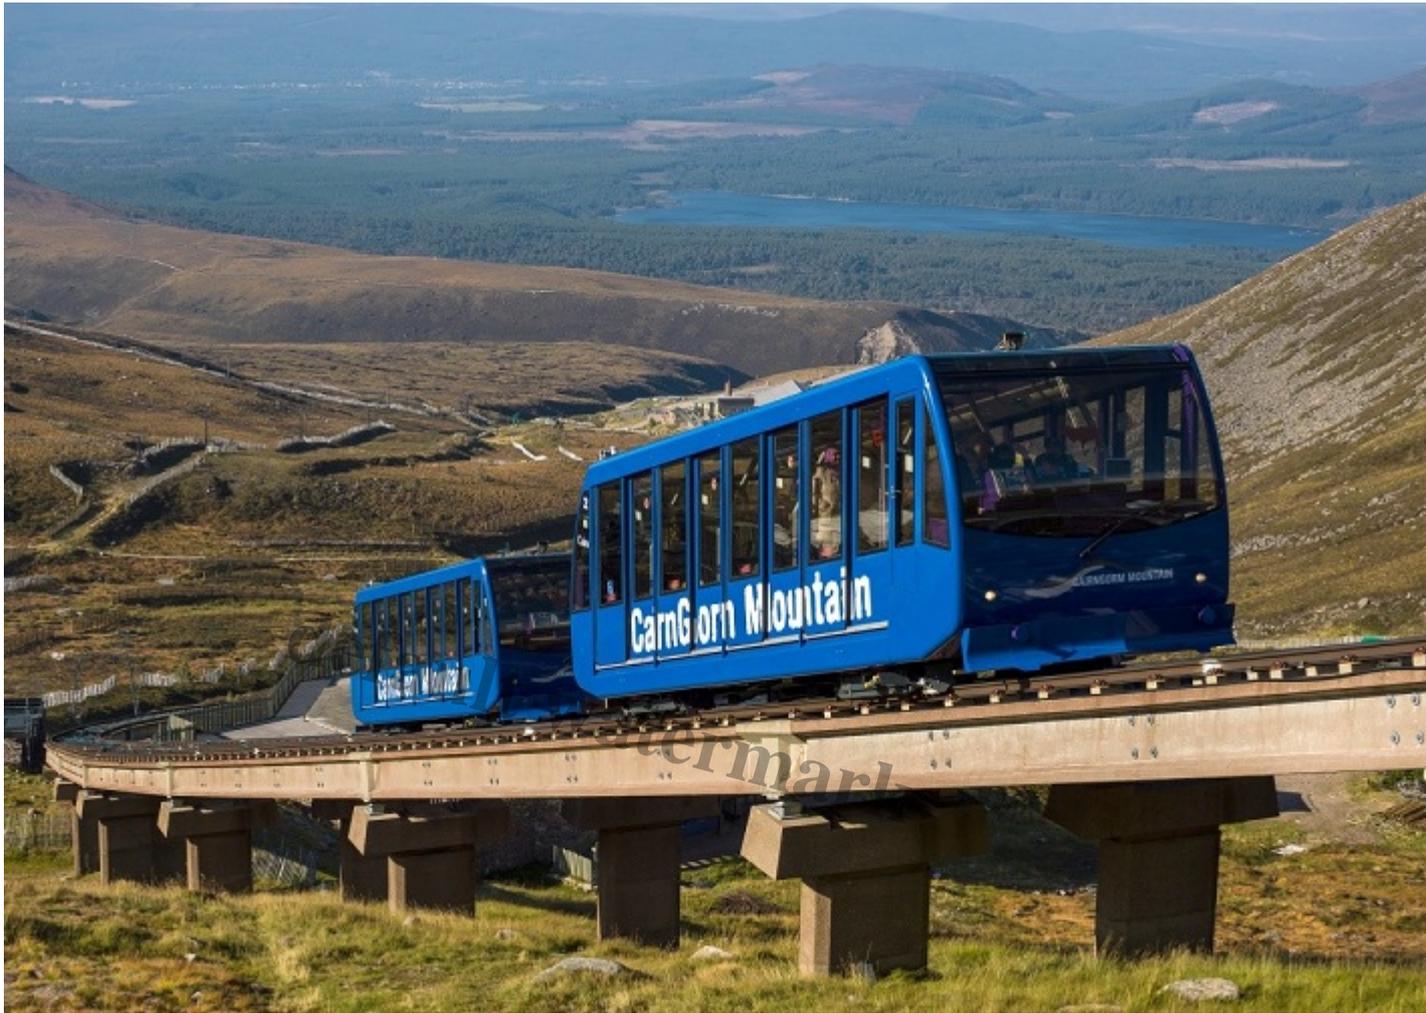
Between piers 51 to 57, the passing loop, there are 19 beams and 355 brackets, an average of over 18 per beam and 38% of the total number fitted. That's not poor quality control, it is proof that there is a significant structural issue with the passing loop which has not been acknowledged in any report I have seen.

Compare this picture of the beams at the passing loop (note the 4 bolt pattern) pre-repair work, courtesy of LECS UK who approved the re-opening of the funicular,

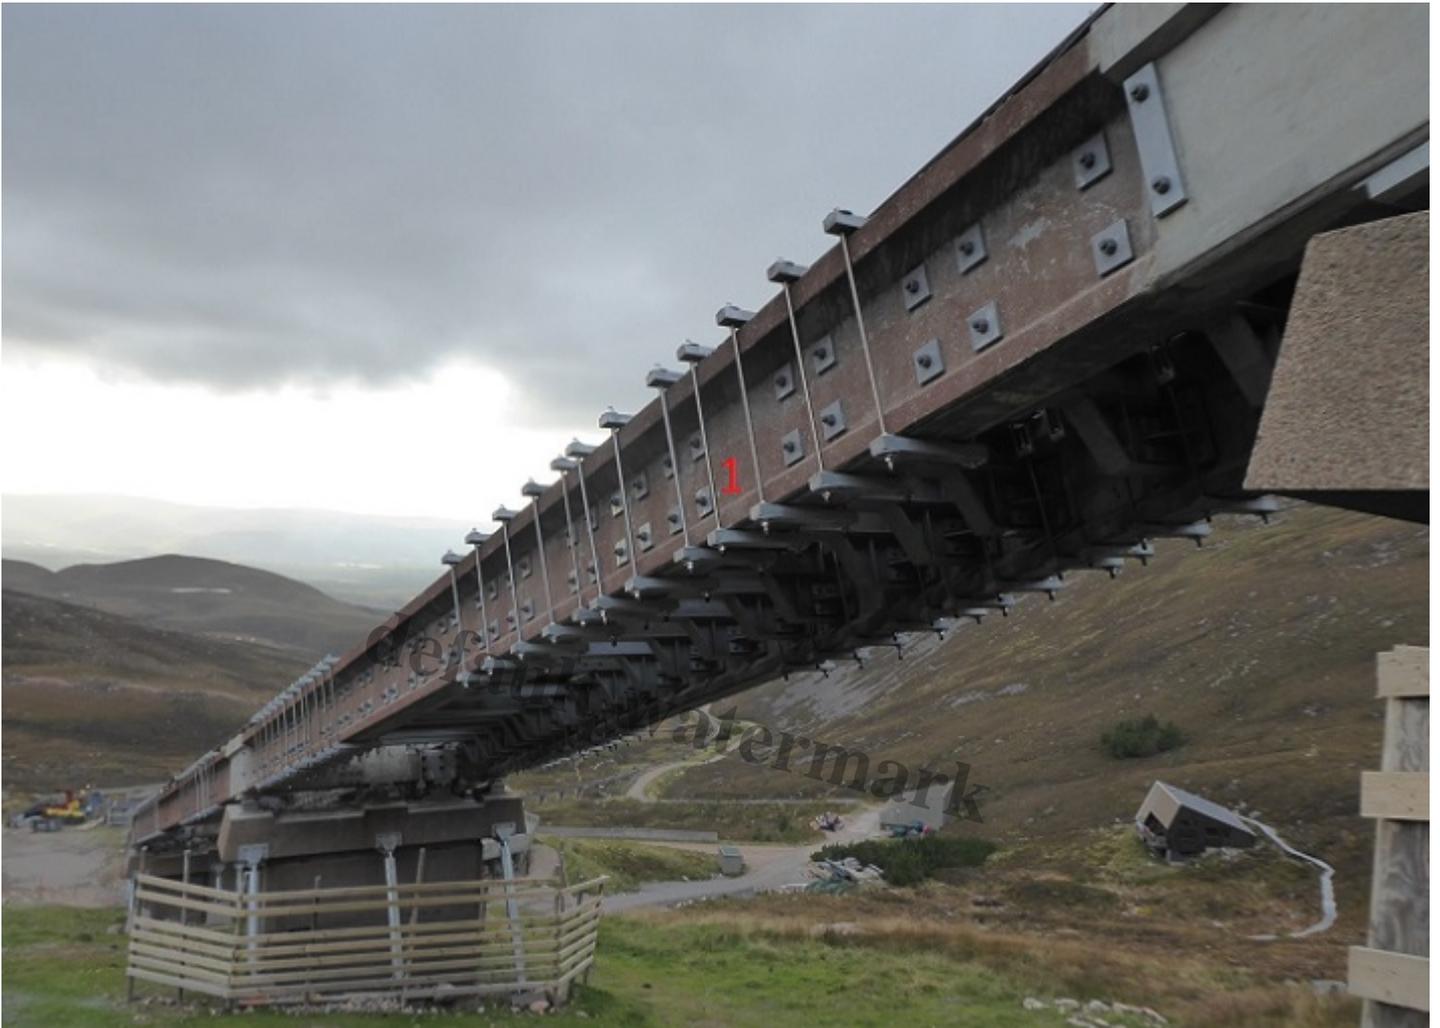
with this next one taken in September 2023:

That is a massive quantity of steelwork that has been added.

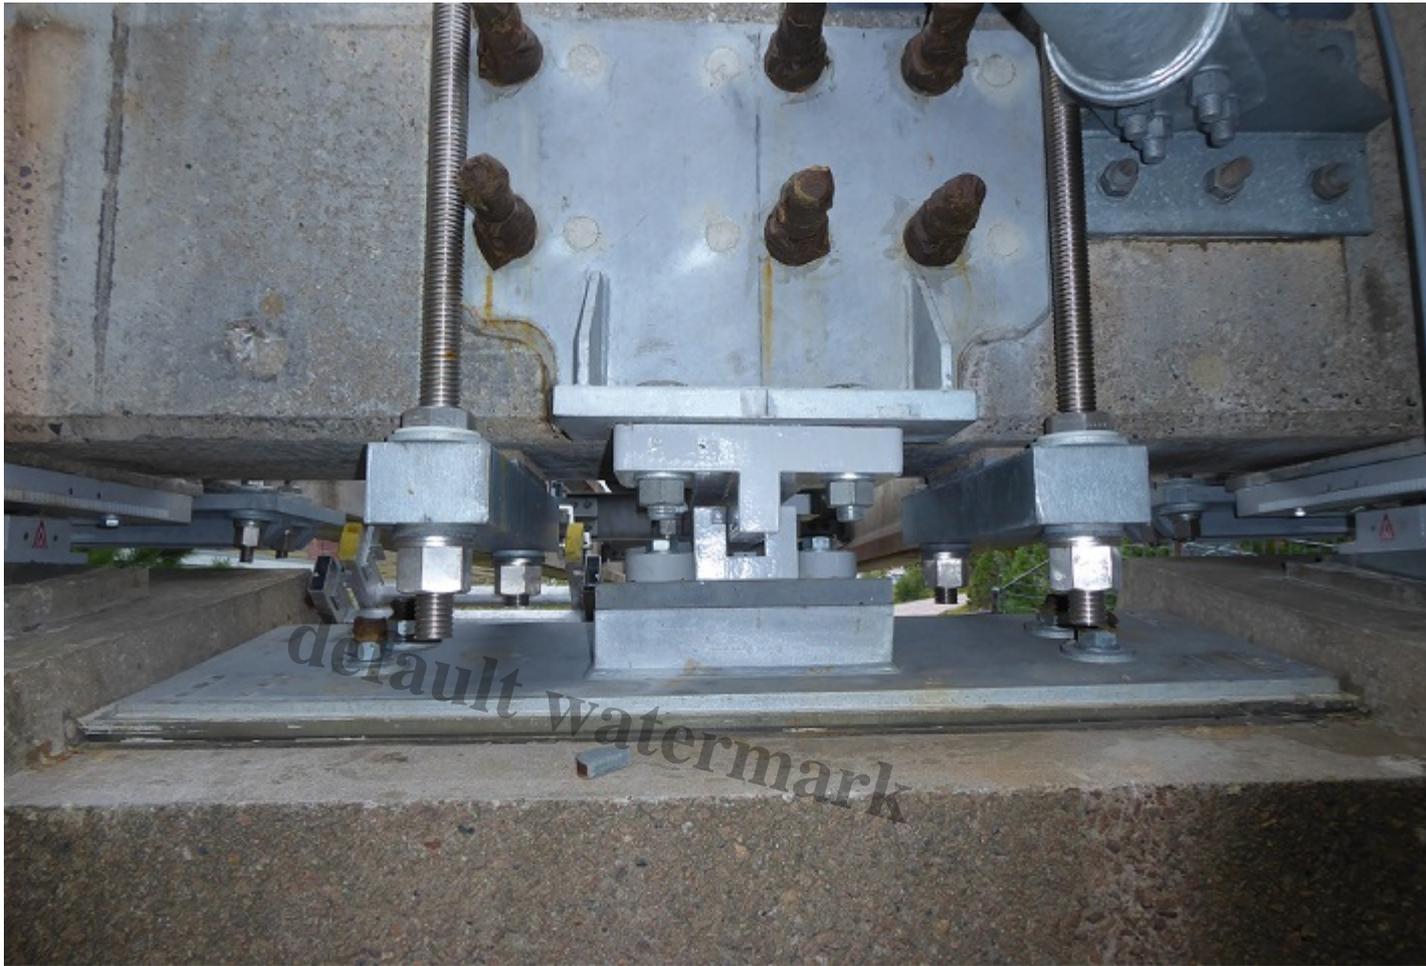
Central bearing with in situ block above and new brackets on each side

All the in-situ joints, apart from the anchor blocks, have at least two Type 2 brackets whose purpose appears to be to strengthen the block around the new central bearings that have been fitted.

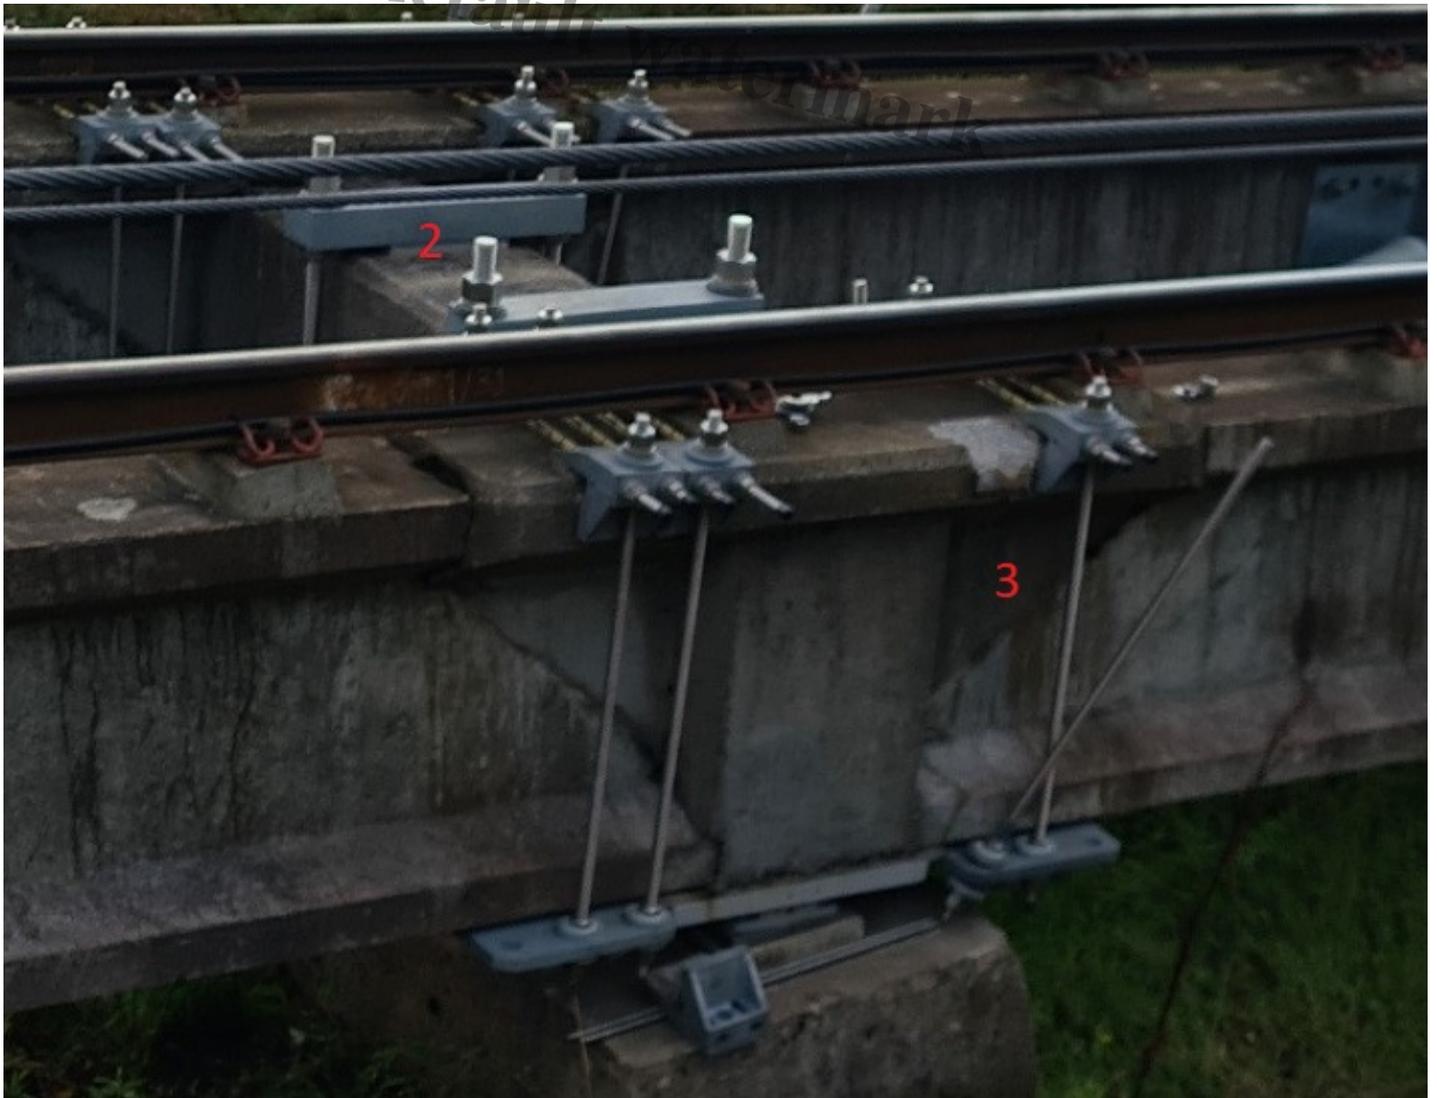
Anyone who has replaced the cylinder head on an engine will know that the cylinder head bolts have a tightening sequence **AND** gradually increasing torque settings. The reason for this is to ensure even loading on all parts of the cylinder head. The same applies to the brackets on the beams and the insitu blocks but are even more critical on the type 3 brackets fitted to the scarf joints because there are four lengths of studding as opposed to two. One corner could be putting excessive force onto the concrete at that point. Is that what has happened here?

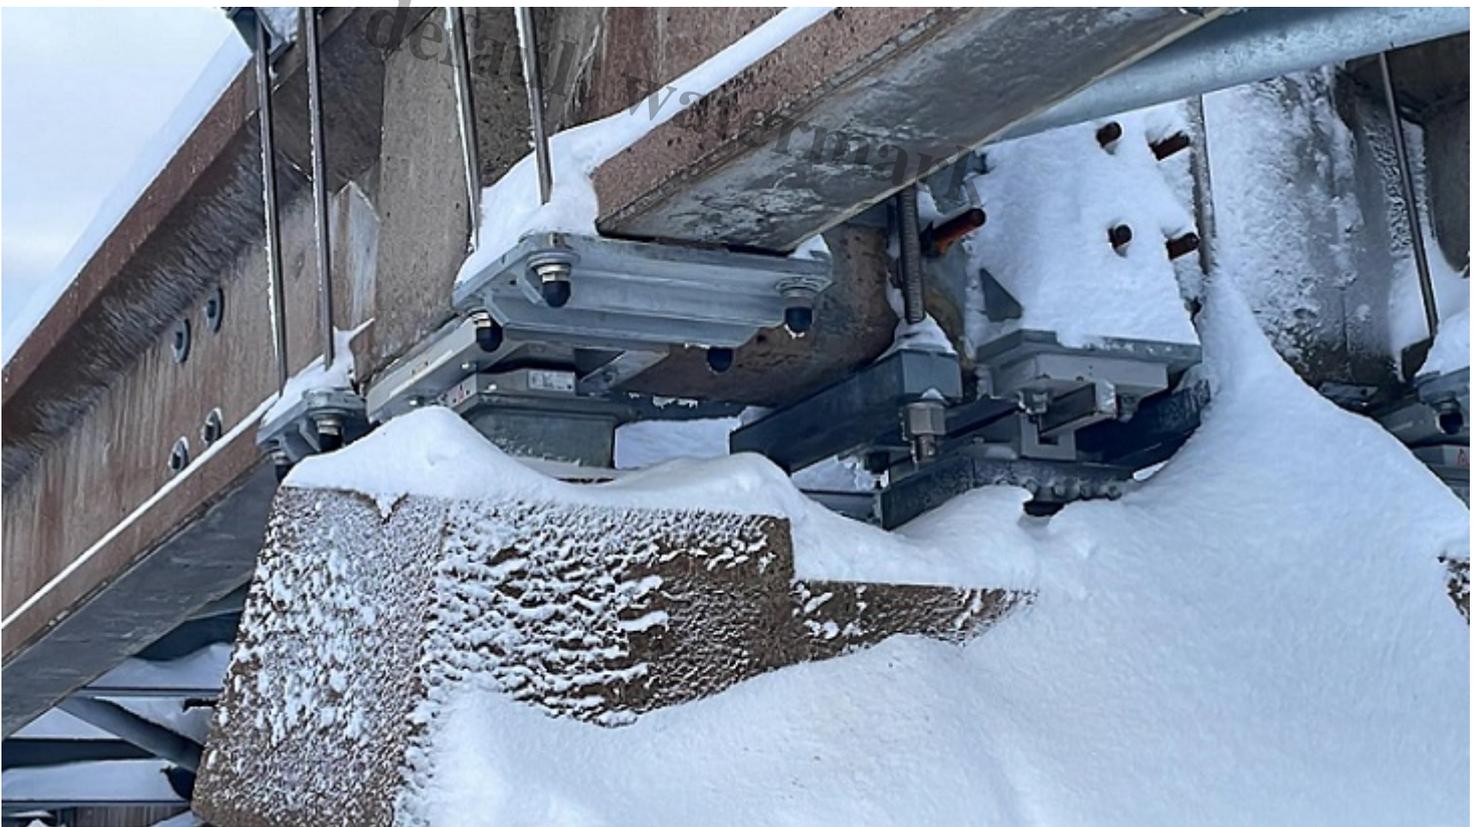
The following picture shows one type of cap as fitted to what I have labeled as a type 3 or scarf joint bracket.

It is used to stop the ingress of water into the threads of the nut/ studding interface which reduces corrosion. The positioning of the caps should therefore have been on the top of all vertical studding NOT the bottom.

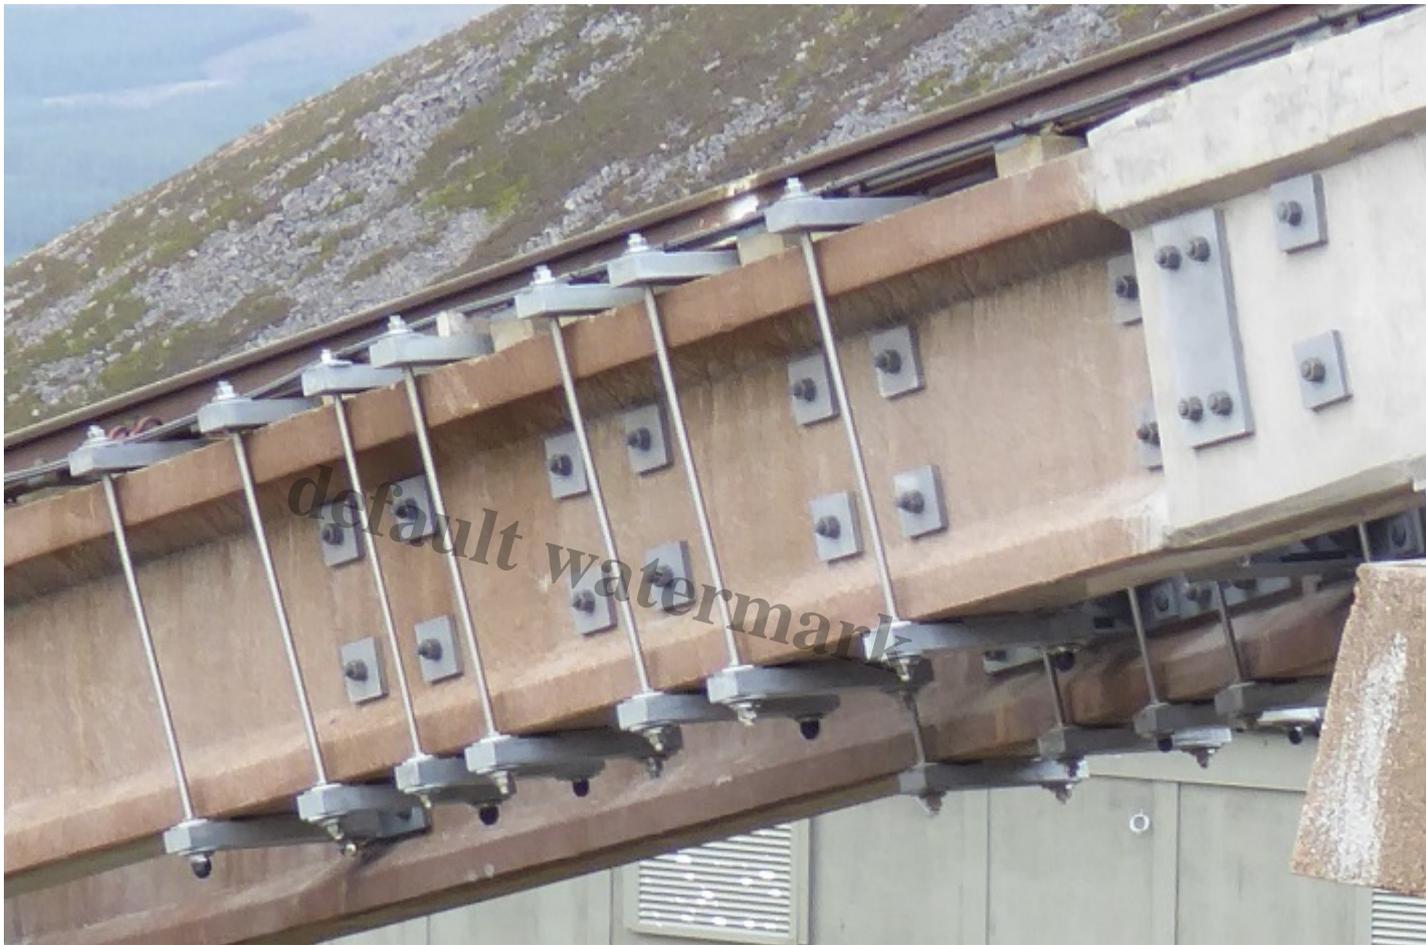
Some caps on bottom, none on top of brackets where most needed!

How many times in the past have we been told about poor workmanship and quality control (see photo above and below)? Did someone not carry enough plastic caps to do the job and forgot to get and fit the extra ones? Has nothing been learned from past mistakes? Apparently not.

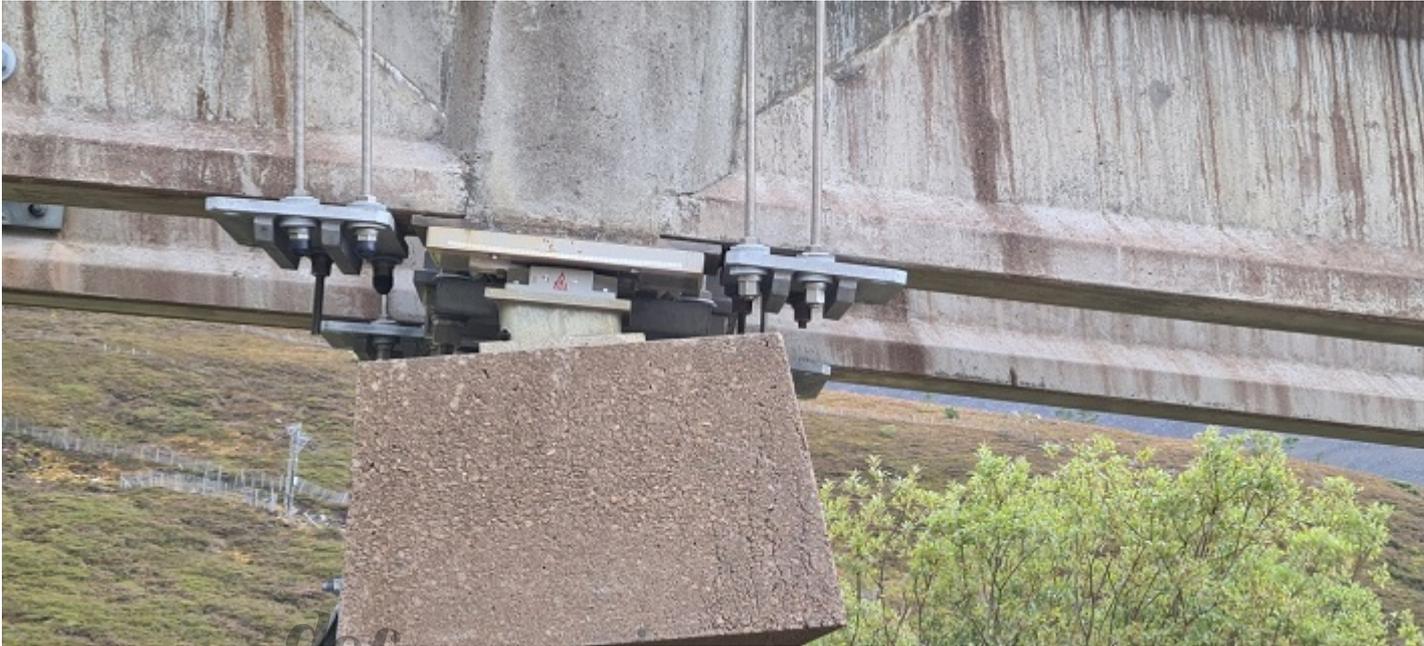
While not that easy to see there are three black plastic caps on the uphill side but none on the downhill side. The protruding stud on the uphill side, a health and safety risk, has not been capped.

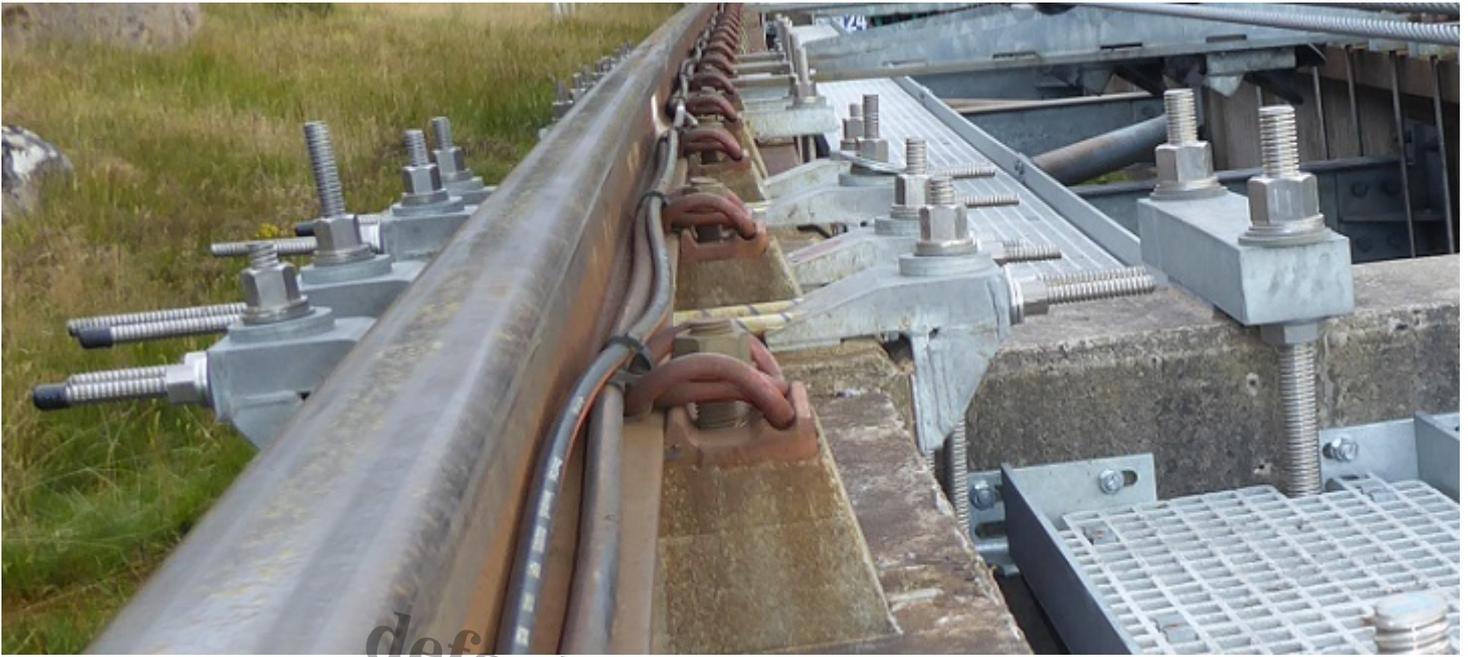
And what about this close up from the top-most photo as another example of poor workmanship/ quality control as well as a H & S risk?

Exposed studding with no protective covering or "Tripping Hazard" warning signs just waiting for a moments lapse in concentration by maintenance staff on the new walkway! All excess lengths of studding should have been cut to less than one nut length above/ beyond the nut. Or a better idea, why not order the correct length in the first place instead of paying for material that is not needed?
