HIE's decision to close the Cairn Gorm funicular again (3)

(A) The steel strengthening brackets

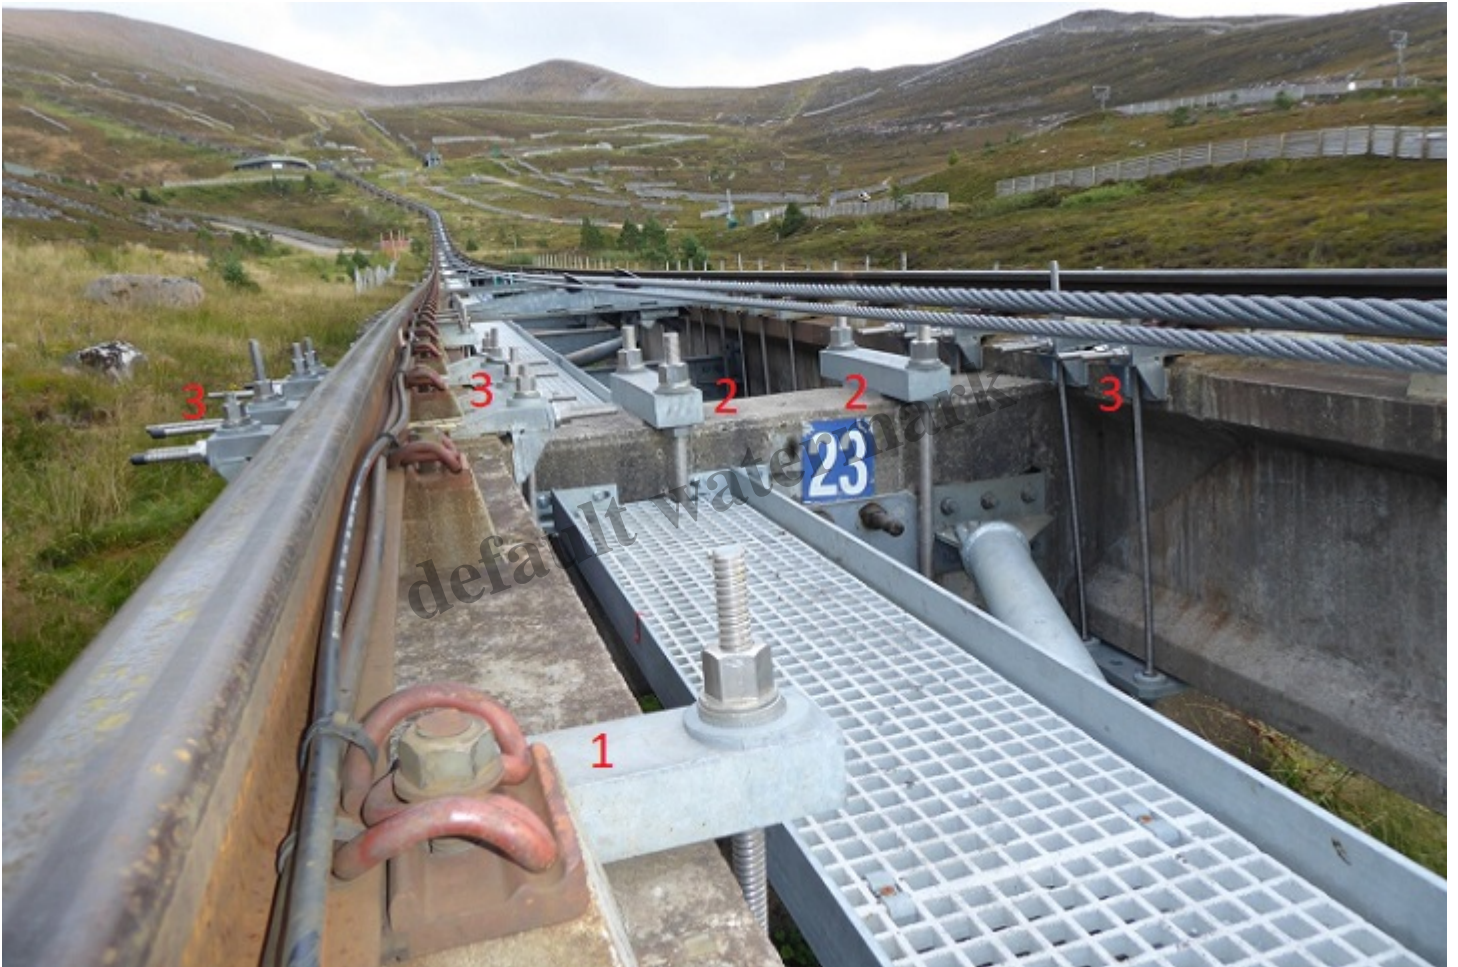
This picture shows the three different types of bracket used in the strengthening works.

Type 1. The bracket in the foreground (used in the central section of the "I" beam

Type 2. The brackets around the insitu block either side of the number 23

Type 3. The brackets around the scarf joint, more clearly seen on the right of the next picture.

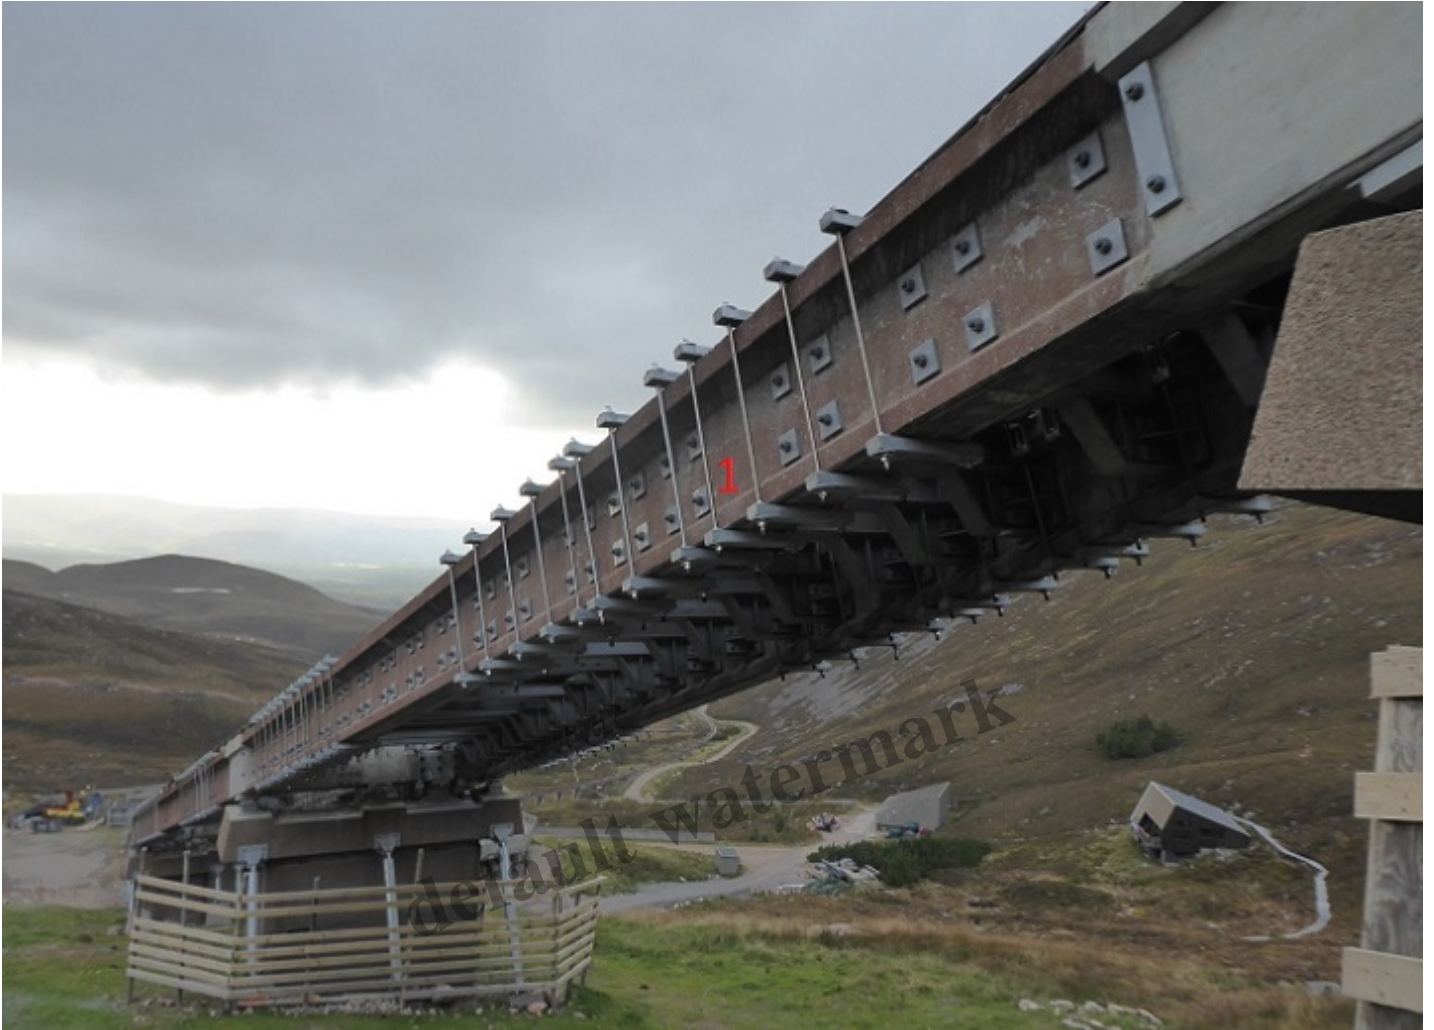
with this next one taken in September 2023:

That is a massive quantity of steelwork that has been added.

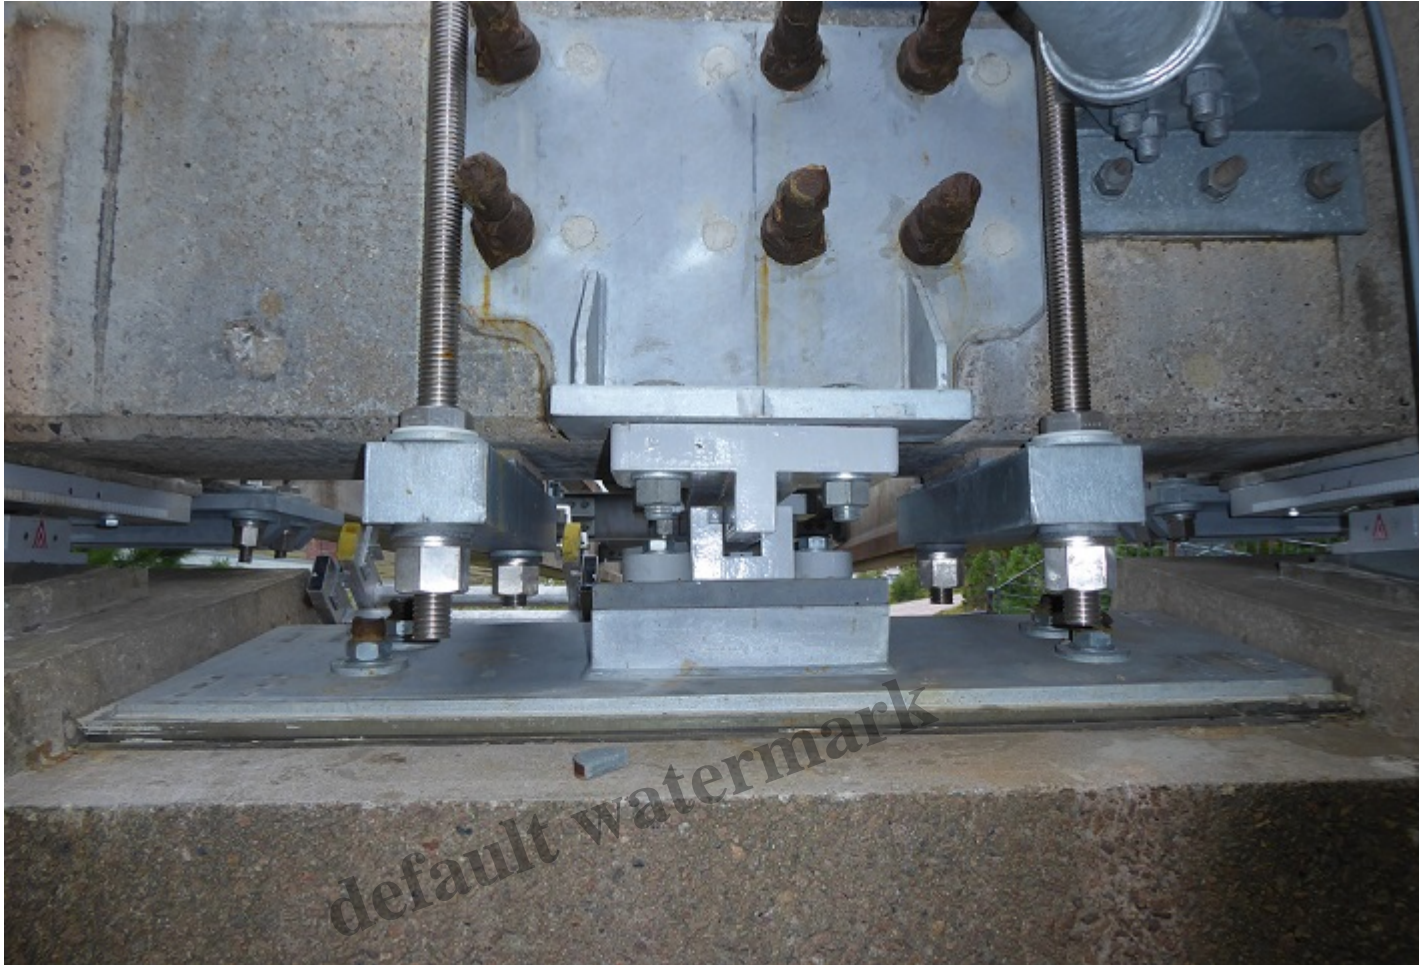
Central bearing with in situ block above and new brackets on each side

All the in-situ joints, apart from the anchor blocks, have at least two Type 2 brackets whose purpose appears to be to strengthen the block around the new central bearings that have been fitted.

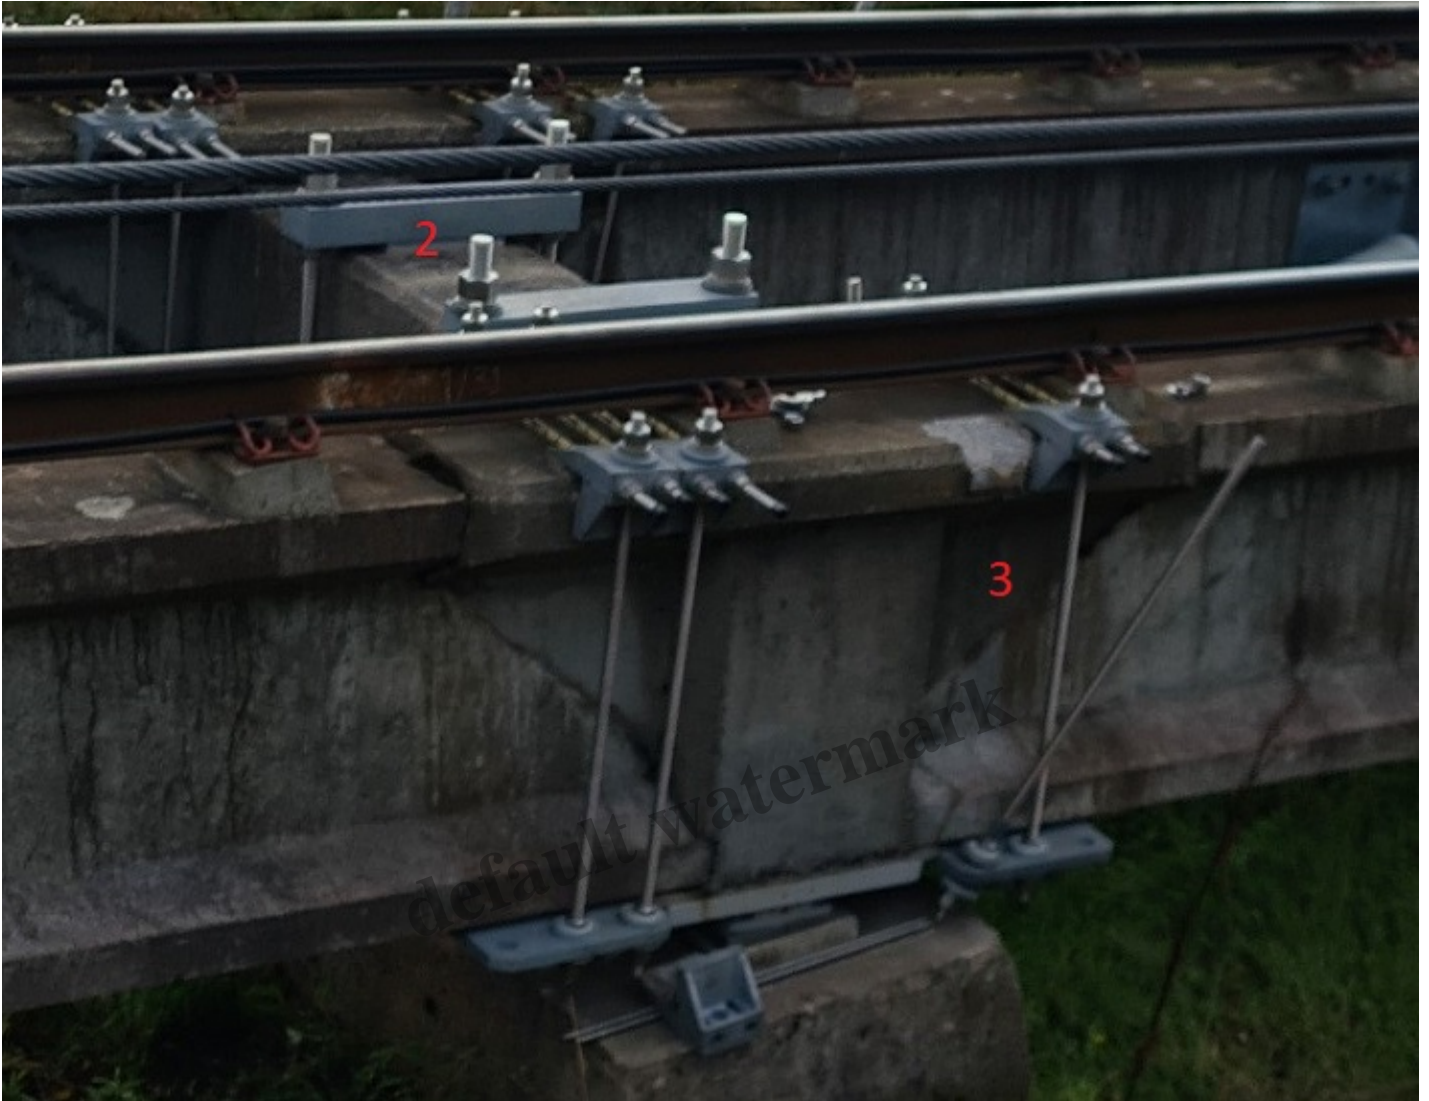
Anyone who has replaced the cylinder head on an engine will know that the cylinder head bolts have a tightening sequence **AND** gradually increasing torque settings. The reason for this is to ensure even loading on all parts of the cylinder head. The same applies to the brackets on the "I" beams and the insitu blocks but are even more critical on the type 3 brackets fitted to the scarf joints because there are four lengths of studding as opposed to two. One corner could be putting excessive force onto the concrete at that point. Is that what has happened here?

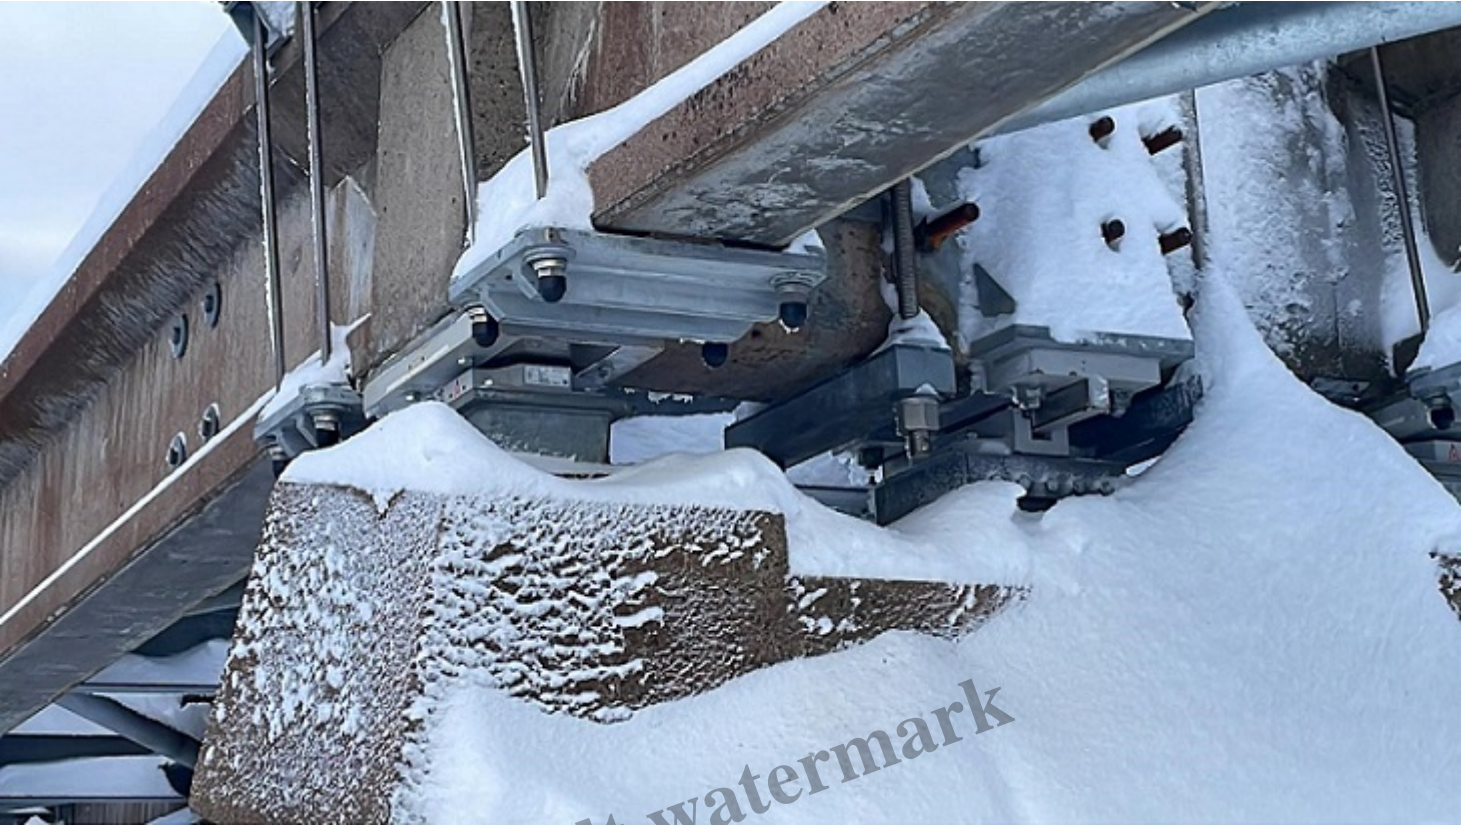
The following picture shows one type of cap as fitted to what I have labeled as a type 3 or scarf joint bracket.

It is used to stop the ingress of water into the threads of the nut/ studding interface which reduces corrosion. The positioning of the caps should therefore have been on the top of all vertical studding NOT the bottom.

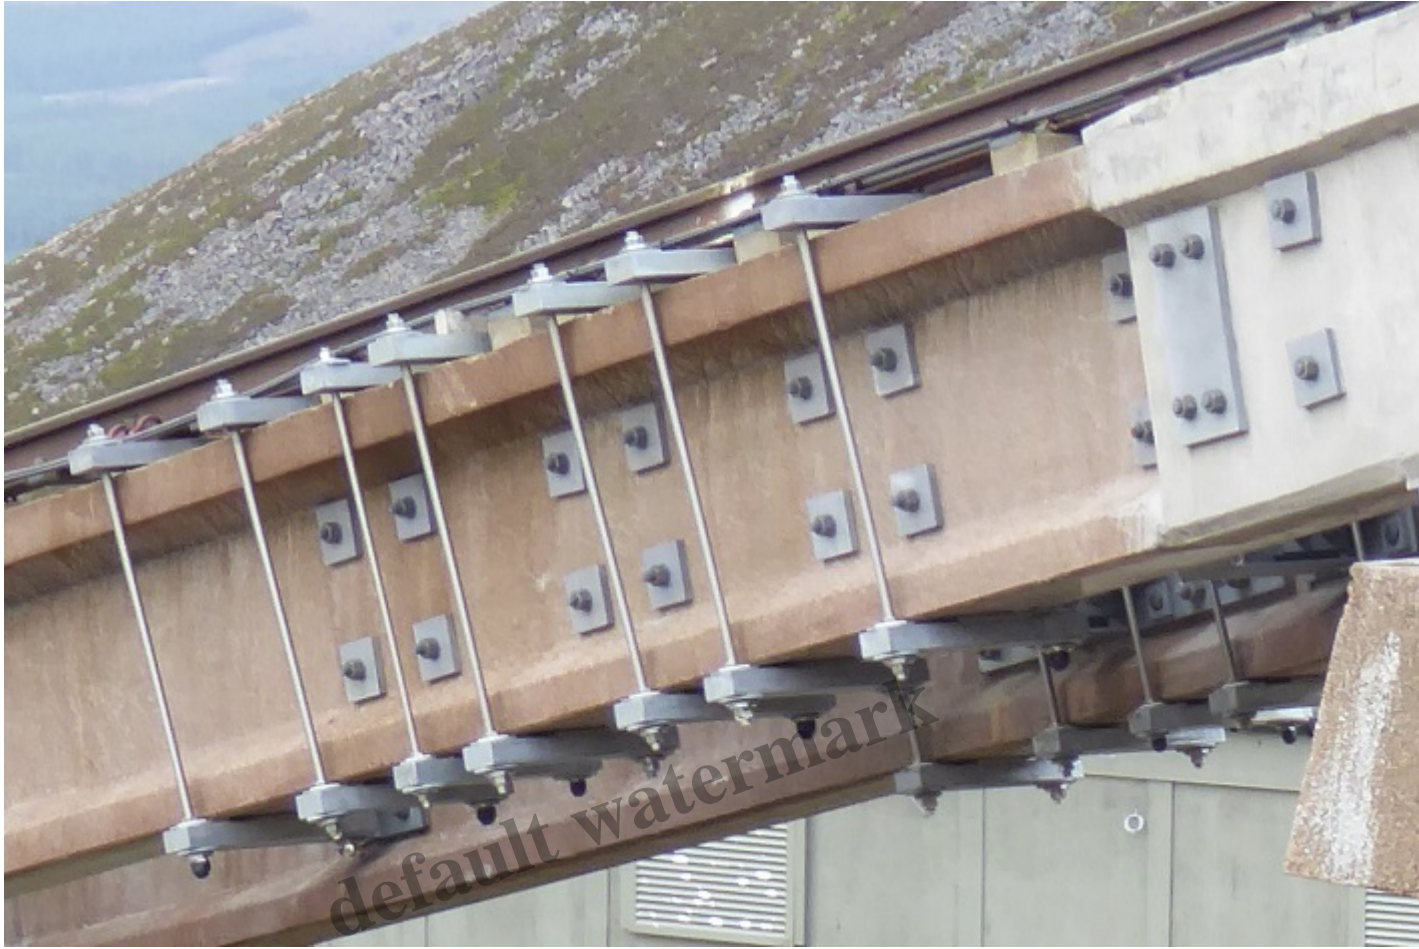
Some caps on bottom, none on top of brackets where most needed!

How many times in the past have we been told about poor workmanship and quality control (see photo above and below)? Did someone not carry enough plastic caps to do the job and forgot to get and fit the extra ones? Has nothing been learned from past mistakes? Apparently not.

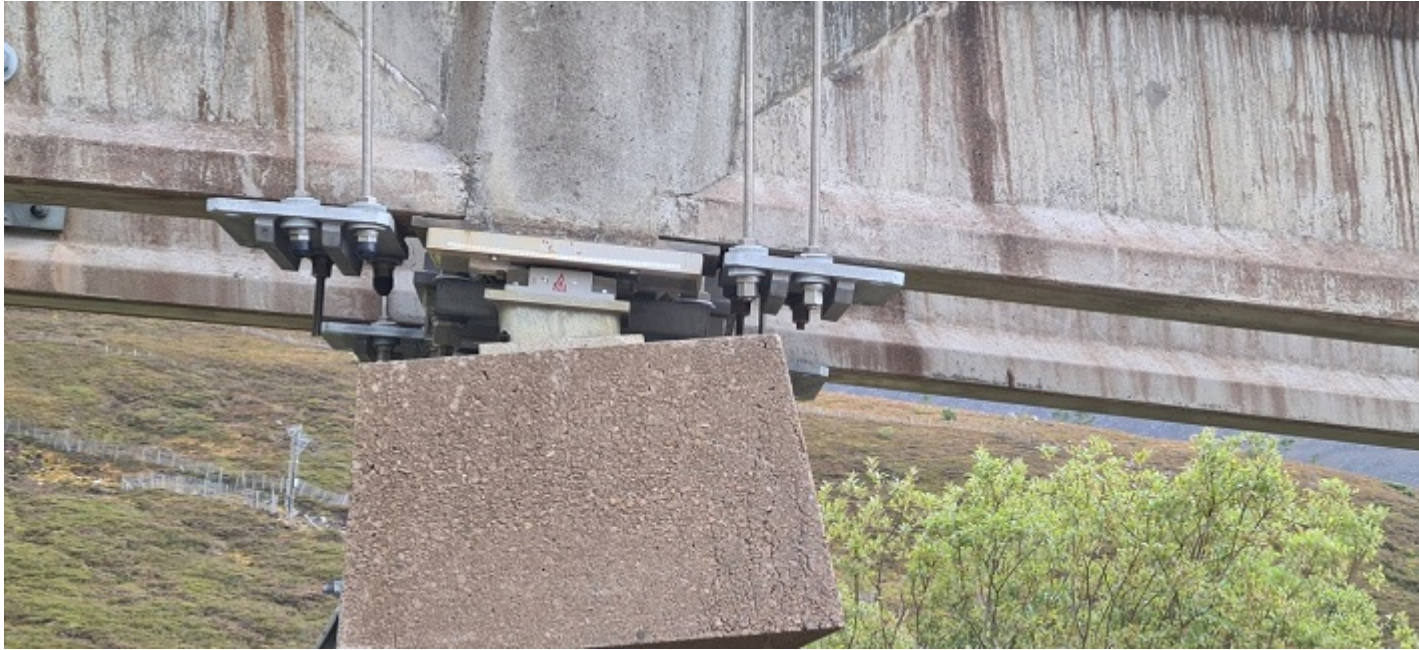
While not that easy to see there are three black plastic caps on the uphill side but none on the downhill side. The protruding stud on the uphill side, a health and safety risk, has not been capped.

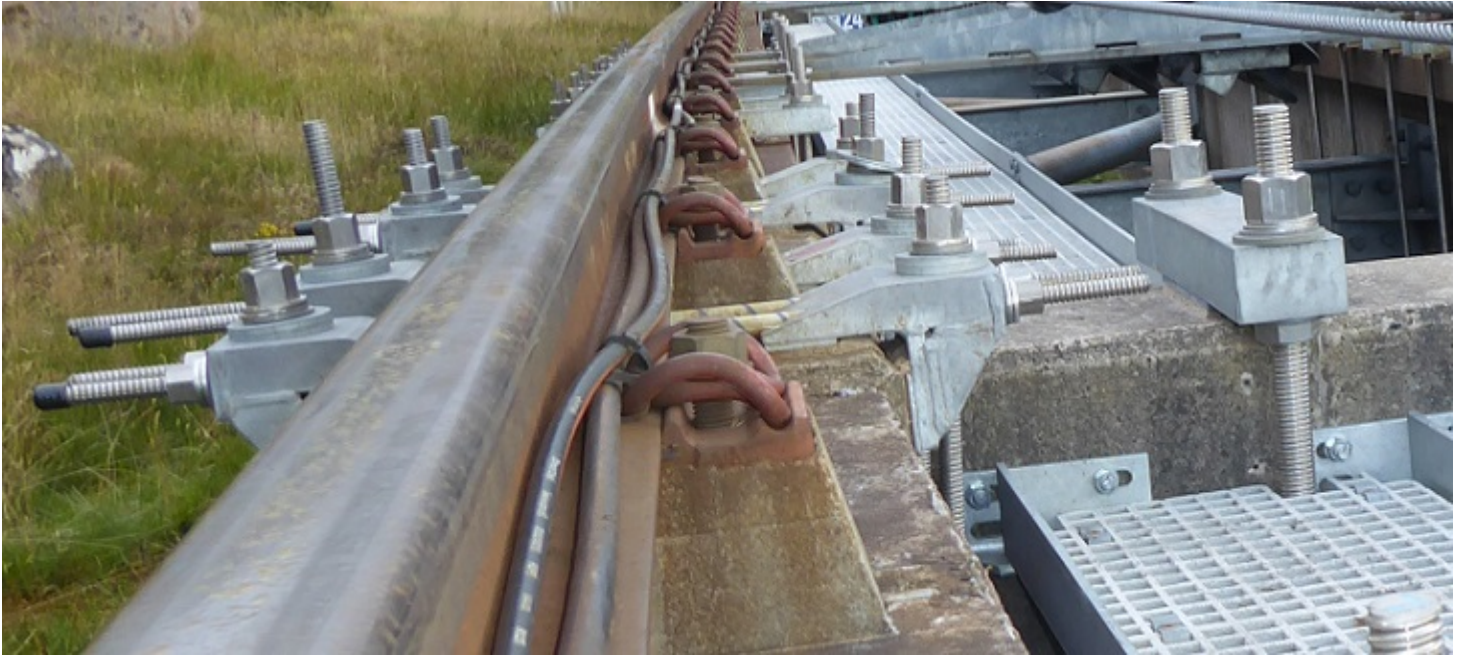
And what about this close up from the top-most photo as another example of poor workmanship/ quality control as well as a H & S risk?

Exposed studding with no protective covering or “Tripping Hazard” warning signs just waiting for a moments lapse in concentration by maintenance staff on the new walkway! All excess lengths of studding should have been cut to less than one nut length above/ beyond the nut. Or a better idea, why not order the correct length in the first place instead of paying for material that is not needed?
