Stainless steel brackets and their use on the funicular

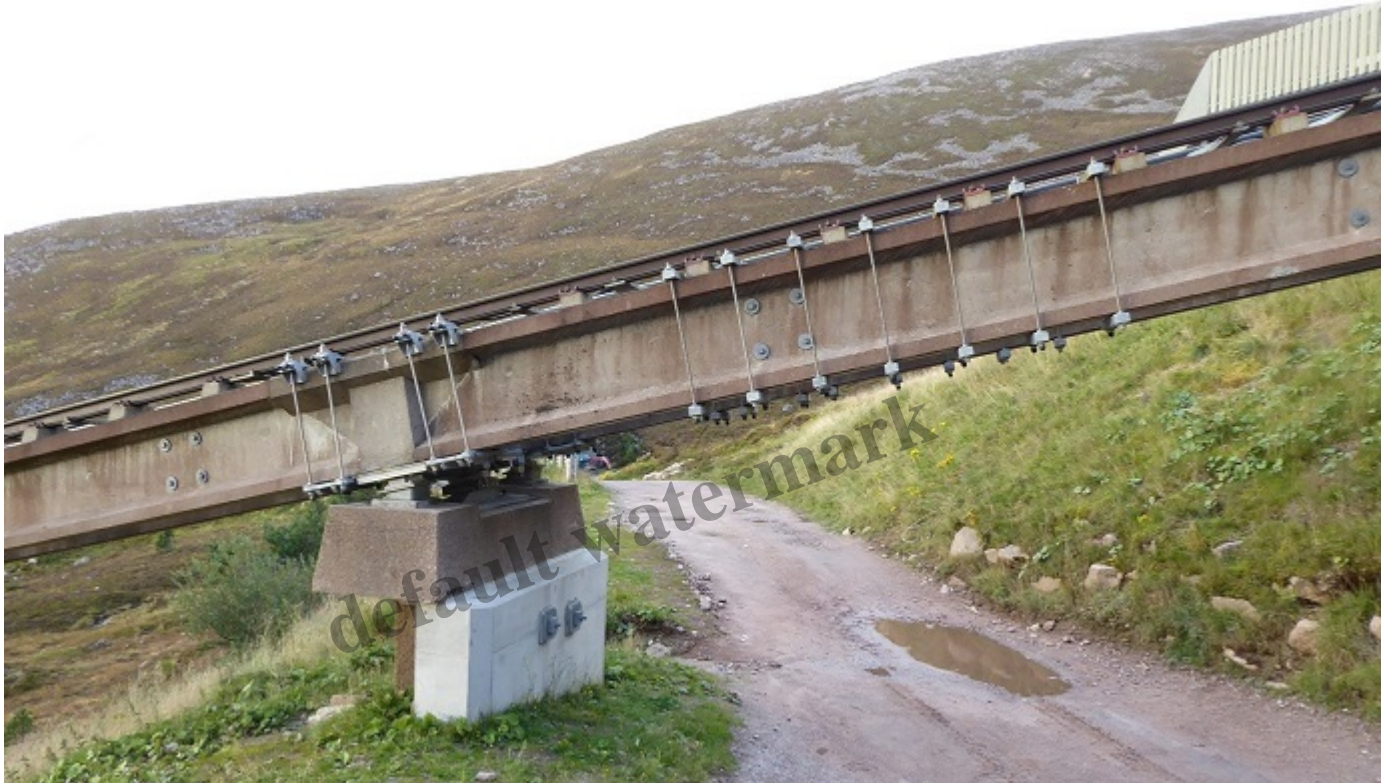
Seven pairs of Type One brackets around the “I” beam are visible centre right and two of the Type 3 brackets around the insitu joint are visible left.

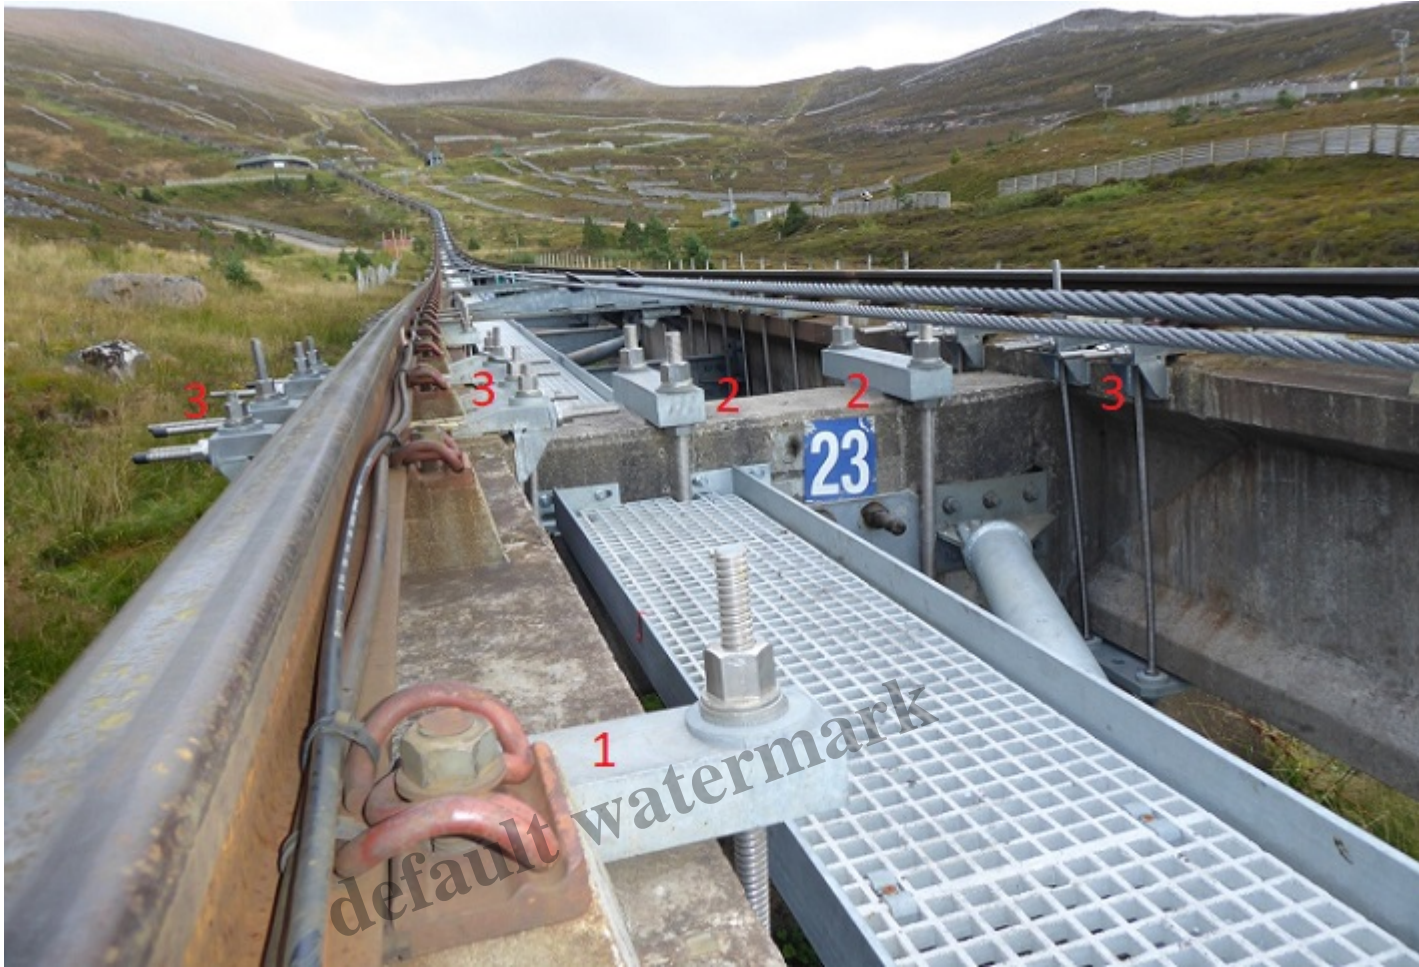
Following what I had written last December ([see here](#)) I expected to see changes/ repairs that would be instantly recognisable as such, e.g. more of the type 1 brackets and/ or larger support plates under the Type 3 brackets as labelled in the following picture:-

Type 1 brackets are used around the I beams, Type two around the beams between and Type 3 around the in-situ joints.

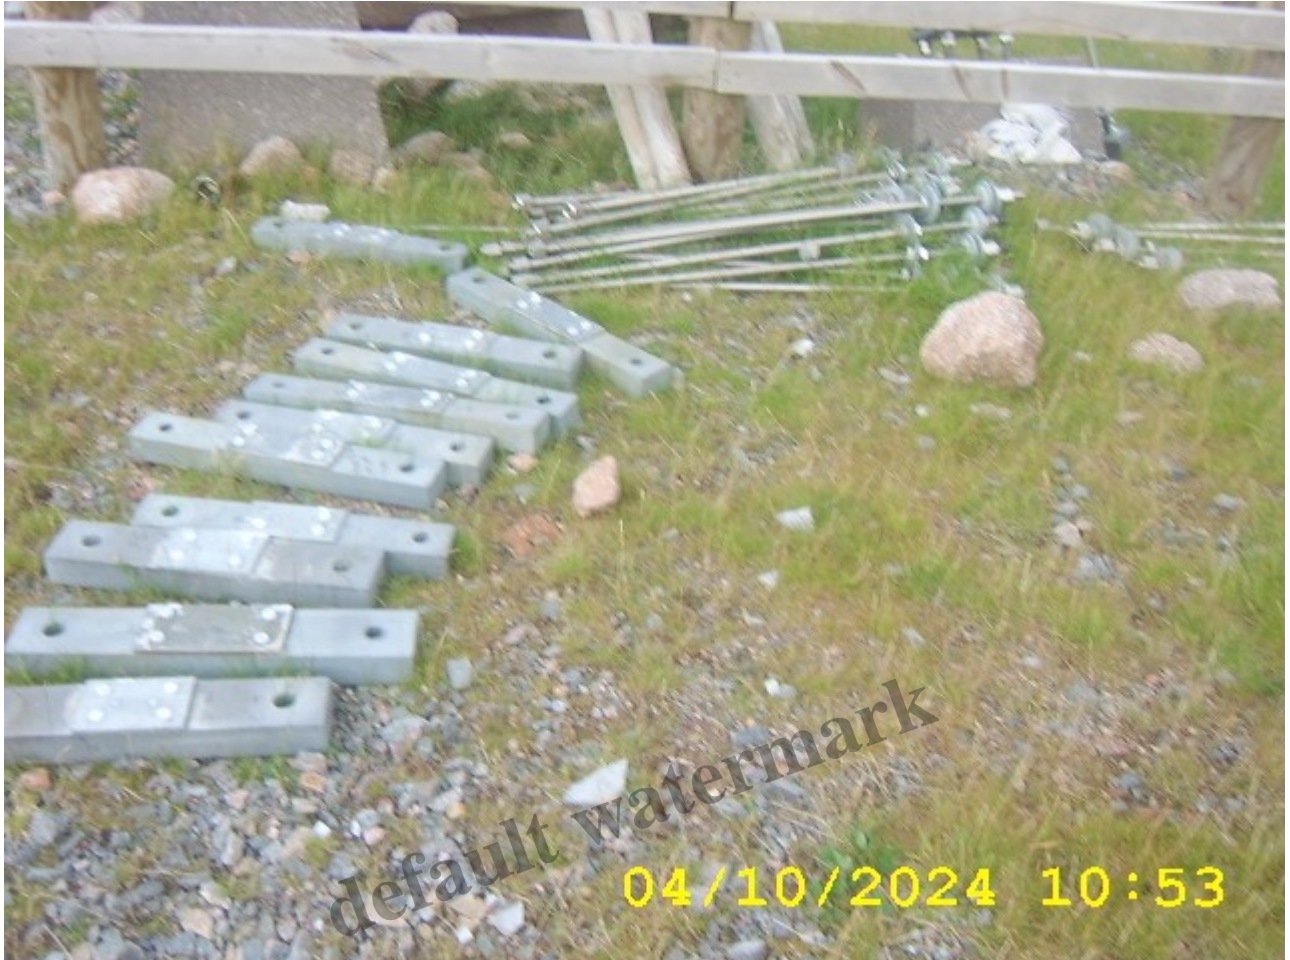
Photo. Type 1 brackets off the top pier of the passing loop.

If that tensioning work was ever completed it now has to be done all over again as almost all of the Type 1 brackets have been removed as shown in the photos above of Type 1 brackets lying on the ground.

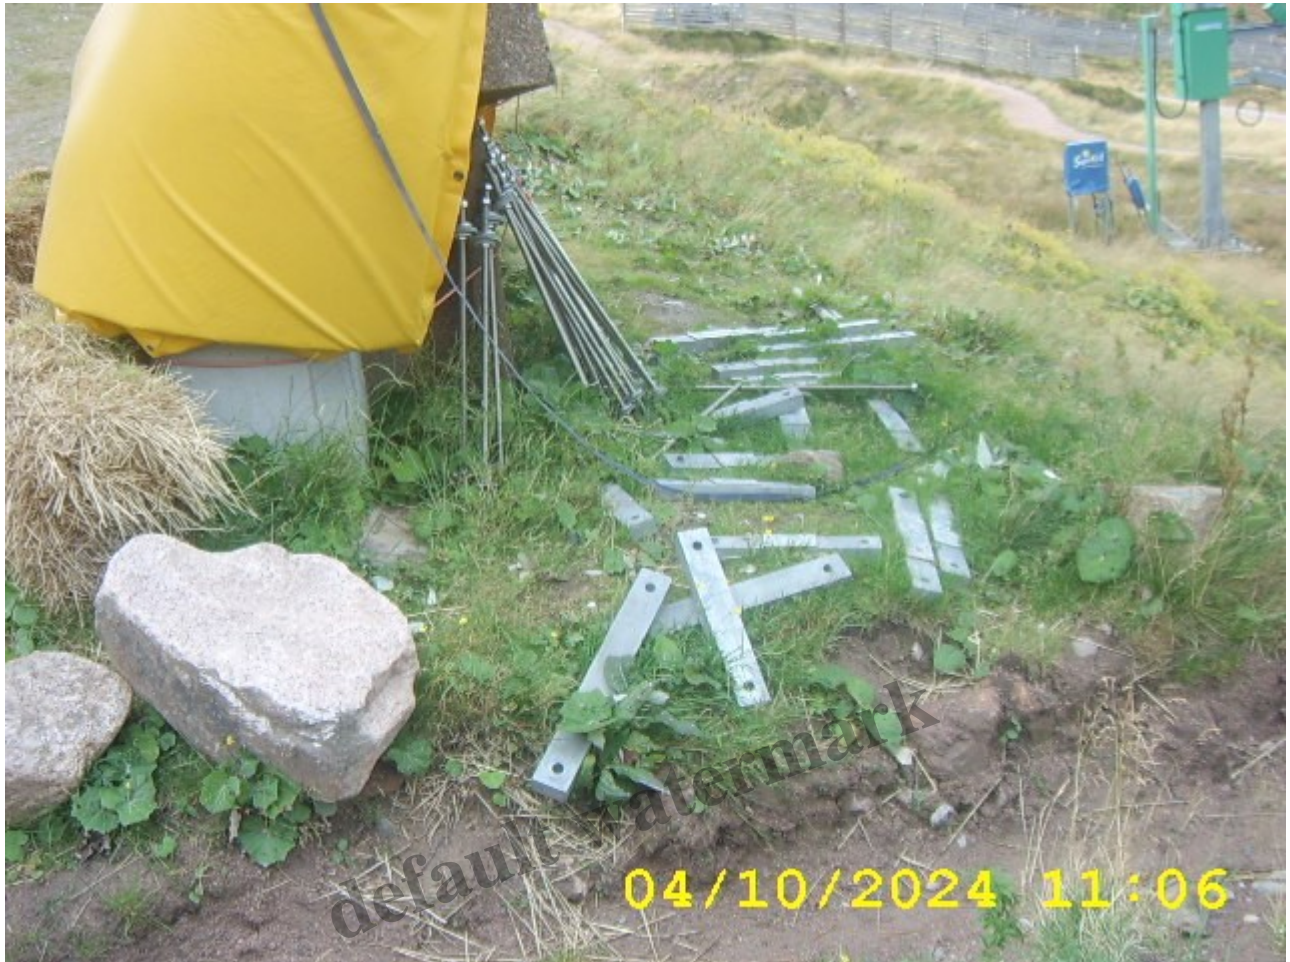
Photo. Type I brackets on the ground below Pier 47.

By my reckoning over 800 of the 917 Type 1 brackets had been removed from the "I" beams by the time of my visit, all of which have to be replaced, tensioned, tested THEN adjustments made and re-tested!
