## Stainless steel brackets and their use on the funicular

### Description

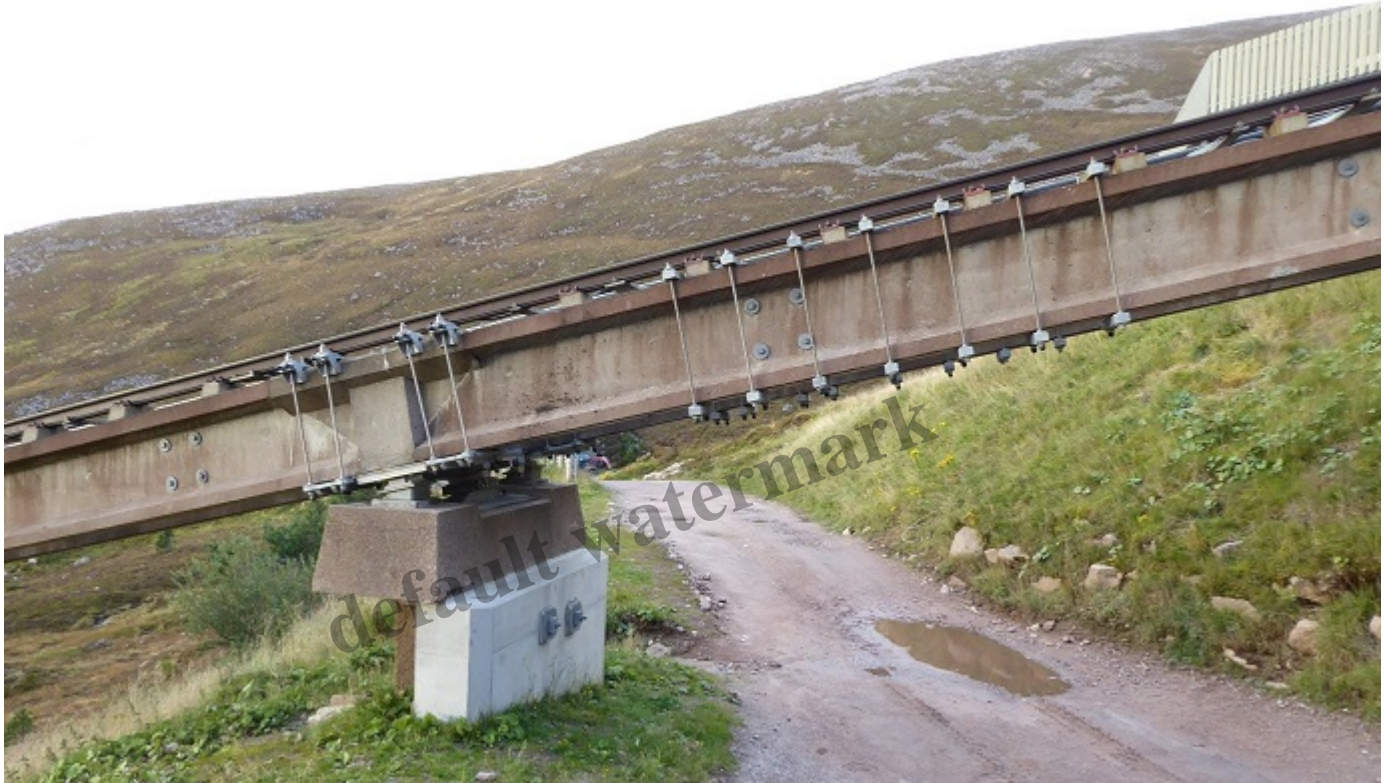
Seven pairs of Type One brackets around the “I” beam are visible centre right and two of the Type 3 brackets around the insitu joint are visible left.

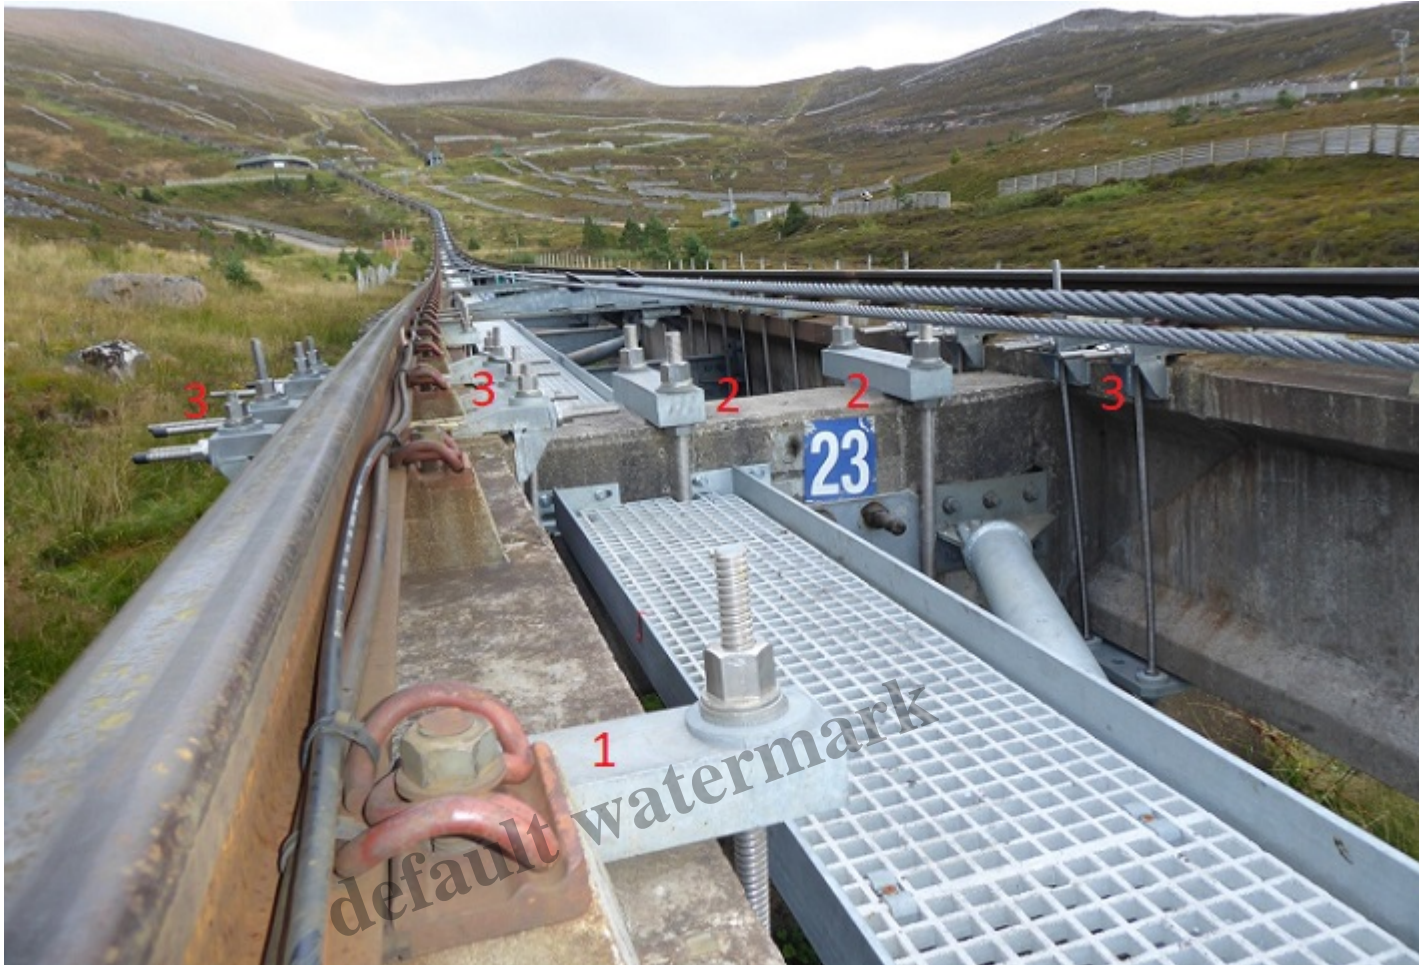
Following what I had written last December ([see here](#)) I expected to see changes/ repairs that would be instantly recognisable as such, e.g. more of the type 1 brackets and/ or larger support plates under the Type 3 brackets as labelled in the following picture:-

Type 1 brackets are used around the I beams, Type two around the beams between and Type 3 around the in-situ joints.

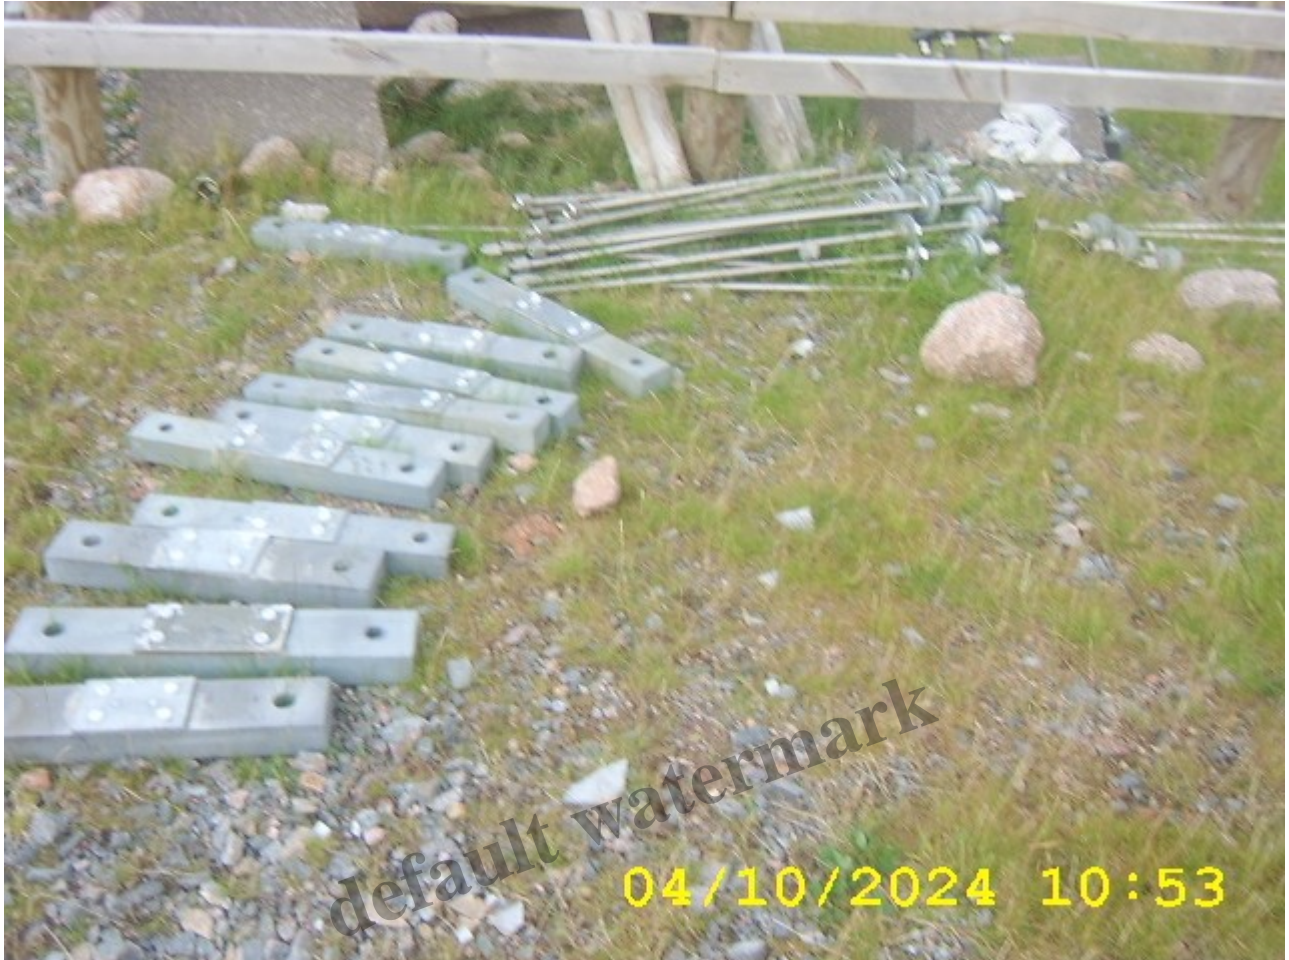
Photo. Type 1 brackets off the top pier of the passing loop.

If that tensioning work was ever completed it now has to be done all over again as almost all of the Type 1 brackets have been removed as shown in the photos above of Type 1 brackets lying on the ground.

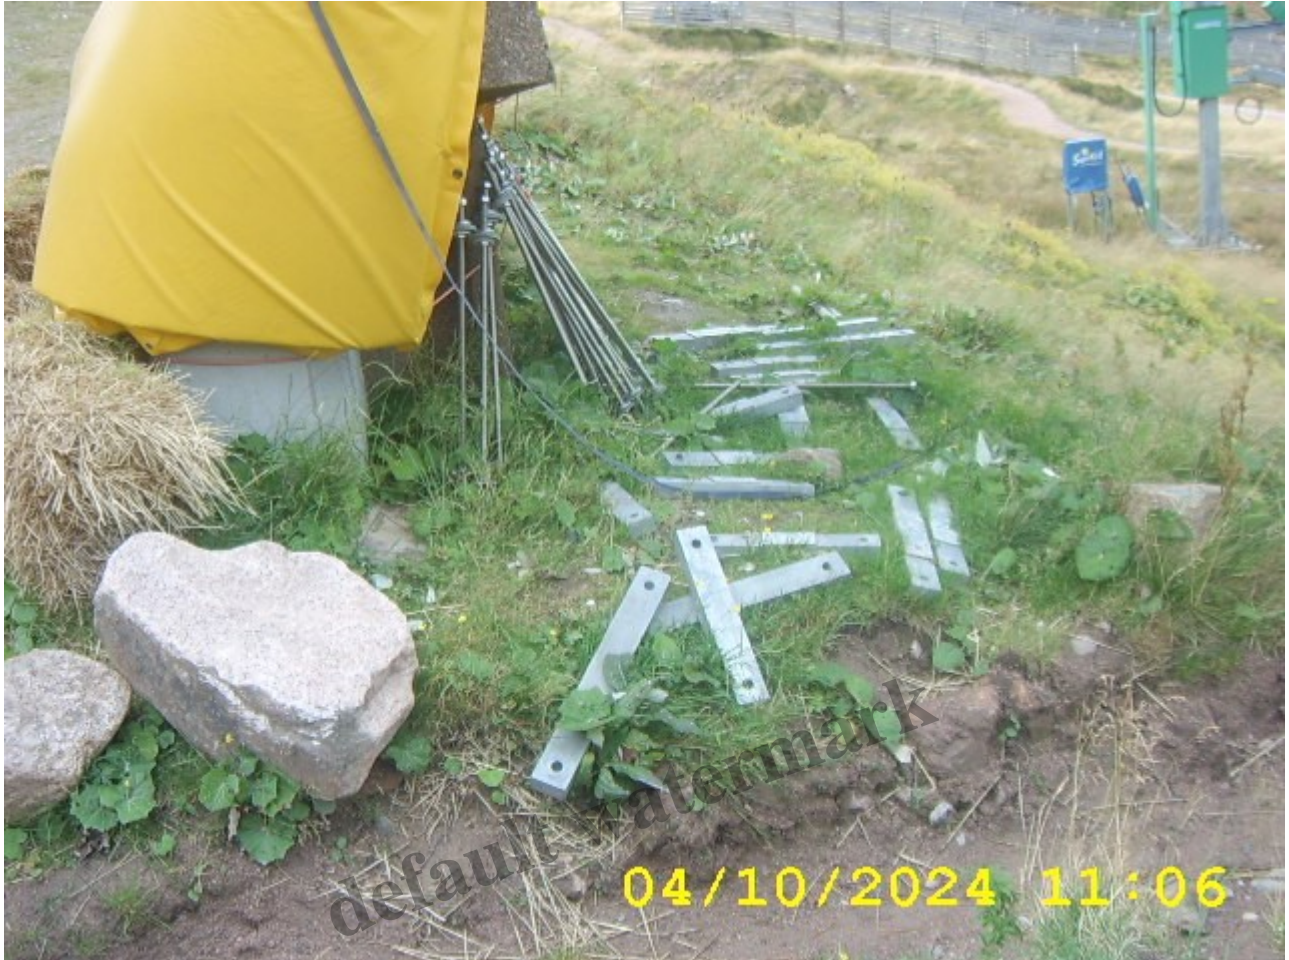
Photo. Type I brackets on the ground below Pier 47.

By my reckoning over 800 of the 917 Type 1 brackets had been removed from the "I" beams by the time of my visit, all of which have to be replaced, tensioned, tested THEN adjustments made and re-tested!

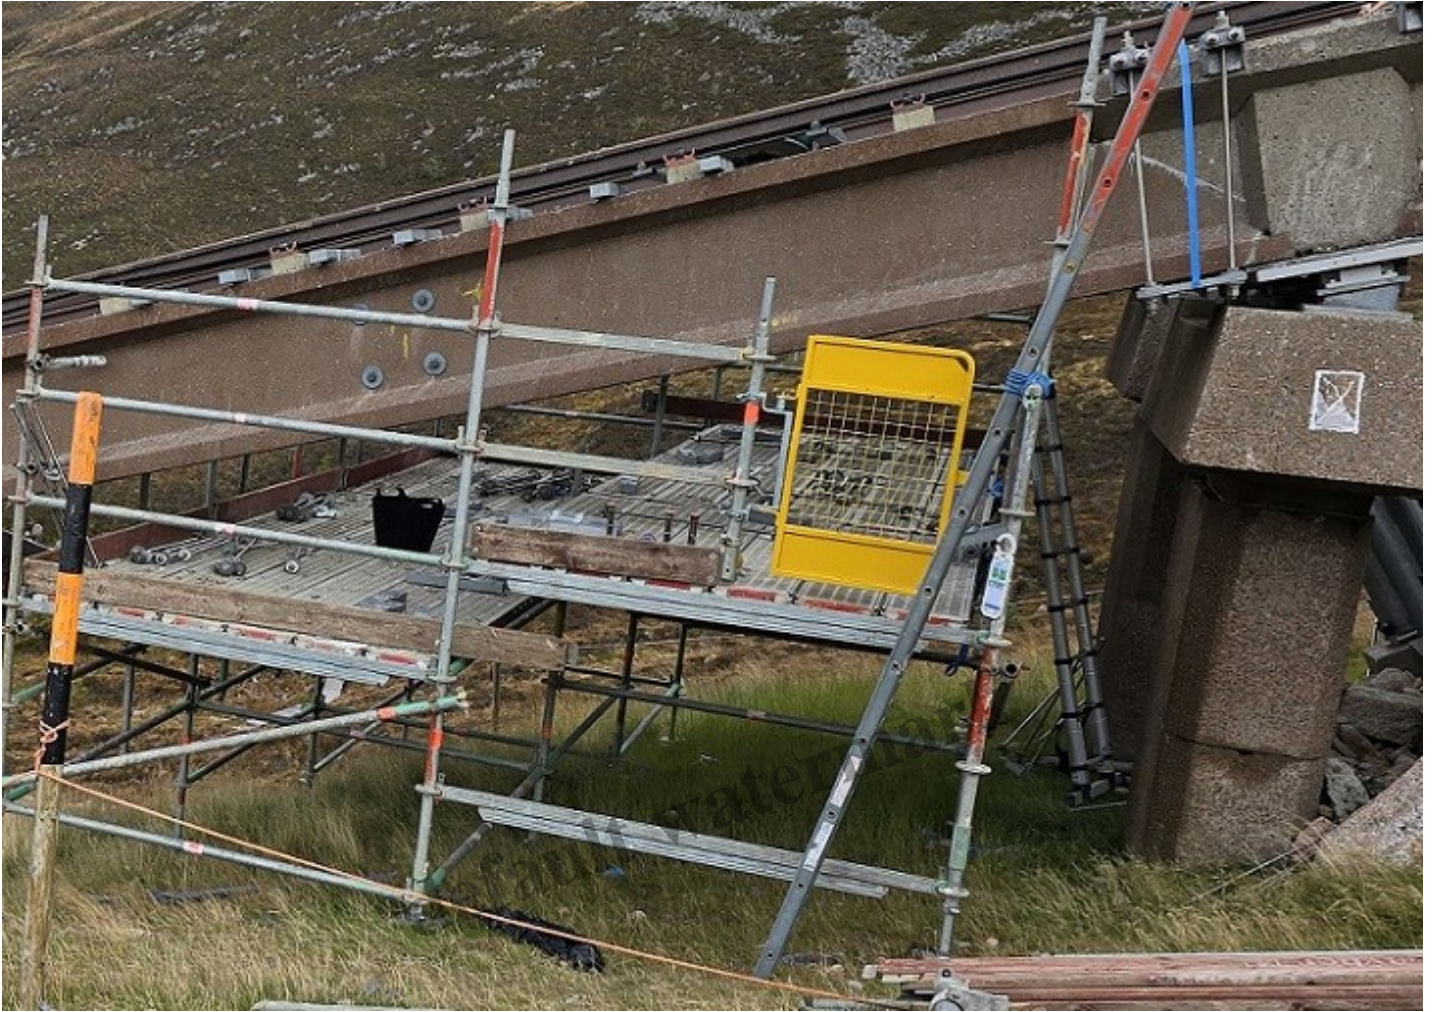
There were also some parts of brackets lying on the funicular beam and on the scaffolding at the passing loop:

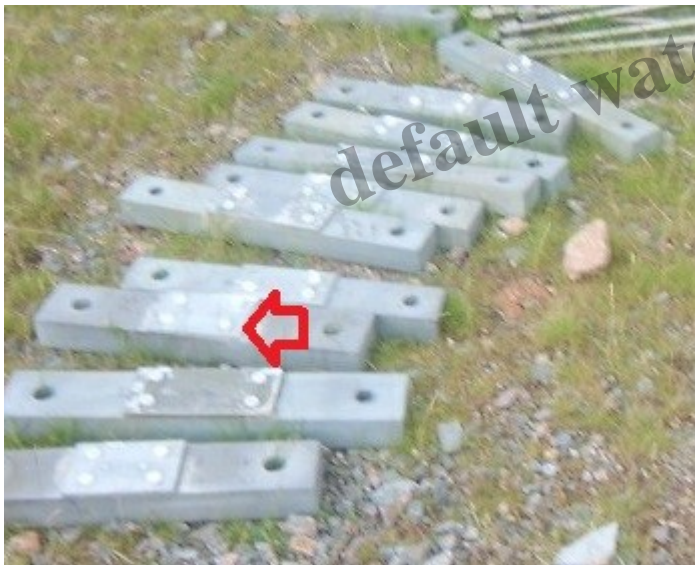
As all the removed brackets are refitted or replaced grout needs to be inserted between them and the concrete. An extract from the third picture shows where the grout has been:

There are four blobs of grout on each plate

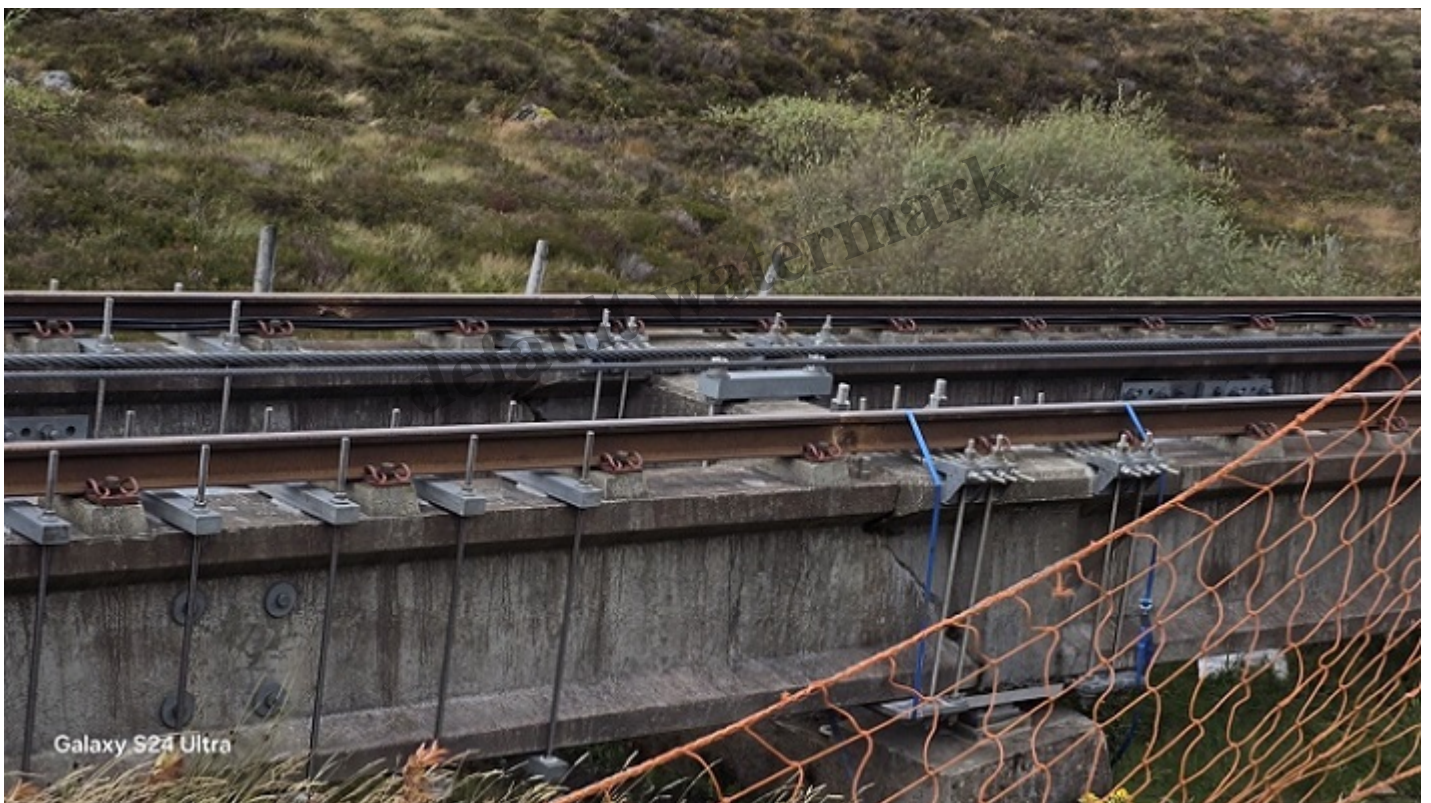
(b) when fastening or removing nuts using powered equipment such as an impact driver – as in the case of the brackets on the funicular – the threads tend to overheat, deform, jam or spall which can result in either the studding snapping or having to be cut with an angle grinder.

The fact that new metal studding (see photo above) is being used suggests that this is what has happened with the brackets round the beams. The way to prevent this is to use either water or a thin oil as a lubricant, although even that can alter the tightening torques, but this would require the work to progress more slowly. Water is actually preferable as you can see the steam if the work gets too hot!
