## Stainless steel brackets and their use on the funicular

October 28, 2024

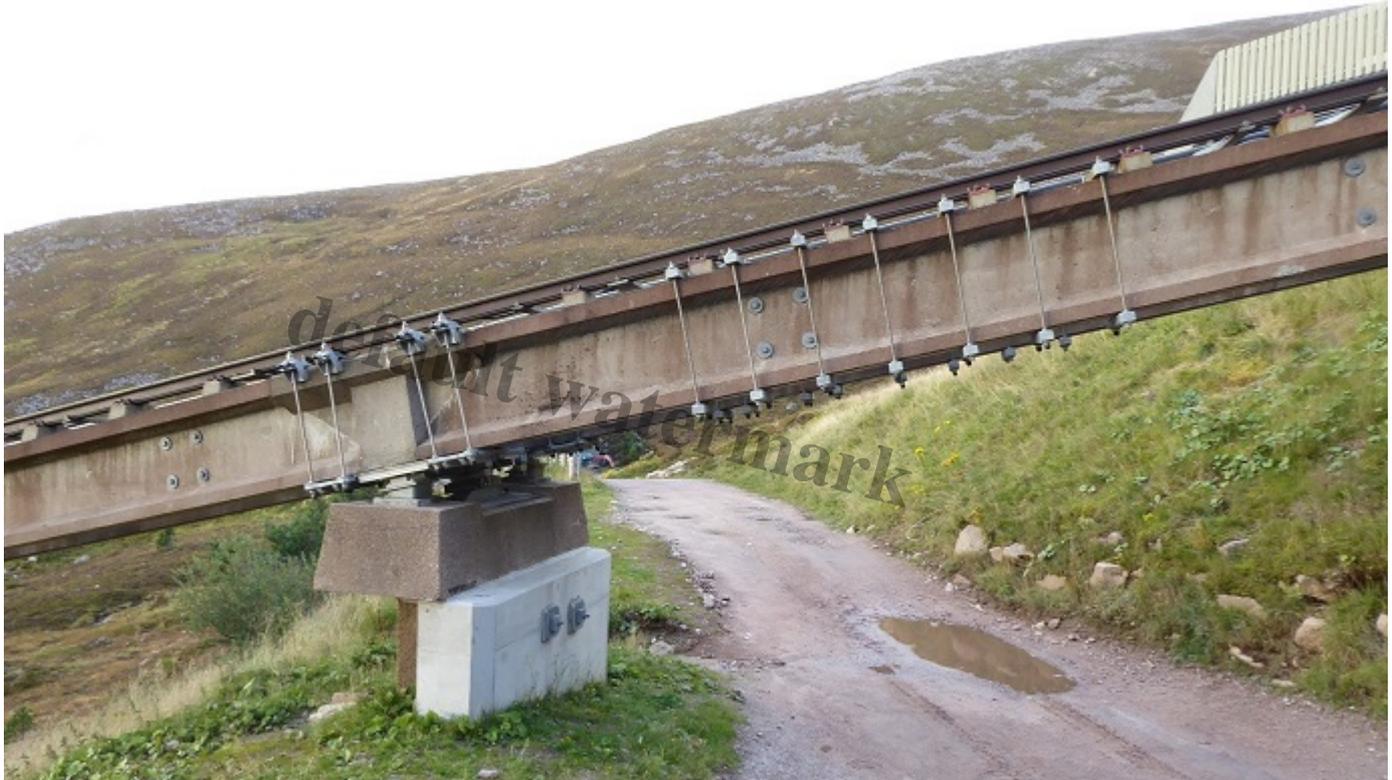
Seven pairs of Type One brackets around the beam are visible centre right and two of the Type 3 brackets around the insitu joint are visible left.

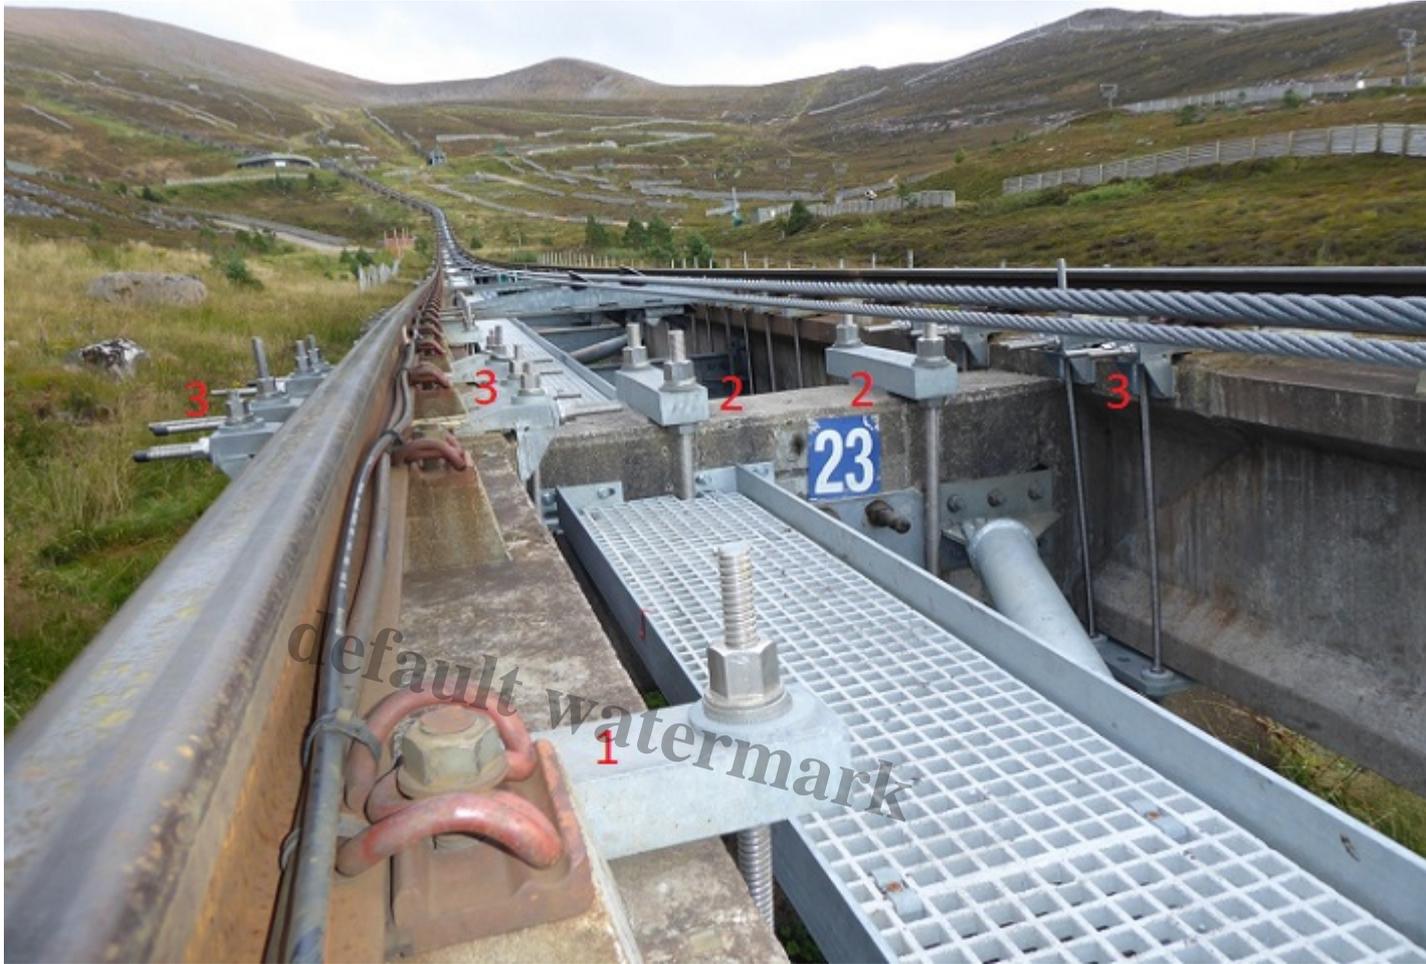
Following what I had written last December ([see here](#)) I expected to see changes/ repairs that would be instantly recognisable as such, e.g. more of the type 1 brackets and/ or larger support plates under the Type 3 brackets as labelled in the following picture:-

Type 1 brackets are used around the I beams, Type two around the beams between and Type 3 around the in-situ joints.

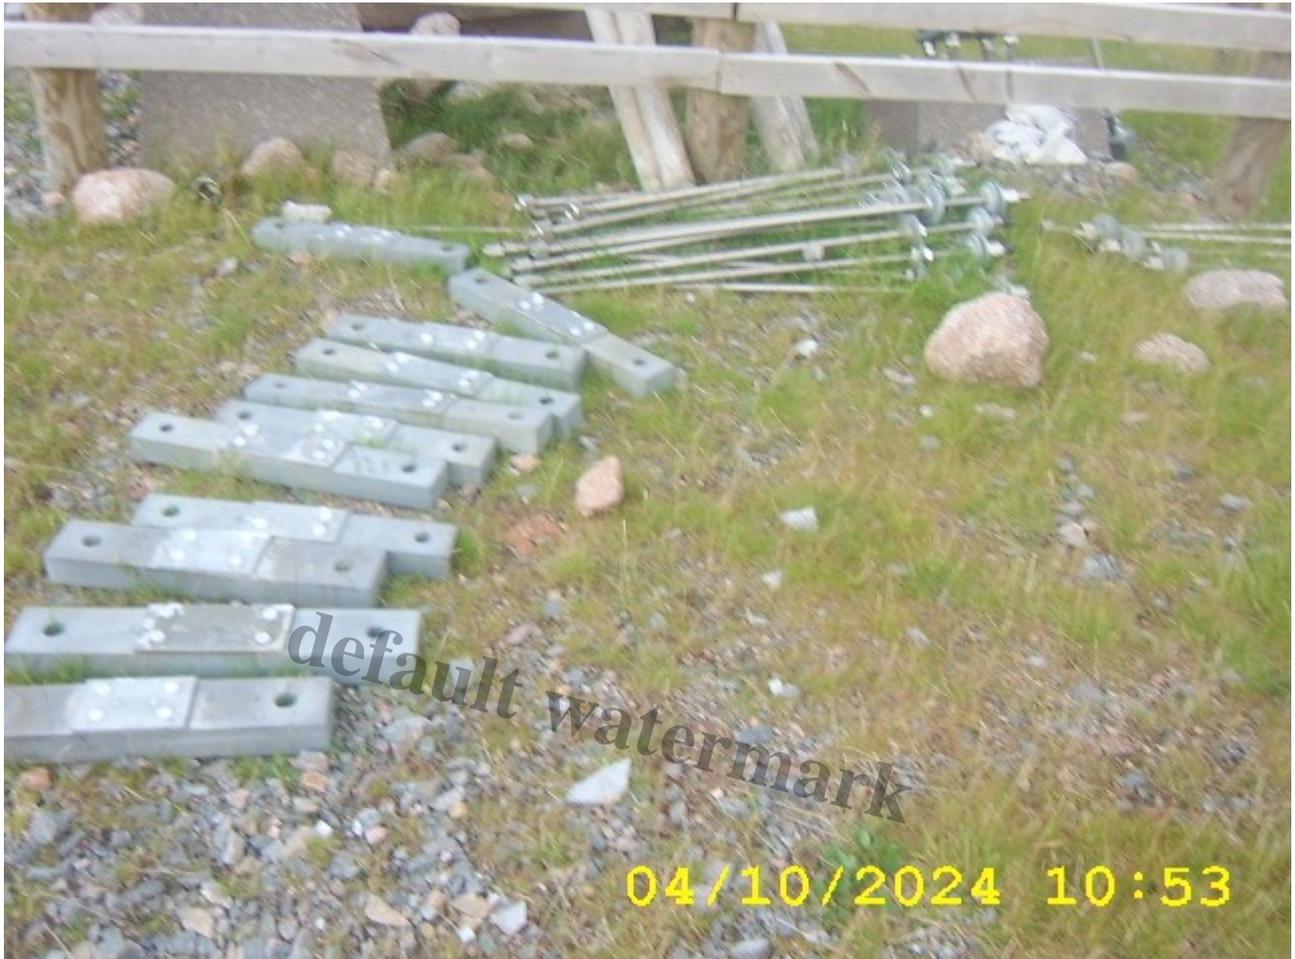
Photo. Type 1 brackets off the top pier of the passing loop.

If that tensioning work was ever completed it now has to be done all over again as almost all of the Type 1 brackets have been removed as shown in the photos above of Type 1 brackets lying on the ground.

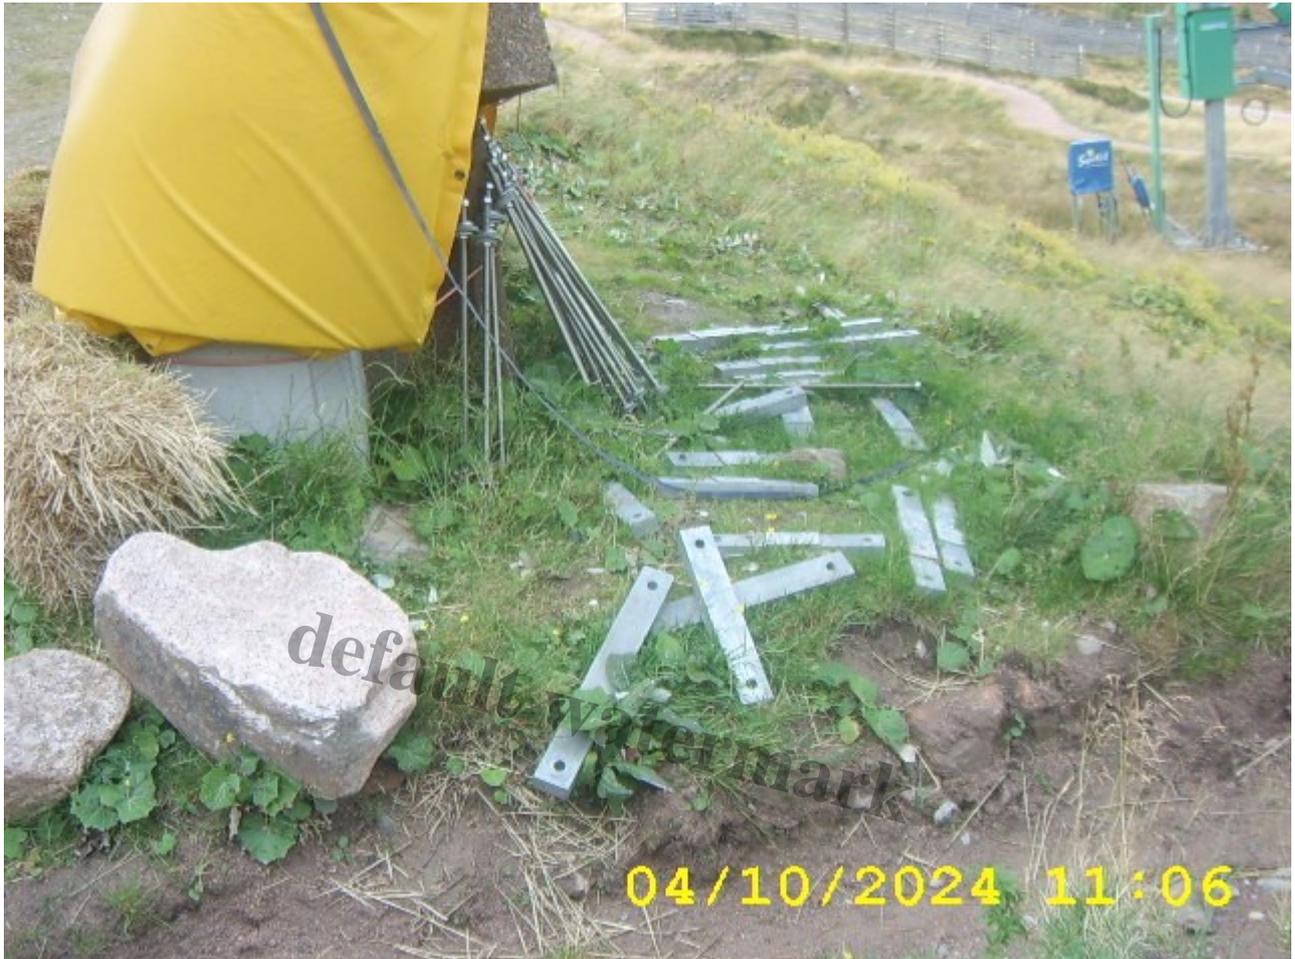
Photo. Type I brackets on the ground below Pier 47.

By my reckoning over 800 of the 917 Type 1 brackets had been removed from the beams by the time of my visit, all of which have to be replaced, tensioned, tested THEN adjustments made and re-tested!

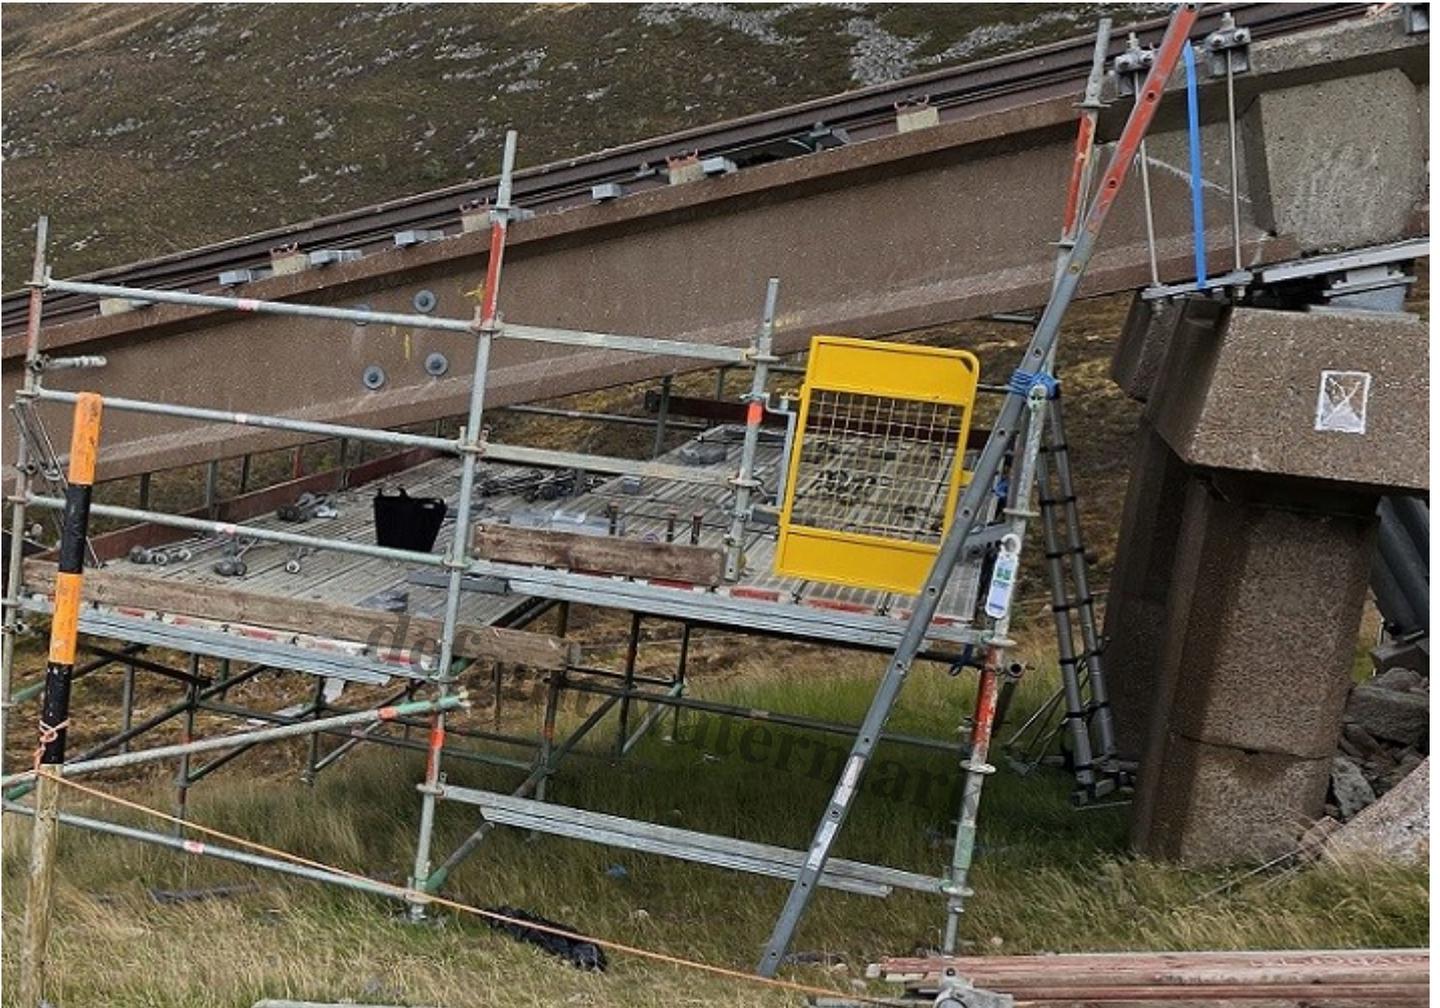
There were also some parts of brackets lying on the funicular beam and on the scaffolding at the passing loop:

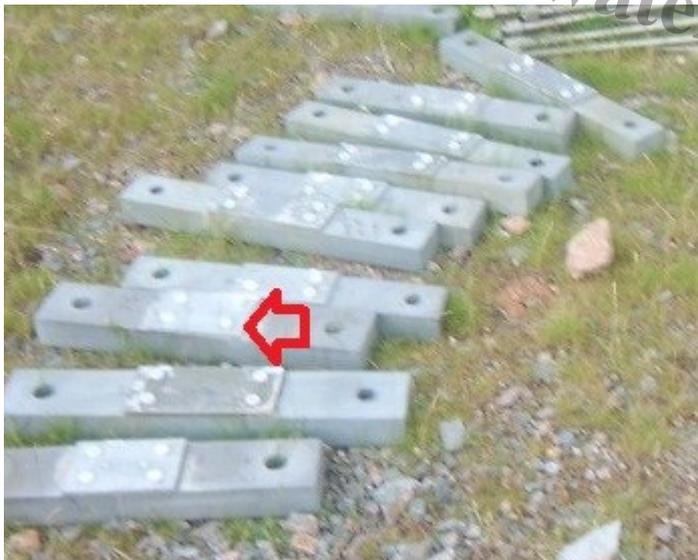
As all the removed brackets are refitted or replaced grout needs to be inserted between them and the concrete. An extract from the third picture shows where the grout has been:

There are four blobs of grout on each plate

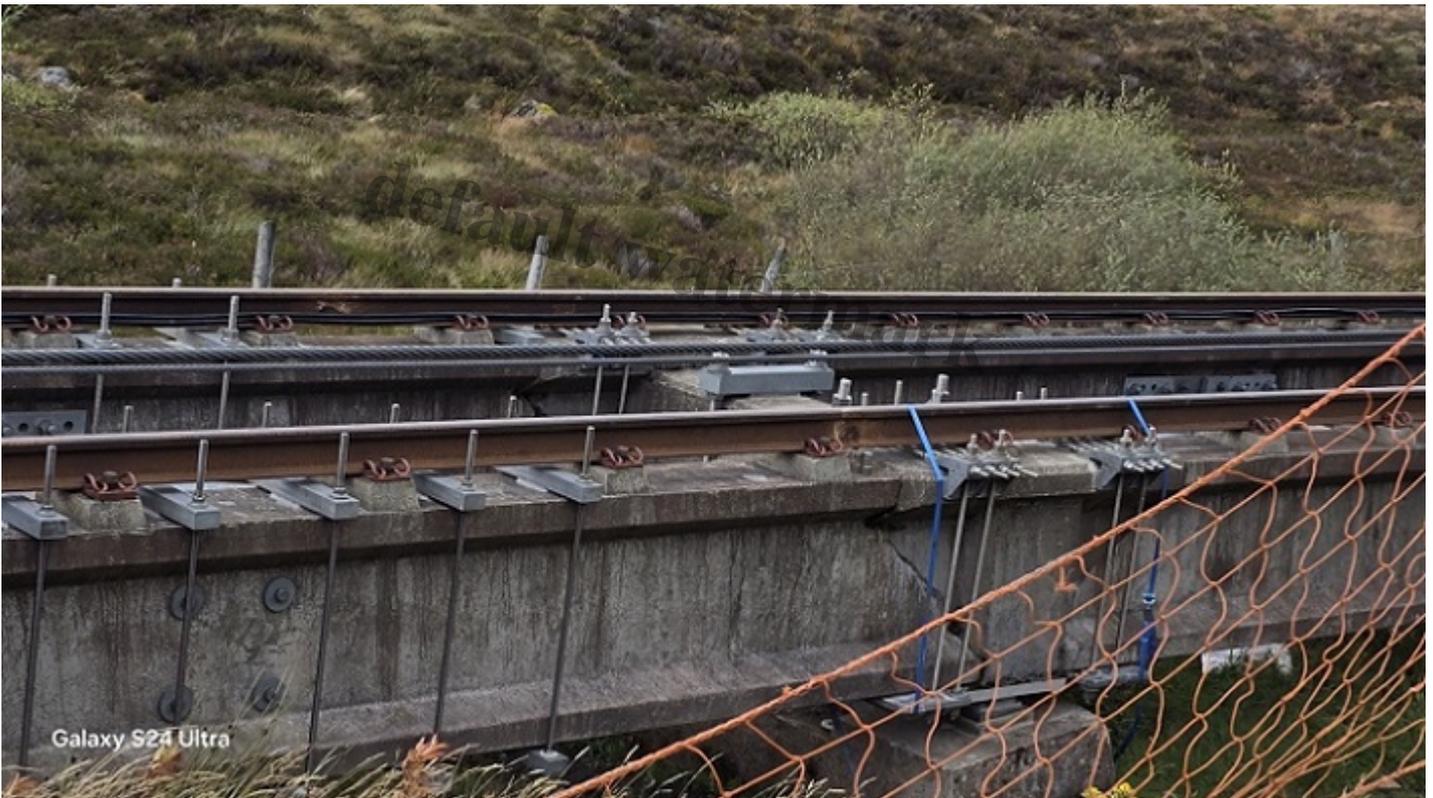
- (a) when cutting or drilling stainless steel it will eat angle grinder discs, hacksaw blades and drill bits, and/or;
- (b) when fastening or removing nuts using powered equipment such as an impact driver as in the case of the brackets on the funicular as the threads tend to overheat, deform, jam or spall which can result in either the studding snapping or having to be cut with an angle grinder.

The fact that new metal studding (see photo above) is being used suggests that this is what has happened with the brackets round the beams. The way to prevent this is to use either water or a thin oil as a lubricant, although even that can alter the tightening torques, but this would require the work to progress more slowly. Water is actually preferable as you can see the steam if the work gets too hot!
