Stainless steel brackets and their use on the funicular

On Friday 04/10/2024, prompted by HIE’s announcements about the timecale for the “snagging works” being carried out and paid for by Balfour Beatty ([see here](#)), I took a walk up to the passing loop of the funicular accompanied by two friends.

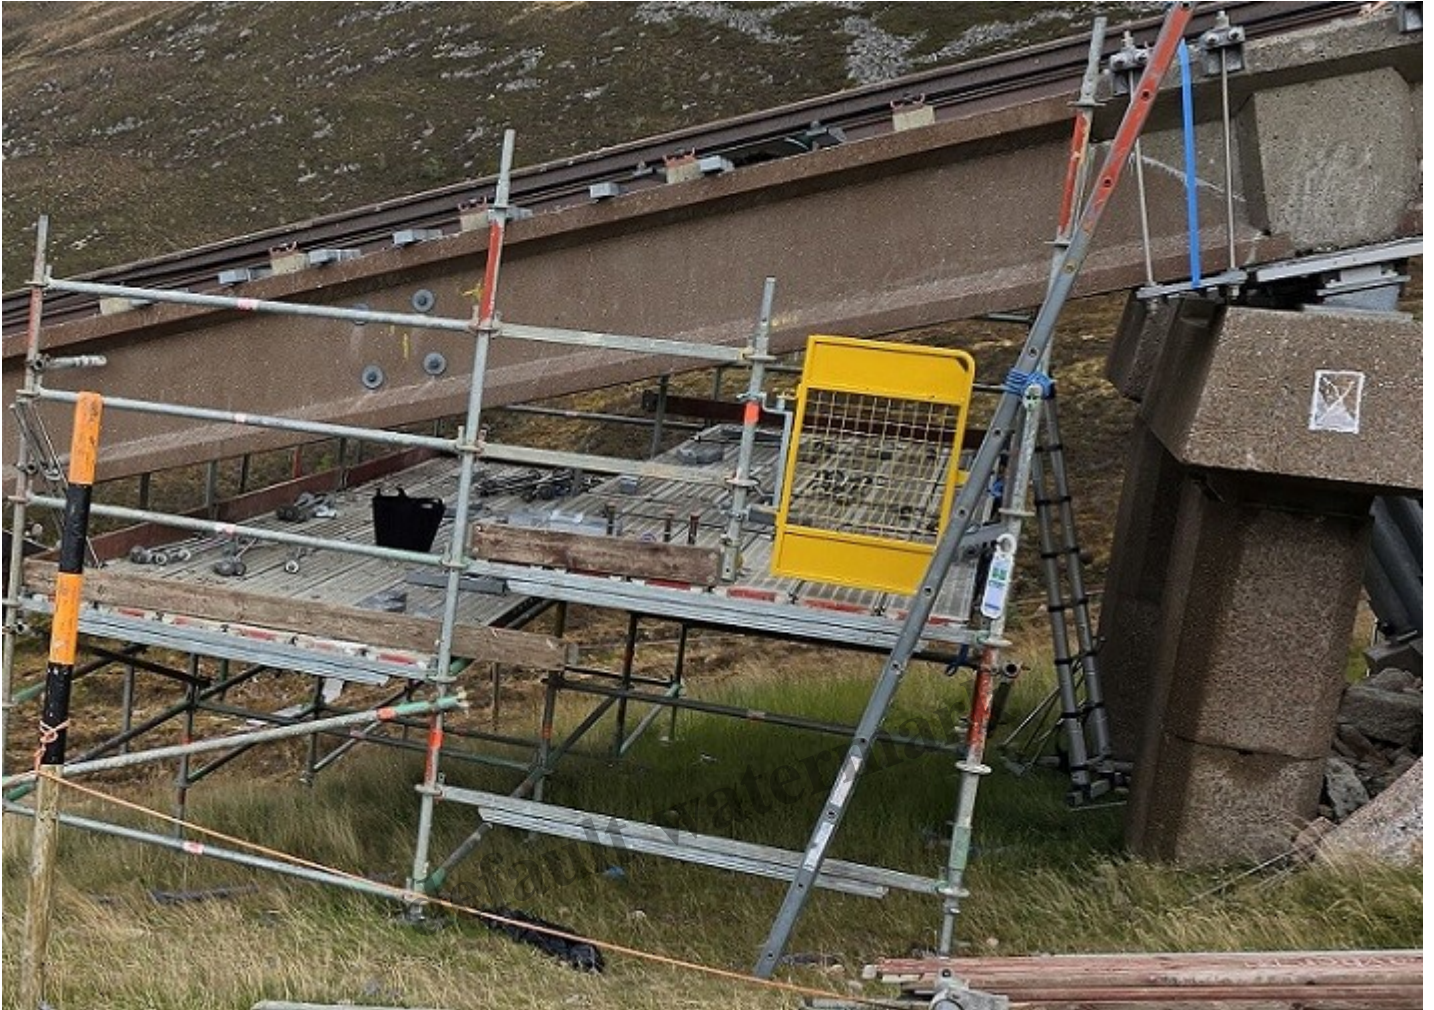
There were also some parts of brackets lying on the funicular beam and on the scaffolding at the passing loop:
