Concrete and its use on the funicular

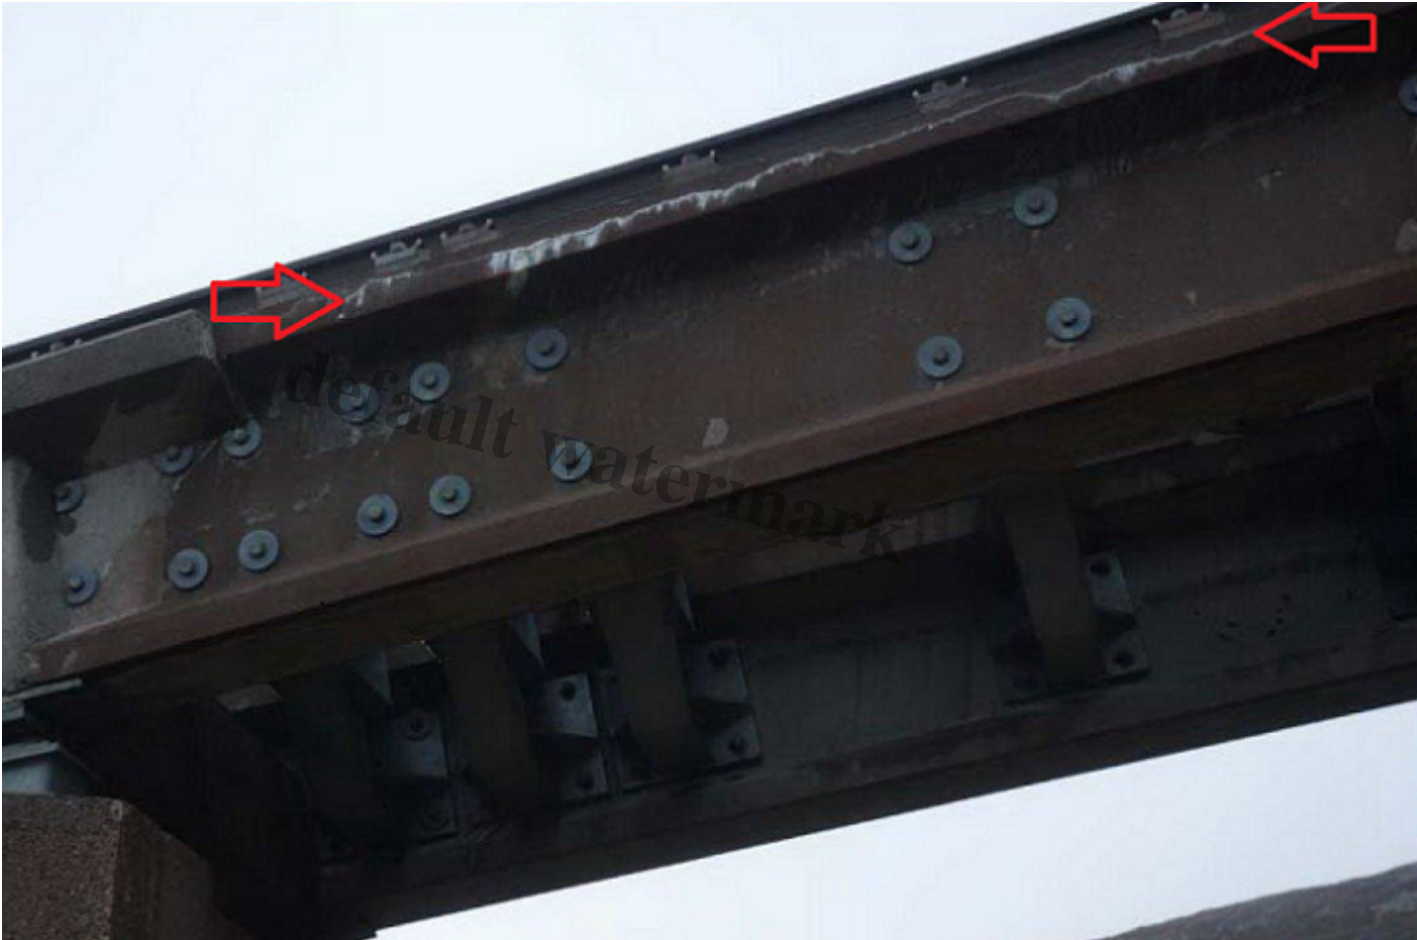
The right hand " " beam, looking uphill, just above Pier 51 (bottom left) showing the calcite bleed and crack running along the flange (arrow). The left hand arrow is just to the right of the insitu joint.

2.2 A crack was clearly seen running along the length of the beam positioned at about mid height of the top flange. It appeared to extend from the lower end up to about mid span. See appendix B for a sketch and photo showing this.

- The writer has been carrying out annual inspections for the last three years. This feature was observed for the first time during last year's inspection.
- The crack is evident on both sides of the beam at the same height and over the same length.
- The crack is particularly evident due to calcite bleed, showing up white. This was seen as significant at the low end, diminishing along the length.

This crack was observed for the first time in the 2016 inspection when it was described as being a few cms. long. By the 2017 inspection it had increased to almost 9m! That is more than a crack, it is the top layer of concrete above the reinforcing rebars inside the beam delaminating. Was this caused by water ingress and rusting of the rebar at the insitu joint?

When water gets into a crack and then freezes it will cause damage at that point. The subsequent freeze thaw process, which in a mountain environment could happen several times a day, will gradually weaken and destroy the concrete joint. Eventually the water will work its way through a joint and when reaching the steel rebar will cause corrosion and then potentially delamination along the length of the rebar. Vibration caused by the train will exacerbate the situation.

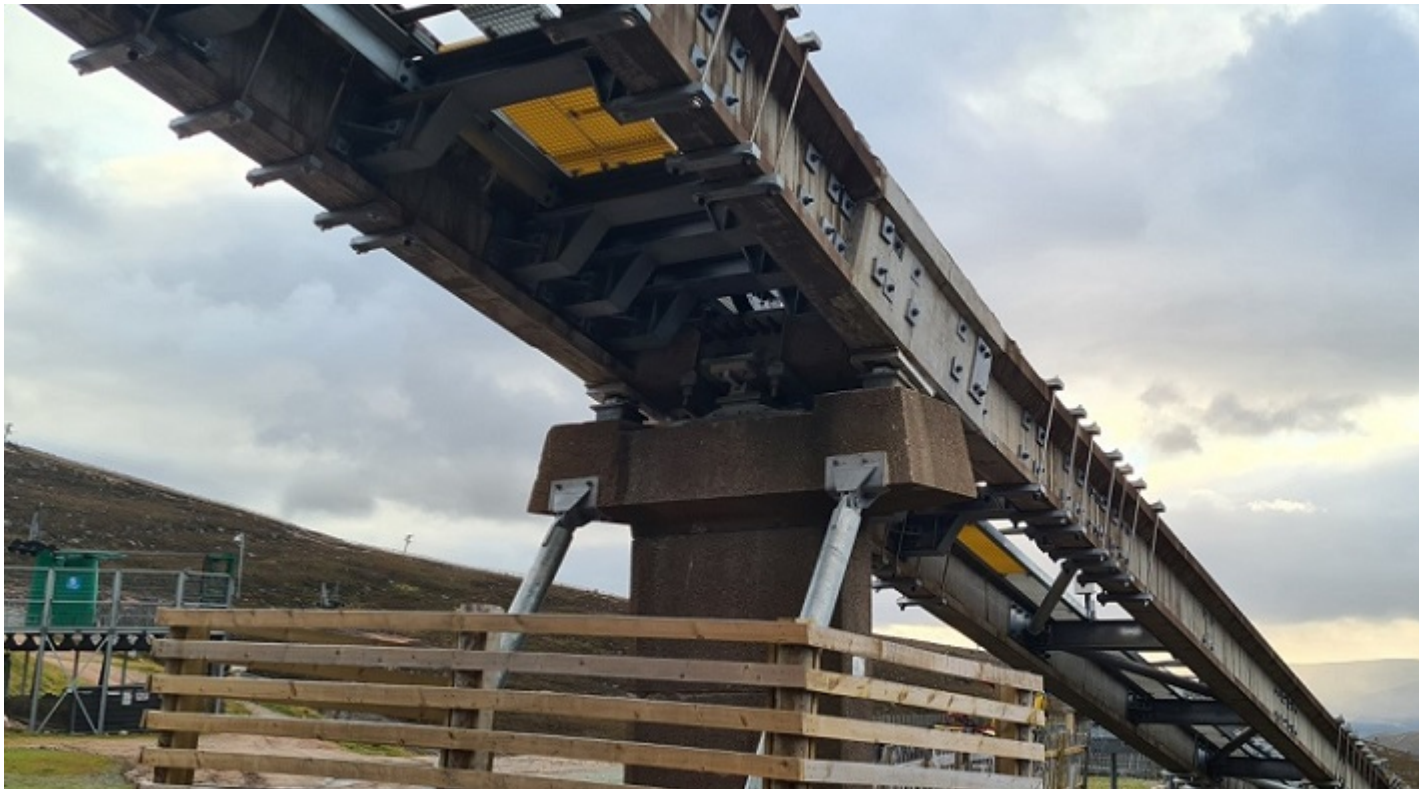
That this may be the case is shown by the extensive repairs that have taken place on the insitu joint above Pier 51:

Pier 51 viewed from the north side, looking downhill, showing the new rectangular section of concrete at the insitu joint. Note the absence of scaffolding. September 2023.

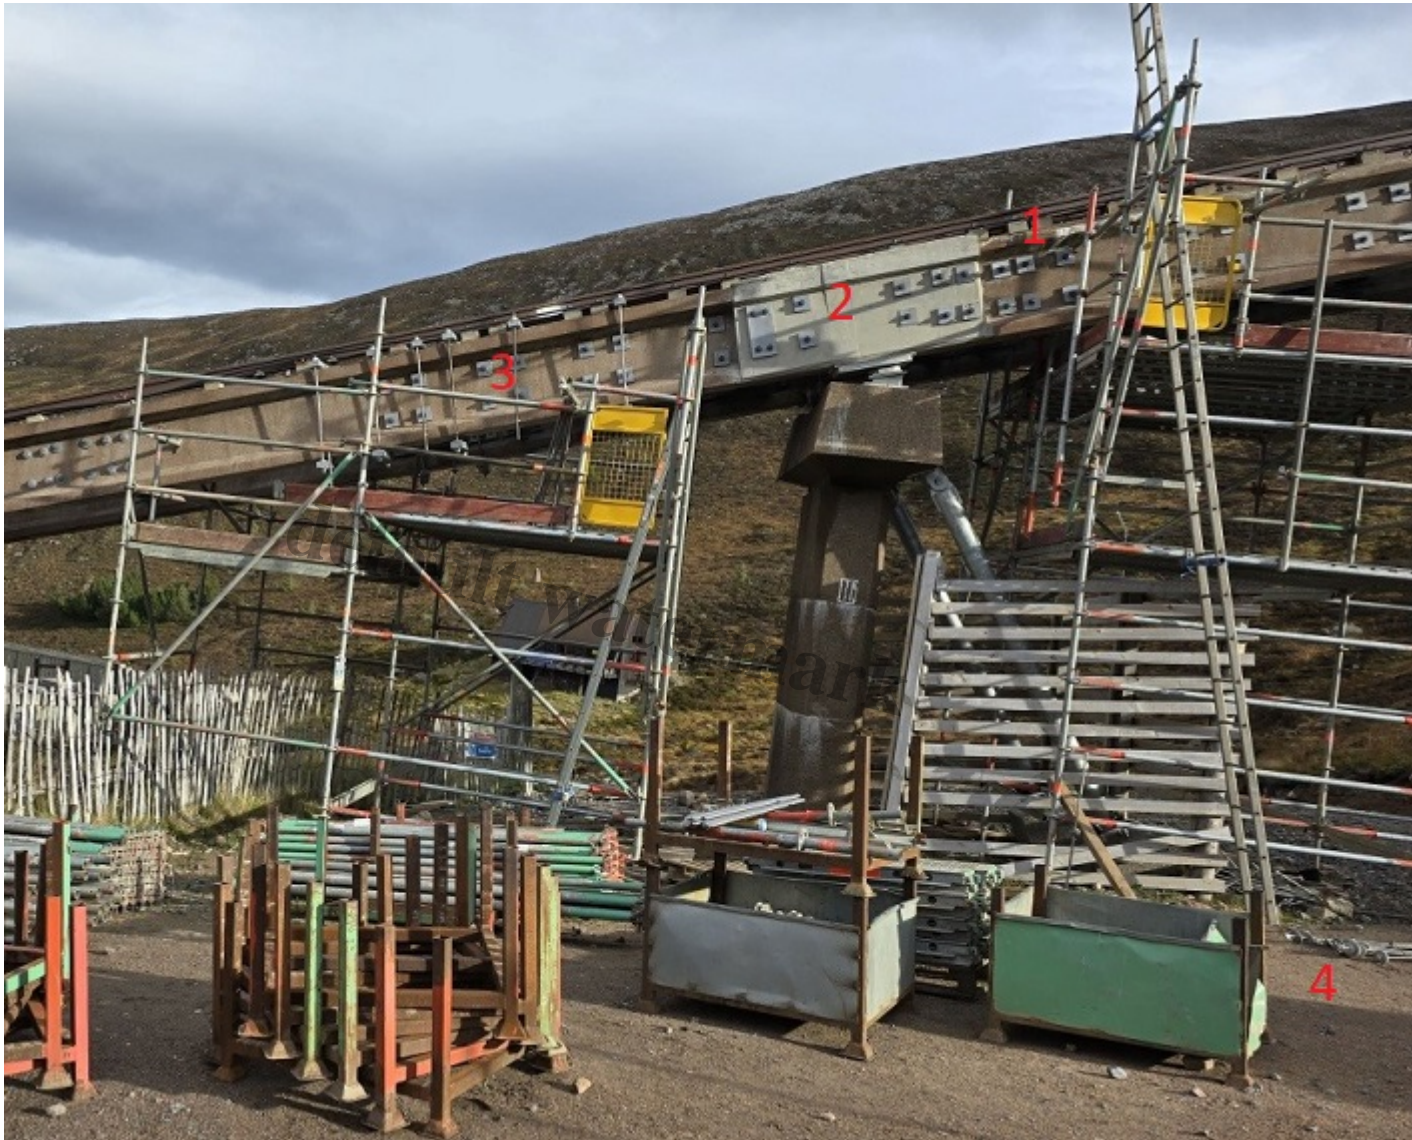
Pier 51 view from the south side October 2024. (1) shows the location of the calcite bleed and crack, (2) the extended insitu joint, (3) metal brackets hanging loose on the beam and (4) metal brackets lying on the ground:

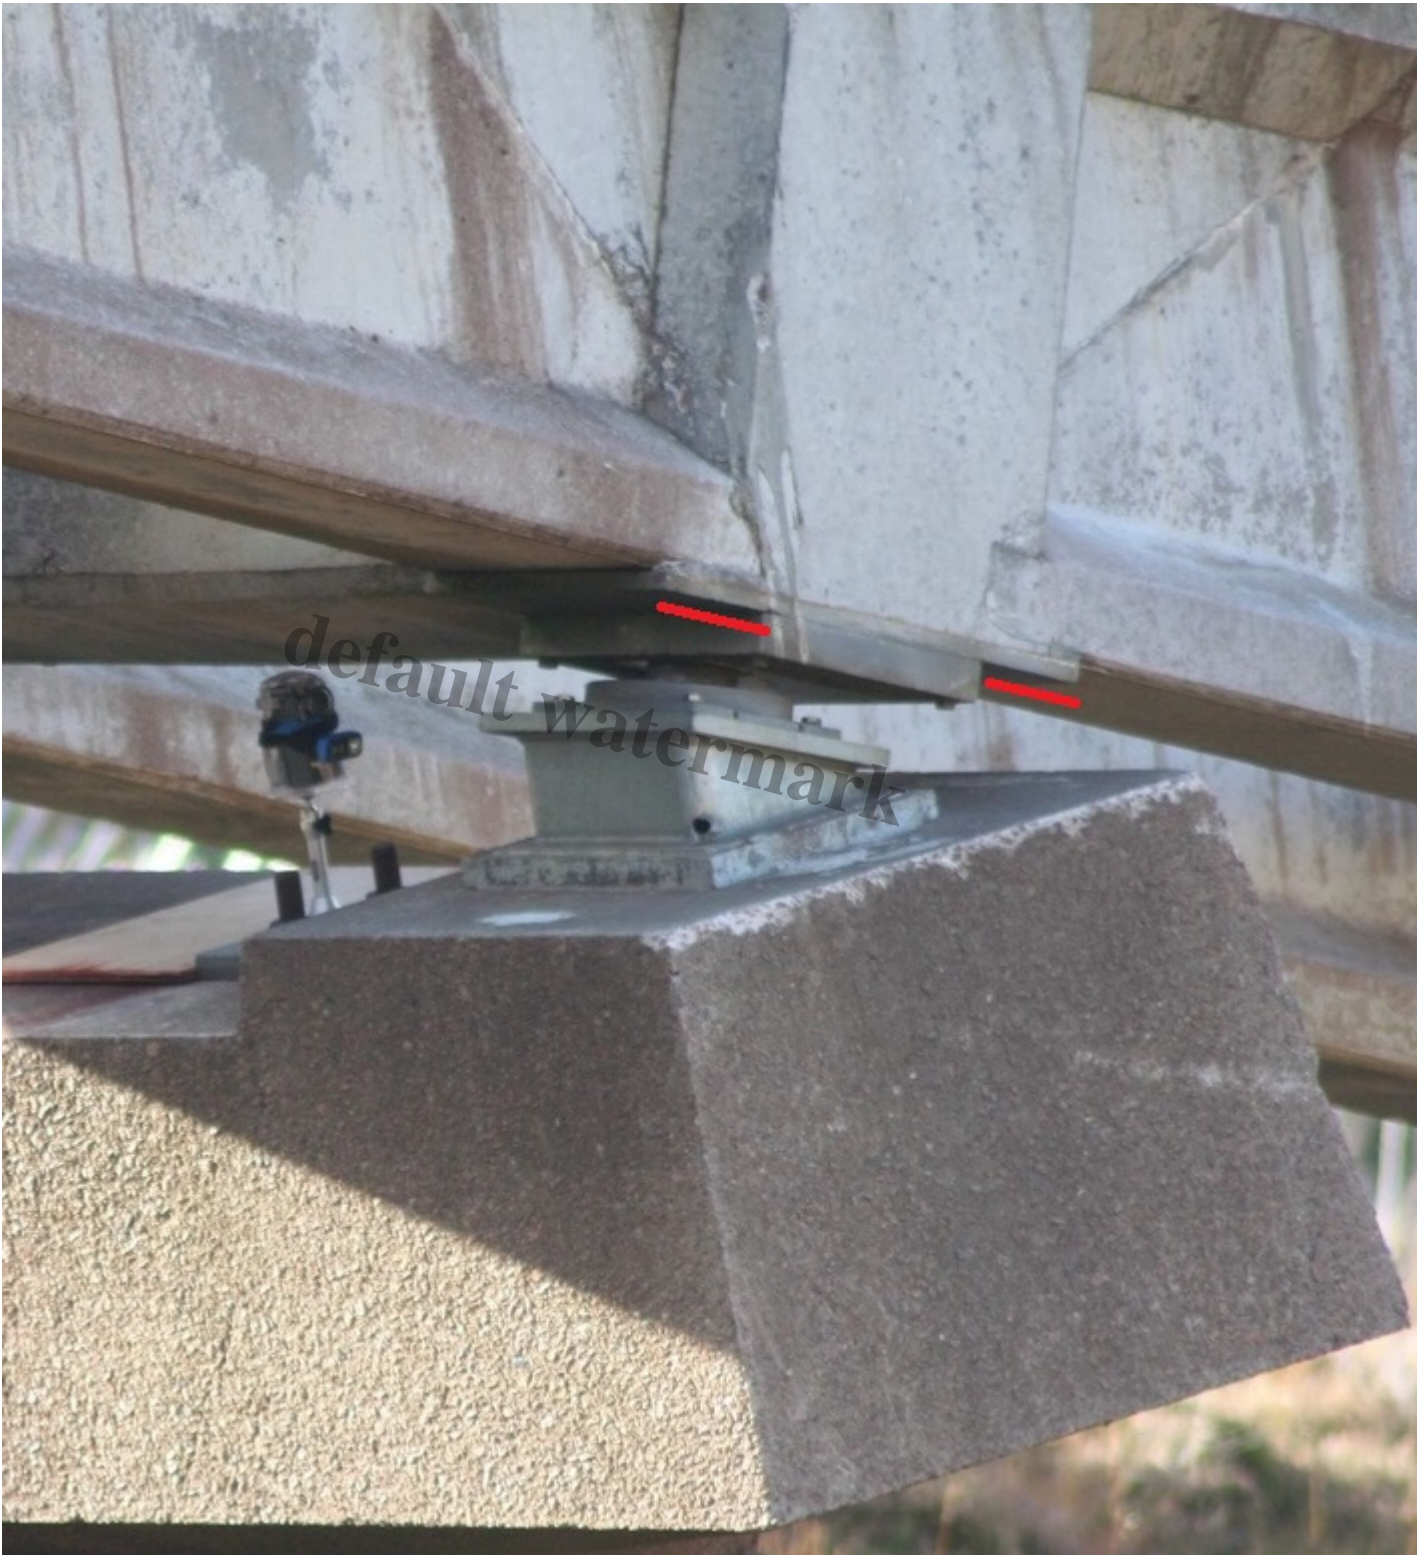
When COWI states that the Type 1 beams were installed as simply supported spans this means that initially their entire weight was held by the piers on either side and, in the case of the funicular by a small metal plate.

The plate supporting the end of the beams

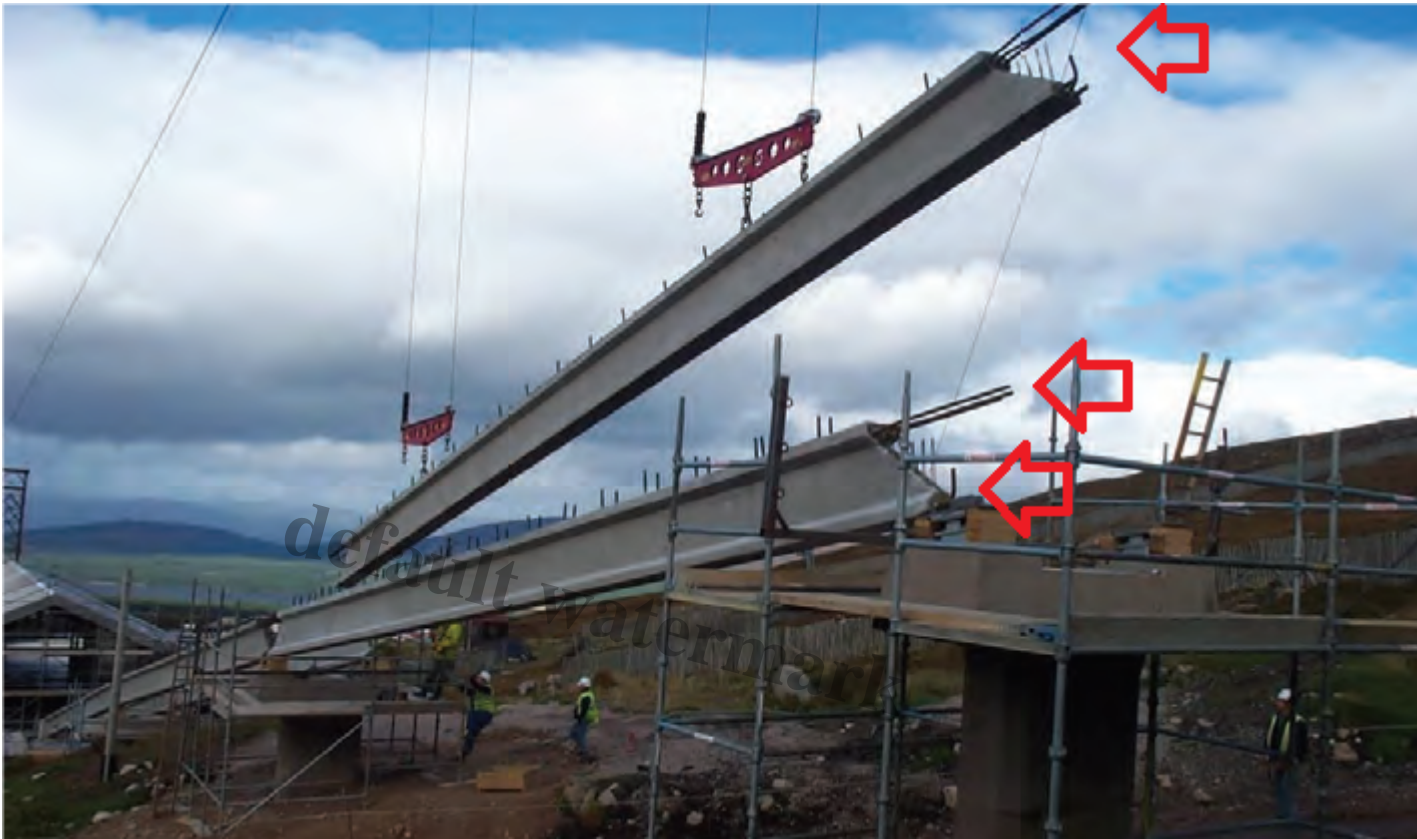
Figure 3-1 Precast beam installation from Cowi Report showing protruding rebars

The picture below shows the rebar protruding from the concrete. The lengths of rebar protruding from the top flange were used to connect one beam to the next and hold them in place:

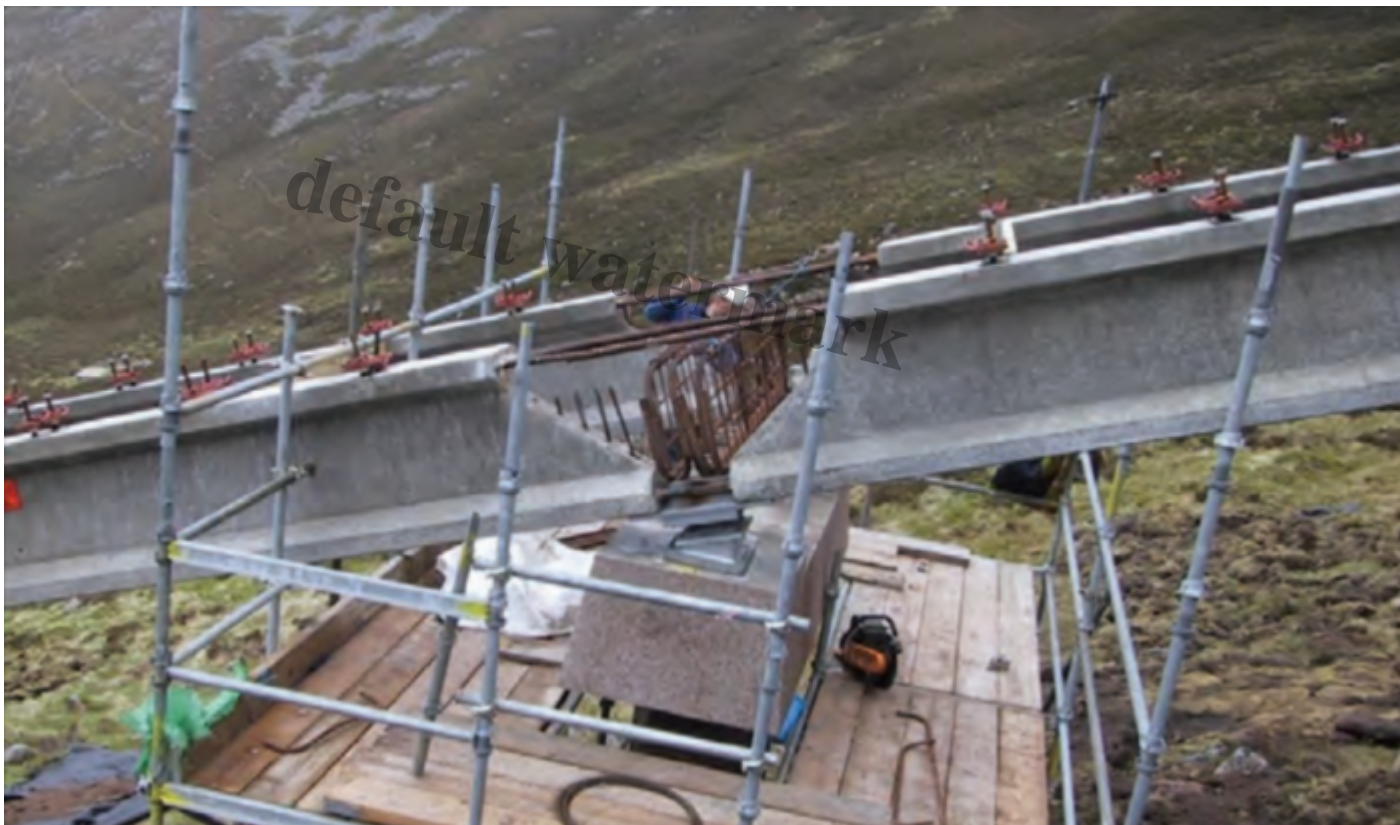
The insitu joint during construction showing the rebars and how the bottom ends of the beams rests on a small metal plate. Photo credit Cowi Report 2018
