## Safety and the closure of the funicular at Cairn Gorm in August 2023

From: [REDACTED]  
Sent: 23 August 2023 23:17  
To: James Palmer [REDACTED]  
[REDACTED]@balfourbeatty.com  
Subject: Cairngorm Funicular - Supervisor Inspection 23/08/23  
Importance: High

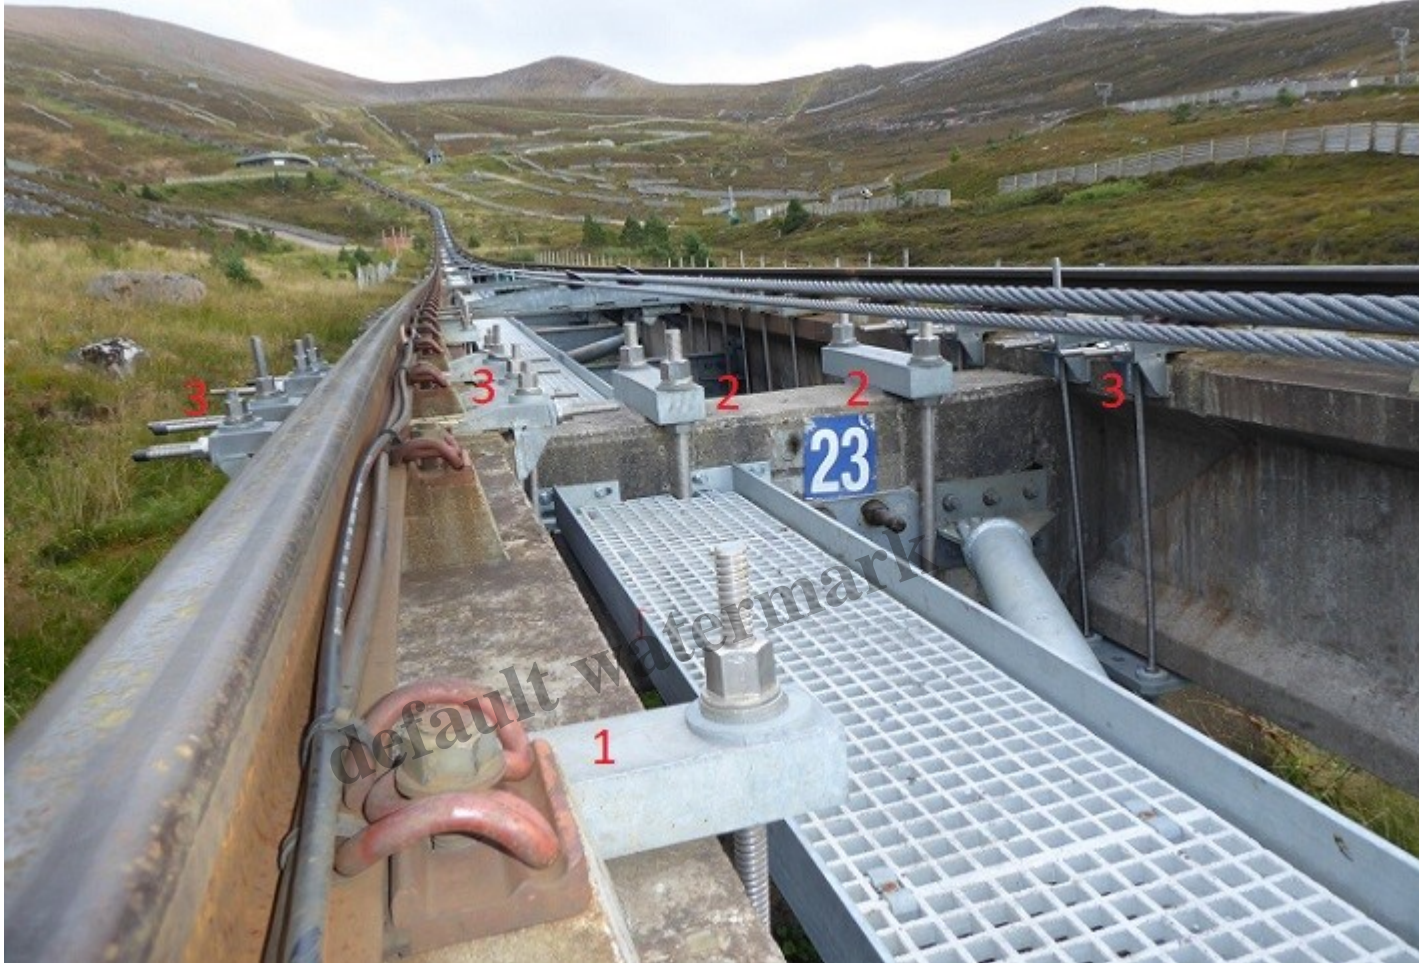
All those nuts were on the scarf joint brackets, numbered 3 in the next photo, and are safety critical”.

The figure one shows the position of the brackets round the beams referred to under Issue 2 below

The whole purpose of the No 3 type brackets was to strengthen the scarf joint to stop the ends of the “I” beams breaking up and to keep tension in those scarf joints.

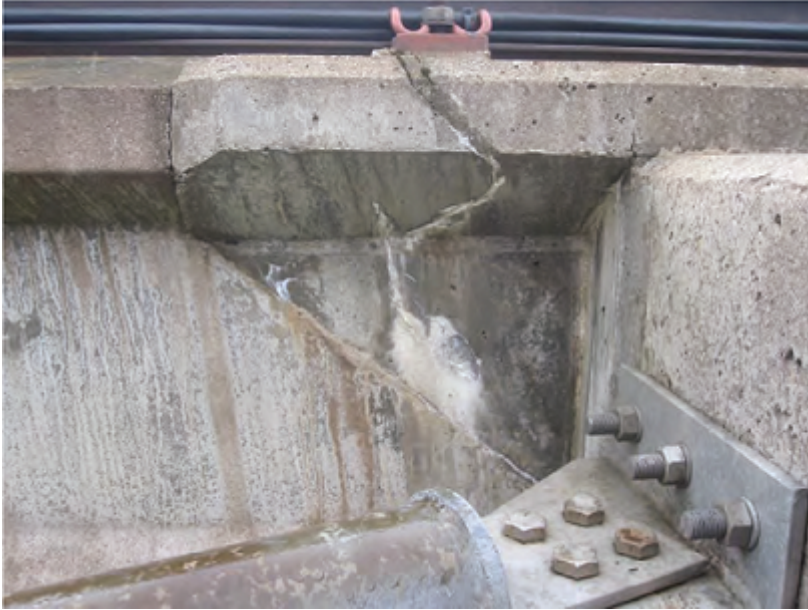
Cracking at Pier 9, where the spanner was found, but before the brackets were fitted. Photo courtesy of the COWI report Dec 2018.

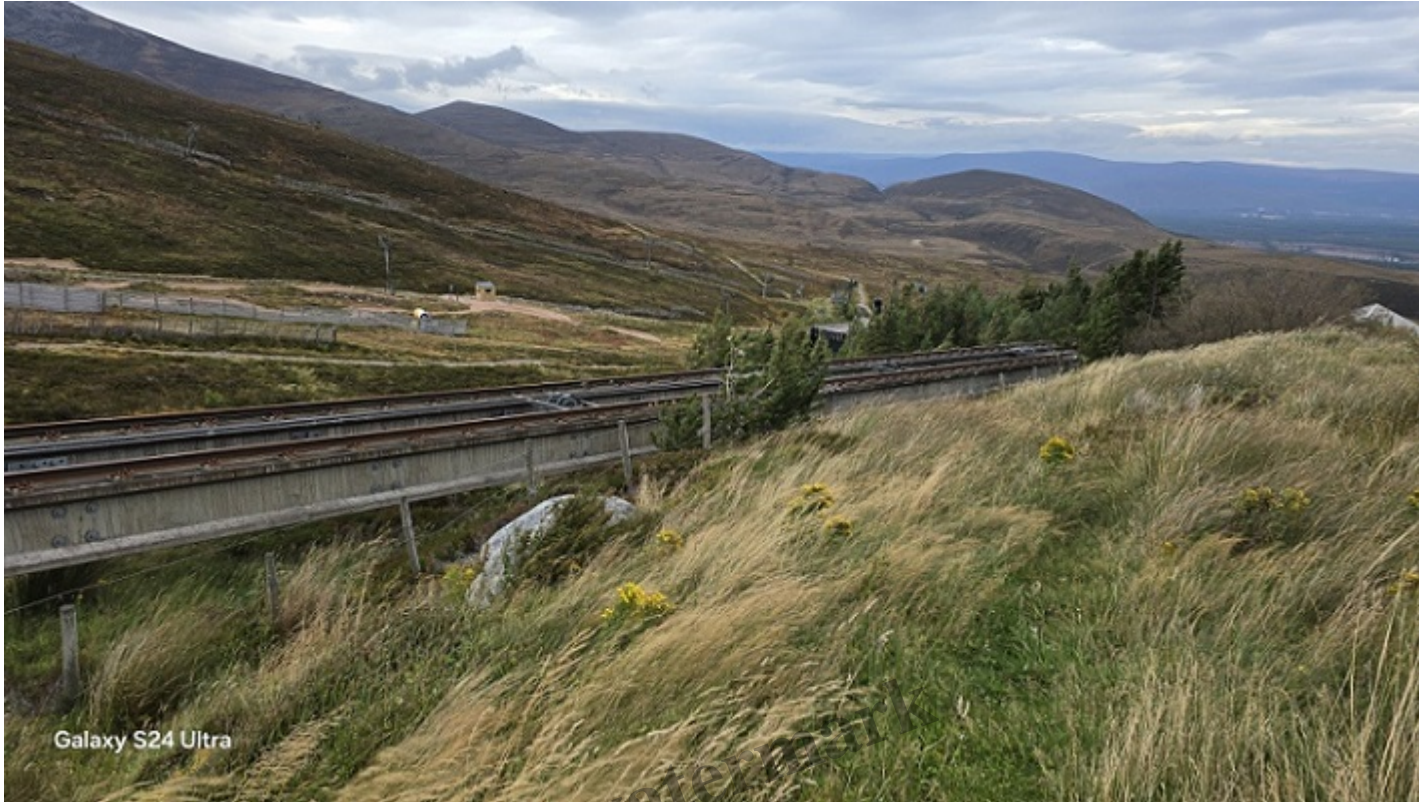
The area near pier 9 and showing how the low height of the funicular above the ground makes the brackets easily accessible in that area:-
