## Safety and the closure of the funicular at Cairn Gorm in August 2023

**From:** [REDACTED]  
**Sent:** 23 August 2023 23:17  
**To:** James Palmer [REDACTED]  
[REDACTED]@balfourbeatty.com  
**Subject:** Cairngorm Funicular - Supervisor Inspection 23/08/23  
**Importance:** High

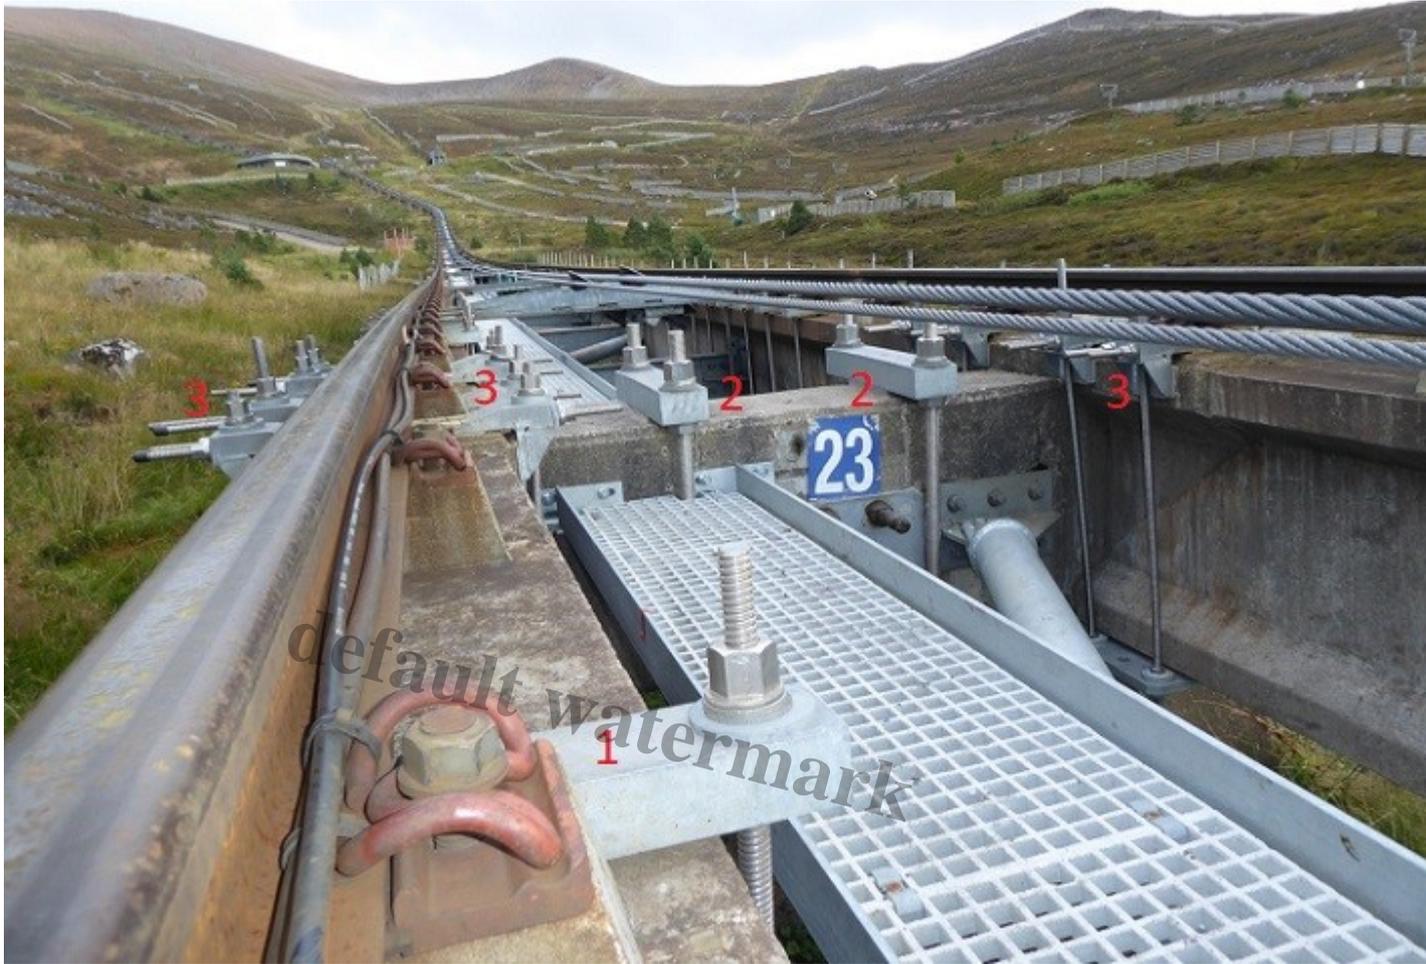
All those nuts were on the scarf joint brackets, numbered 3 in the next photo, and are safety critical?•.

The figure one shows the position of the brackets round the beams referred to under Issue 2 below

The whole purpose of the No 3 type brackets was to strengthen the scarf joint to stop the ends of the beams breaking up and to keep tension in those scarf joints.

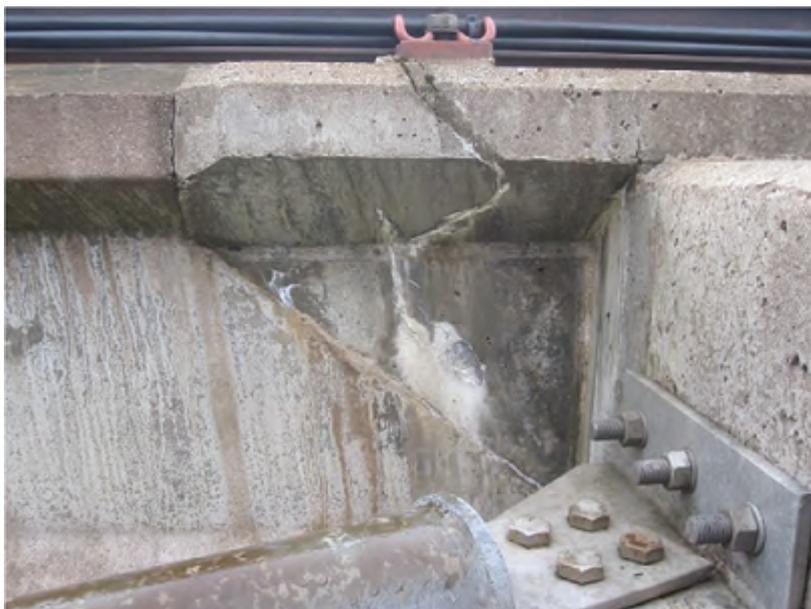
Cracking at Pier 9, where the spanner was found, but before the brackets were fitted. Photo courtesy of the COWI report Dec 2018.

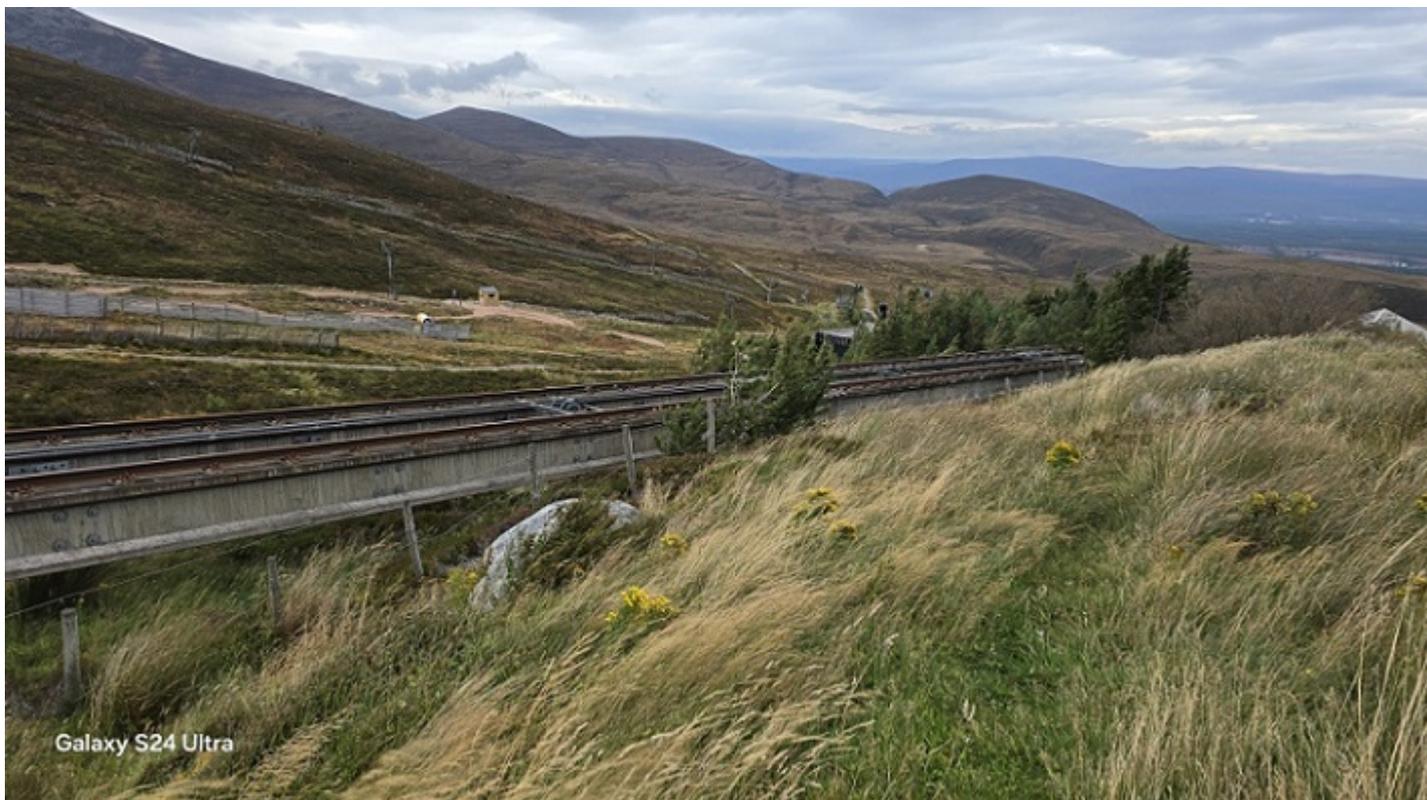
The area near pier 9 and showing how the low height of the funicular above the ground makes the brackets easily accessible in that area:-
