Safety and the closure of the funicular at Cairn Gorm in August 2023 (2)

This post comments further on the heavily redacted replies to Mr Gordon Bulloch's FOI request of 05/12/2024 about the 2023 closure of the funicular. **Email 1**, sent on 23rd August at 23.17, was considered in the first post in this series.

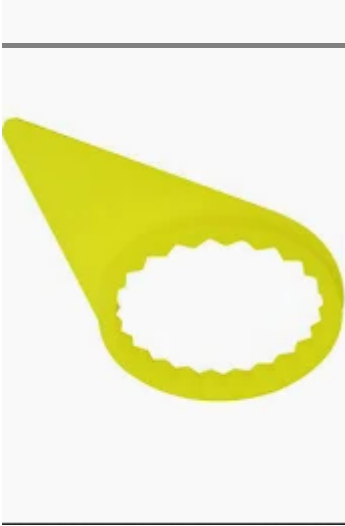
While “consider use of a paint marking system or something similar” might

appear mickey mouse when you can buy nut position indicators (left) the key point is a system should have been in place for identifying whether nuts were at the right tension before the funicular was re-opened in January 2023.

1. Consider use of a paint marking system or similar for the bar ends/nuts to indicate the final position of the nut relative to the bar on completion of all stressing operations. The aim being that a simple visual inspection would identify if significant loss of tension has occurred as this would be visible by change in relative paint marks.
