Safety and the closure of the funicular at Cairn Gorm in August 2023 (3)

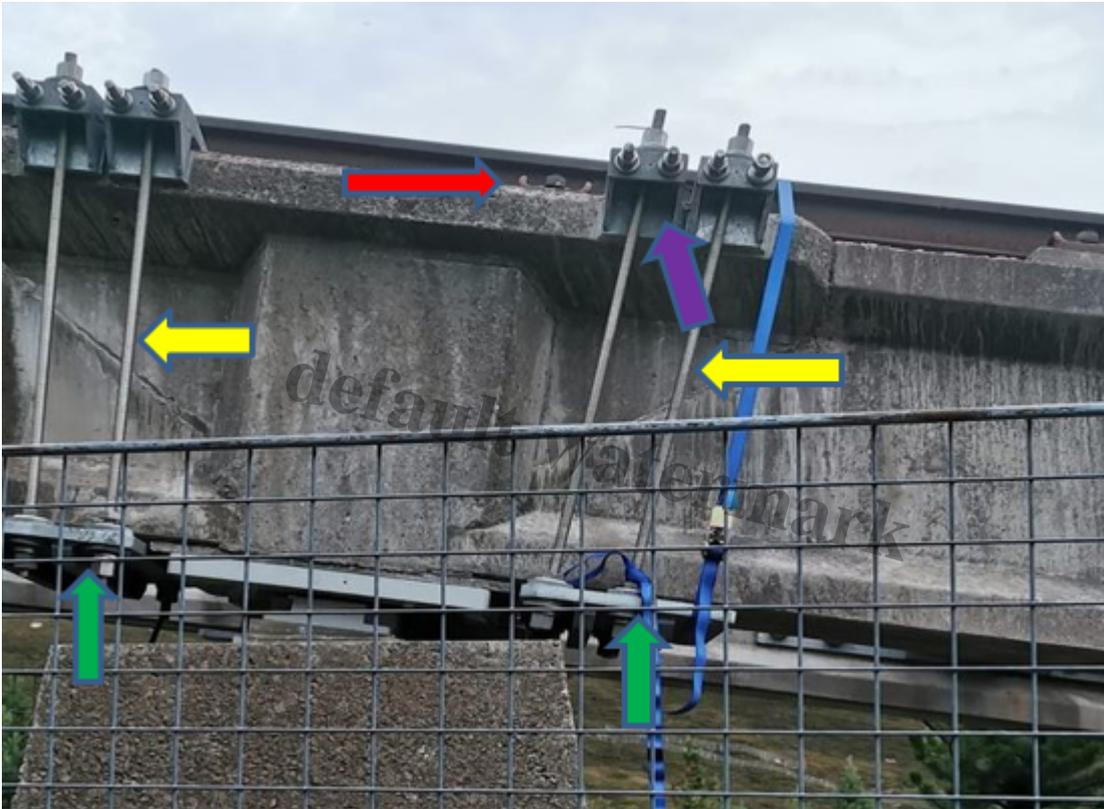
The red arrow points to a rail fixing, the two yellows to the "studding" on the scarf joint brackets, the green arrows to the single lower plate and the purple to the two upper brackets

(1) Part of the answer lies in the photo above of the brackets around the insitu joints.

(a) The original design for the strengthening of the insitu joints was for FOUR "channel sections", two at the top and two at the bottom. At some point this design was changed, as can be seen in the photo above, and not for the better. It only takes ONE nut to lose tension and the whole bracket

becomes unstable and ceases to do its job. It is also more awkward to tension all four lengths of studding to the same tension so, whoever changed the design, built in a fault which made it more likely for the repairs to fail!

(b) Because of the position of the rail fixing (red arrow above), the right hand bracket on the downhill side of the in situ joint has had to be fitted with both lengths of studding sloping to the right. It is difficult to be 100% certain if the studding on the left hand and uphill bracket is sloping to the left although it looks like it is. Both should have been fitted perpendicular to the in situ joint and beam for the tensioning to hold the whole structure together effectively.

The downhill bracket has been fitted by a team who apparently did not understand the strengthening regime and why the studding should have been perpendicular in relation to the in situ and the $\hat{\imath}$ beam. That begs the question where was the supervision and the quality control?

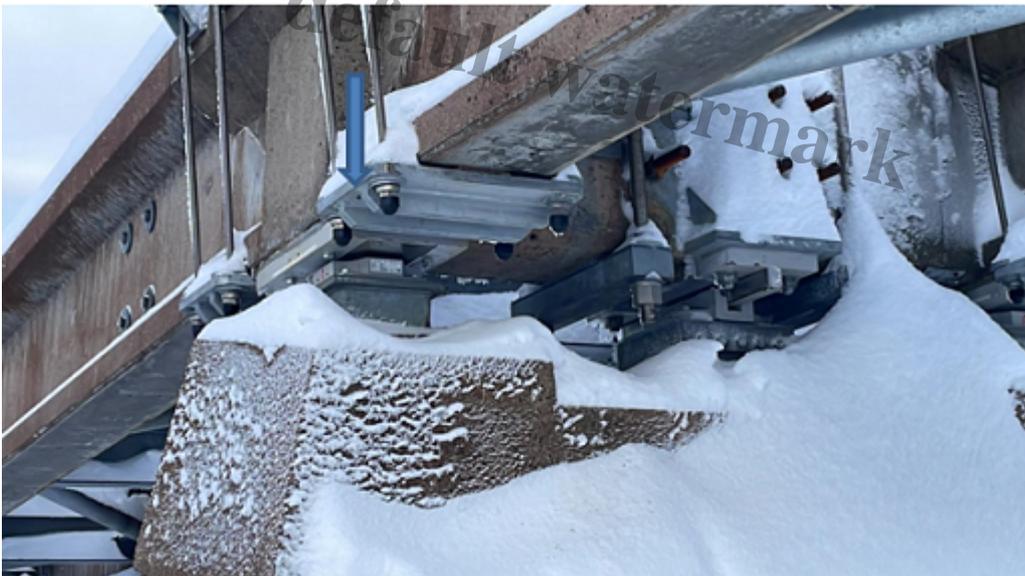
(c) What can't be seen from the top photo is that the single bottom plate, which replaced the original design of two brackets, has 3 pairs of holes for the studding, not just the two that are in use.

Photo courtesy of PW reader. The middle hole in the lower plate is just visible at the tip of the arrow. Photo credit PW reader 2022/23..

Had the studding been fitted to the middle and right hand holes it would then have been vertical and exerted the tensioning as intended. In this position the bracket could not have moved because it is butted up against the rail fitting on top and by the bearing plate at the bottom.

Contrast that with the sloping bracket(s) where vibration from the funicular may have shaken the bracket to the point where it slid down the $\hat{\imath}$ beam thereby reducing the tension that was so necessary for the bracket to do its job. That would explain the loose nuts that led to the funicular being closed again

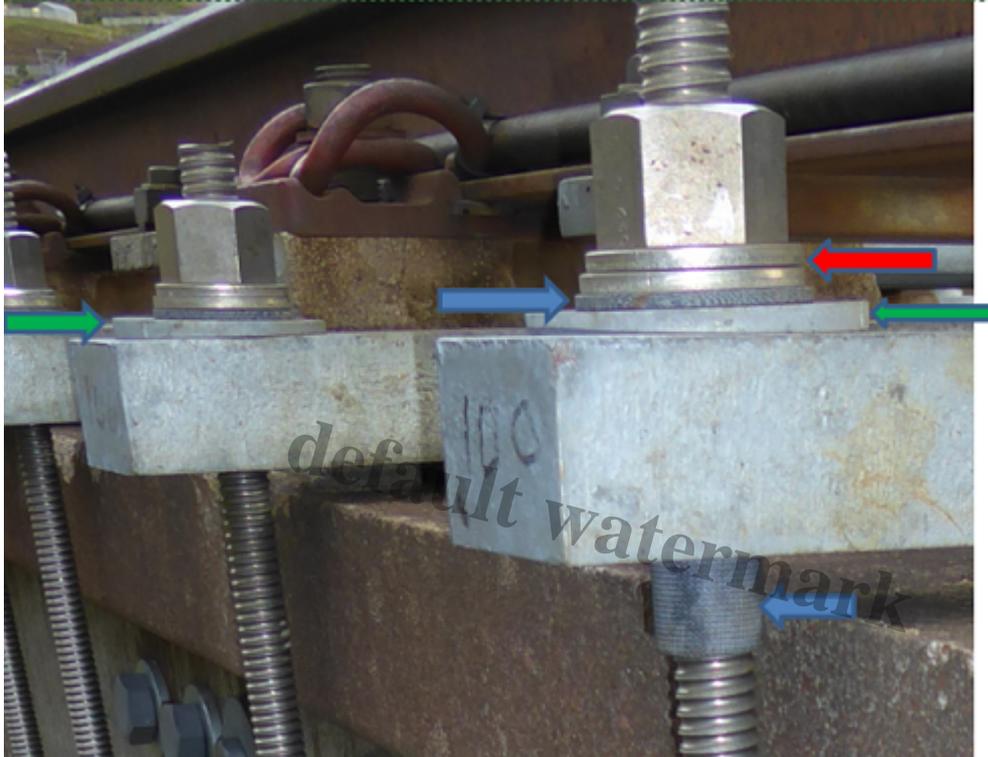
Beam strengthening bracket above pier 15. The blue arrows point to the bushing, the lower at the tube part of the bushing with the upper one at the flange. The red arrow points to TWO stainless steel washers . The two green arrows point to tapered washers.

This photo shows how the fixing of the brackets was all wrong. One of the two stainless steel washers (red arrow) should have been above the bushing flange and the other between the flange and the tapered washer so the **lower washer is in the wrong place!** Moreover both tapered washers should face in the same direction but they don't (it's the tapered washer on the left that has been fitted wrongly).

What is clear from this is that the metal brackets were fitted by someone people who didn't understand what they were supposed to be doing.

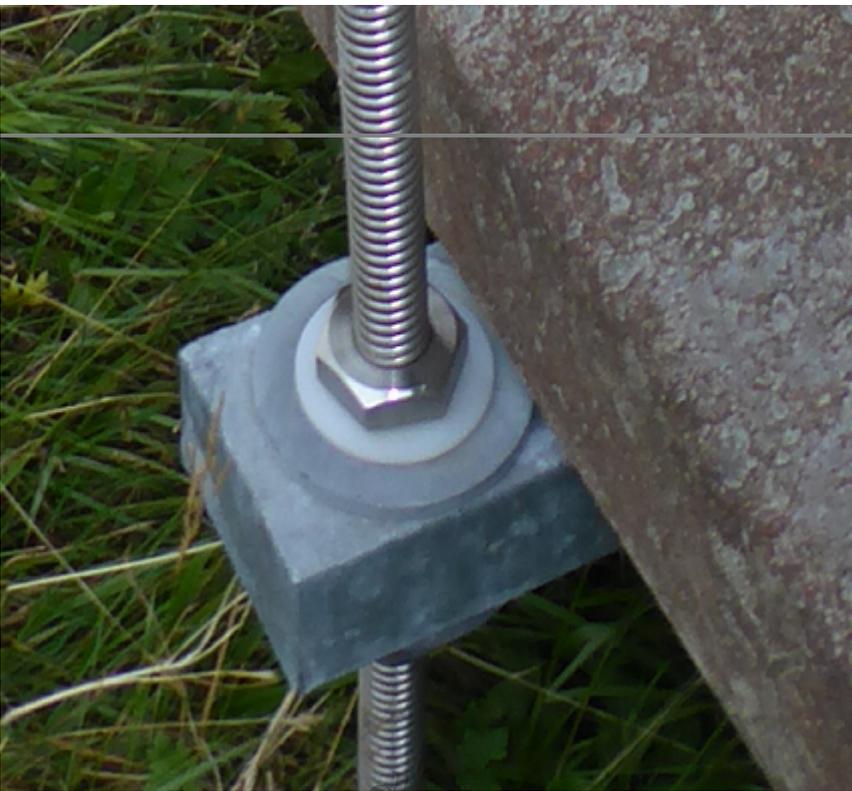
The upper nut is only being used to hold

the studding in place on the bracket while assembly is taking place so being smaller makes sense but it further illustrates the complexity of the fitting process. It is not possible to determine from the photo what has been used below although it should be two tapered and two flat washers.

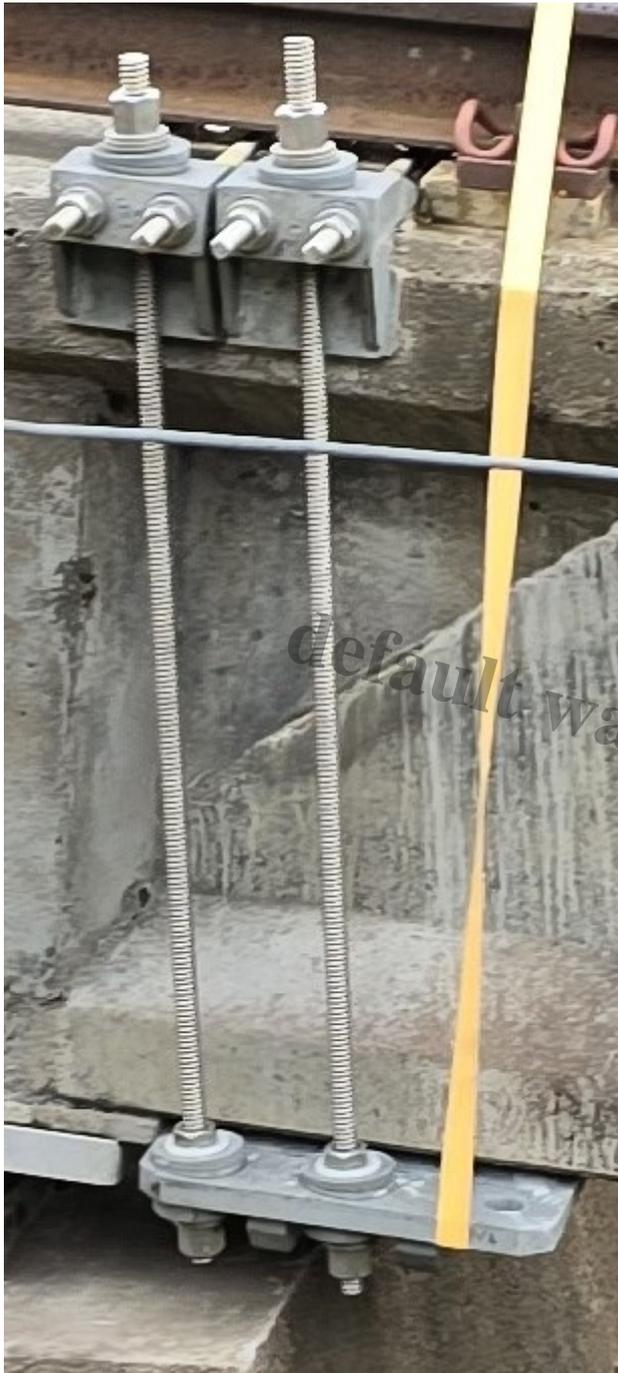
Photo taken on 04/10/2024 after the funicular had been closed for further repairs

The top two stainless washers are not fitted to protect the bush flange and there are **TWO** tapered washers! If that was the finished job BEFORE the funicular re-opened in February 2025 then how long before it all goes wrong again? The workmanship is shocking.
