Safety and the closure of the funicular at Cairn Gorm in August 2023 (3)

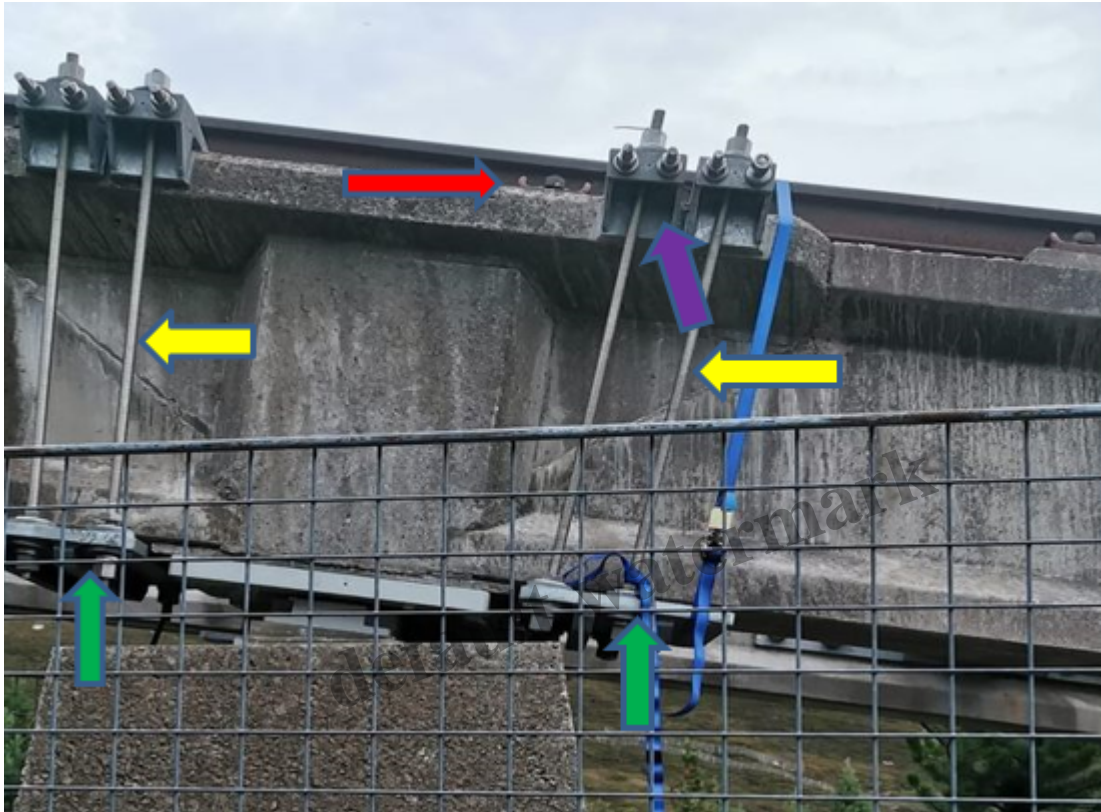
The red arrow points to a rail fixing, the two yellows to the “studding” on the scarf joint brackets, the green arrows to the single lower plate and the purple to the two upper brackets

(1) Part of the answer lies in the photo above of the brackets around the insitu joints.

(a) The original design for the strengthening of the insitu joints was for FOUR “channel sections”, two at the top and two at the bottom. At some point this design was changed, as can be seen in the photo above, and not for the better. It only takes ONE nut to lose tension and the whole bracket becomes

unstable and ceases to do its job. It is also more awkward to tension all four lengths of studding to the same tension so, whoever changed the design, built in a fault which made it more likely for the repairs to fail!

(b) Because of the position of the rail fixing (red arrow above), the right hand bracket on the downhill side of the in situ joint has had to be fitted with both lengths of studding sloping to the right. It is difficult to be 100% certain if the studding on the left hand and uphill bracket is sloping to the left although it looks like it is. Both should have been fitted perpendicular to the in situ joint and beam for the tensioning to hold the whole structure together effectively.

The downhill bracket has been fitted by a team who apparently did not understand the strengthening regime and why the studding should have been perpendicular in relation to the in situ and the "I" beam. That begs the question where was the supervision and the quality control?

(c) What can't be seen from the top photo is that the single bottom plate, which replaced the original design of two brackets, has 3 pairs of holes for the studding, not just the two that are in use.

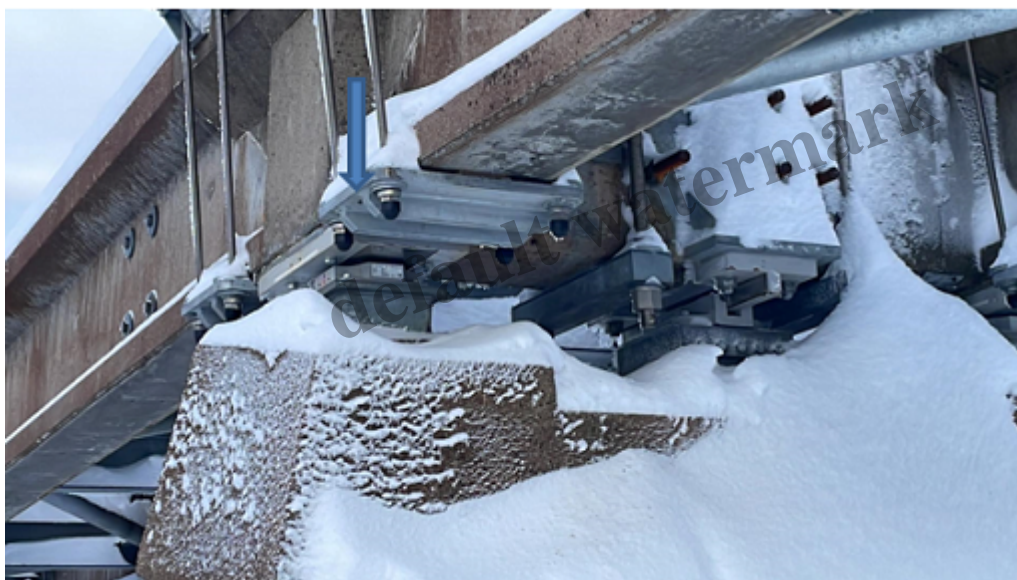
Photo courtesy of PW reader. The middle hole in the lower plate is just visible at the tip of the arrow. Photo credit PW reader 2022/23..

Had the studding been fitted to the middle and right hand holes it would then have been vertical and exerted the tensioning as intended. In this position the bracket could not have moved because it is butted up against the rail fitting on top and by the bearing plate at the bottom.

Contrast that with the sloping bracket(s) where vibration from the funicular may have shaken the bracket to the point where it slid down the "I" beam thereby reducing the tension that was so necessary for the bracket to do its job. That would explain the loose nuts that led to the funicular being closed again

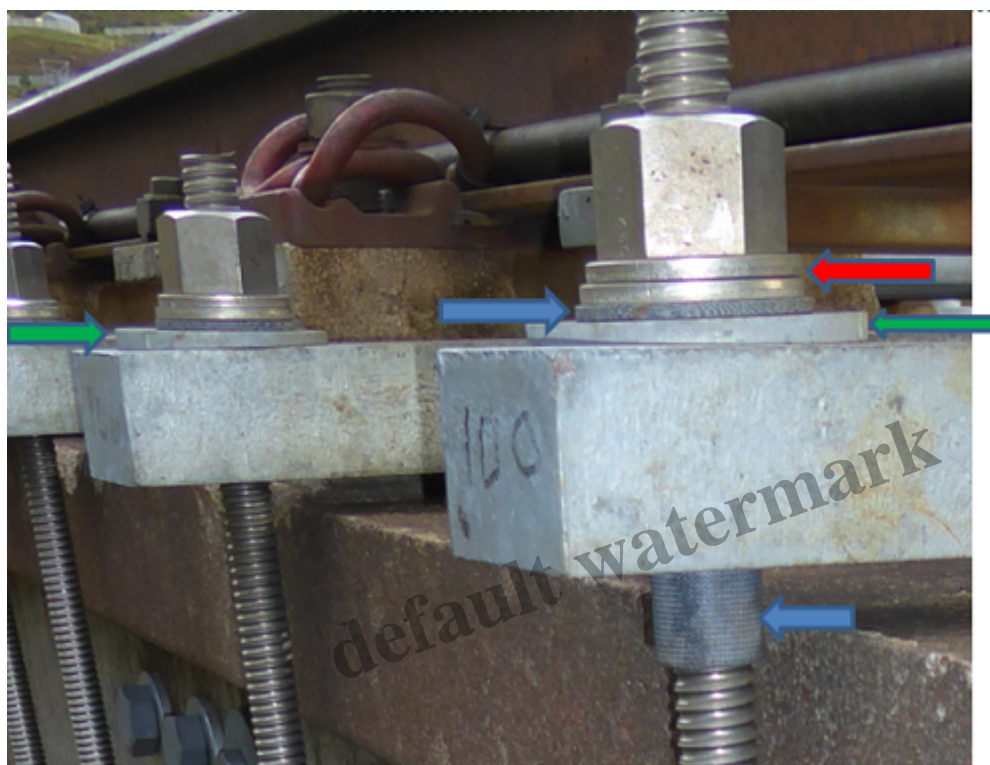
Beam strengthening bracket above pier 15. The blue arrows point to the bushing, the lower at the tube part of the bushing with the upper one at the flange. The red arrow points to TWO stainless steel washers . The two green arrows point to tapered washers.

This photo shows how the fixing of the brackets was all wrong. One of the two stainless steel washers (red arrow) should have been above the bushing flange and the other between the flange and the tapered washer so the **lower washer is in the wrong place!** Moreover both tapered washers should face in the same direction but they don't (it's the tapered washer on the left that has been fitted wrongly).

What is clear from this is that the metal brackets were fitted by someone people who didn't understand what they were supposed to be doing.

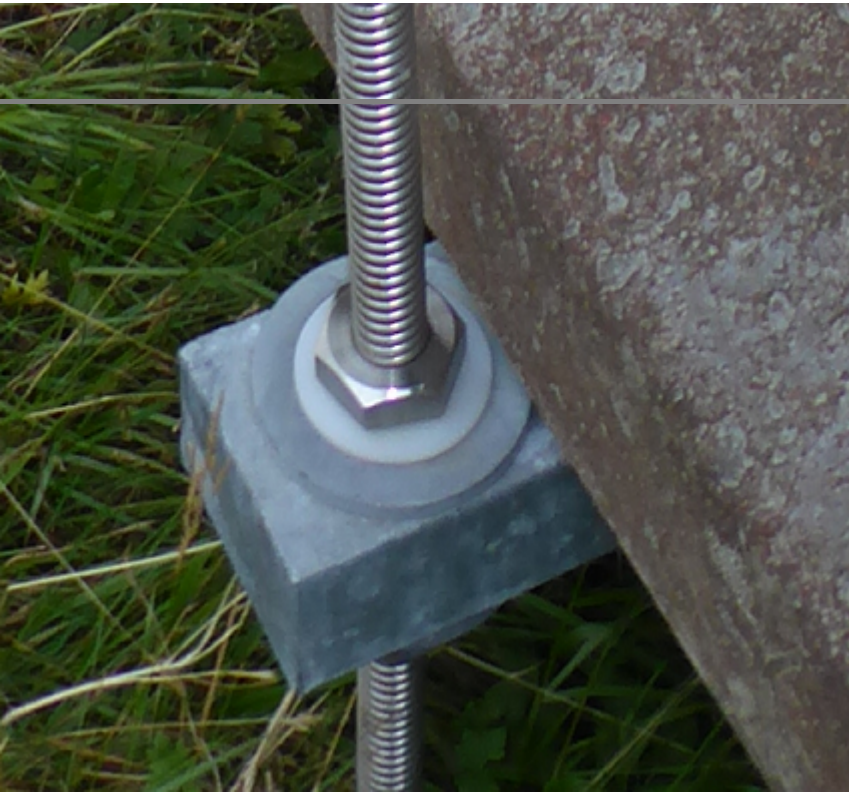
The upper nut is only being used to hold

the studding in place on the bracket while assembly is taking place so being smaller makes sense but it further illustrates the complexity of the fitting process. It is not possible to determine from the photo what has been used below although it should be two tapered and two flat washers.

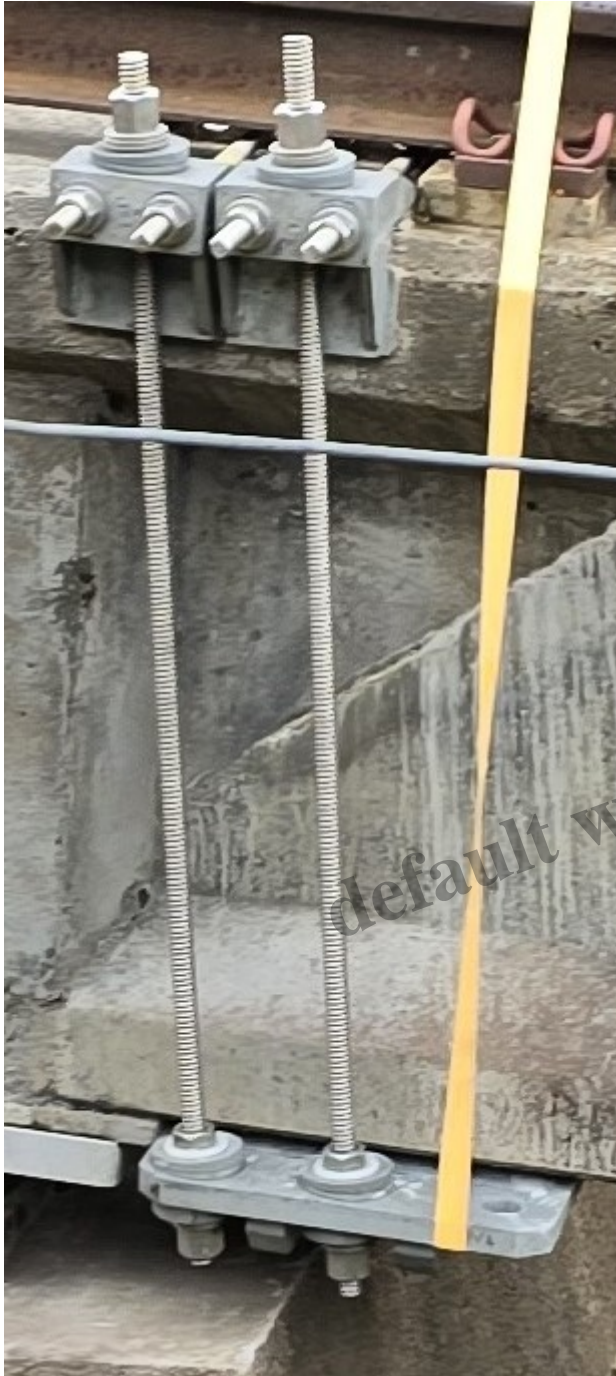
Photo taken on 04/10/2024 after the funicular had been closed for further repairs

The top two stainless washers are not fitted to protect the bush flange and there are **TWO** tapered washers! If that was the finished job BEFORE the funicular re-opened in February 2025 then how long before it all goes wrong again? The workmanship is shocking.
