Will the repairs to the Cairn Gorm funicular railway work (8)?

Description

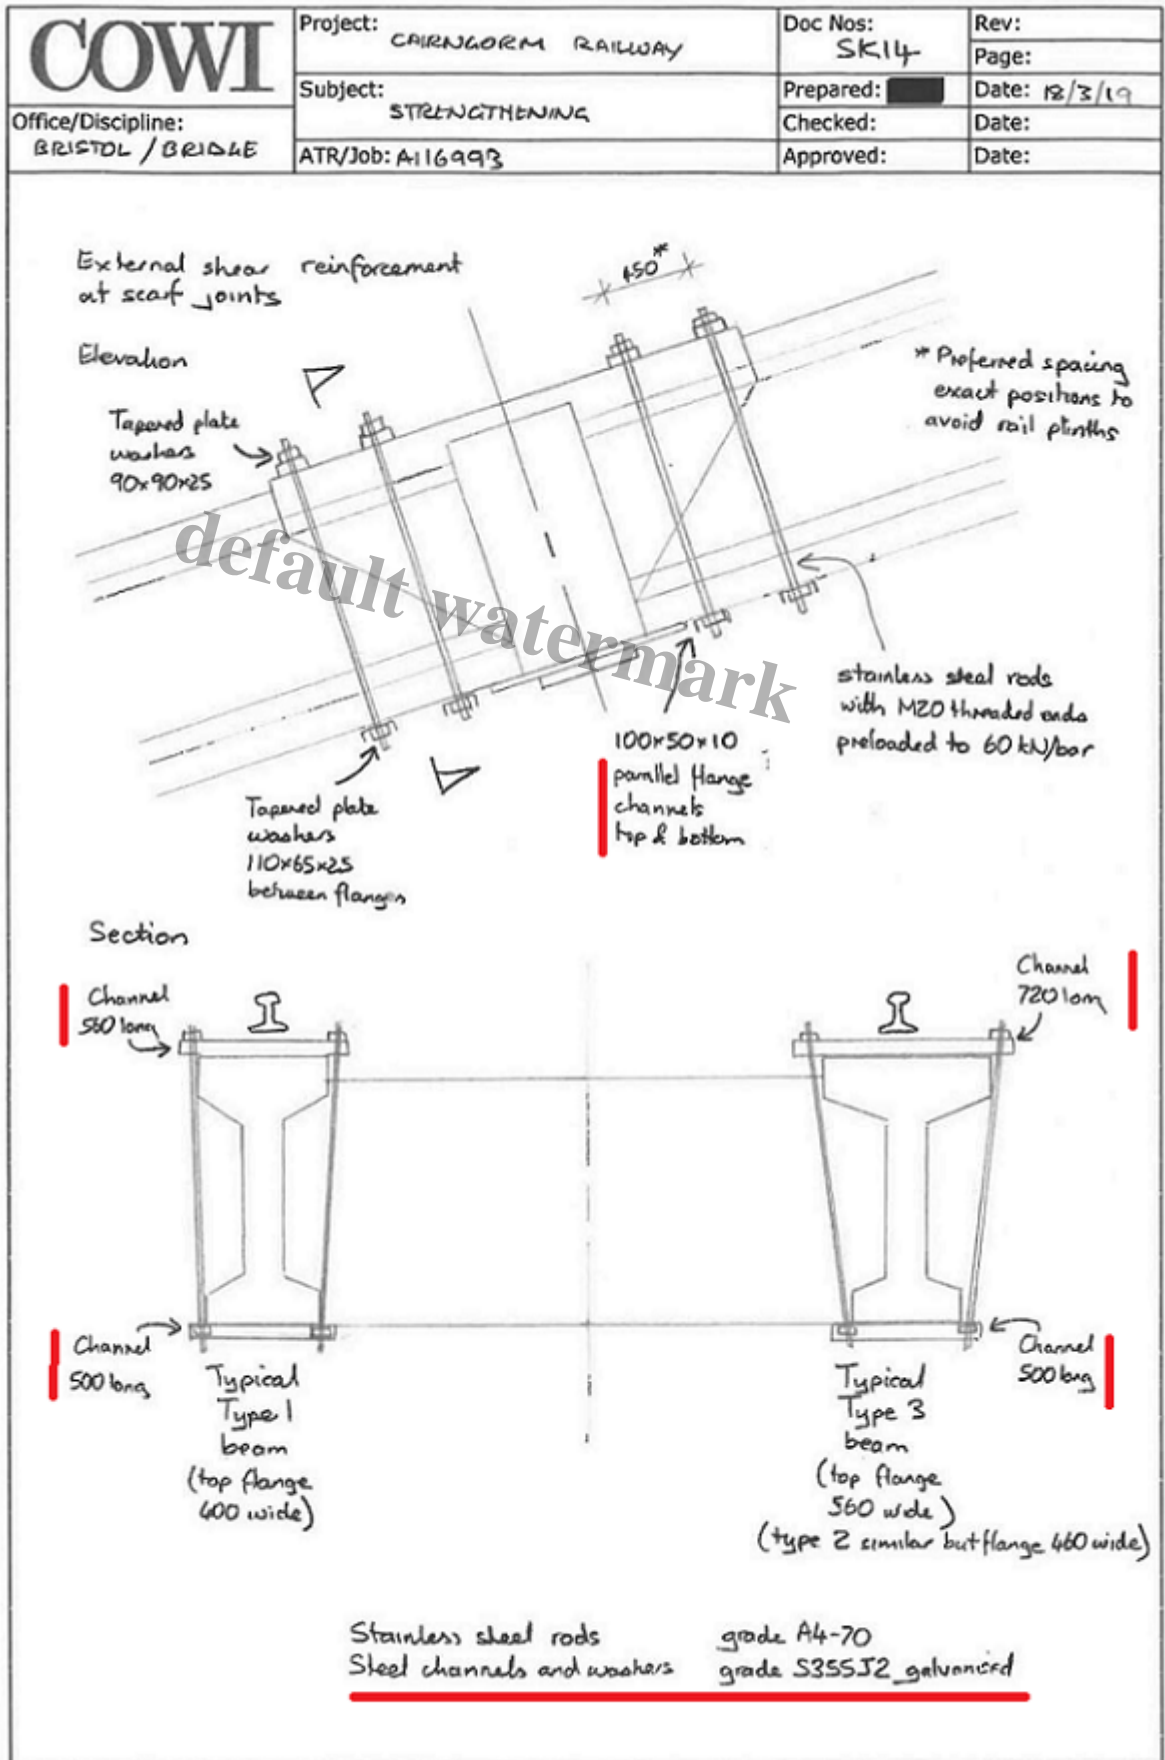
The COWI design on 18/03/ 2019 with top diagram showing 100x50x10 flange channels top & bottom and lower diagram showing different length channels for Type 1 and Type 3 beams

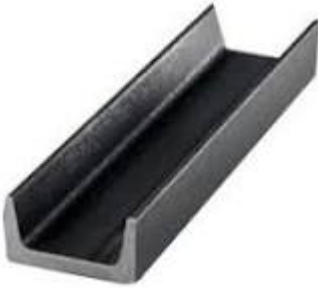
The picture is of 100mm x 50mm steel channel, one component of the brackets COWI originally designed for the repairs. Each end of the channel would be drilled to accept the studding with one length on top of the insitu joints/ beams and the other underneath. The widest part of the channel, 100mm, to sit against the concrete to spread the load as the studding is tensioned.

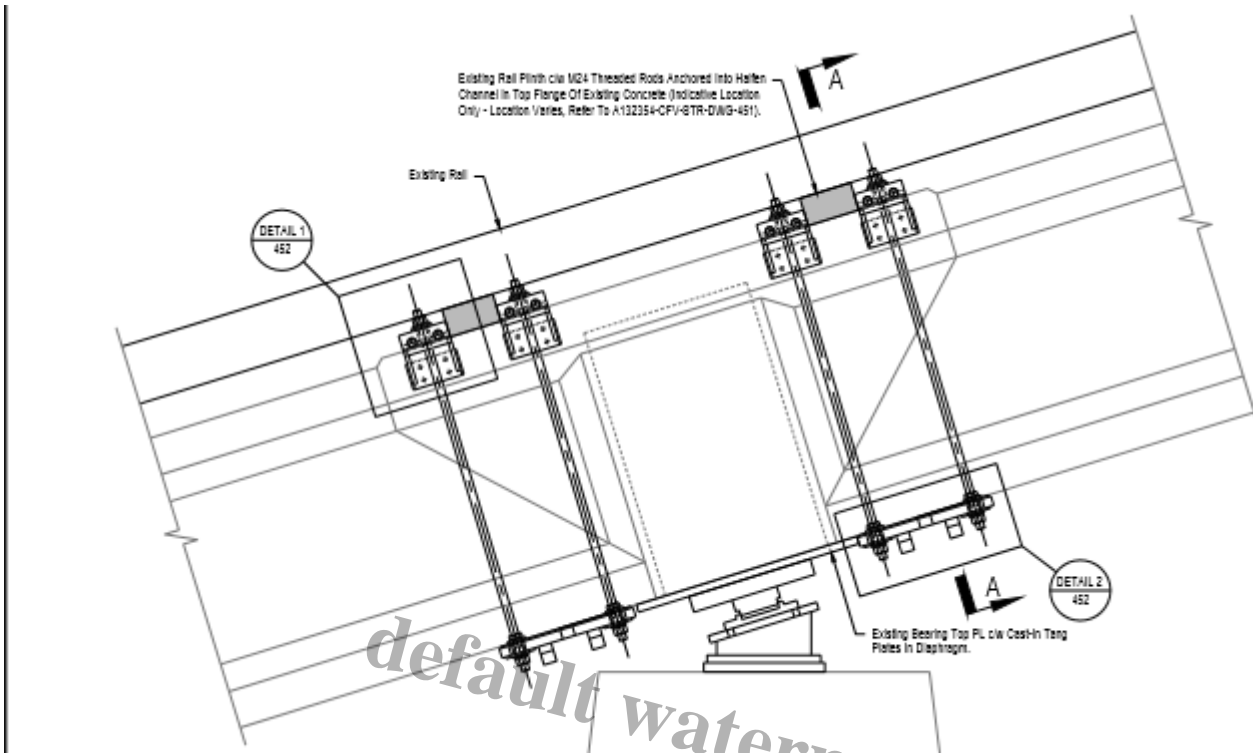
This shows metal plates instead of channel at the bottom of the in-situ joints and brackets at the top which are joined together across the beam by two further pieces of metal studding

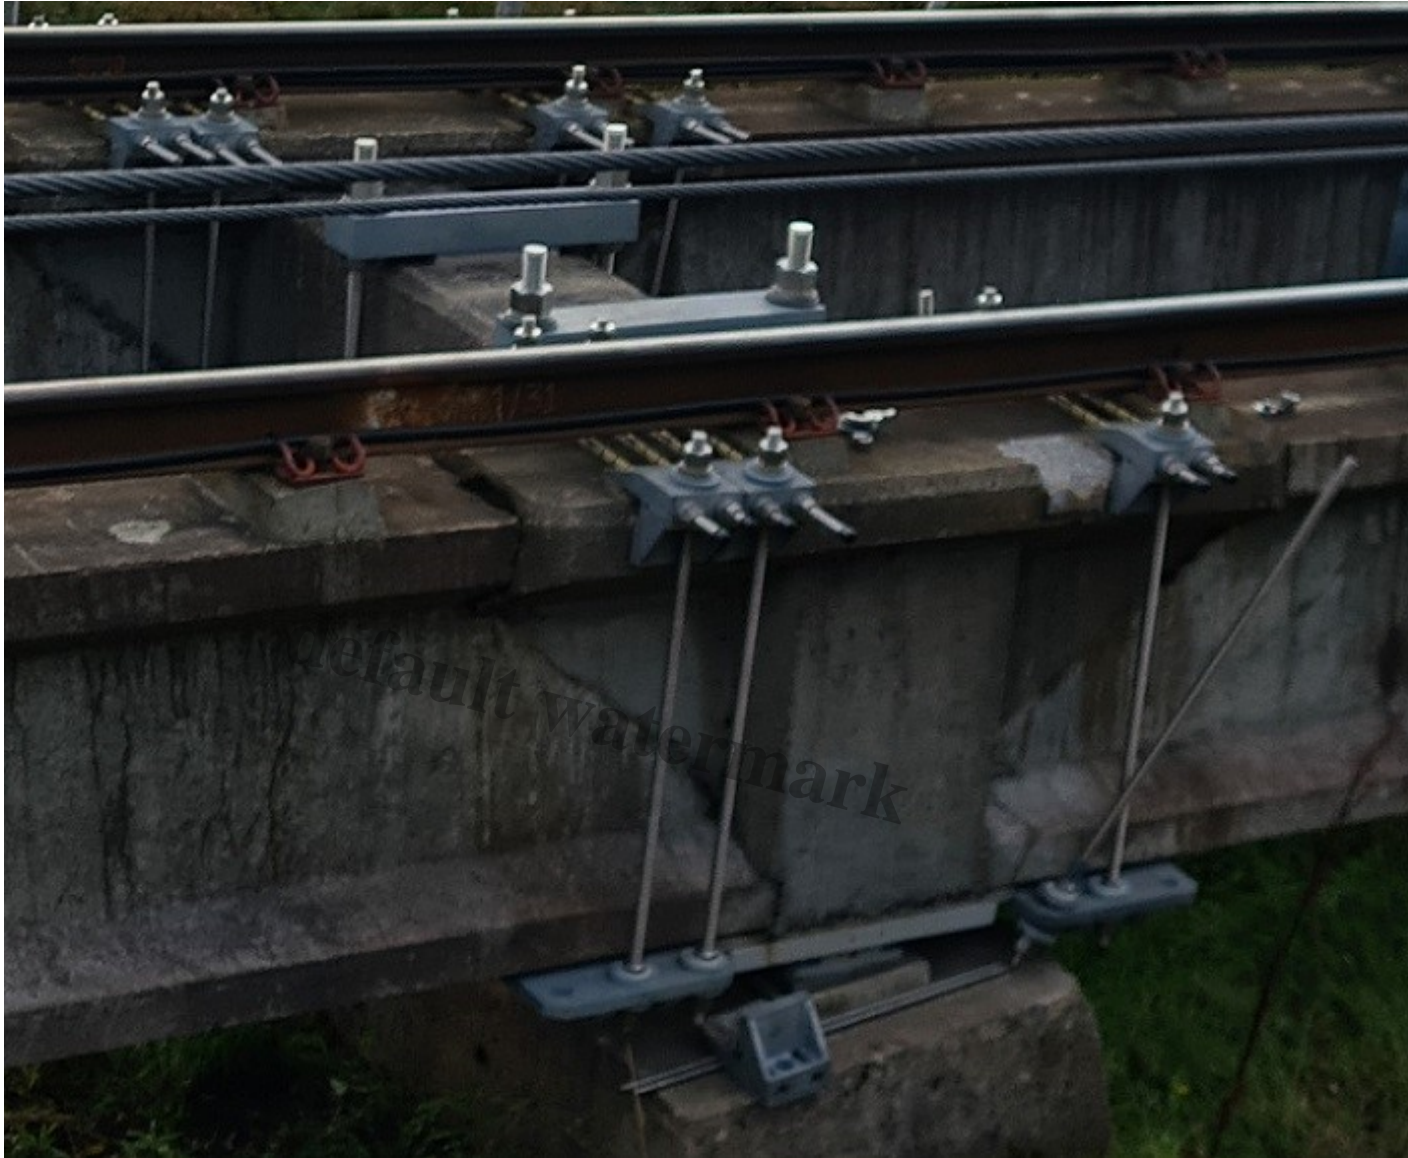
Photo showing the low clearance under the rails at the top of the insitu joints and how the brackets and steel plates all had to be joined together by metal studding.

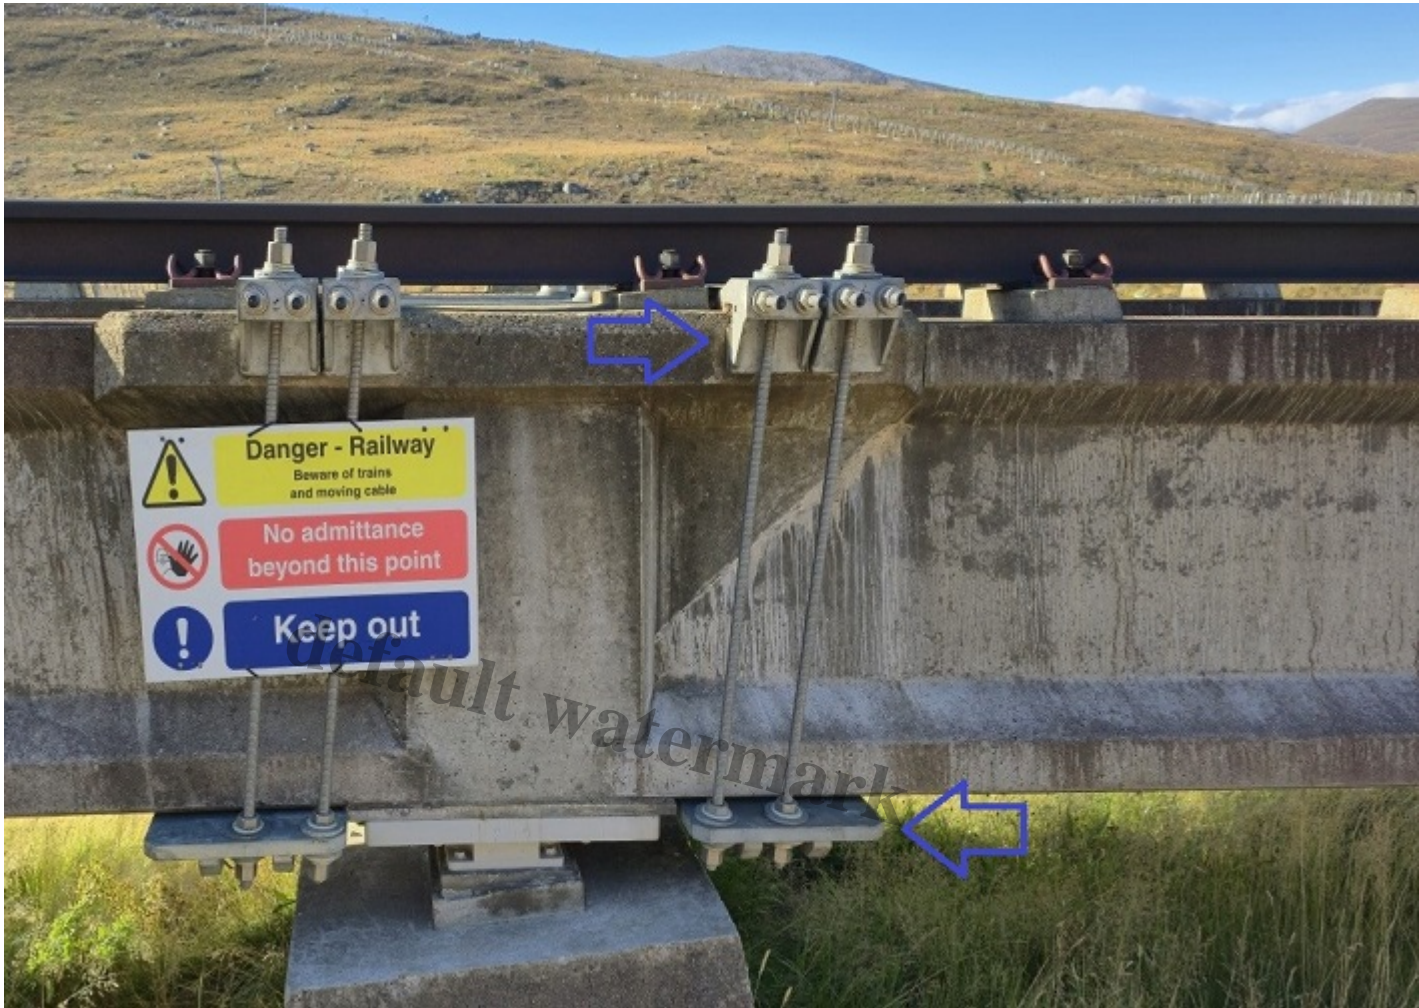
The four brackets (upper arrow shows two on the right of insitu joint with the rear part hidden on the inside of the track) and the bottom plates (lower arrow points to the one on the right) (Photo 1/228)

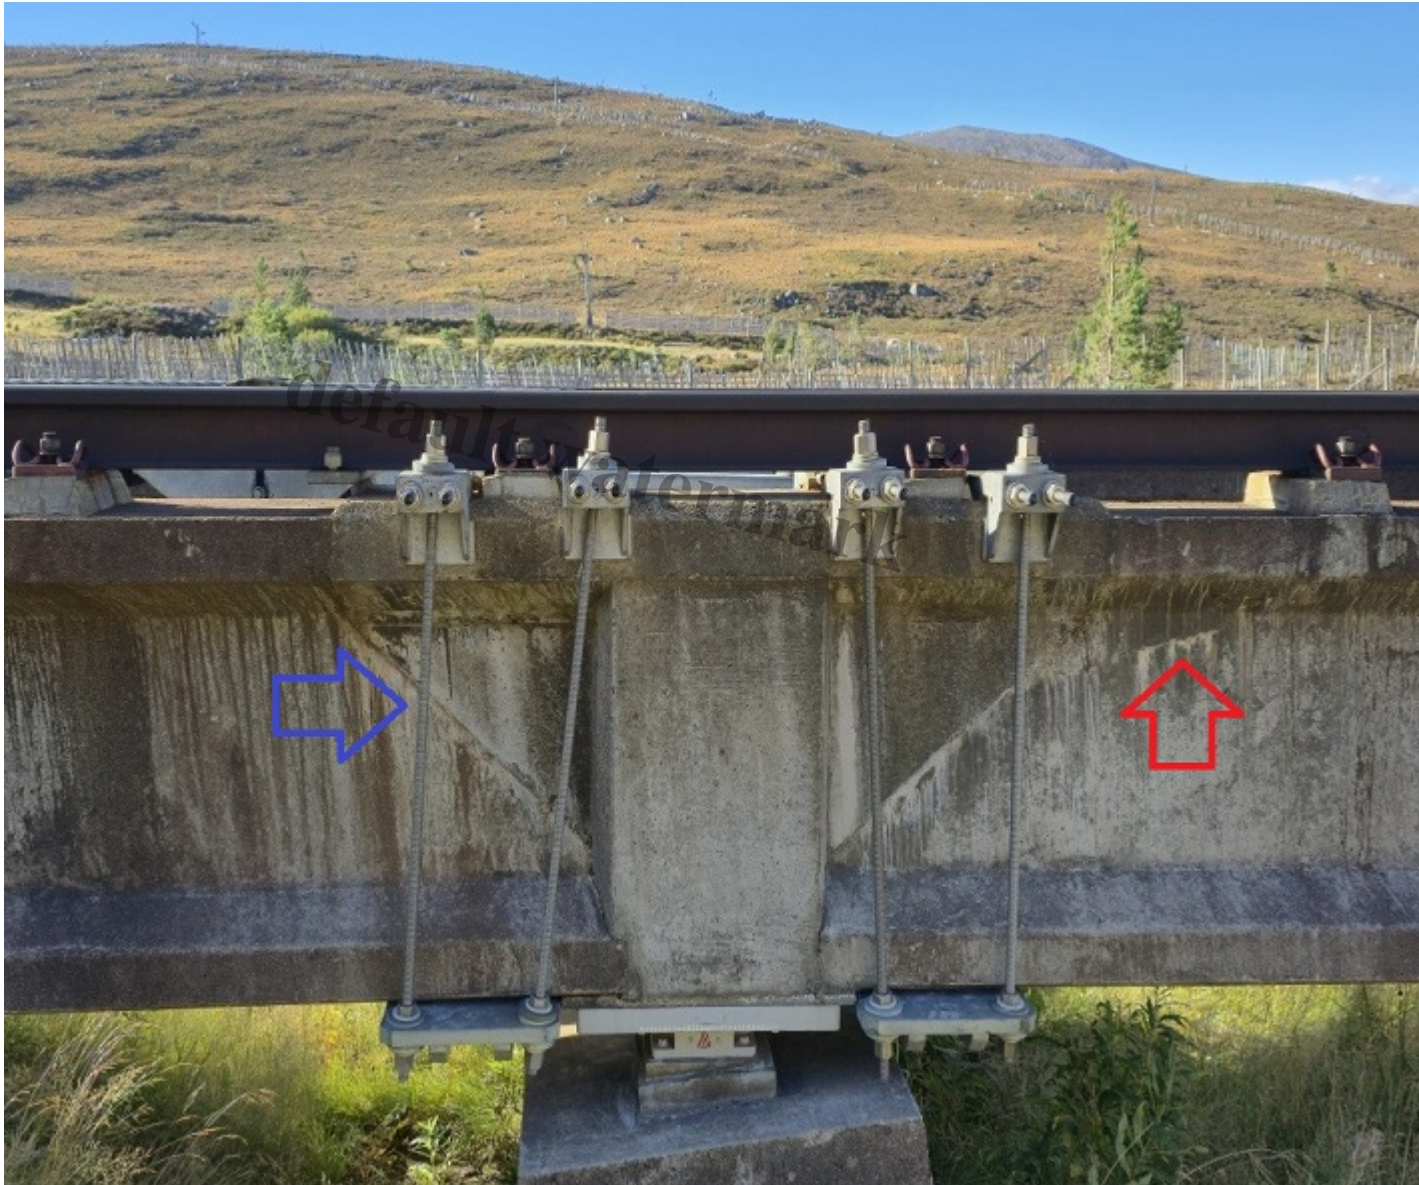
Seven. squads all working at once! What could possibly go wrong for quality control? There is however an even more significant quality control issue which I will come back to in post 9 in this series.

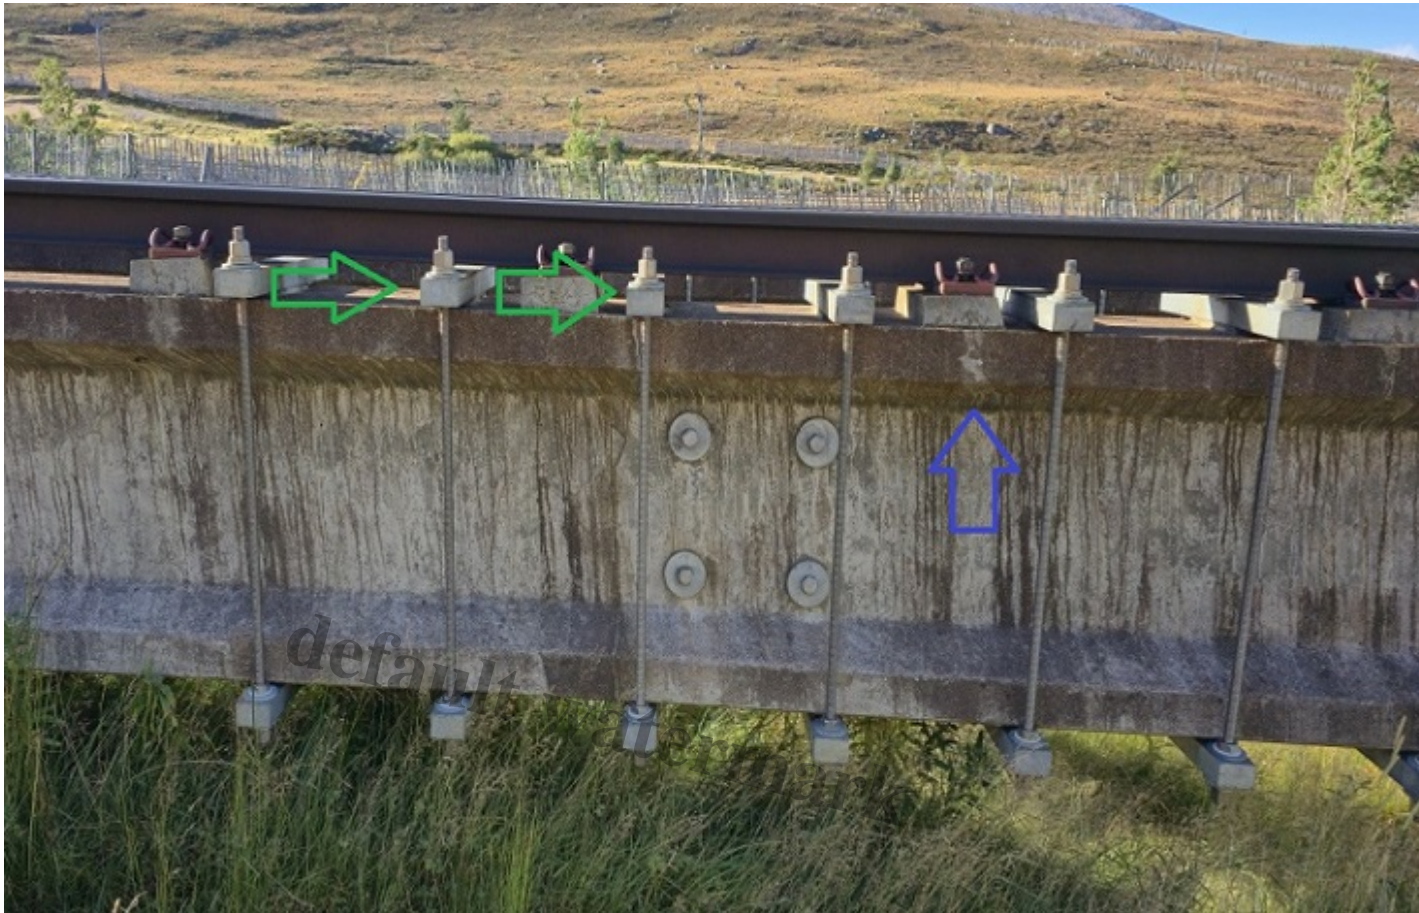
Although the studding does not appear perpendicular, this is probably due to camera distortion. Note there is at least one crack in the upper concrete flange (blue arrow).(Photo 3/449).

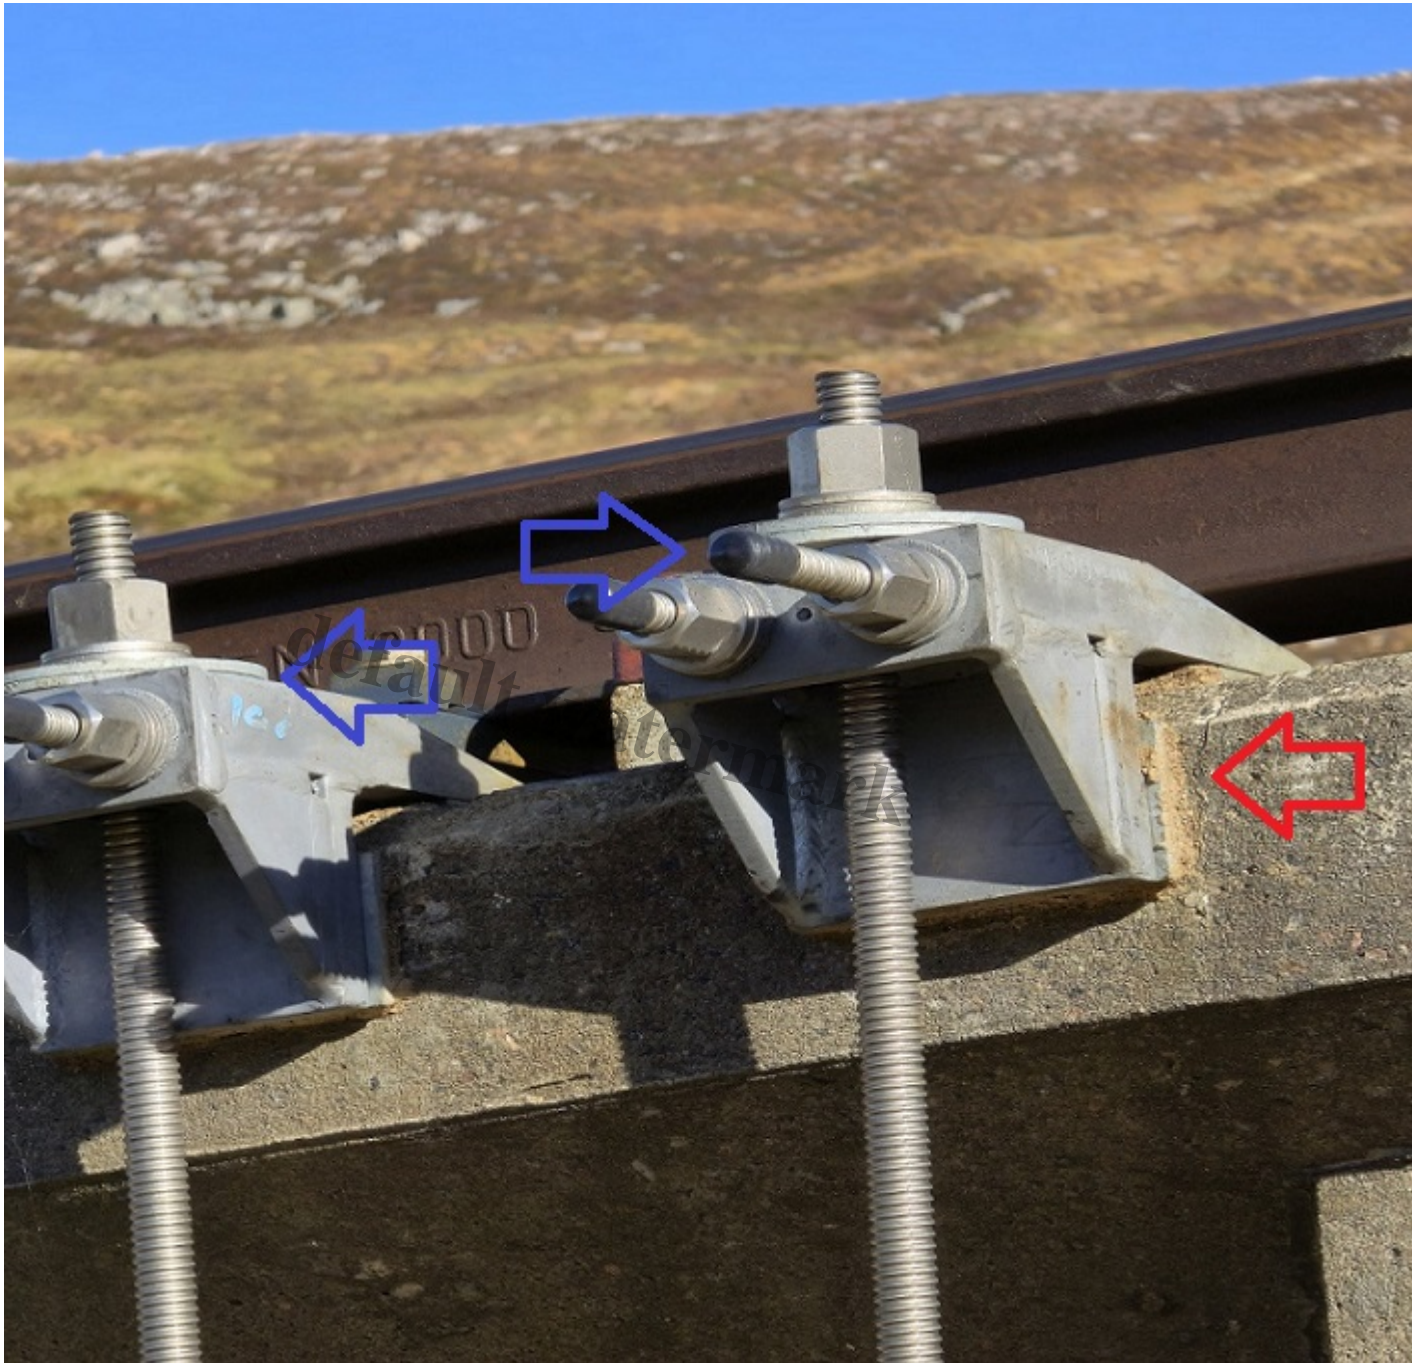
Besides too many washers there also appear to be a crack in the top flange, red arrow (Photo 4/706).

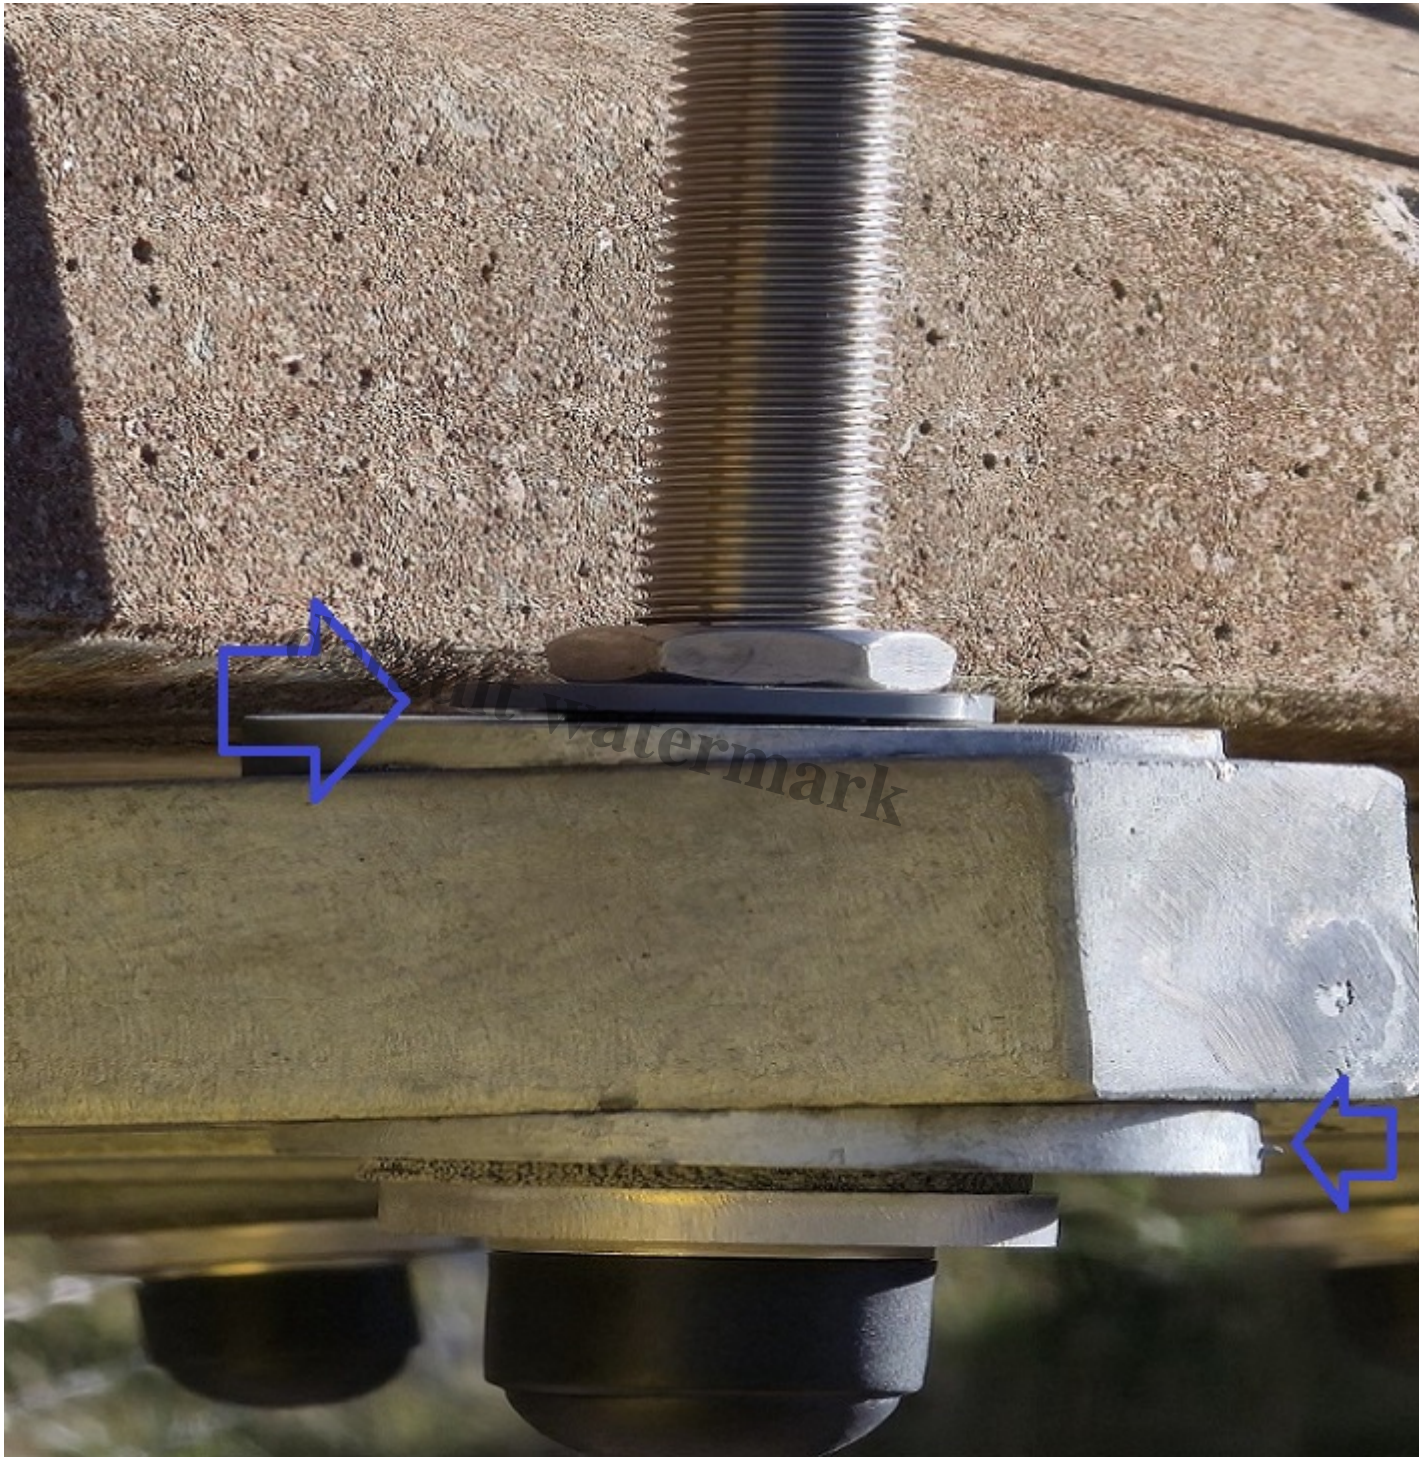
Bottom arrow shows tapered washer appears to be facing out, in the right direction (Photo 5/919)

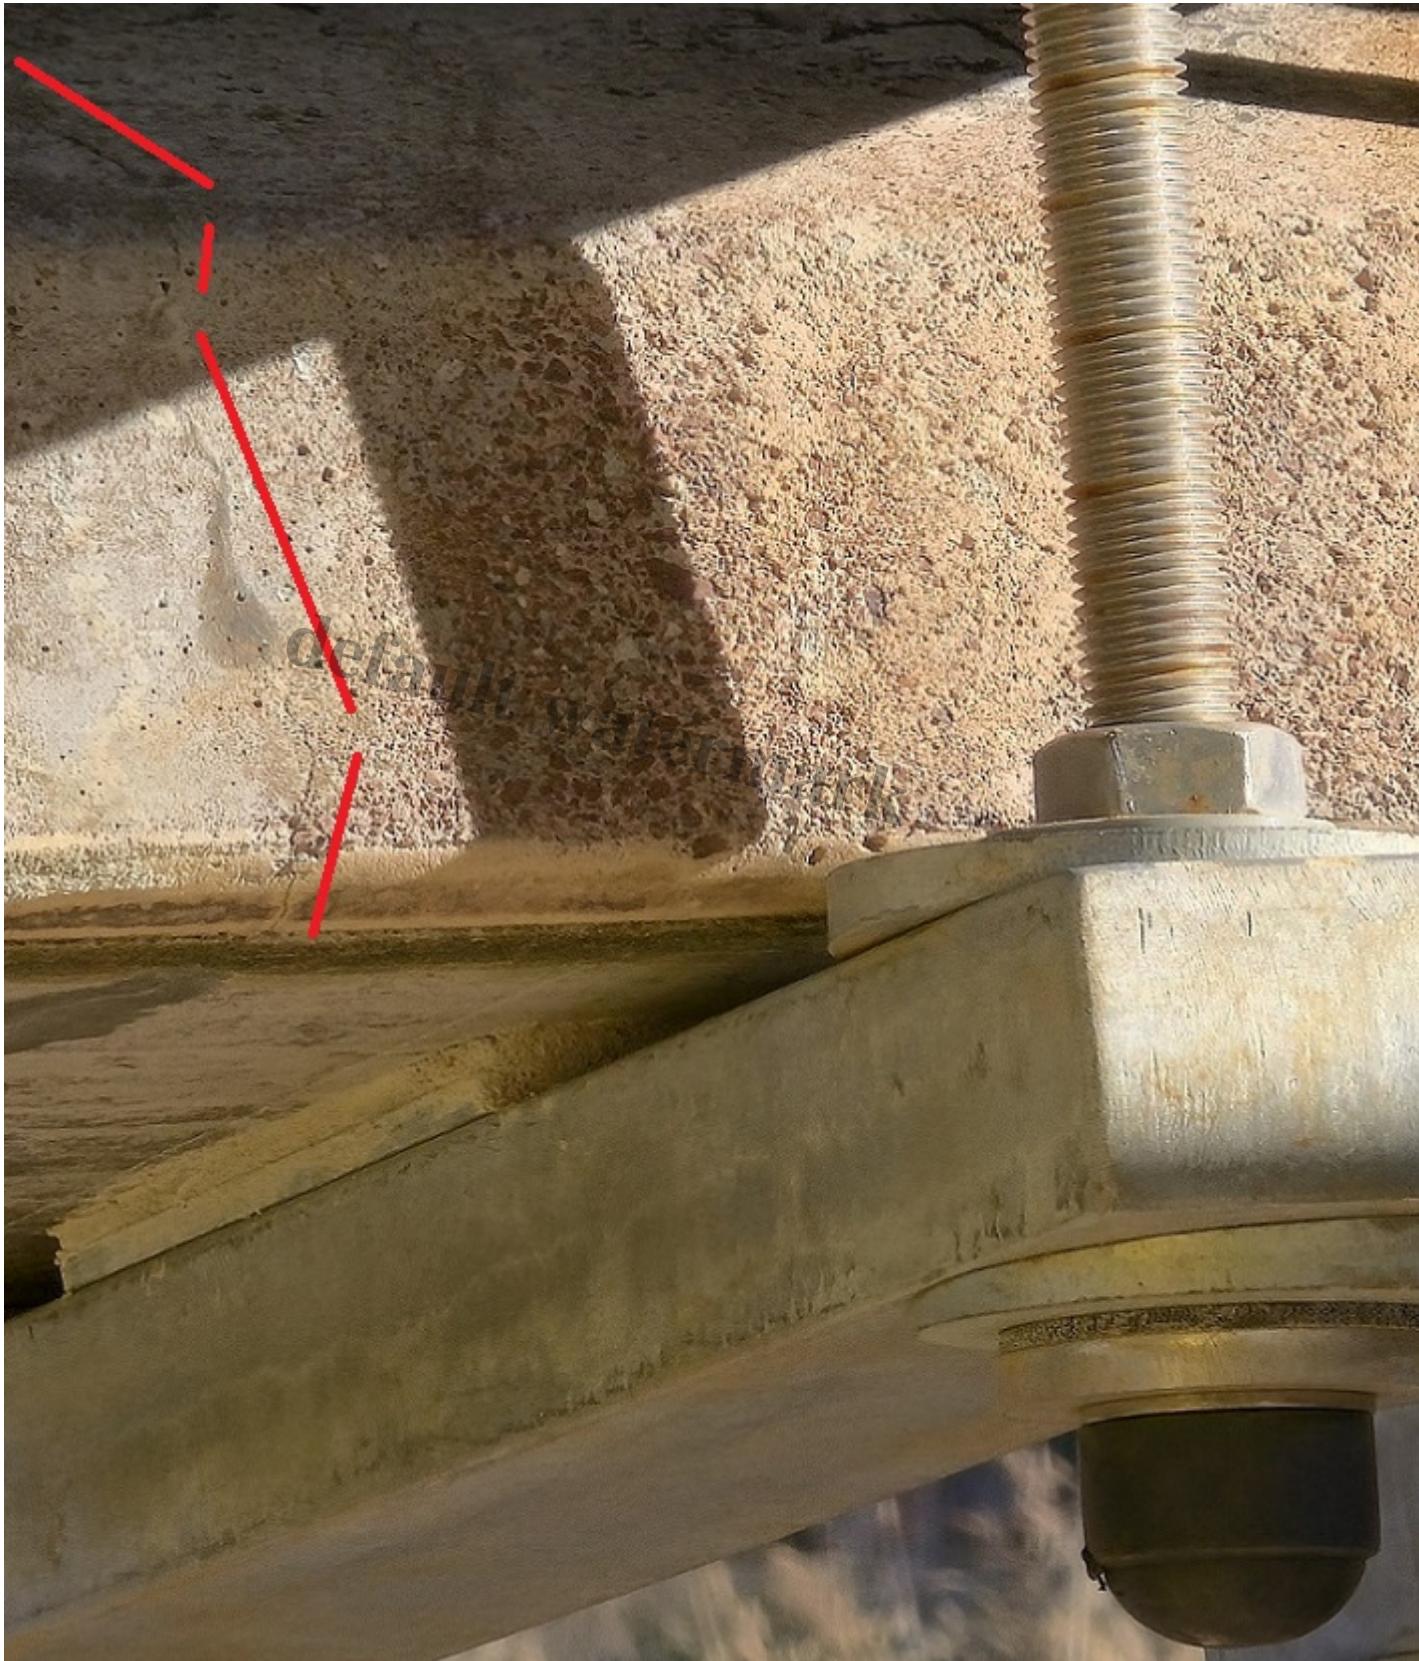
The red broken line highlights a crack from the underside of the beam up the bottom flange- although it is hard to see how far it then goes .(Photo 6/126)

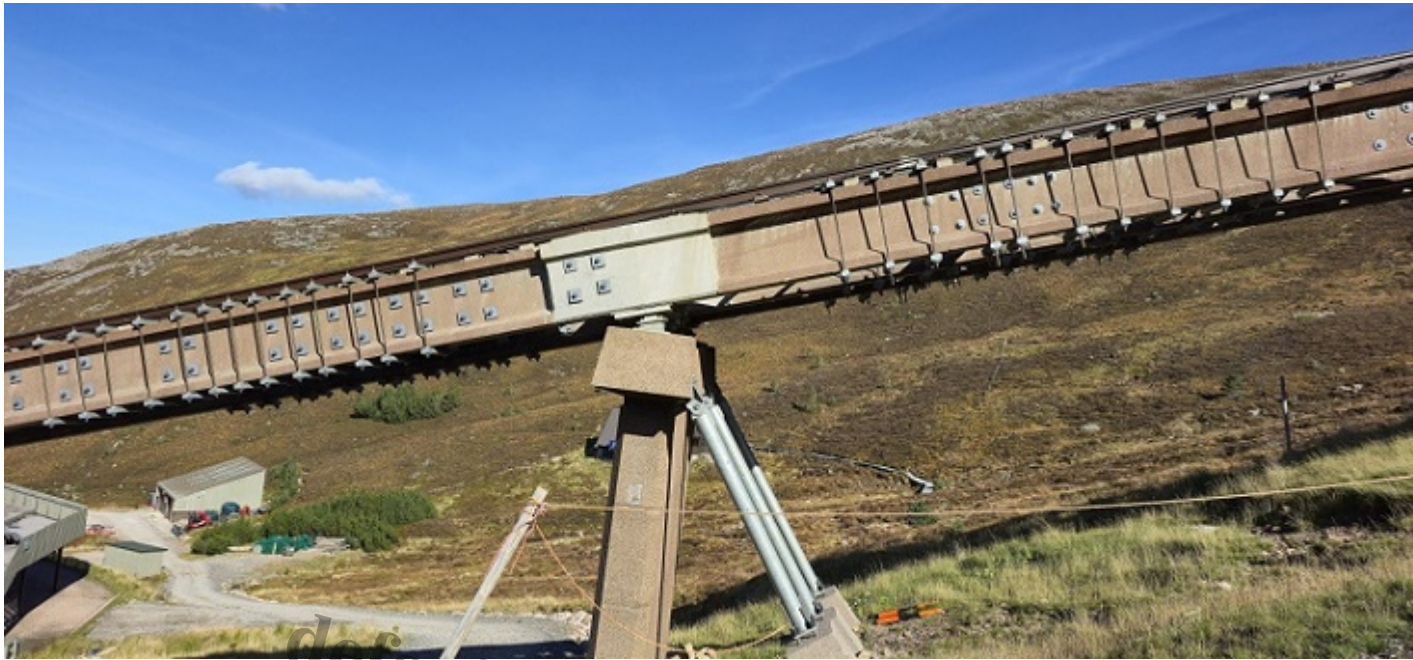
The next photo is of Pier 52 and the beams on either side:

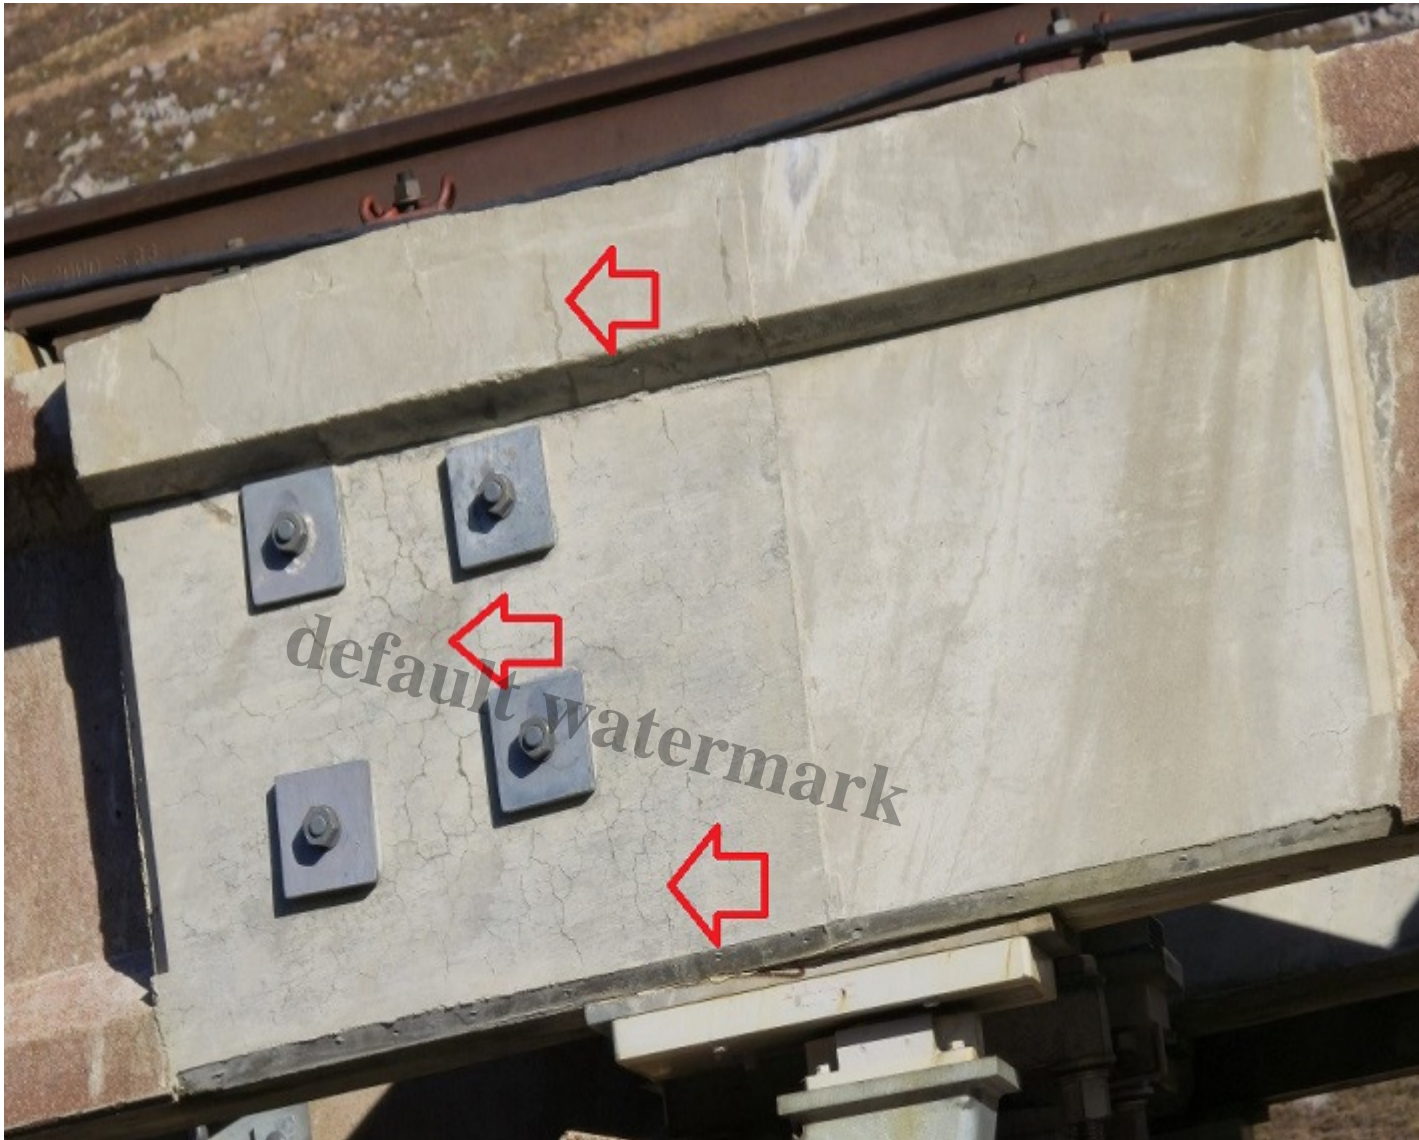
This is a picture of Pier 52 (Photo 7b/929).

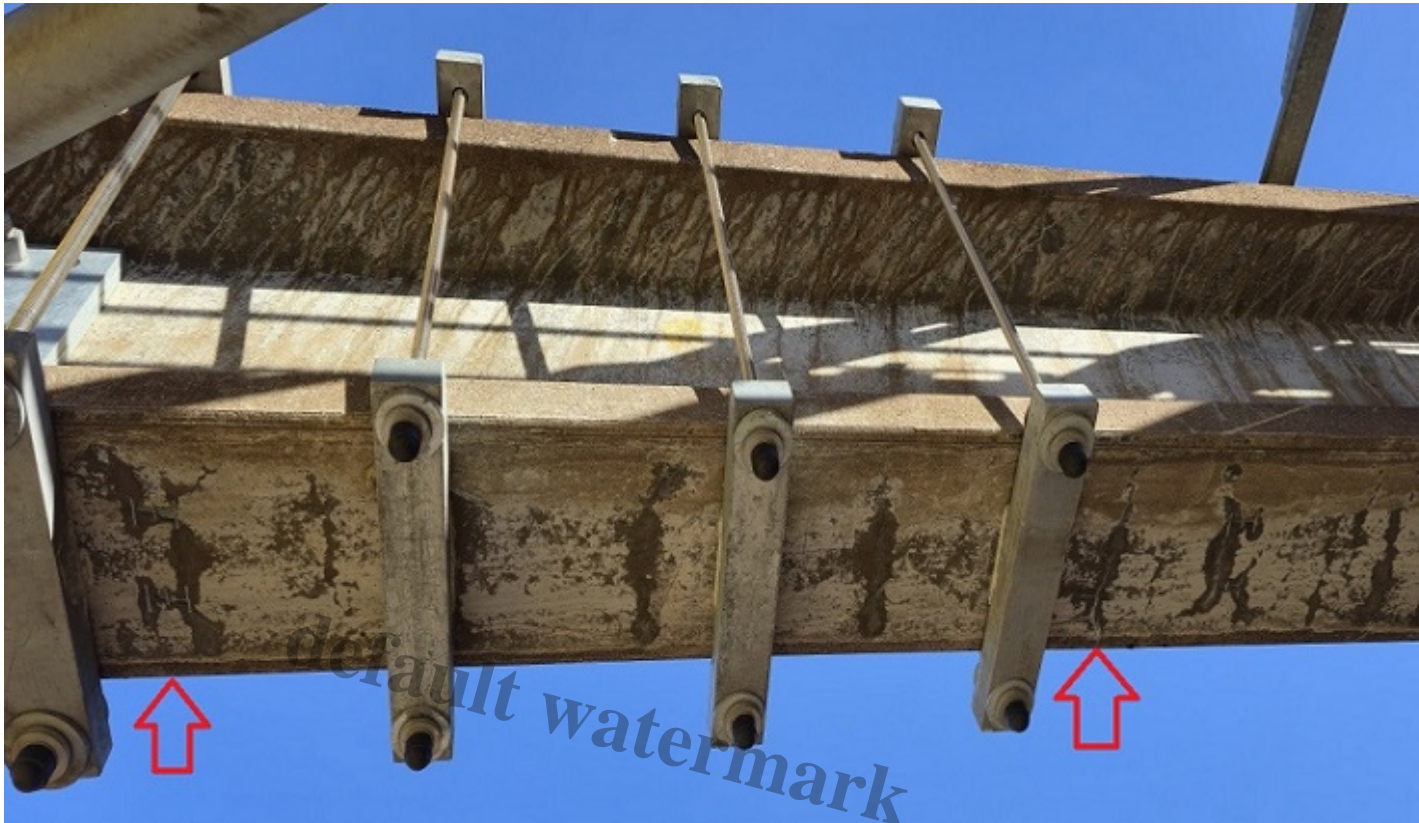
Left arrow shows exposed metal rebar, right a crack (Photo 8a/404)
