Will the repairs to the Cairn Gorm funicular railway work (9)?

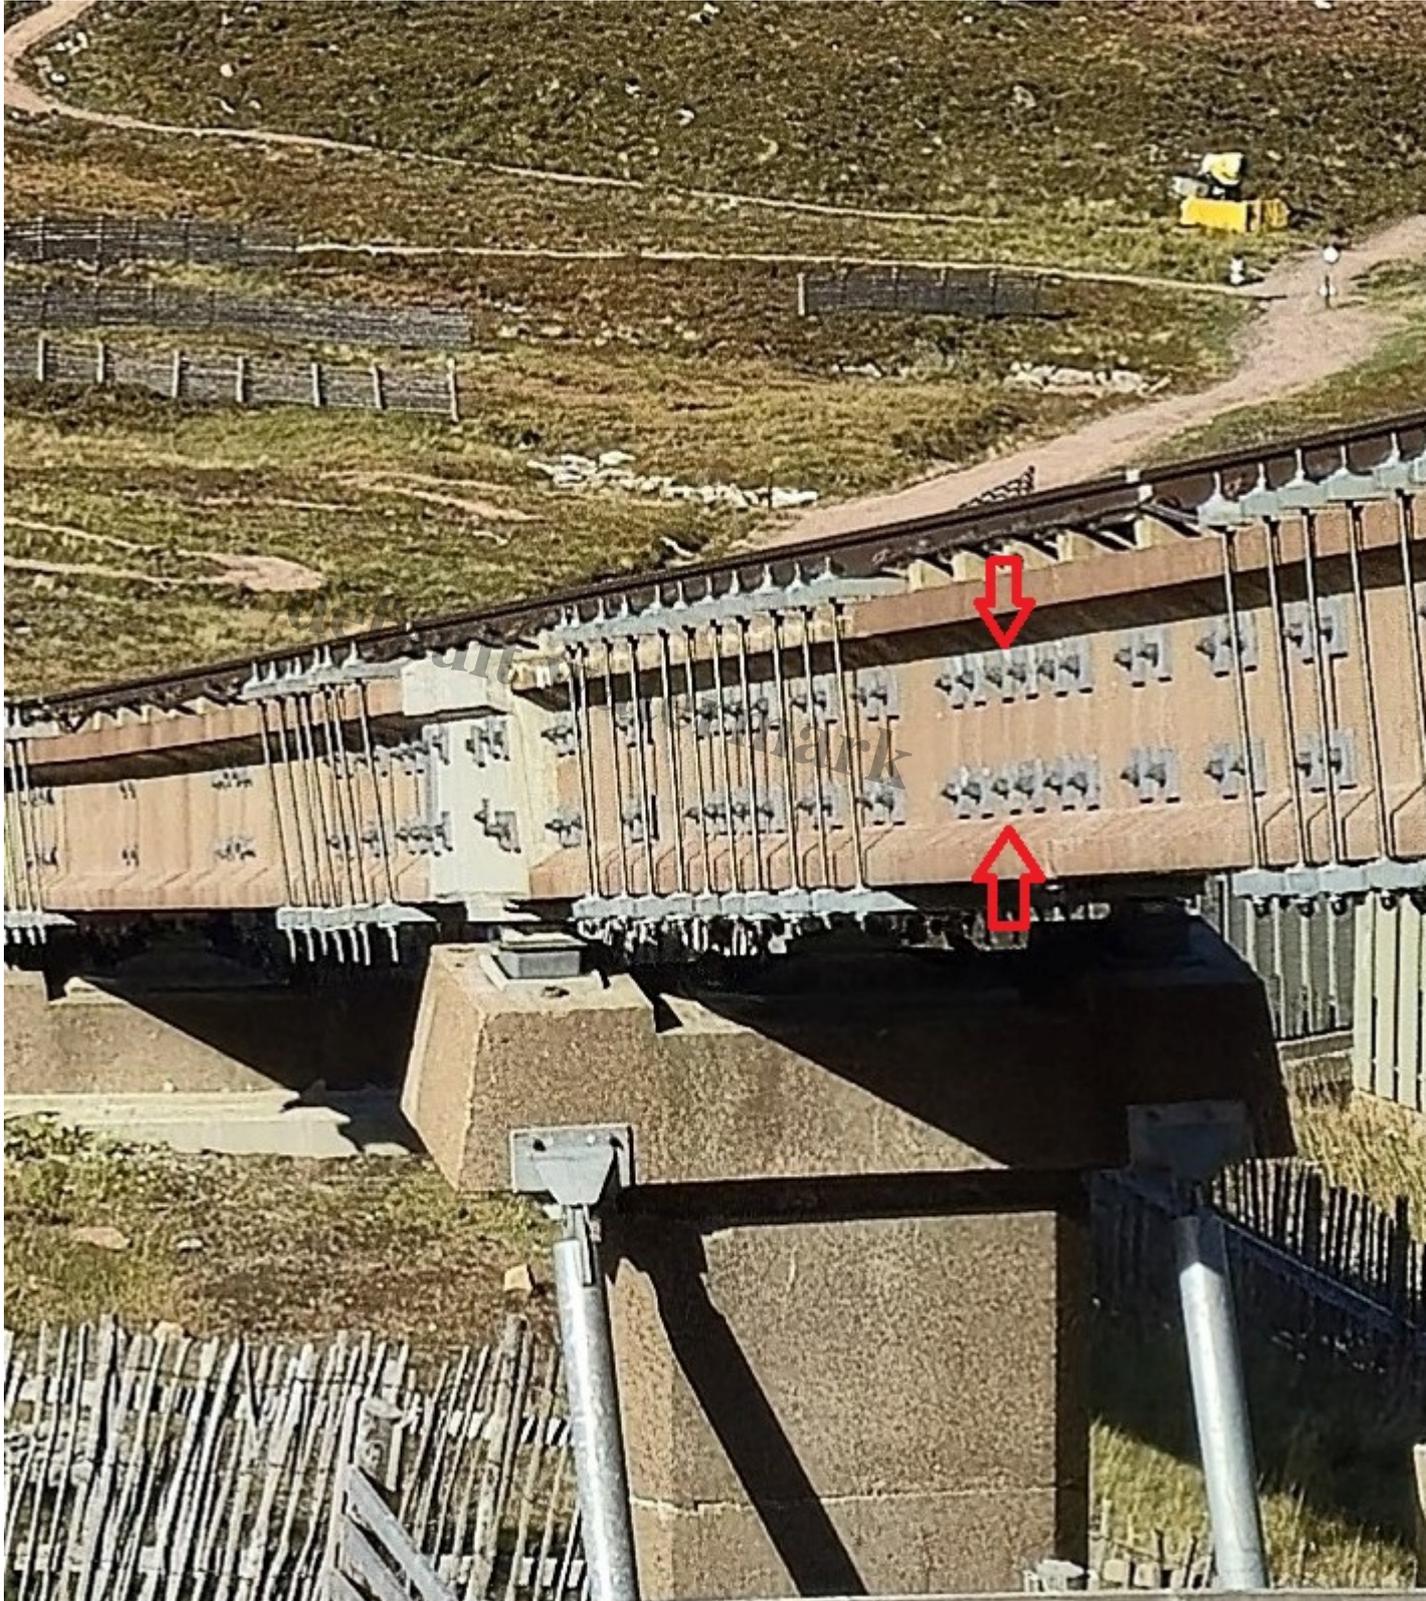
Pier 51 left, pier 52 right. The insitu joints which have been rebuilt are the new light concrete. Photo

This picture of two piers below the passing loop show just how bad things are. There are 47 brackets on the two beams between those piers and the two insitu joints have been rebuilt. The beam in the photo was found to be delaminating in 2017 and the calcite bleed can still be seen (to the left of the

top red arrow). Note also the rows of new plates (between the red arrows) on the upper beam compared to the one further down also indicating major strengthening between the two beams. The differing quality of repairs is also evidenced by the finish to the studding on the brackets. All the upper brackets just left of pier 52 are cut to length and capped, the ones either side of pier 51 left as fitted! No attempt to keep the job tidy.

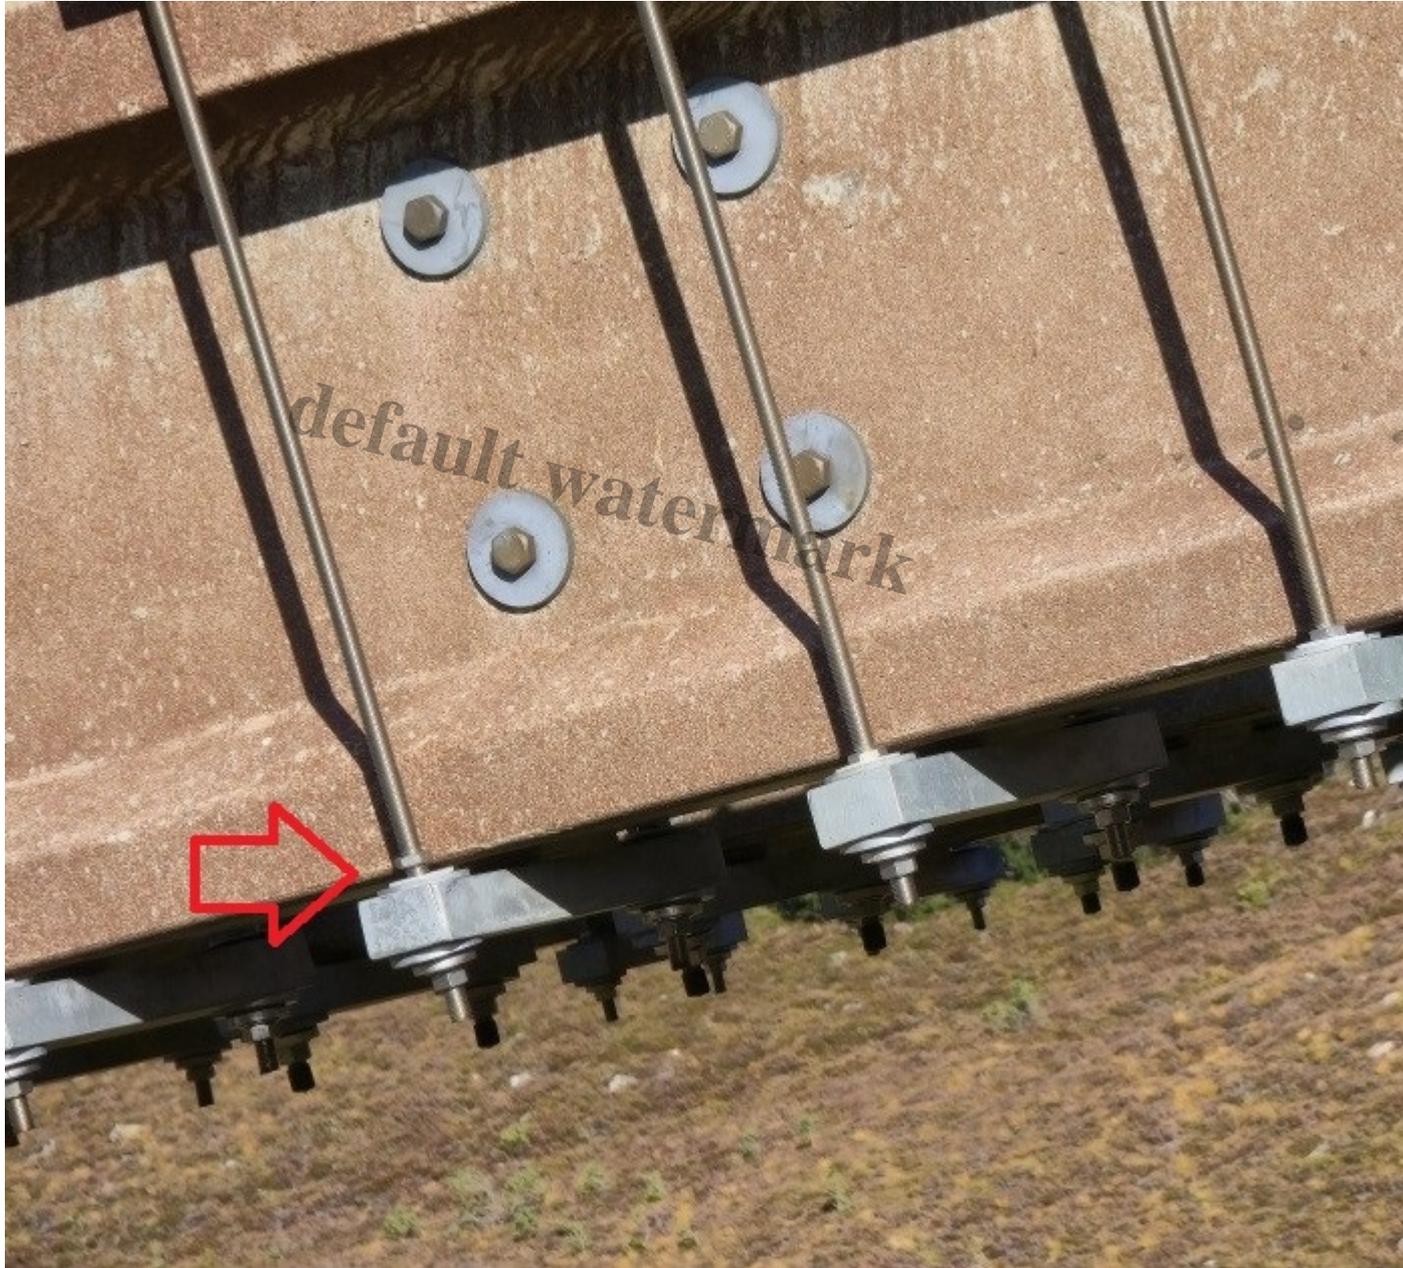
Another loose nut! This nut may not be doing anything, as explained in my last post ([see here](#)) but was first photographed on 13/07/2025.

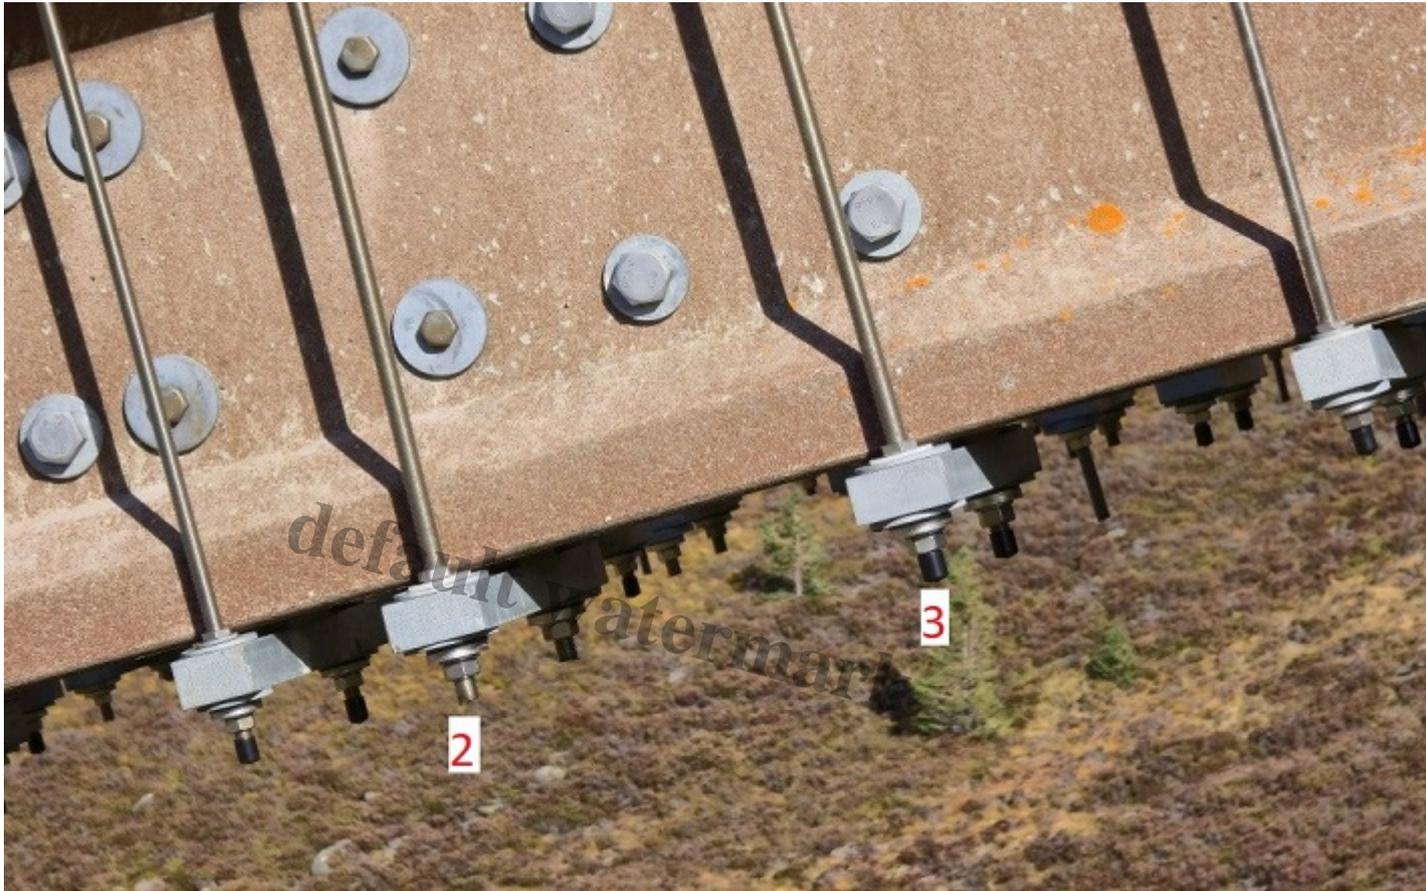
Note the missing black plastic cap by 2. Photo credit Gordon Bulloch (Ref 3/158)

This beam has different thicknesses of studding (the metal rods), most easily seen in the shadows, but the second and third metal bars are also bigger than the ones on either side and have large plastic washers above them. Does this require different levels of tensioning?

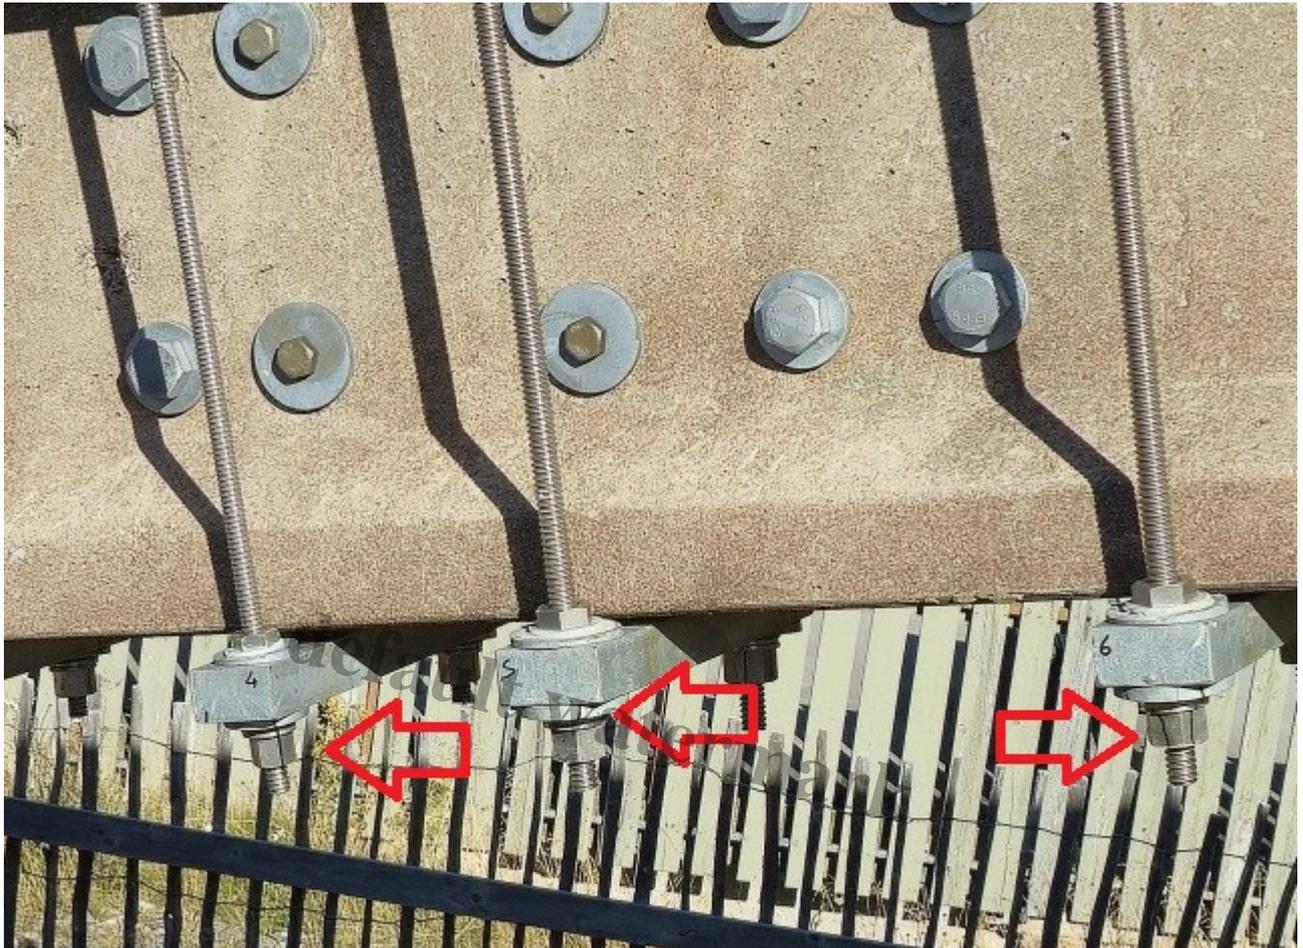
Again studding not capped but it would appear that someone has or is trying to simplify an inspection by putting a black line (strike marks) from the washer down to the nut. Why then wasn't every bracket marked like this? Did they run out of marker pens? There is an easier way to check the tension in all the brackets, a hammer commonly known in the vehicle trade as a "toffee" hammer or more nel pin or cross pein hammer.

Simply tapping any bolt, nut or length of studding will produce a sound. If the

tension is high it will be a high pitched noise, anything that is loose i.e. not under tension, will be just a dull thud, also all studding should make the same high pitched sound, but this is only a very basic test confirming tension in a length of studding. [If you have ever seen a guitar being tuned it is done one string at a time. Turning the tuning peg increases or decreases the pitch of the sound produced by a string. The tighter or greater the tension in the string the higher the pitch].

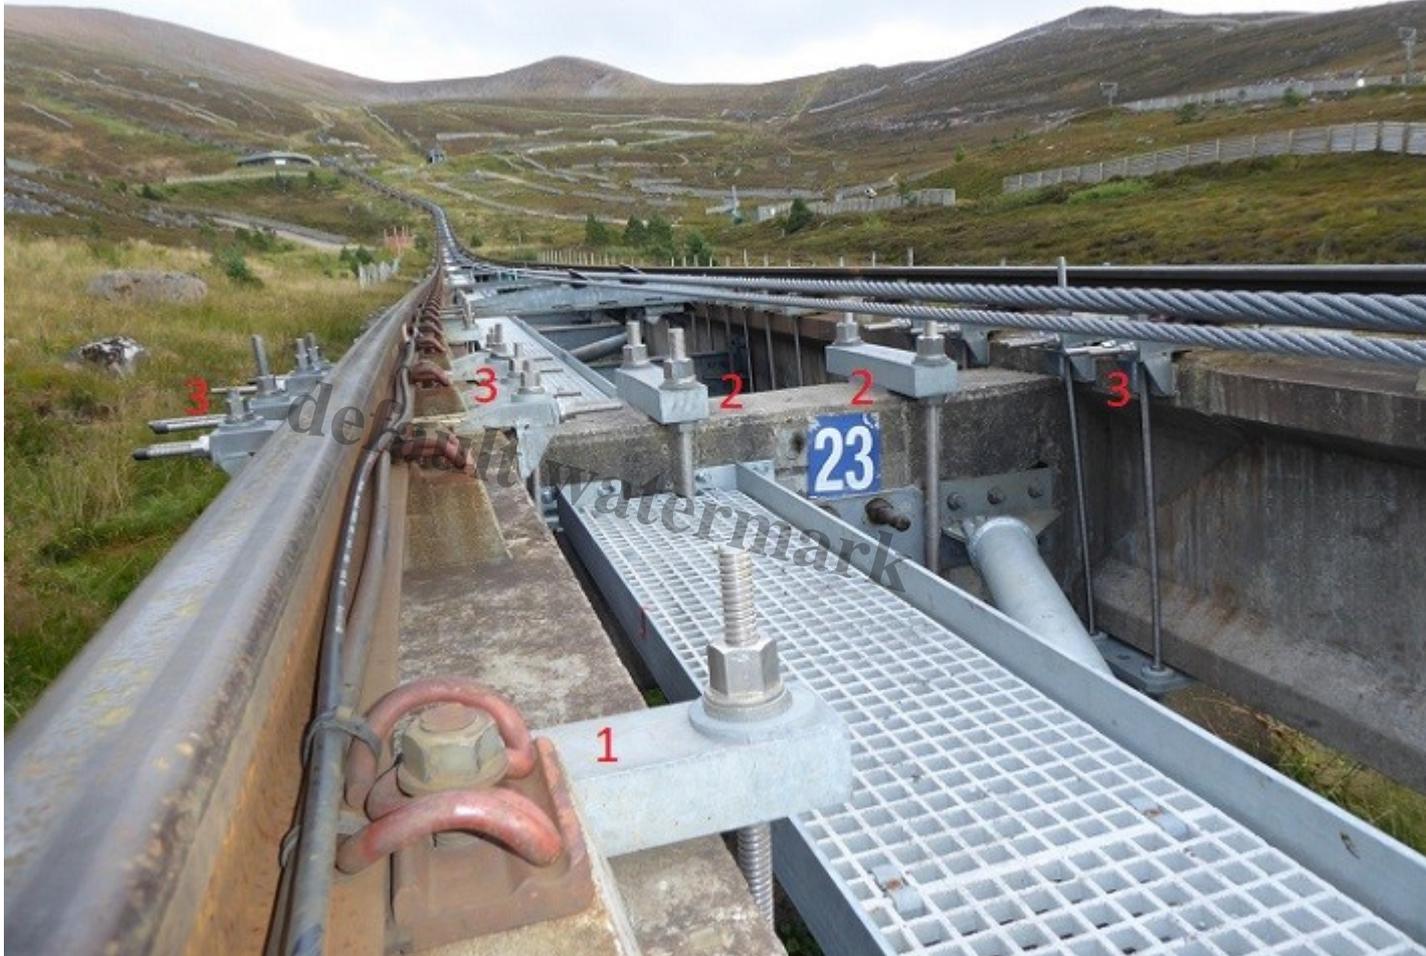
Photo showing Type 1, 2 and 3 brackets. Photo credit Gordon Bulloch

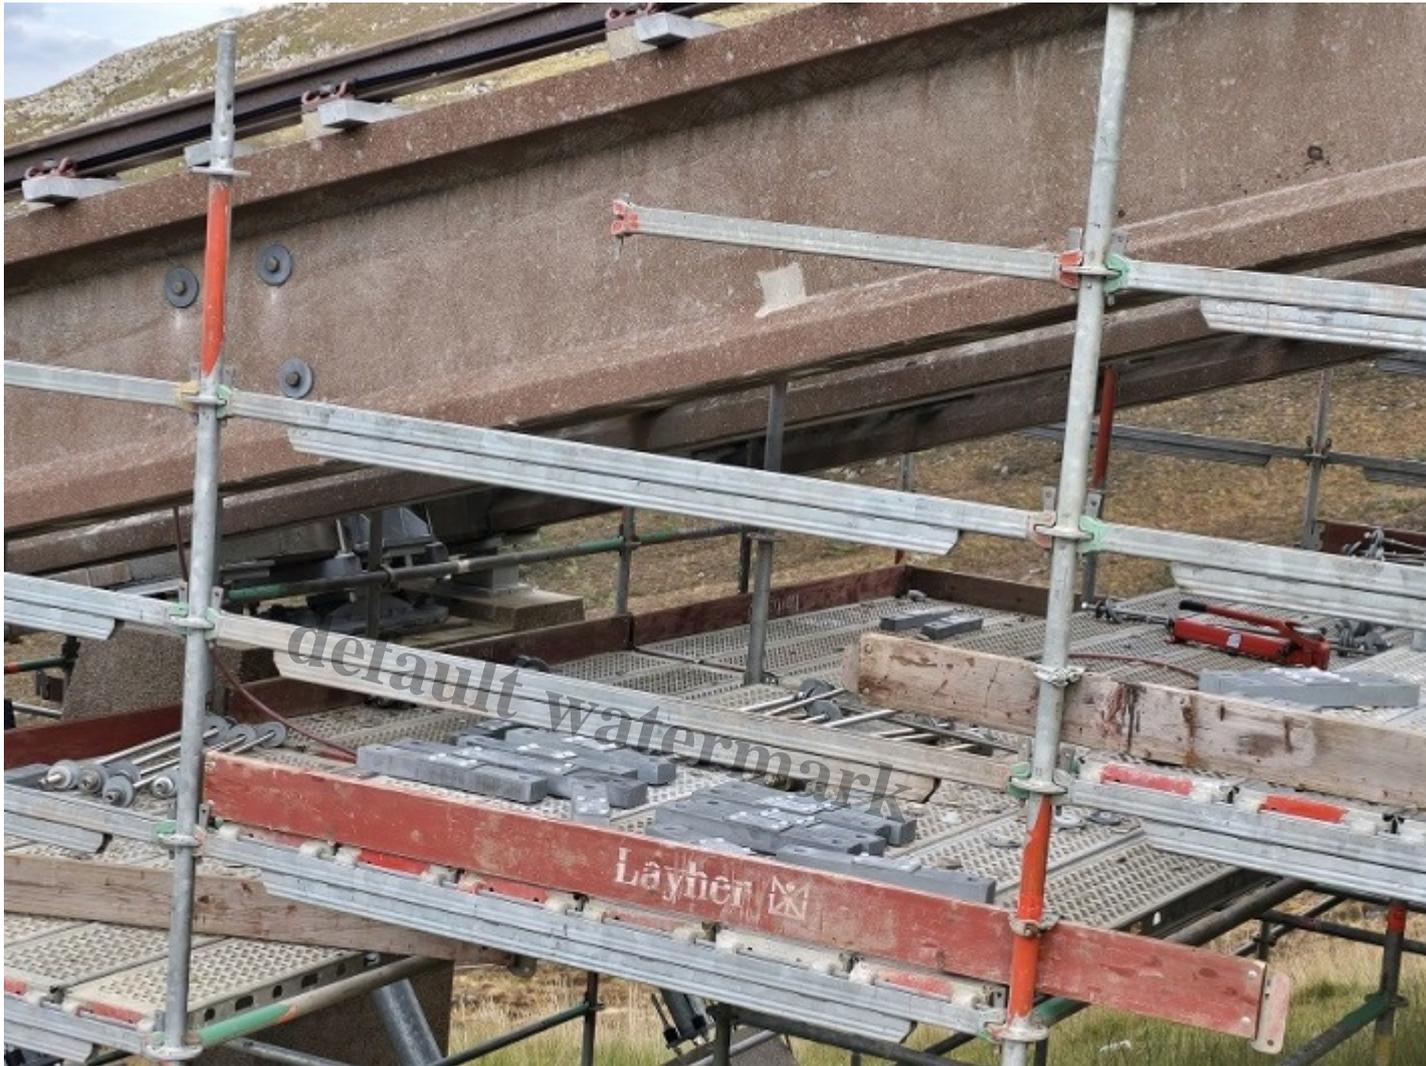
All of this raises yet another question to which HIE and CM(S)L have not commented. The funicular was closed in August 2023. On 04/10/2024 the majority of the brackets were lying on the ground or on the scaffolding some even lying on top of the beams. This can be seen in the next photo.

Brackets lying on scaffolding. Photo credit Gordon Bulloch October 2024.

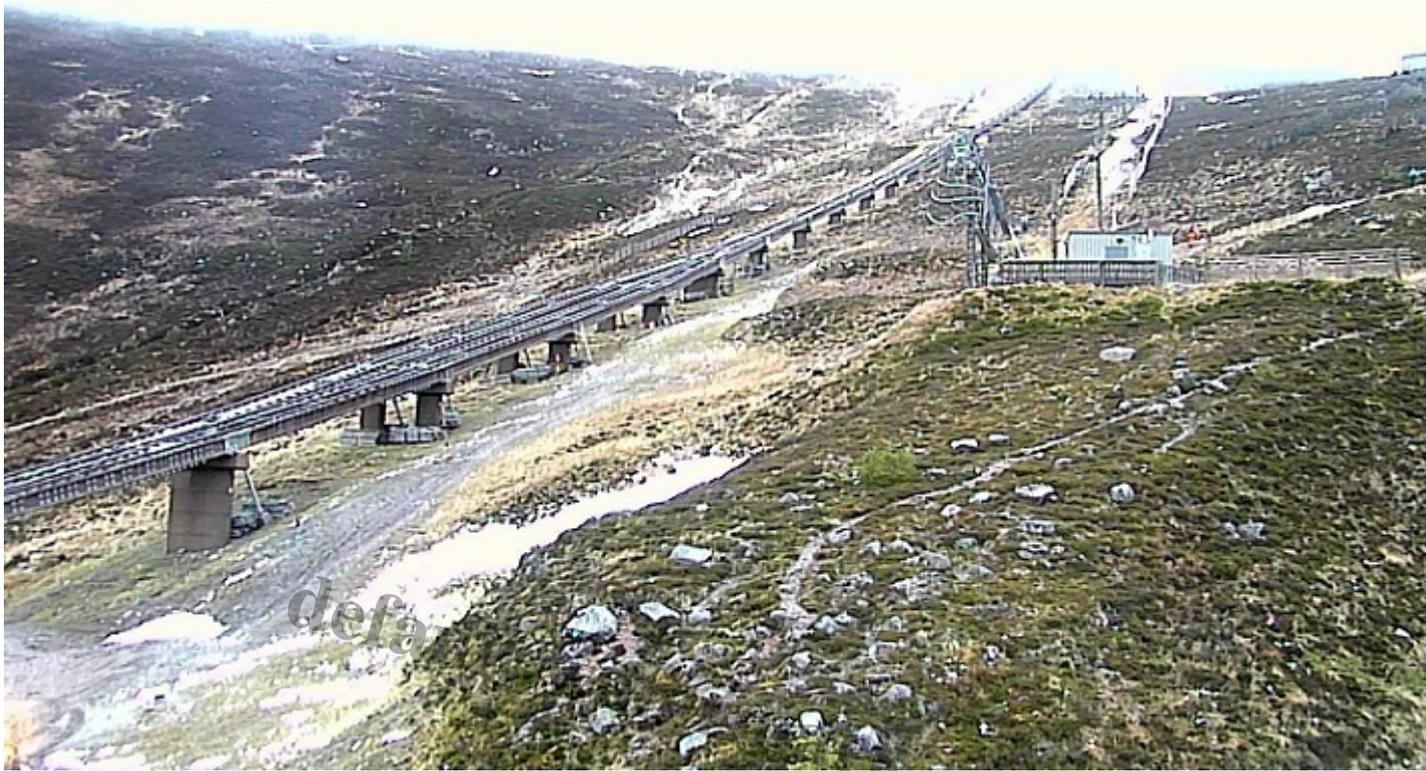
WhiteLady 2024-12-20 14:26:37

Yet by 20/12/2024, as can be seen in the next photo, all the brackets had been replaced, presumably tensioned according to the COWI design, and the scaffolding had been removed.
