Comment on Sheiling Track Retrospective Application

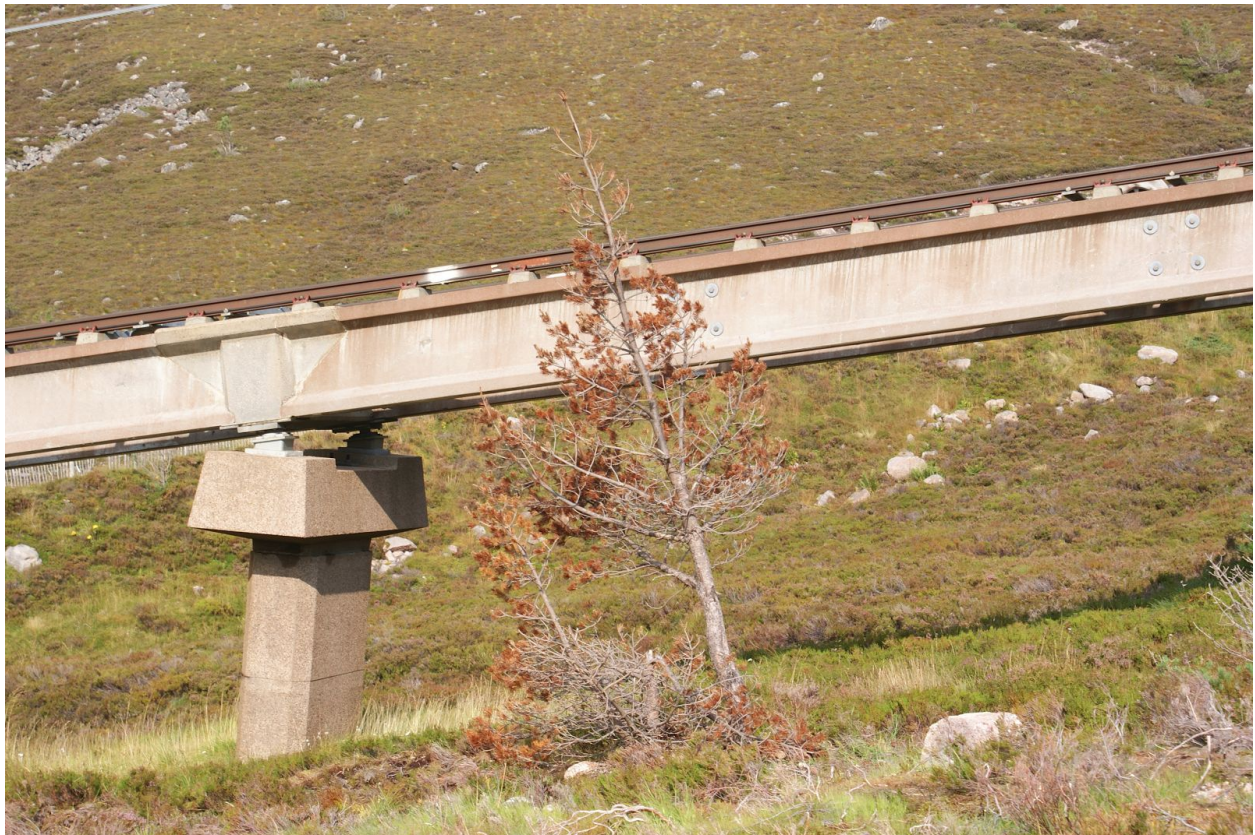
Image 1: One of numerous montaine scrub Scots Pines that has died post Sheiling Tow works due to combination of waterlogging and/or root damage through destruction of soil profiles and drainage creating an area of artificially boggy ground between new track and the Funicular.

- The above should be extended to adequate drainage (including silt trapping) to reduce the artificial boggiess of the ground between the new track and funicular railway, followed by additional native tree planting of above noted species.

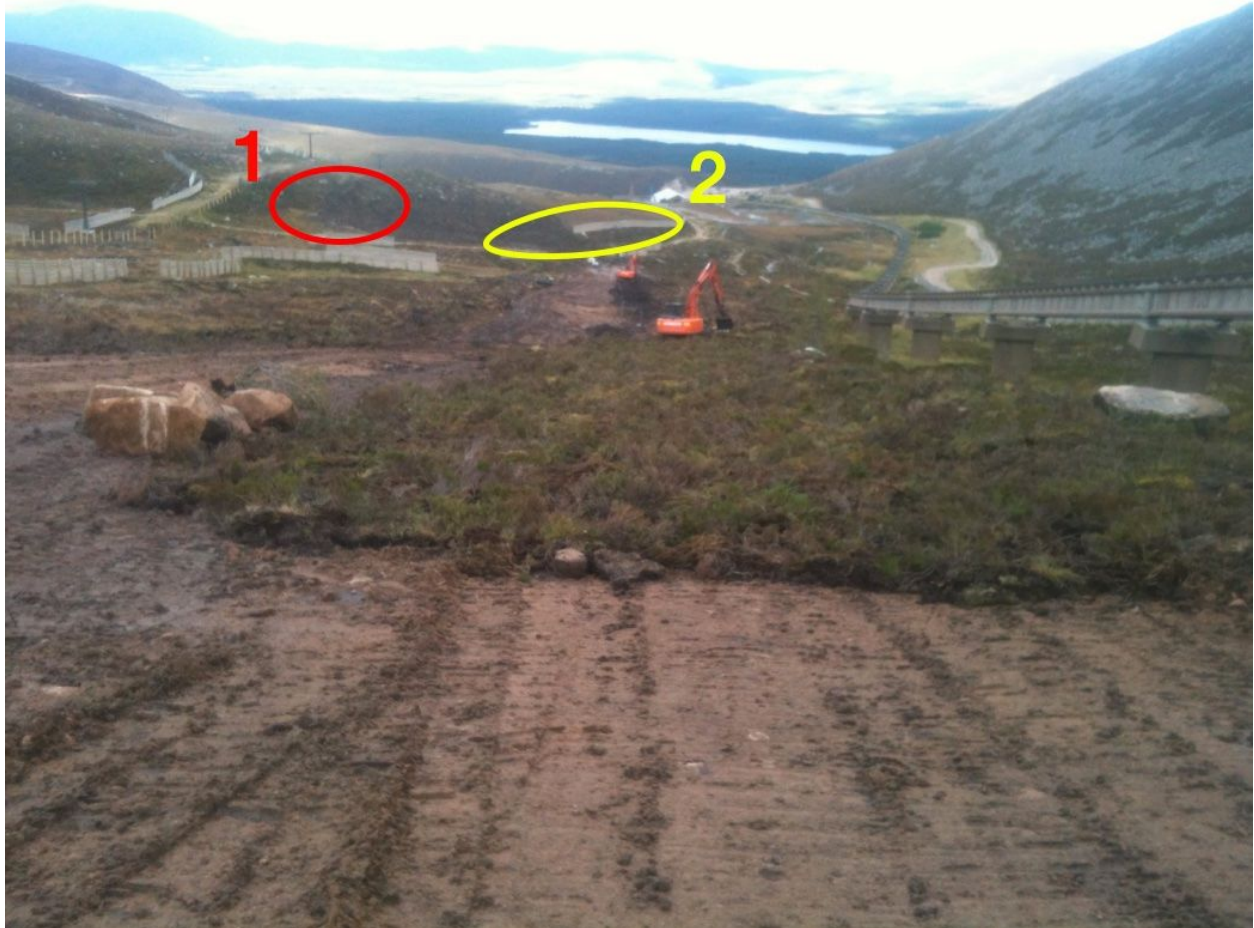
Image2: Highlighted on the image are the site of the following features which were not yet present on date photograph was taken:

1. A 3m+ deep borrow pit for materials was dug in the area marked 1 [red], later backfilled with large rocks recovered from October and November's ground works.
2. Bank and snow fencing above 'the Slot' still intact at area marked 2 [yellow]. The fencing was removed to allow this bank to be dug back for additional material for re-profiling the tow uptrack.

The area between the two machines in image 2 which purports to show reinstatement works in progress in October 2015, was heavily disturbed and further modified in the attempt to get the required profile for the lift line.

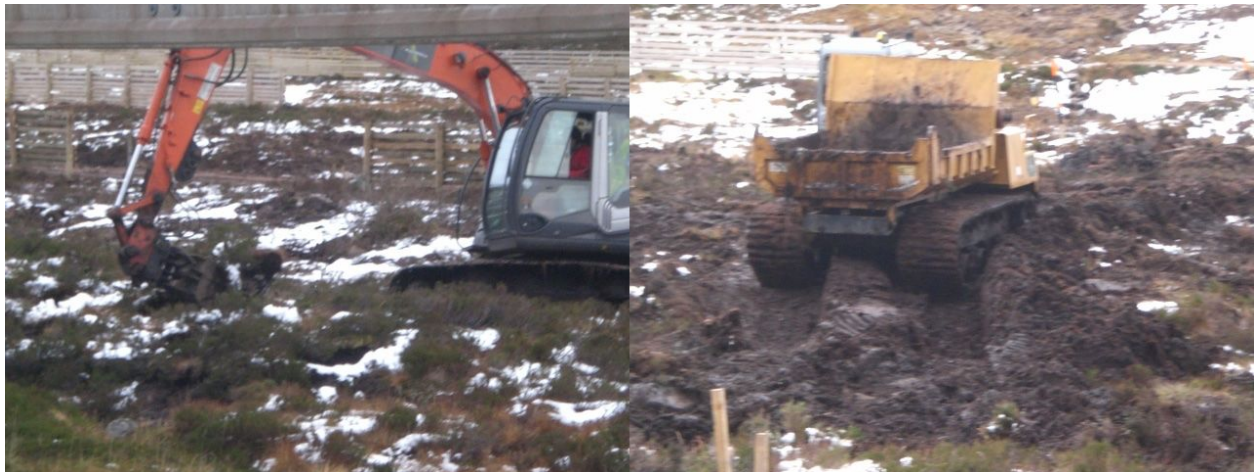
These photos taken by Alan Bratney on 25th November 2015 show an excavator ripping out material and them being transported to the side of the Sheiling Tow uptrack in a tracked dumper which is sinking into the heavily disturbed peat.

Image 3: Ground works between the Funicular and Sheiling Tow on 25th November 2015. At least a month after the photo included in the application's supporting statement showing reinstatement works in progress in October 2015.

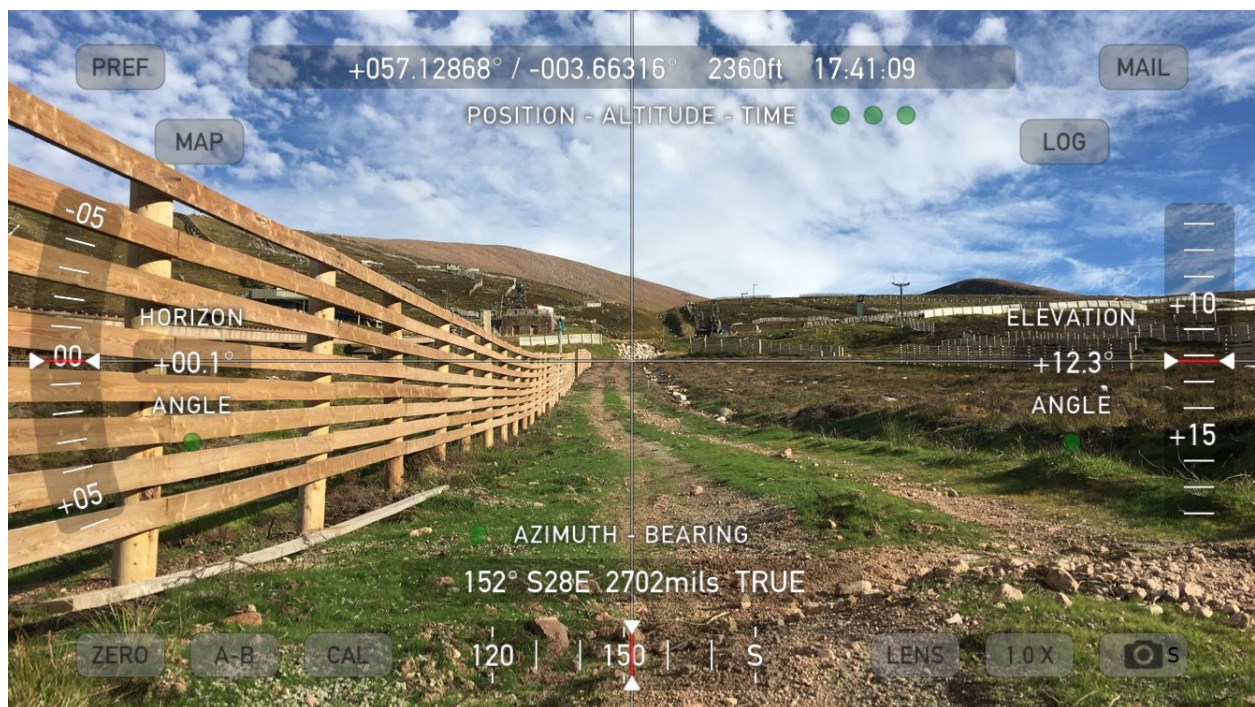
- The maximum recommended gradient in the SNH guide for light all terrain vehicle tracks is 8°:
 - The Sheiling Track exceeds this gradient, with the track averaging 12° on top half and reaching 15° (near top of rope tow and link onto pre-existing hill track).
 - Contrary to good practice the bulk of the track runs in a straight alignment at right angles to the contours of the land.
 - Lack of adequate drainage or camber to prevent water channeling and resulting erosion from track.
 - Central verge may help funnel run off down the exposed grit.
 - Steel box drains elsewhere on mountain quickly fill with washout and add to visual impact.

Image 4: Top half of the Sheiling Track averages a gradient of 12° exceeding that recommended as the limit in the SNH good practice guide “Constructed tracks in the Scottish Uplands” by 50%.

- Given the track follows the fall-line for the entire length of the tow and exceeds the maximum recommended gradient in the SNH handbook, measures are required to prevent water channeling and run off damage to the track and subsequent damage to surrounding ground.

- The use of ground reinforcement grids (similar to those used at the funicular mid-station platform and winter entrance/exit from the Top Station), filled with suitable soil and seeded on top of the exposed grit would provide both a robust driving surface that would blend in almost entirely while stabilizing the ground thus preventing water run off erosion.

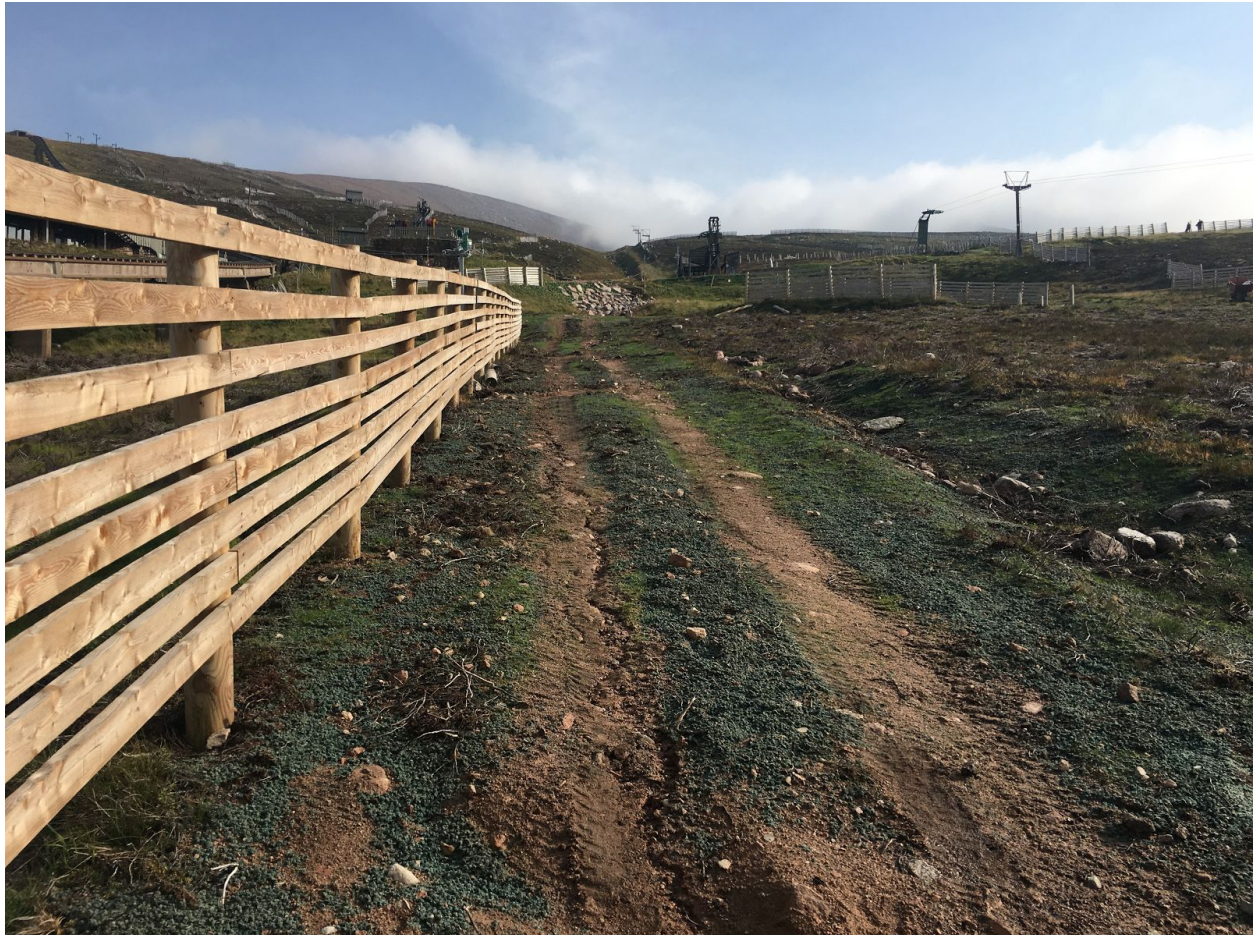
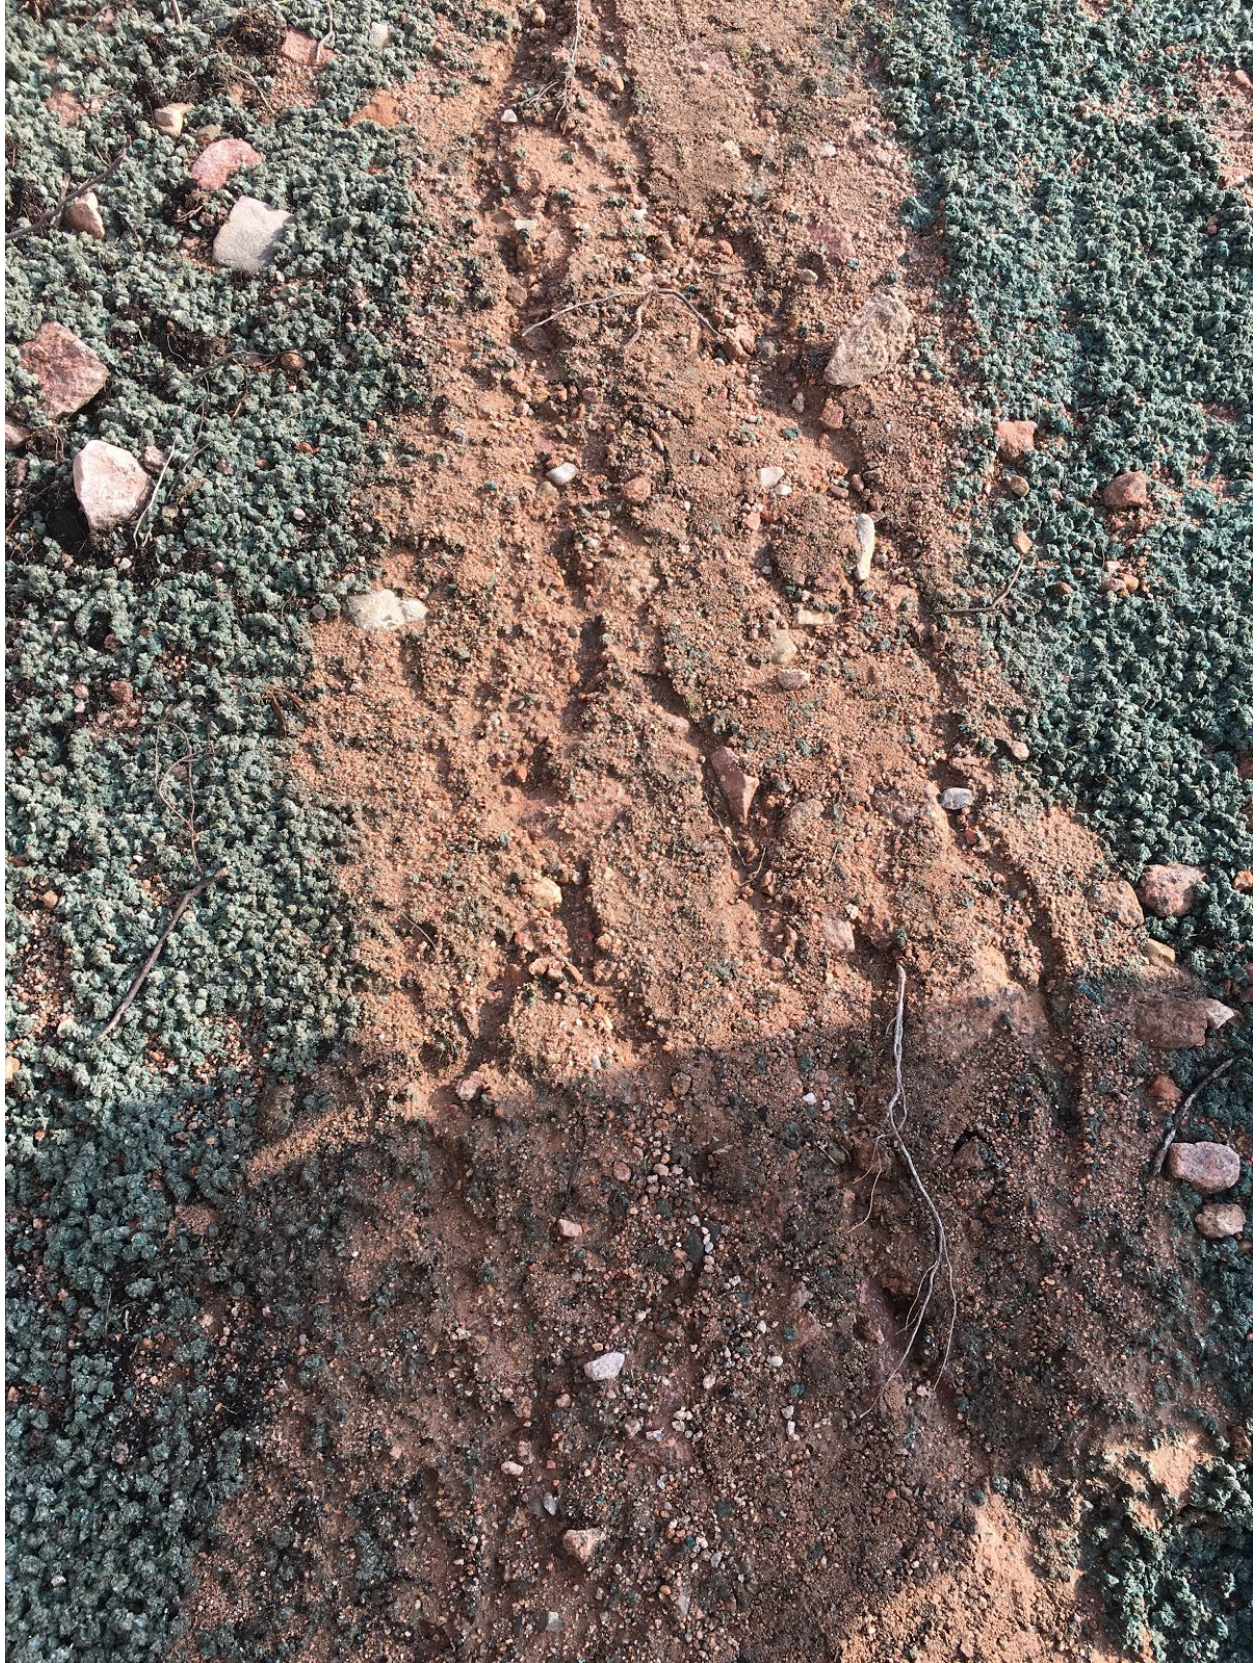
The track is already undergoing renewed runoff erosion despite having been worked on over the summer months and seedaide mulch applied to attempt stabilization. Washout from the previous winter/spring was already repaired earlier in the summer.

Images 5 & 6 (on page 7): Runoff runnels indicating new water erosion of the recently worked on track. Photos were taken in dry conditions on Wednesday 14th September. Despite a dry day track was noticeably soft and boggy in places.

Clearly due to the fall-line nature of the track and gradient, runoff erosion will be a constant problem and even if steel cross drains were installed, washout would continue in between and repairs to the track and clearing of the cross drains would be constantly needed.

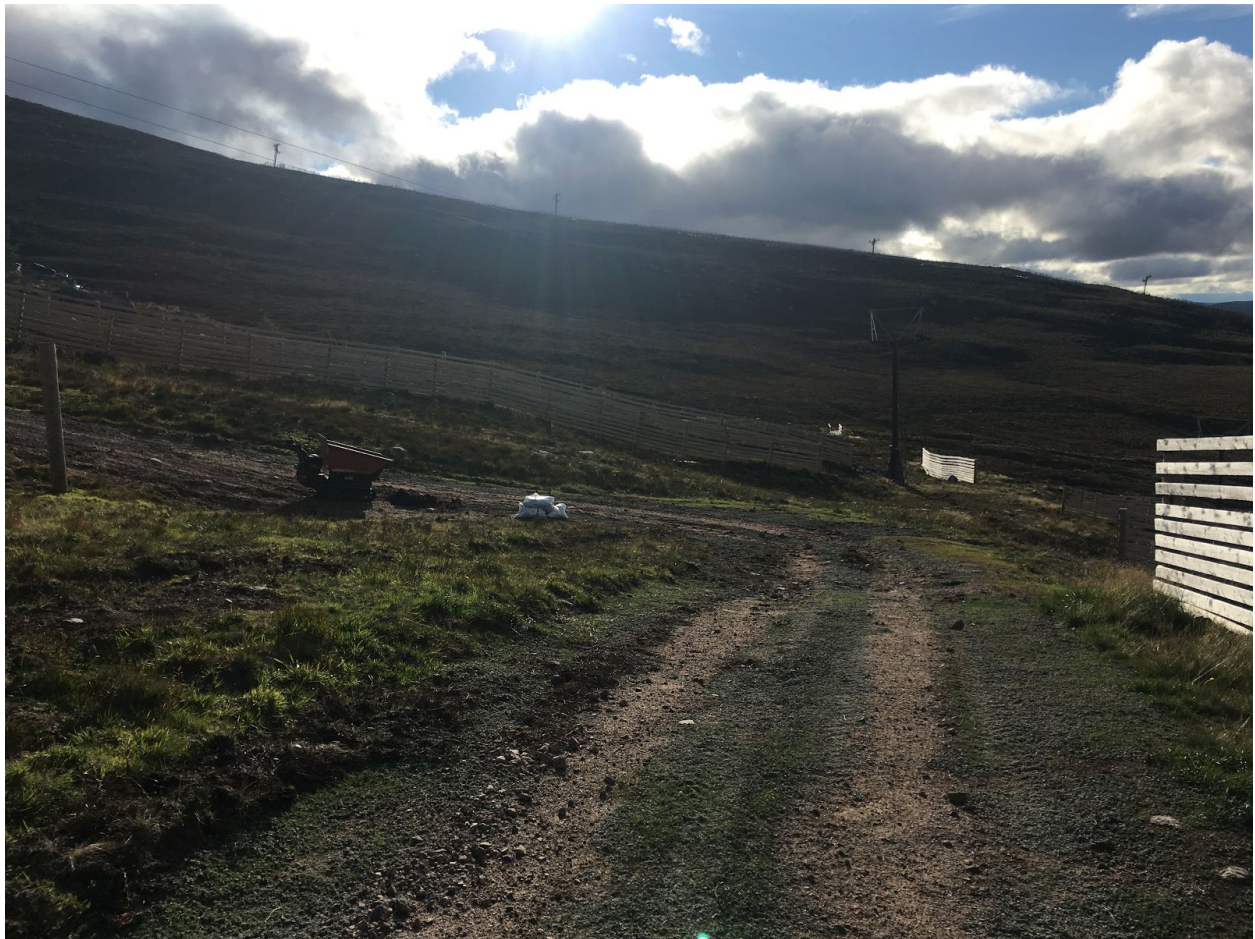
In order to connect to the pre-existing hill track the new track drops firstly downhill, then turns very sharply back uphill. This corner has such a tight turning radius that even small all terrain vehicles are likely to constantly be churning up the track/ground at this location.

As this corner occurs at the bottom end of a steep straight down slope section, it is likely that water will funnel down here and wash out churned material onto the vegetated ground below.

Image 7: Very small radius turn back up slope approaching top of the new Sheiling Track.

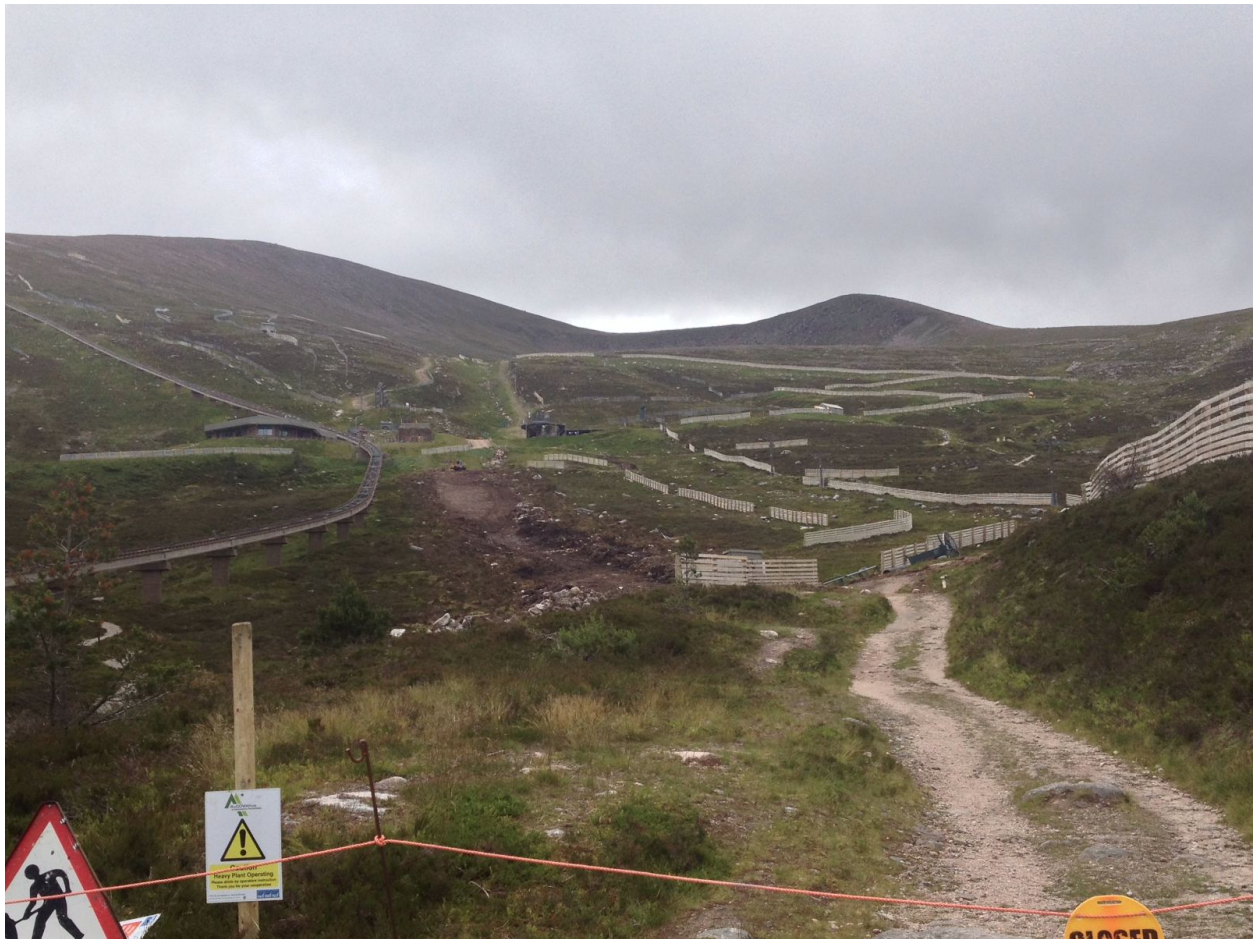
Contrary to this claim (originating with the applicant?) as can be seen from the following photo, there was no erosion taking place on this bank prior to construction of the new tow and associated track. The bank had a healthy and full vegetation cover.

Image 8: Looking up to the Sheiling Tow works on 9th August 2015. At this stage the bank and snow fencing above the Cas Loop Trail footpath remained intact.
