9 Nellfield Road,
Crieff,

PH7 3DU, UK

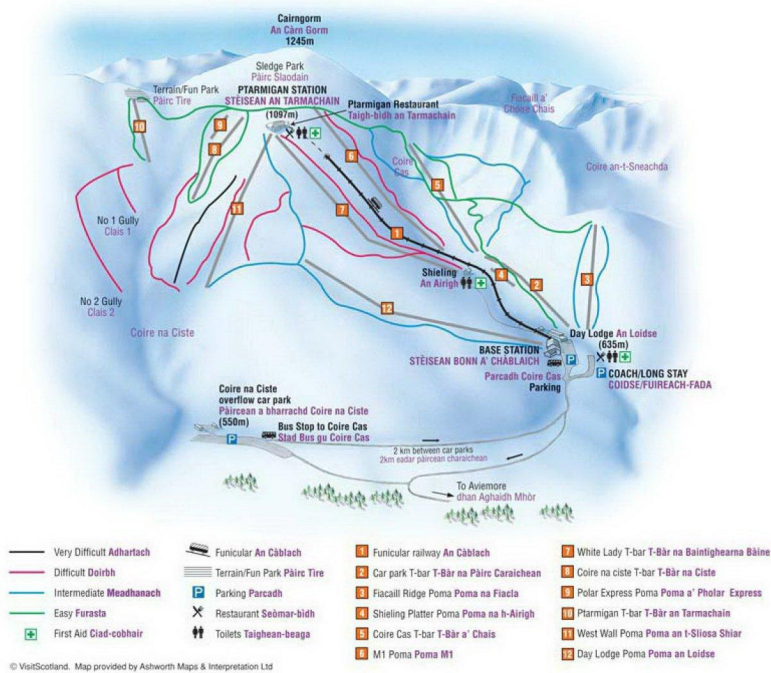
Location map showing railway

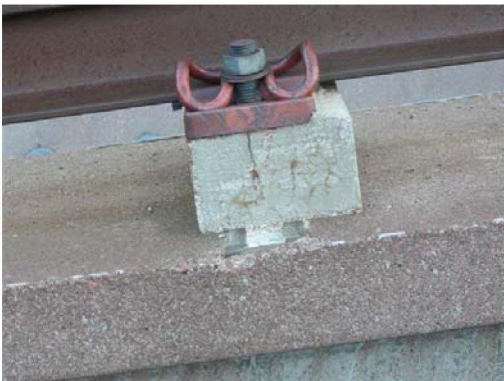
Photo [3] Grout plinth showing fracture. Regarded as stable at this time.

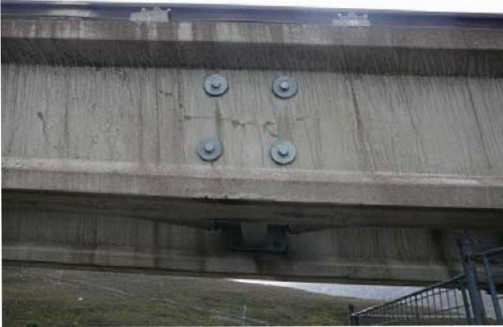
Photo [4] Typical crack patterns around bolt groups.

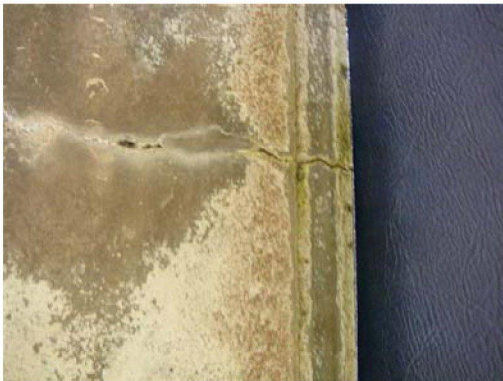
Photo [6] View of crack on typical mid-span underside of beam.

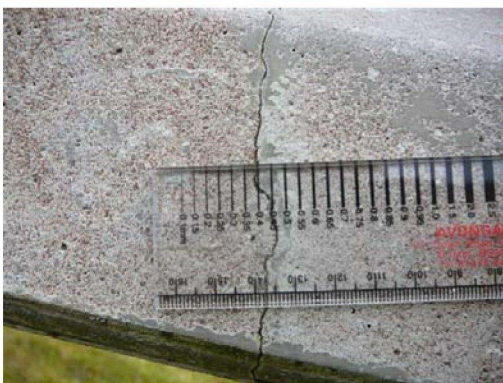
Photo [7] The above photographed crack as it appears on the side of the beam.

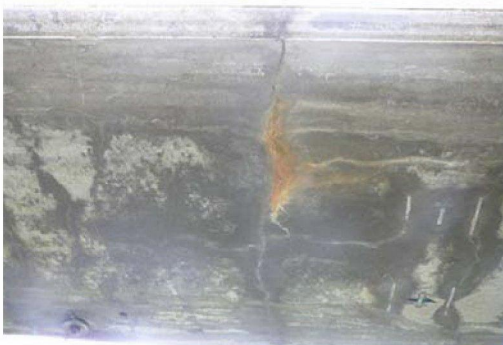
Photo [8] Crack at mid span of beam exhibiting rust staining.

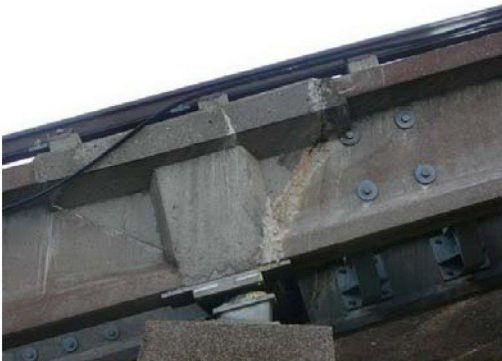
Photo [10] Pier 56 crack near top of flange unloaded.

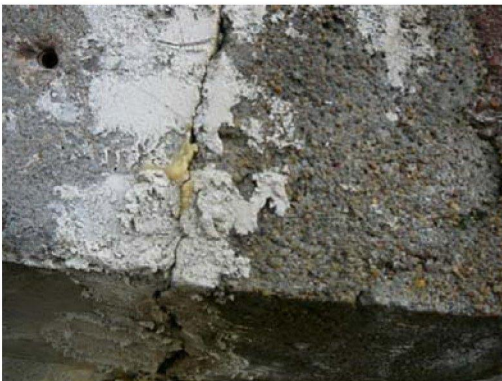
Photo [11] Pier 56 crack near top of flange as train passes. Estimate increase in crack width = 1.0mm.

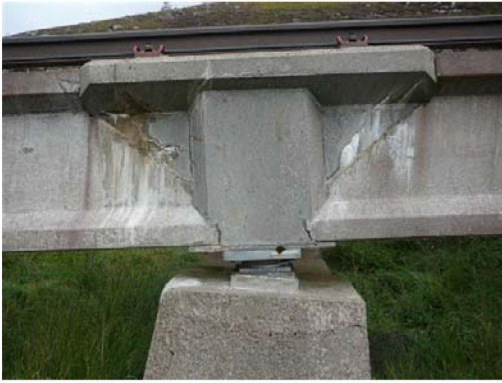
Photo [12] Pier 8, one of the poorer insitu infills. Showing joints opening between Insitu and precast plus cracking within the mass of the Insitu, both inclined and near vertical.

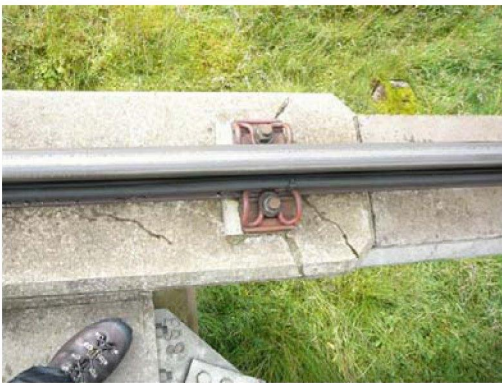
Photo [13] Pier 8 from above.

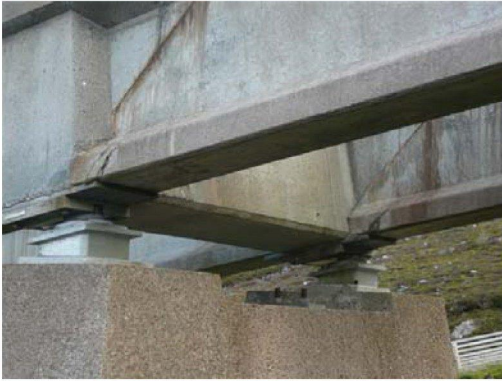
Photo [14] Diagonal cracks through the lower flange of the precast beam bearings.

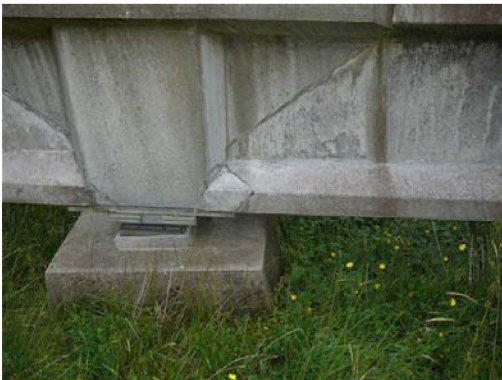
Photo [15] Showing bottom corner fracturing away.

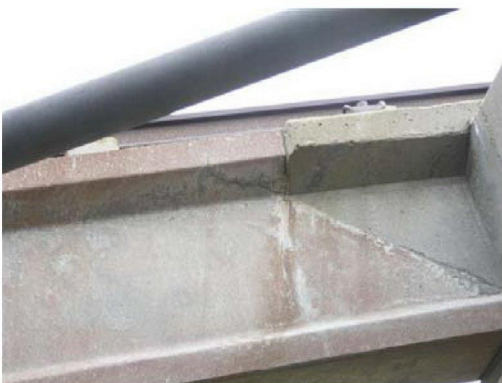
Photo [16] Flange fracture also seen at top of beams. This was less often.

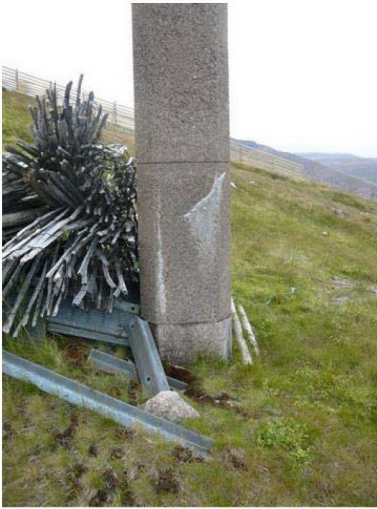
Photo [17] Main pier 91 showing cracks in shell.

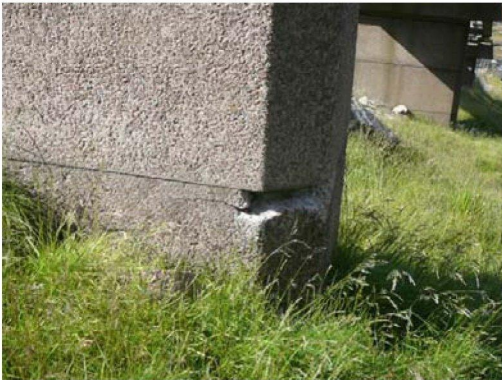
Photo [18] Significant chip out of pier shell.

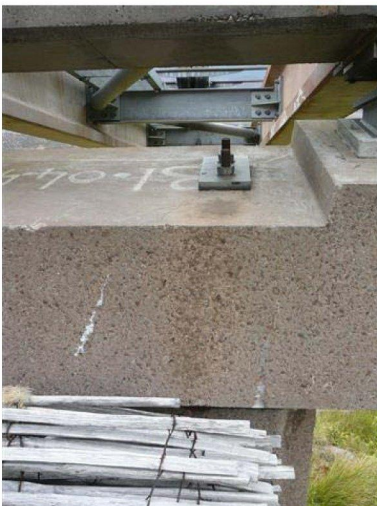
Photo [19] Pier 93. Crack rising up through pier crosshead and passing through bolt group. This was the only cross head where this was observed.

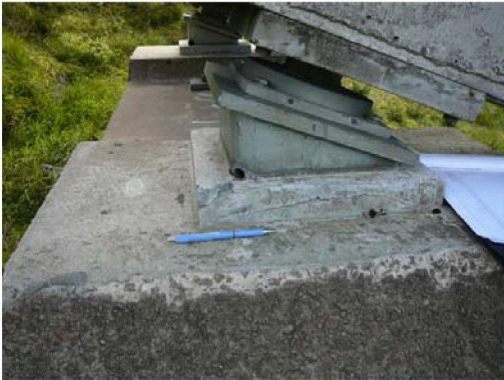
Photo [20] Showing deterioration of bearing plate grout.

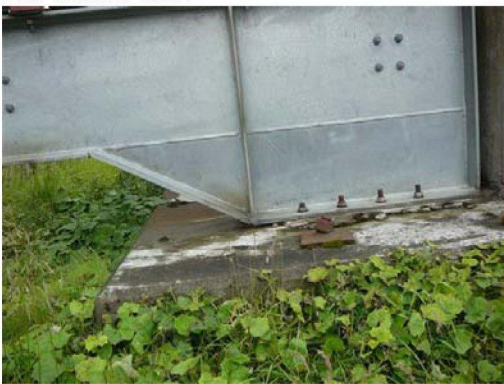
Photo [21] Crumbling grout pack under steel beam at pier 0.
