Job name: **Condition report - Funicular Railway, Cairngorm Mountain.**

Job number: **16011**

Client: **Cairngorm Mountain Ltd**

Date: **December 2016**

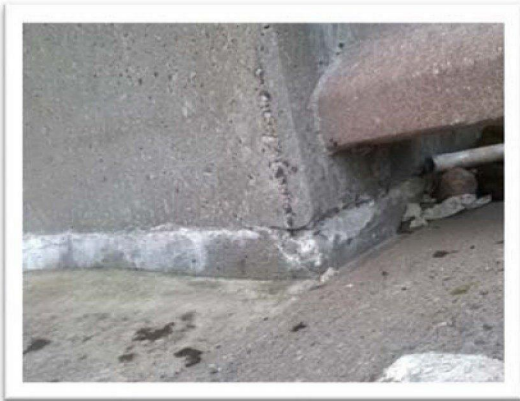
Ref clause 5.1.3

5.1.3 Horizontal shear cracking was observed between the upstand block and the main bulk of the foundation at: Ref photo [1]

Pier 48
Pier 78

Photo [1] Construction joint / shear fracturing where thrust block upstand meets main foundation.

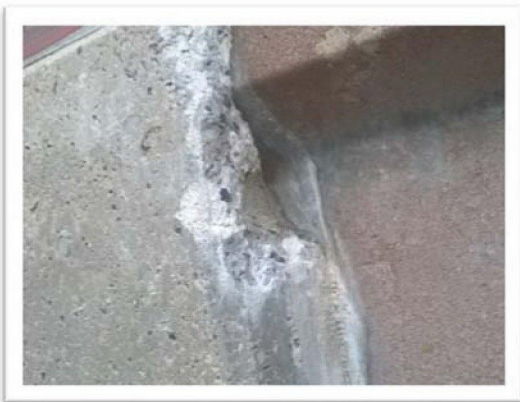
Ref clause 5.1.5

5.1.5 On pier 78 where the PCC beam enters the top right side of the thrust block a large flake has spalled off. **This should be repaired.** Ref photo [2]

Photo [2] Large chip out of face of thrust block where PCC beam meets it.

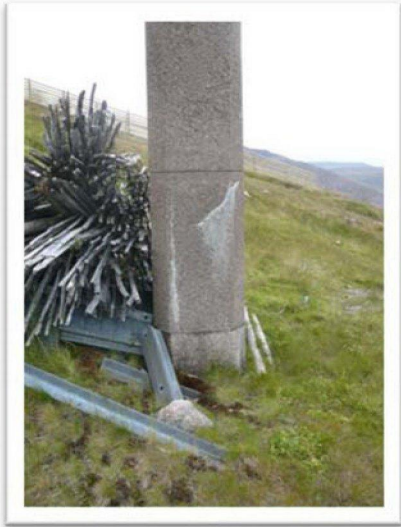
Ref clause 5.1.2

5.2.2 Description: Fractures of the main piers were observed at a number of locations. The available drawing show that the piers were pre-cast shells that were infilled with insitu reinforced concrete. It is therefore concluded that cracks to the shells are of no grave consequence, although they should be reviewed at each annual inspection. Ref photos [3].

Location: Pier 3 crack in bottom casing.
Pier 46, showing efflorescence at mid height.
Pier 51, much efflorescence at joint. Also crack up face on top side.
Pier 72, lowest unit showing signs of frost damage and seepage through horizontal crack.
Pier 91, cracked with calcite bleeding on E, W & S faces.

Photo [3] Main pier 91 showing cracks in shell.

Recommendation: There is no cause for concern at this time.

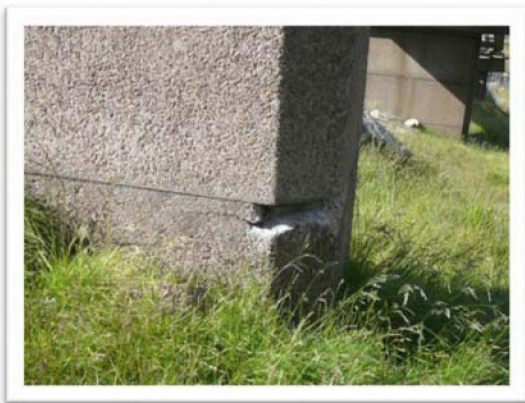
Ref clause 5.1.3

5.2.3 Description: Cracks, chips and missing chunks were seen in other piers. Ref photos [4].

Location: Piers 45, 54 and 57.

Photo [4] Significant chip out of pier shell.

Recommendation: Patch repairs are recommended to match the existing. This is not thought to be urgent.

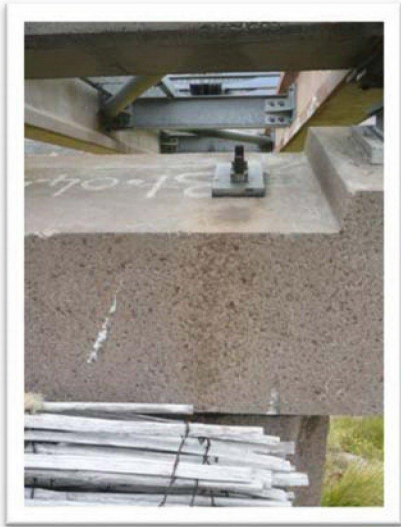
Ref clause 5.2.3

5.3.3 Description: Crack through pier cross head, running up one face and through the PT bolts holes on the top and down the other side, this is apparent on the line of both PT bolts. This appears to be a development on the previous year, when the cracks were only recorded on the line of one bolt. Ref photos [5].

Location: Pier 93.

Photo [5] Pier 93. Crack rising up through pier crosshead and passing through bolt group. This was the only cross head where this was observed.

Recommendation: This would not be a concern in its self as the cracks are of a minor nature, but the appearance of a developing situation is of concern. It is recommended that **crack monitoring is implemented immediately** and that this is monitored at close intervals until a feel for the situation is achieved.

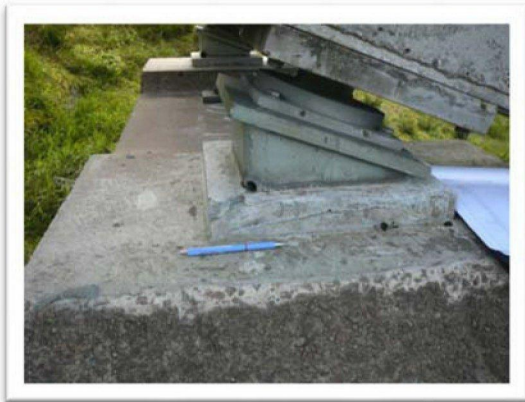
Ref clause 5.3.2

5.4.2 Description: At a number of locations the insitu grout under and around these plates was seen to be deteriorating. Repairs were carried out during 2016, but further plates have been recorded this year. Ref photos [6].

Location: **Pier 43, grout disintegrating – repair.**

Photo [6] Showing deterioration of bearing plate grout.

Recommendation: Remove deficient grout and replace on piers so noted. Note this is a key load bearing component and required skilled operative to carry out this work. In some cases it may require temporary propping of the main beams and closing of the railway for the duration and until the grout achieves design strength.

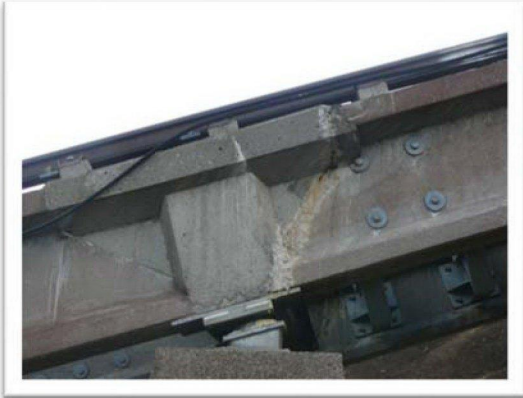
Ref clause 5.5.1

Photo [7] Pier 56, an overview showing previous repairs carried out.

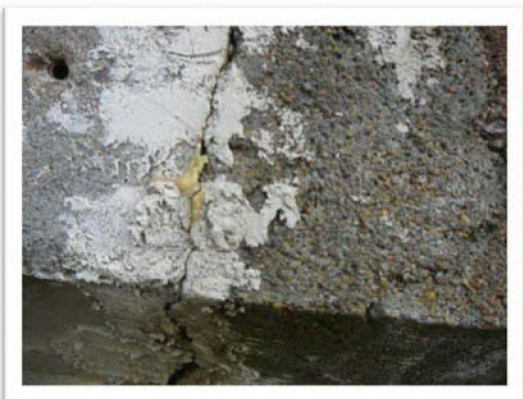
joint as a train passes was limited to one location, pier 56. Here the crack was clearly seen opening then closing again, by an estimated 1mm, as the train passed. The concern here is that the coupler may have failed leading to a redistribution of stress to the midspan of the beams. Correspondence with A F Crudens, Consultant Civil and Structural Engineers for the scheme, confirm that the beams were designed to have sufficient strength as a simply supported beam, but that continuity reinforcement was added to restrict deflections. If this coupler has failed then greater than desirable deflections would be expected and this would compromise the durability of the structure. This appears to be happening. Ref photo [7], [8], [9]

Photo [8] Pier 56 crack near top of flange unloaded.

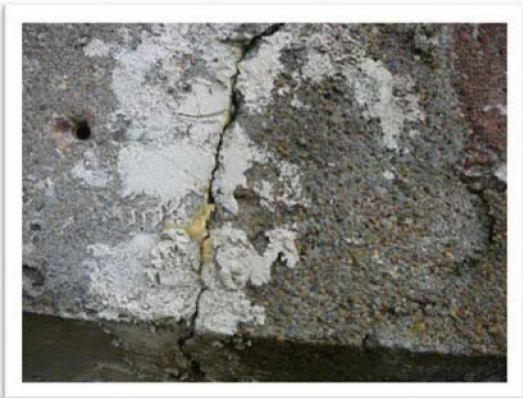
Photo [9] Pier 56 crack near top of flange as train passes. Estimate increase in crack width = 1.0mm.

Recommendation: Refer to section 6.

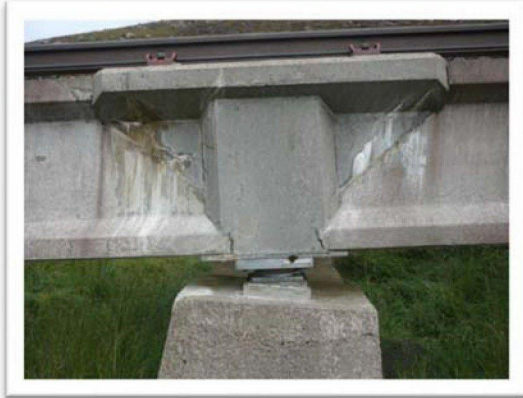
Ref clause 5.4.2

- 5.5.2 Description: Cracking within the insitu fill, between the precast beam ends. This generally appeared as vertical cracks, often with considerable calcite bleed, sometimes white, elsewhere stained brown. Ref photos [10], [11].

Photo [10] Pier 8, one of the poorer insitu infills. Showing joints opening between Insitu and precast plus cracking within the mass of the Insitu, both inclined and near vertical.

Recommendation: An assessment of the significance should be made as part of the review being made in 5.5.3.

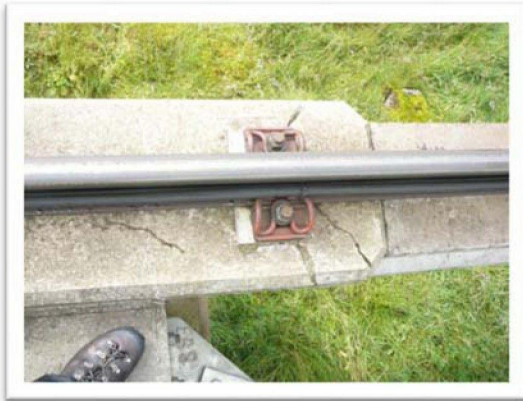
Photo [11] Pier 8 from above.

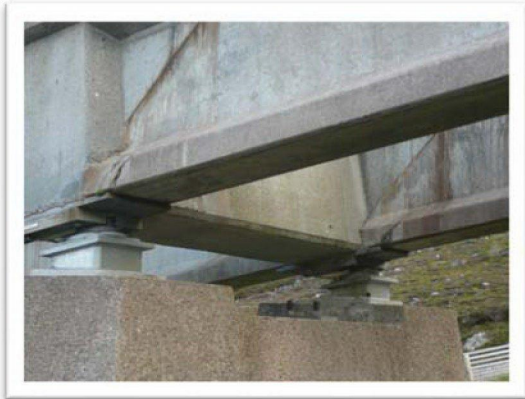
Ref clause 5.4.3

- 5.5.4 Description: Fracturing of the flange ends of the precast beams, usually the bottom flange. This would suggest that the beams are not bearing evenly on the bearing plates, leading to local overstress and local failure. It is thought likely that this local failure will lead to a redistribution of stress that would re-center the load. Ref photos [12], [13], [14].

Photo [12] Diagonal cracks through the lower flange of the precast beam bearings.

Recommendation: Exploratory repairs should be carried out to a number of these areas, then rolled out to all such defects. This work should be carefully planned and an assessment of structural stability made before removing any concrete in these areas.

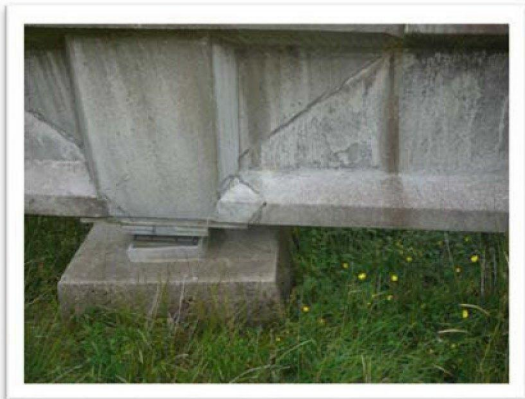
Photo [13] Showing bottom corner fracturing away.

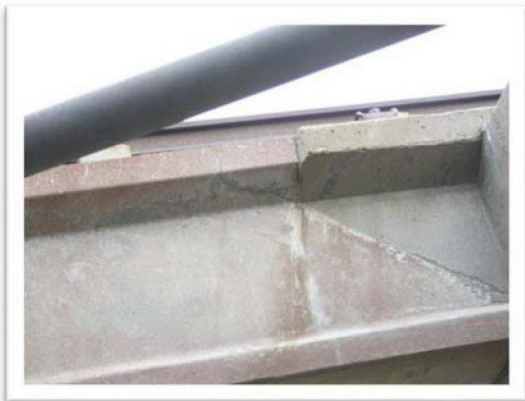
Photo [14] Flange fracture also seen at top of beams. This was less often.

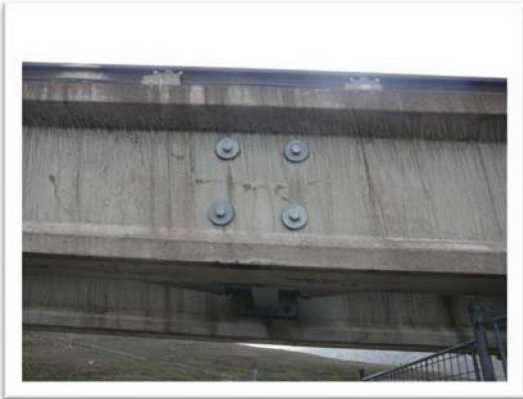
Ref clause 5.5.4

- 5.6.4 Description: A repeating pattern of micro cracking was observed between the bolts through the web of the precast concrete beams at the cross bracing connections.

Photo [15] Typical crack patterns around bolt groups.

Recommendation: None of these observations were of a scale or nature to give rise to concern.

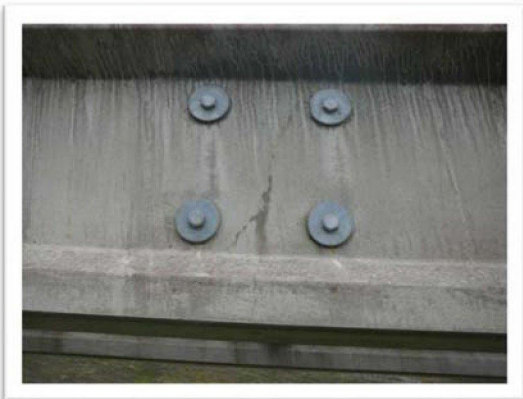
Photo [16], ditto

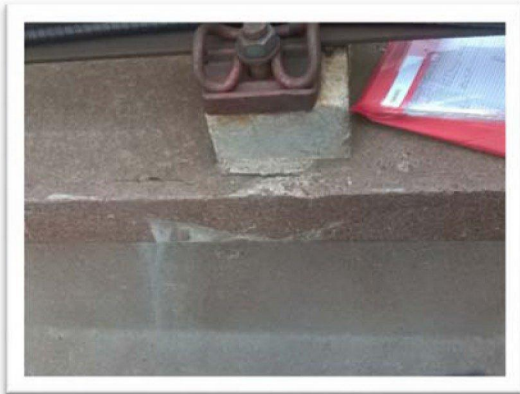
Ref clause 5.6.5

- 5.6.5 Description: A number of beams showed longitudinal cracking in the top flange. Ref photo [17], [18]

Location: This issue was seen at the following locations, each occurrence was slightly different:
43 – R/B, top flange inside face, longitudinal fracture approximately 150mm.
51 – R/M, mid depth top flange, several meters long.
93 – T/L, top flange under plinths L17 & L18.

Photo [17] Longitudinal cracking of the top flange of the PCC beams, here short.

Recommendation: Carefully breakout smaller defects (beams 43 & 93) to investigate for cause of defect, then repair. Using knowledge gained carry out repair to beam 51. Note this may require temporary propping – these are significant operations.

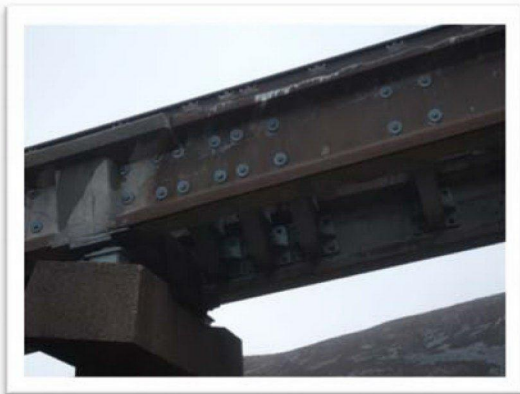
Ref clause 5.6.5

Photo [18] Longitudinal cracking of the top flange of the PCC beams, here several meters long.

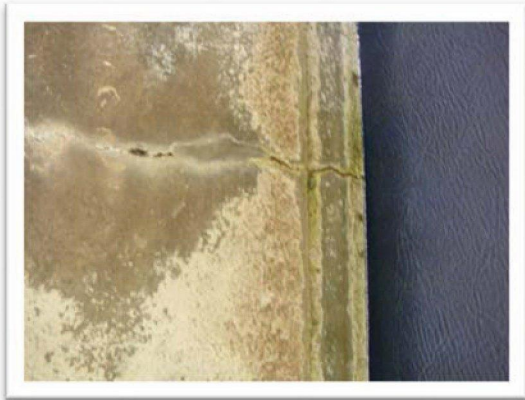
Ref clause 5.5.6

5.6.6 Description: Cracks were observed on the underside of most beams. Most were well distributed and hairline in nature. In many locations, the cracks were wider and extended up the face of the lower flange, these were up to 0.5mm wide. In some instances, there appeared to be rust staining coming out of these cracks. This gives cause for concern over the durability of the structure.

Photo [19] View of crack on typical mid-span underside of beam.

Recommendation: Refer to section 6.

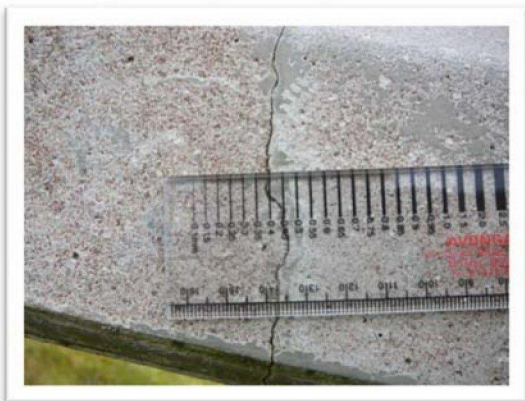
Photo [20] The above photographed crack as it appears on the side of the beam.

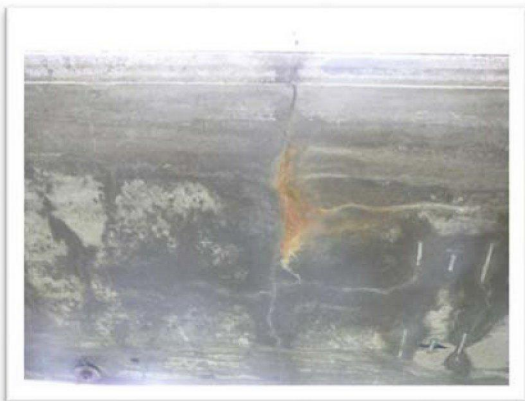
Photo [21] Crack at mid span of beam exhibiting rust staining.

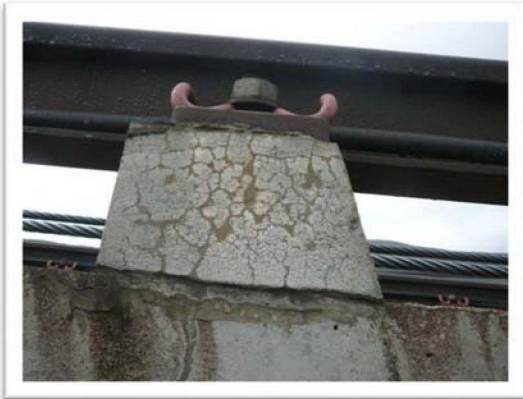
Ref clause 5.6.1

5.7.1 These plinths were in various conditions. Most were seen to be acceptable, particularly following the Summer 2016 work programme. A number of plinths were seen to be in poor condition and should be repaired during the coming summer works programme, others should be placed on the watching brief. Ref photos [22], [23], [24]

Photo [22] Typical grout plinth, exhibiting crazing, but stable

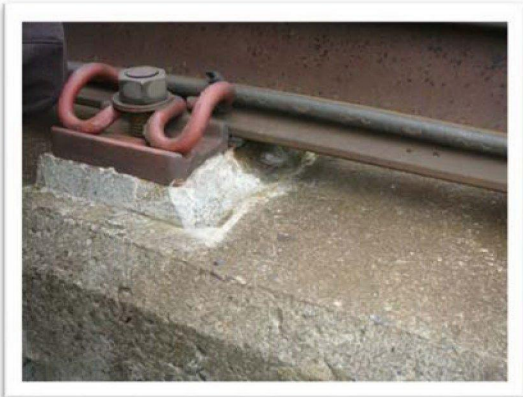
Photo [23] Typical case of a flake off one face of plinth. This regarded as stable.

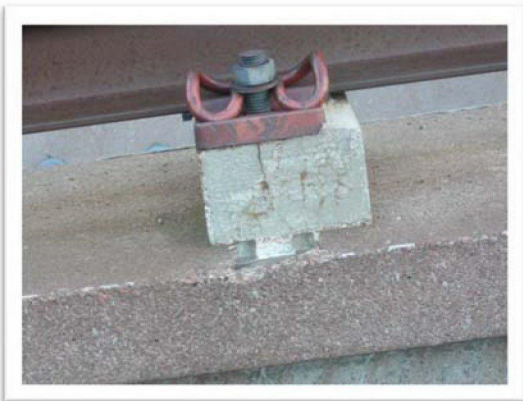
Photo [24] Grout plinth showing fracture. Regarded as stable at this time.
