Funicular Railway Inspection report - 2018

Job name: **FunInsp 2018**
Job number: **18011**
Client: **Cairngorm Mountain Ltd**
Engineer: [REDACTED]
Date: **July 2018**

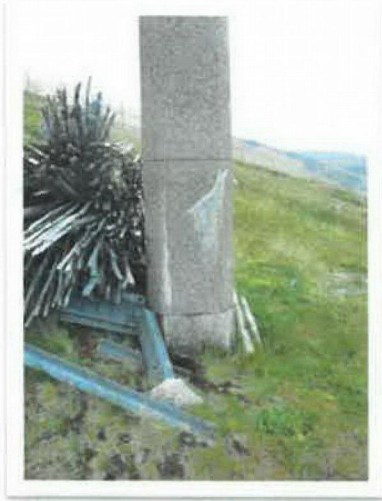
Ref clause 4.2.2

4.2.2 Description: Fractures of the main piers were observed at a number of locations. The available drawing show that the piers were pre-cast shells that were infilled with insitu reinforced concrete. It is therefore concluded that cracks to the shells are of no grave consequence, although they should be reviewed at each annual inspection. Ref photos [3], [4].

Photo [3] Main pier 91 showing cracks in shell.

Recommendation: There is no cause for concern at this time.

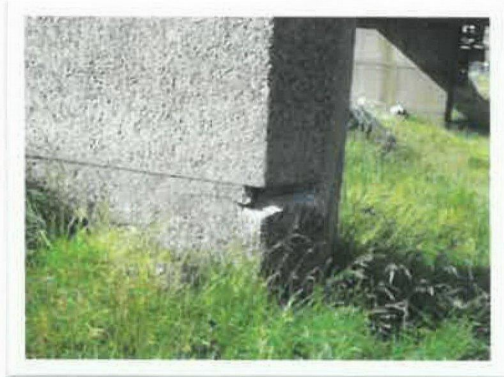
Ref clause 4.2.2

Photo [4] Significant chip out of pier shell.

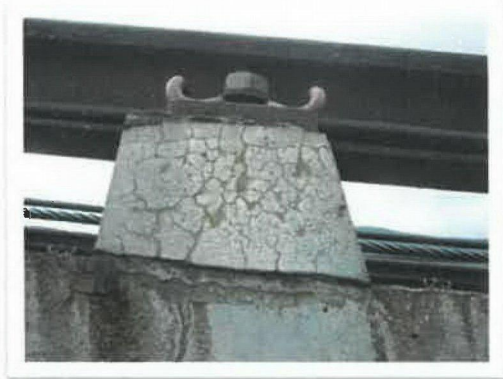
Photo [22] Typical grout plinth, exhibiting crazing, but stable

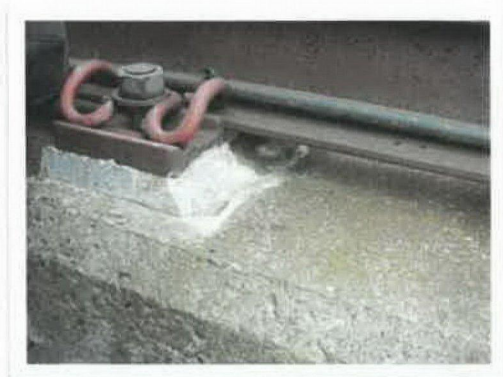
Photo [23] Typical case of a flake off one face of plinth. This regarded as stable.

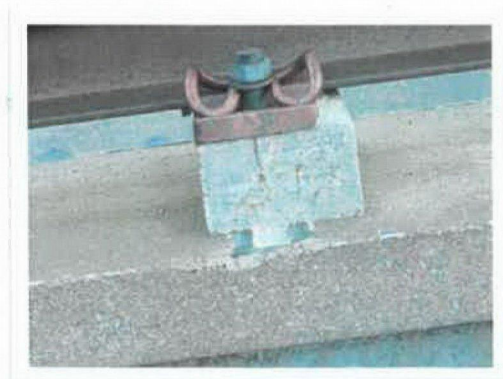
Photo [24] Grout plinth showing fracture. Regarded as stable at this time.
