The Loch Earn hydro schemes – and surprise general elections!

Ardvorlich estate hydro scheme

Tarken Glen hydro scheme

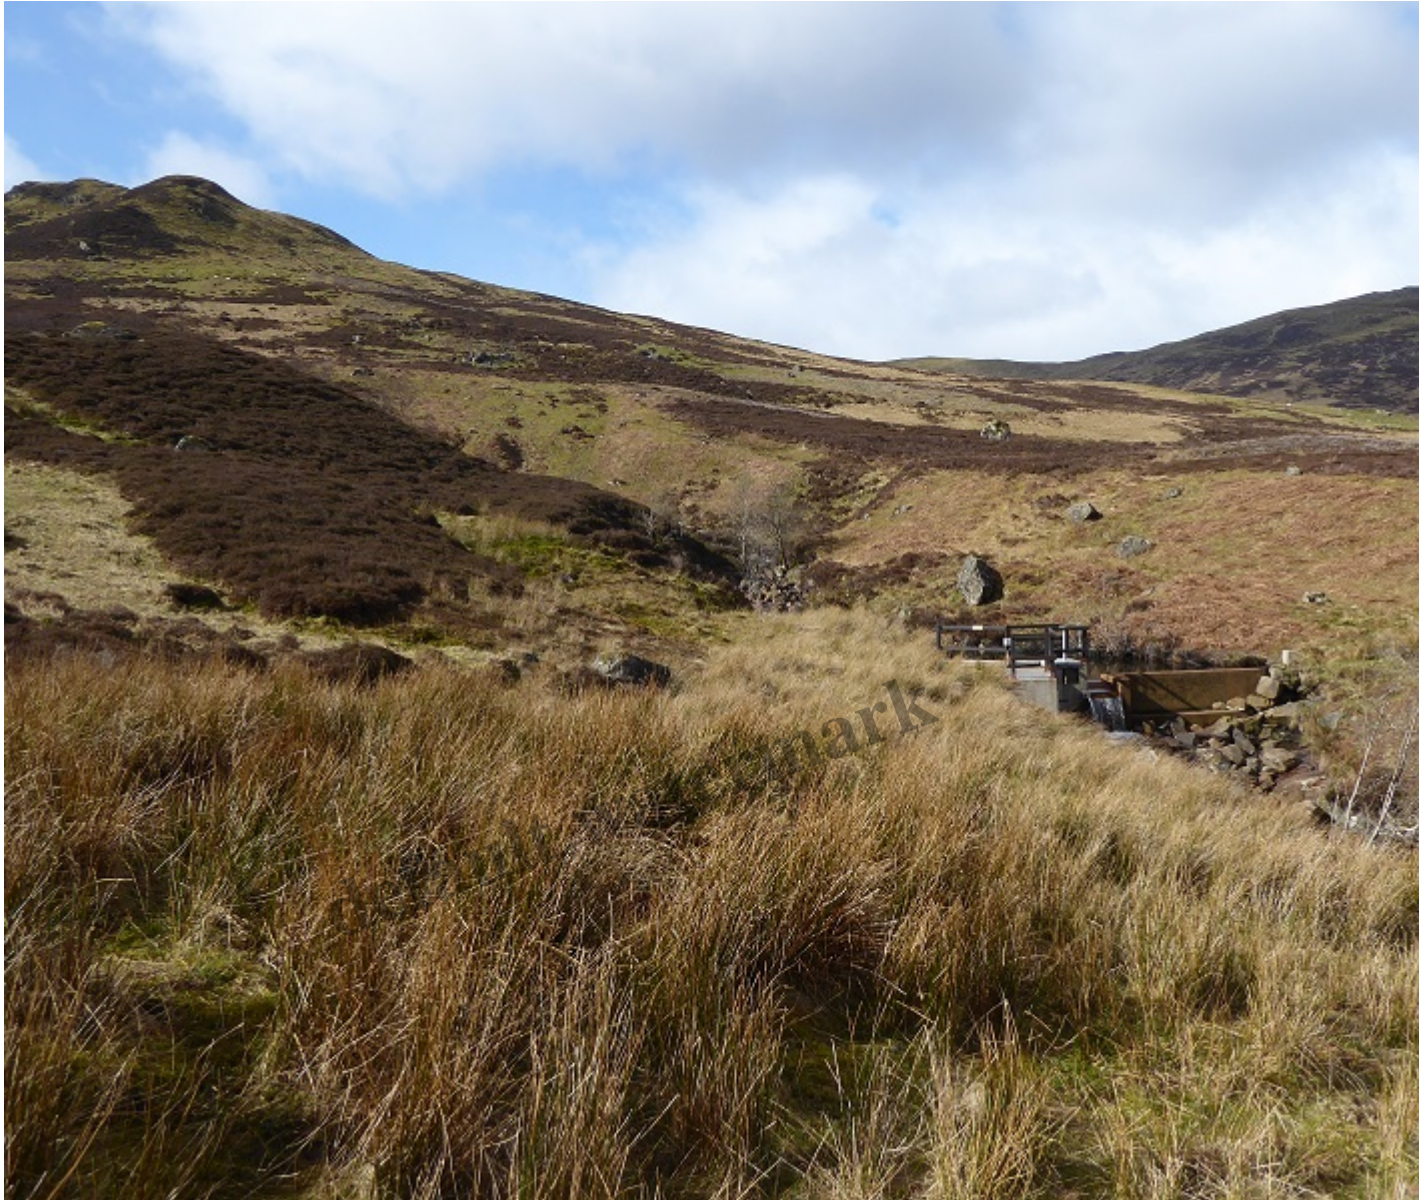
View of western intake above fork in the burn – the main walker’s path up Ben Vorlich from the north
the skyline

There are two intake to the hydro scheme. The main visual impact of the western intake is the concrete on left side of dam which has not been faced with natural materials. The concrete on the right side appears to have coloured due to water flowing over it regularly so it blends better into the landscape. The wooden safety fence is also unobtrusive and fits in Park’s subsequent policy to use natural materials, such as wood for fencing.

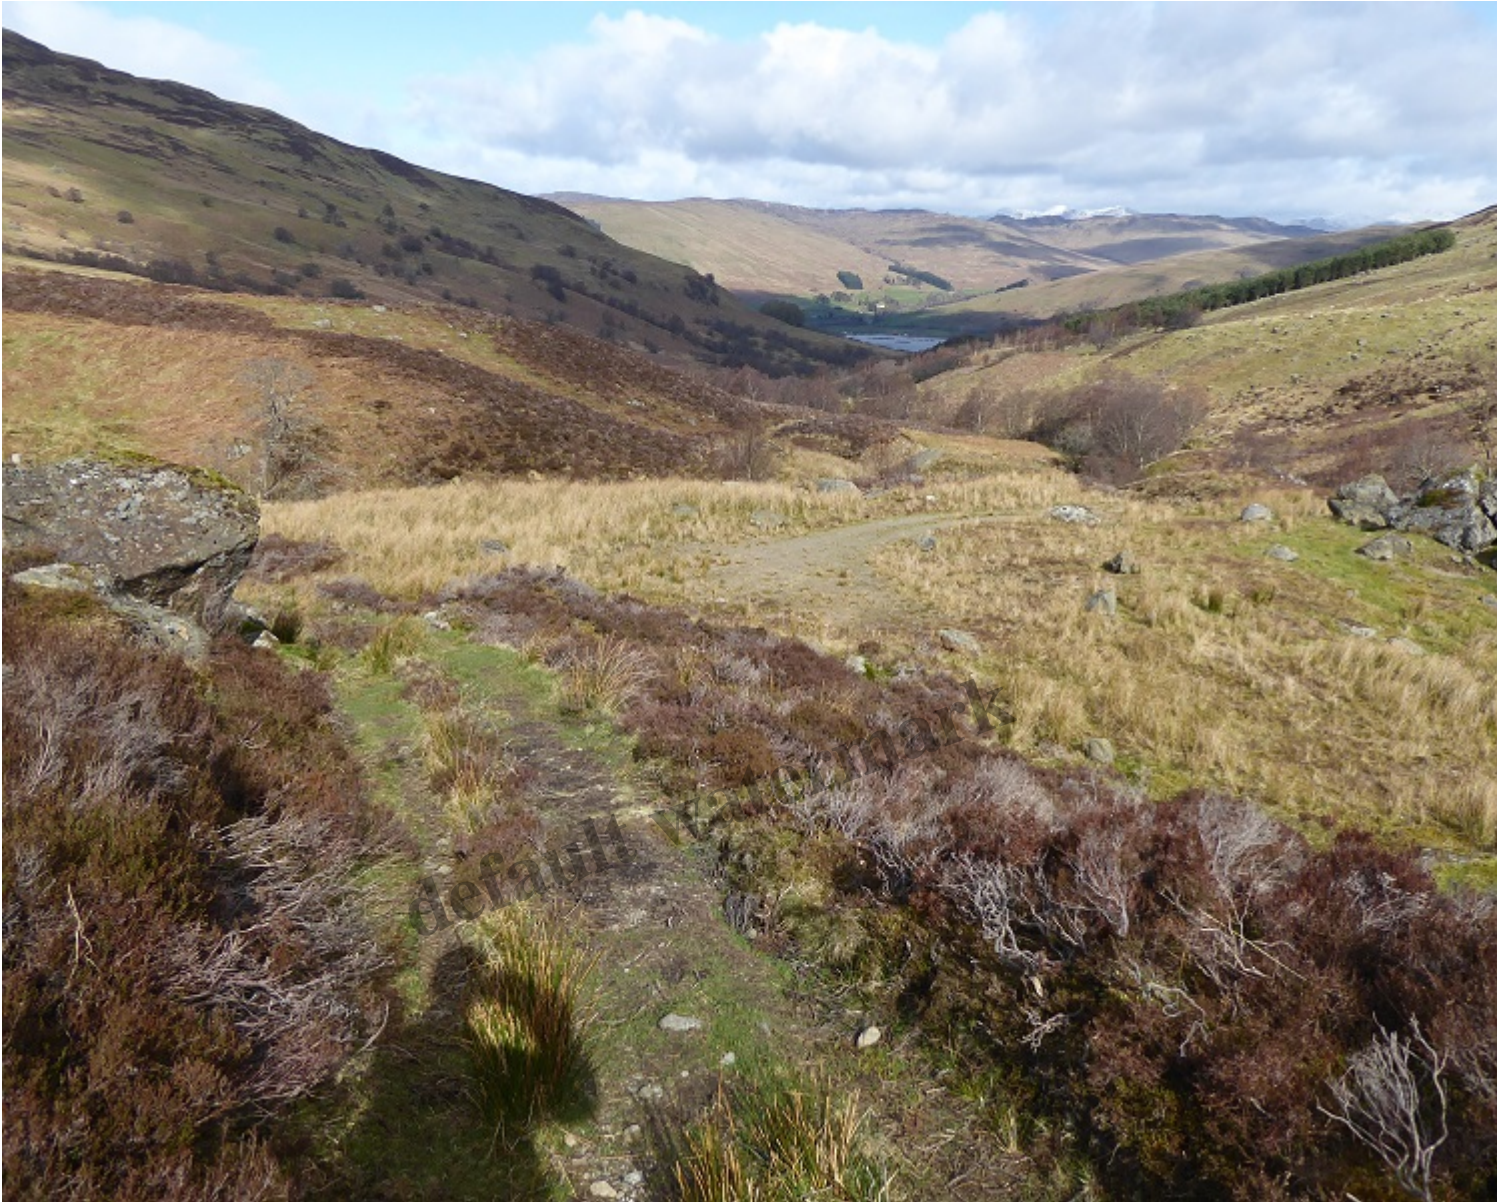
The formal track also ends short of the eastern intake (to right of view in photo) although an ATV eroded track continues up the glen (in place of the old path). What is good about this track is that there is no large turning area which is so common with so many other hydro tracks.

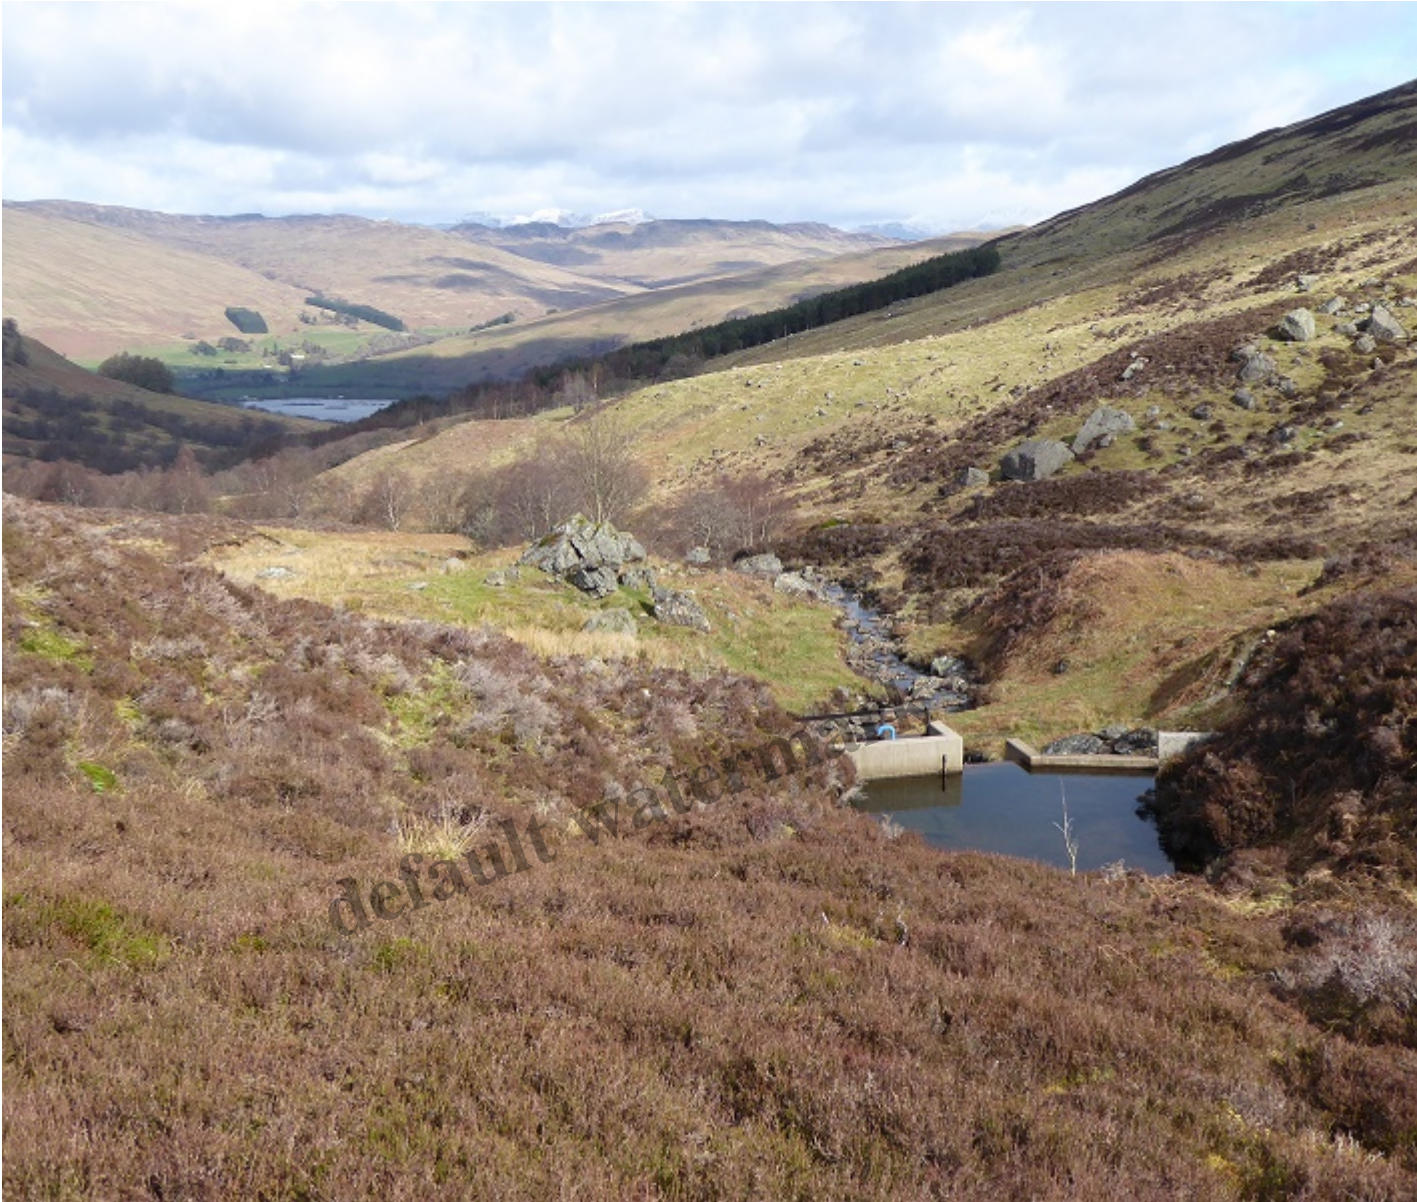
Eastern intake on Allt

The second intake is closer to the track than the first and more intrusive. While the lower concrete has stained there is a much greater expanse of light grey concrete retaining wall, which is made even more obvious by the Lomond blue piping. Added to this there rip-rap boulder embankment on the far side of the burn and the excavation of the banks on either side of the burn where vegetation has not recovered (its too steep, just like the bank of the track below the bridge). The design of this intake could, in my view, have been considerable improved and the impact on the landscape reduced.

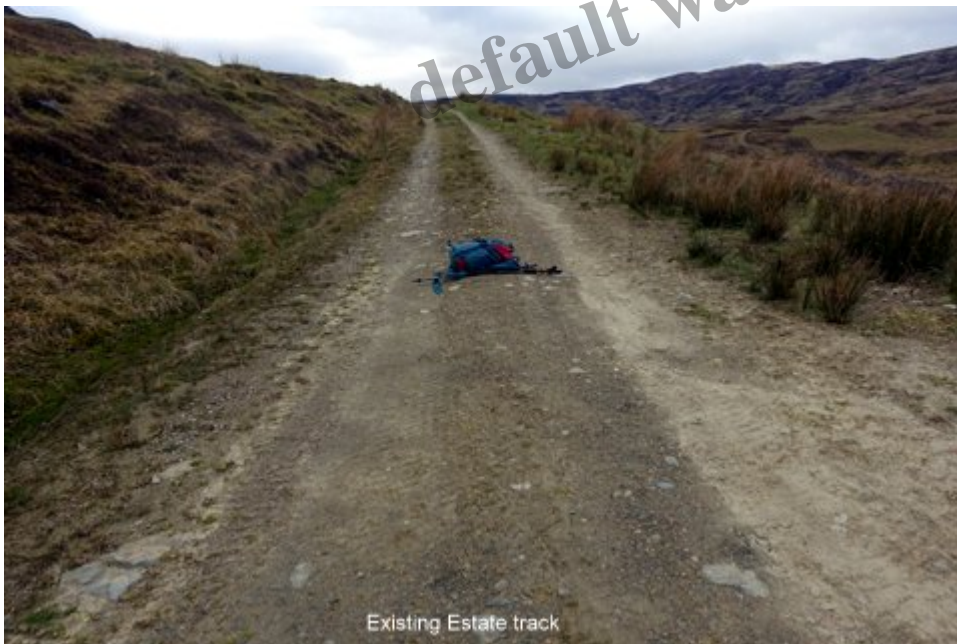
An existing track was used for construction purposes and, because the size of the scheme was relatively small, it appears the track did not require extensive upgrading. Vegetation appears to be recovering well which will give it a more “natural” feel for walkers.

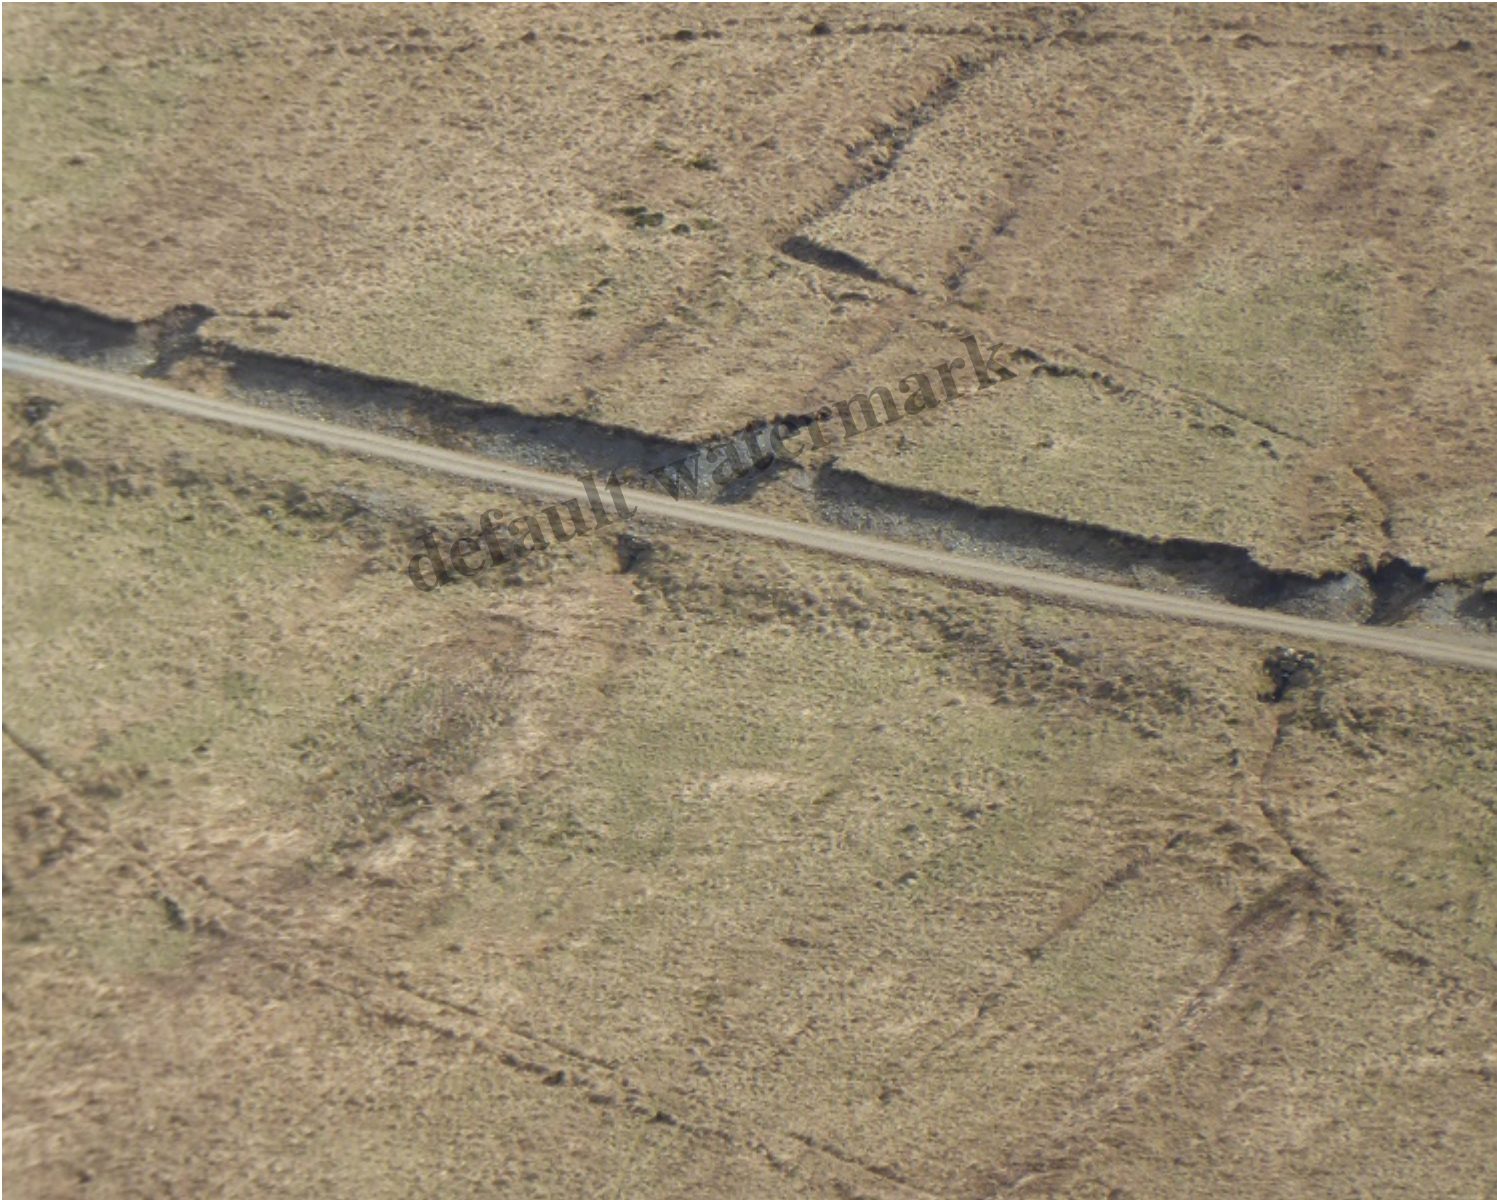
The Tarken Glen track though is not nearly as bad as the new track (above) you can see from the summit of Meall Rheamhar in Gleann Ghoinean which again lies outwith the National Park boundary to the south.
