The Loch Earn hydro schemes – and surprise general elections!

Ardvorlich estate hydro scheme

Tarken Glen hydro scheme

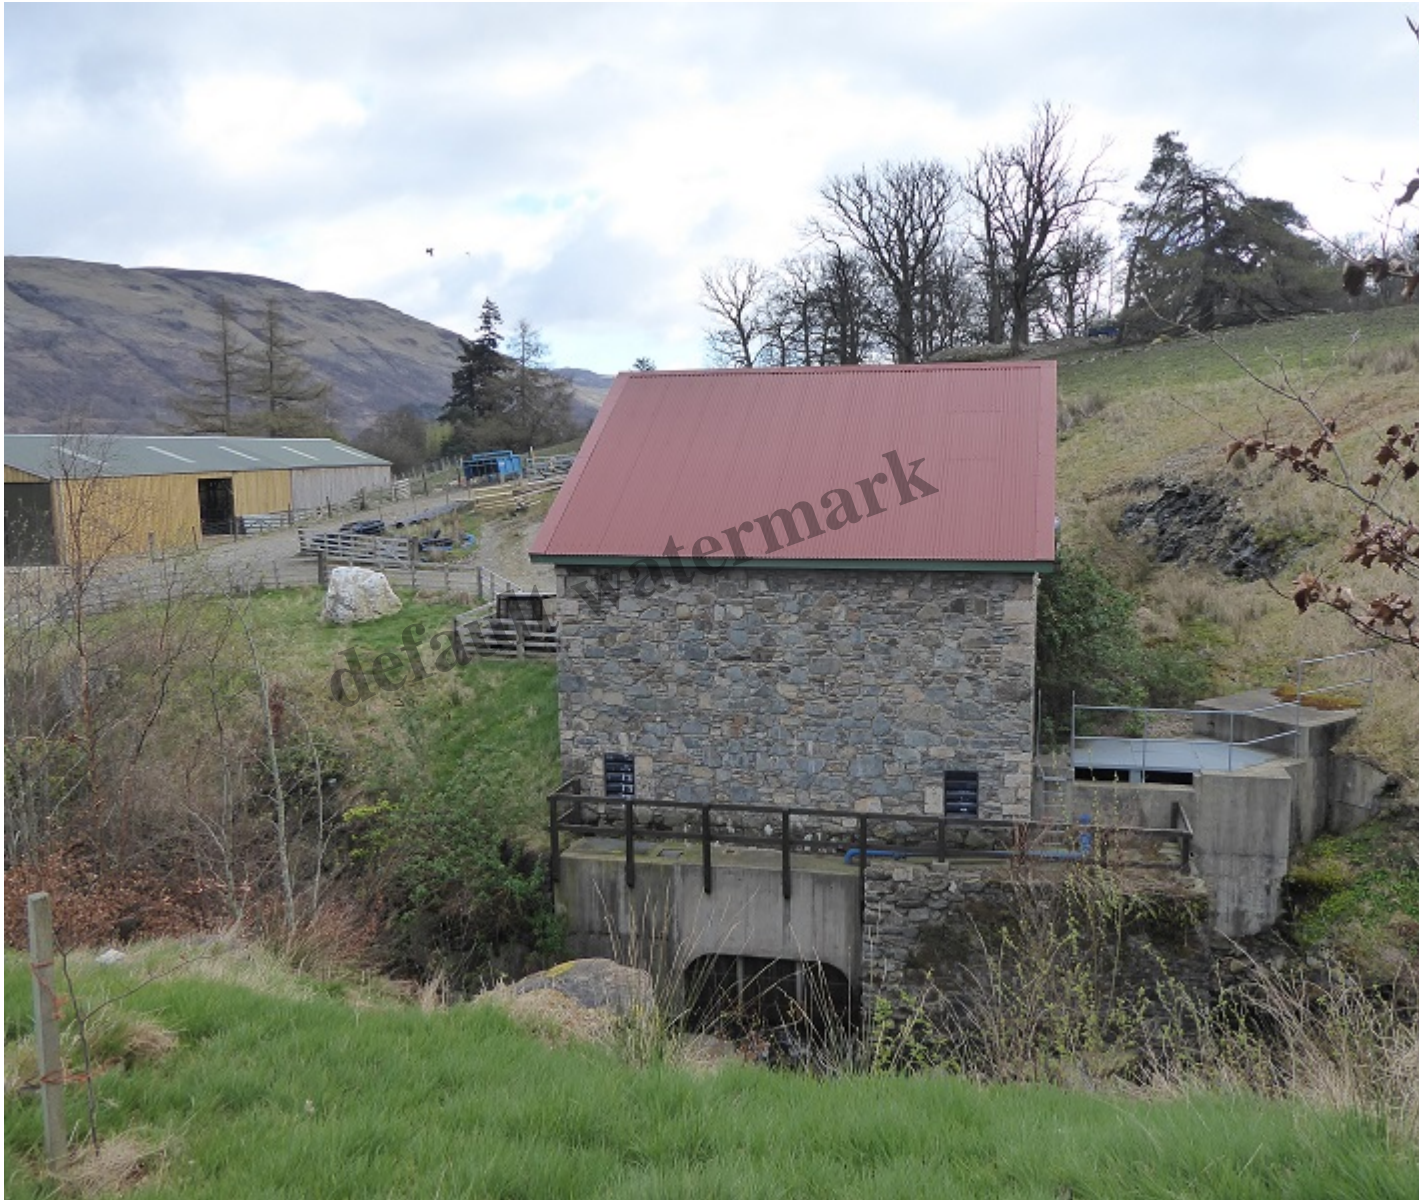
The Ardvorlich powerhouse on the east side of the burn followed by the main path up Ben Vorlich from north. It was designed to resemble the traditional water mill that was once located here. Had the intake tailrace also been finished in natural stone, this aspiration would have been met.

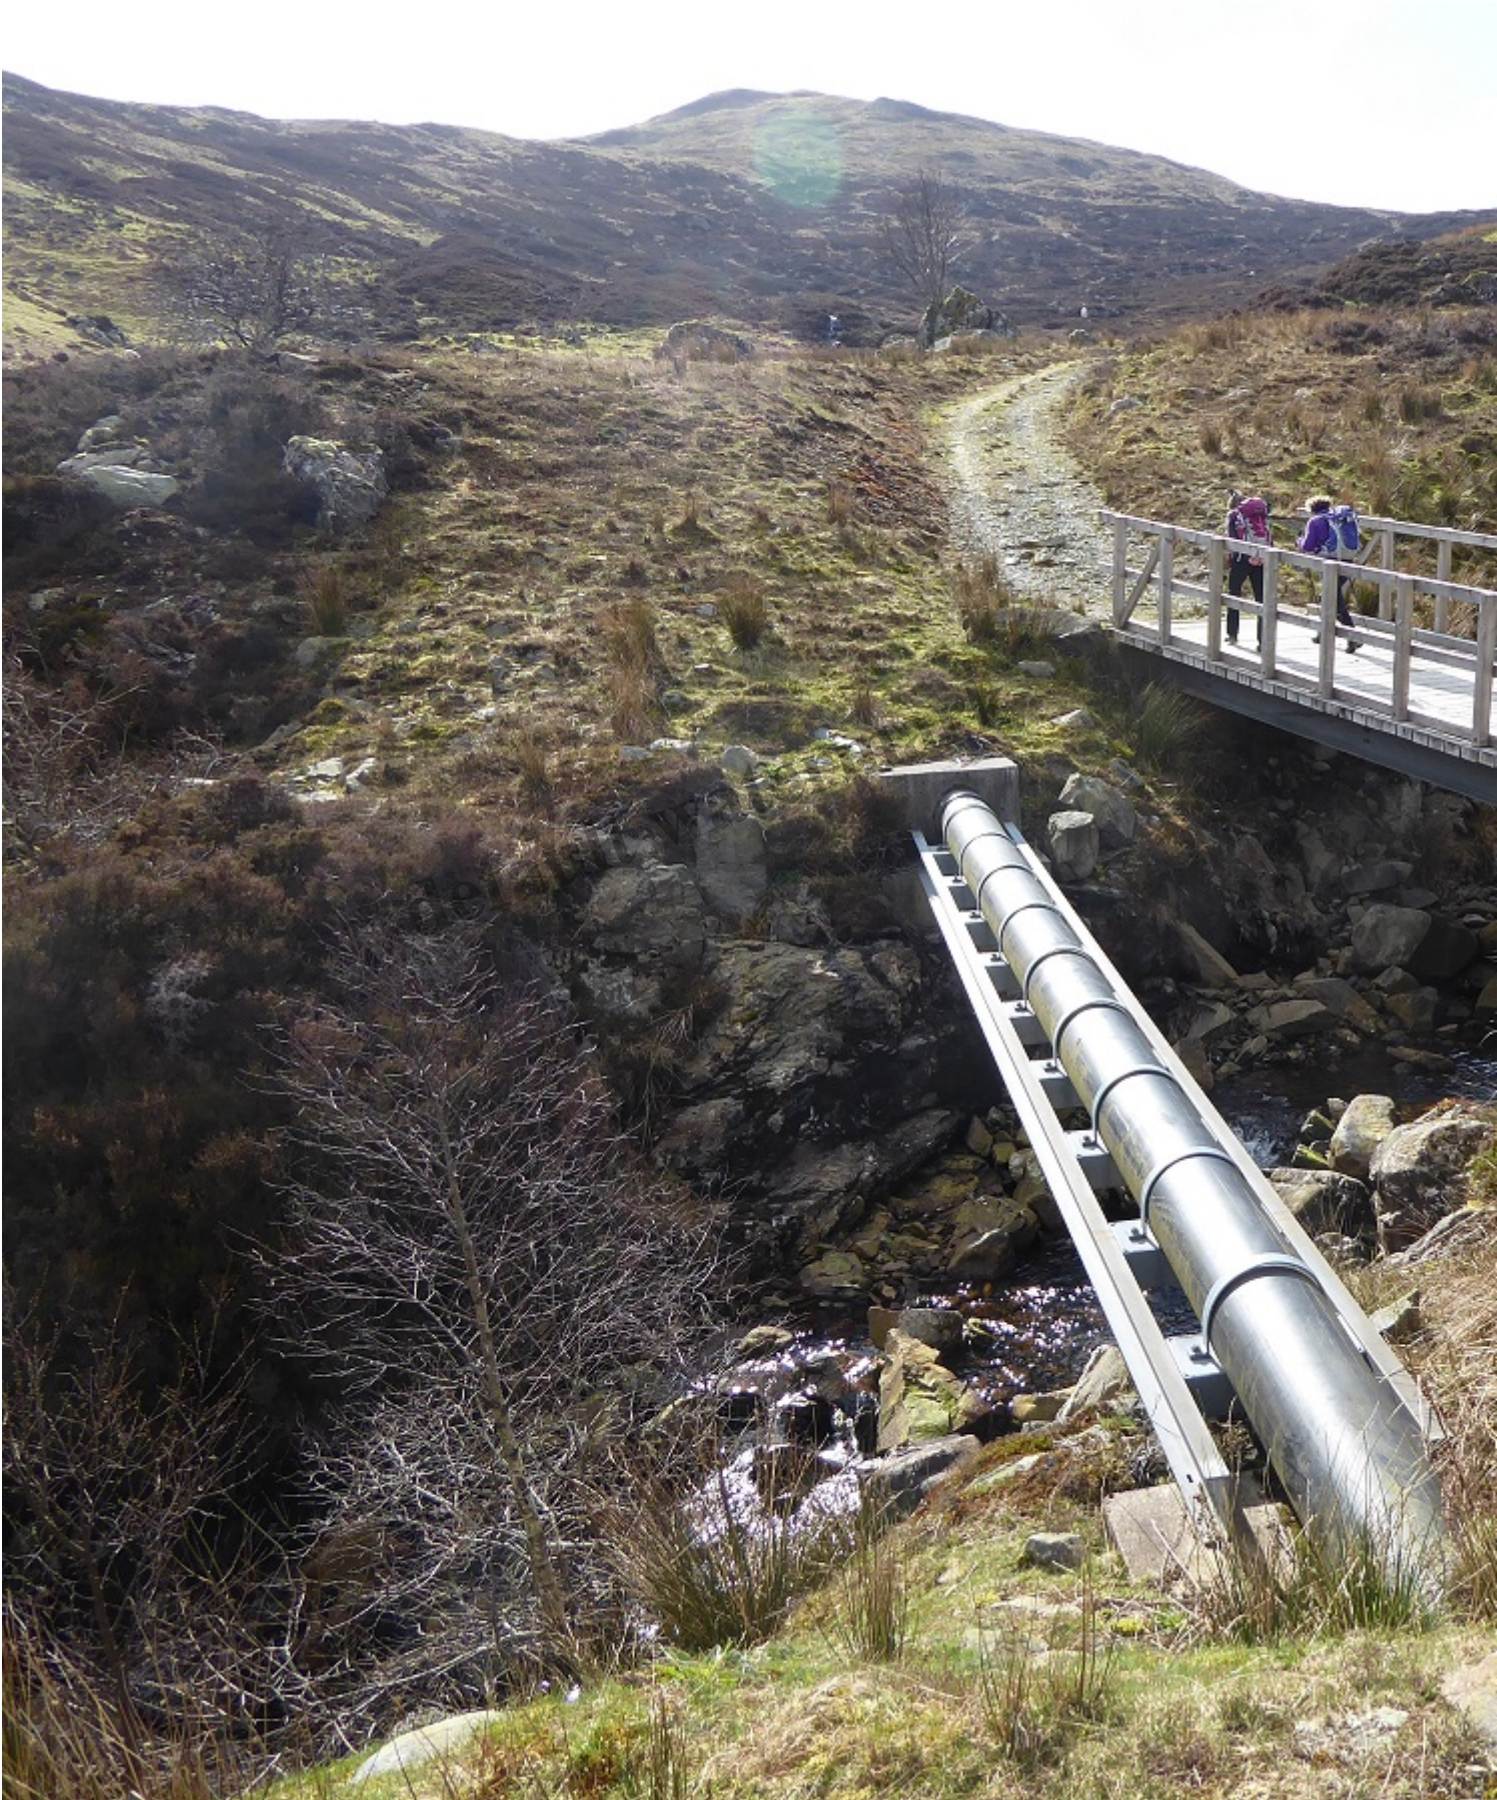
The Ardvorlich hydro was granted planning permission back in 2009, before the LLTNPA published its guidance stating that pipes should wherever possible be placed under bridges and the only paper currently on the planning portal is the decision notice ([see here](#)). Its not possible therefore to what what consideration was given to this pipe across the burn which in my view is the single worst aspect of scheme. It should not have been so difficult to align the pipe with the bridge and track so the pipe was concealed by the bridge as at Keltie Water.

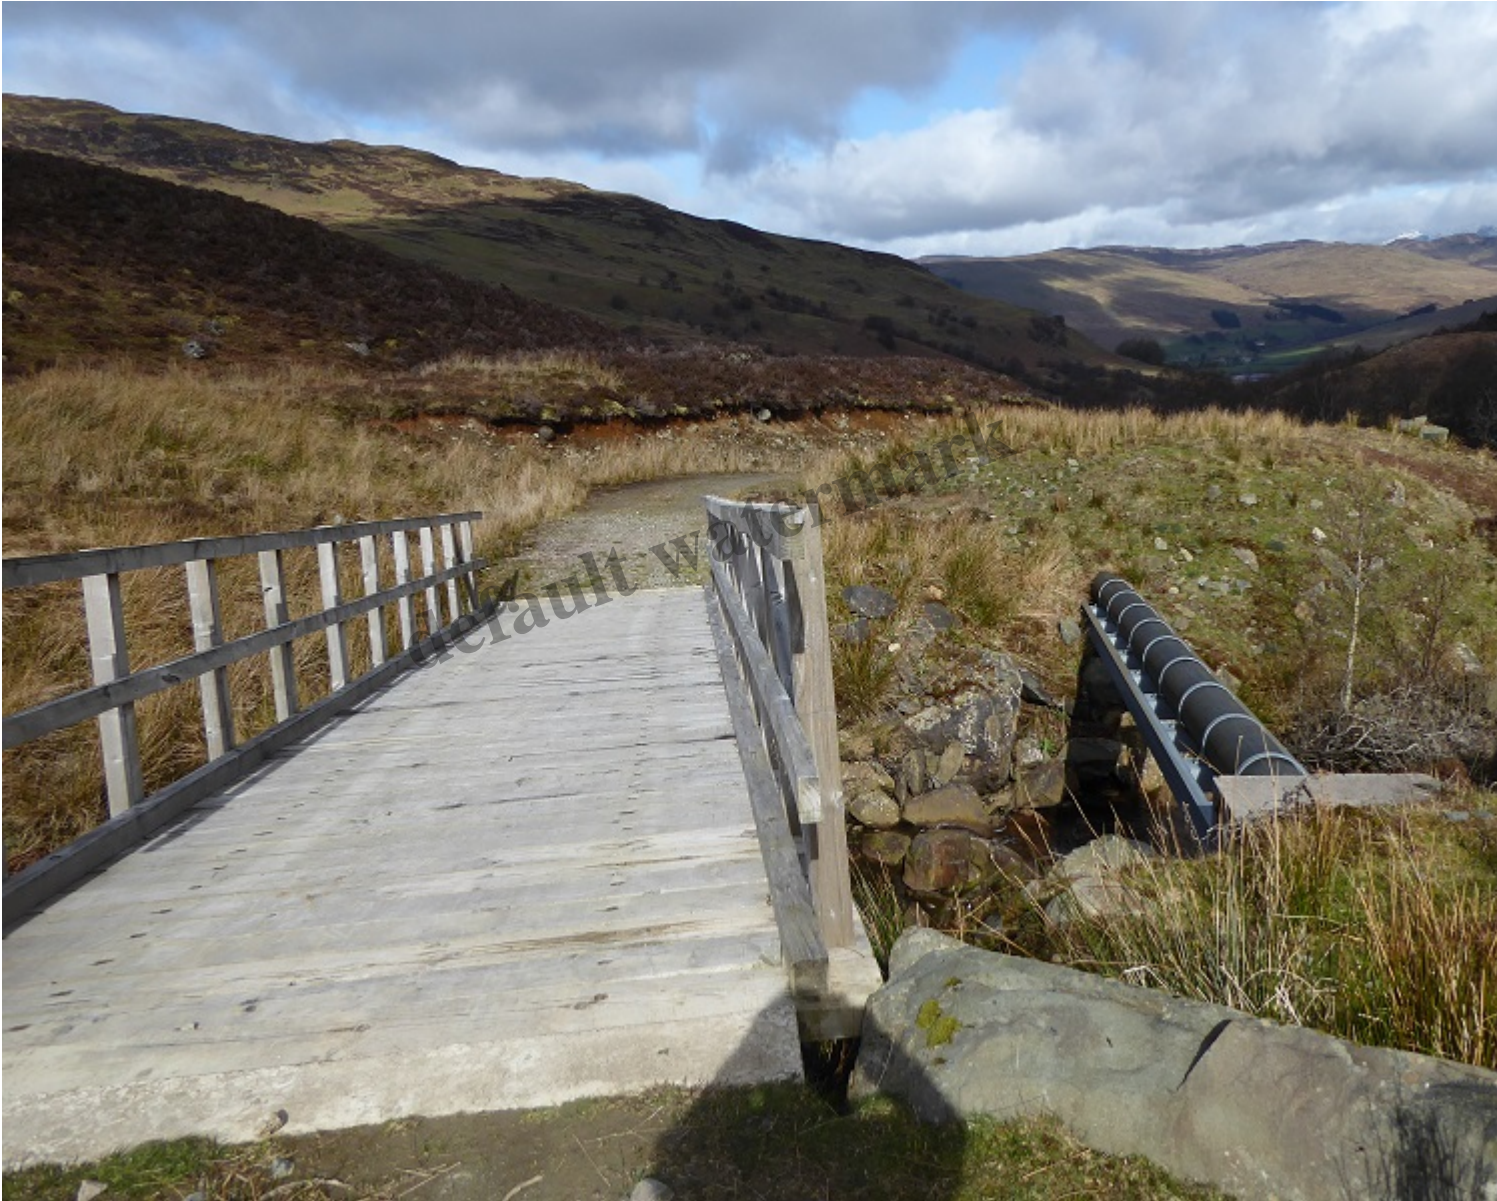
The biggest landscape impact is not where pipe runs underground – the ground above the buried pipe is recovering well – but the steep edge of the track – too steep to regenerate naturally and which is likely to continue eroding for years.

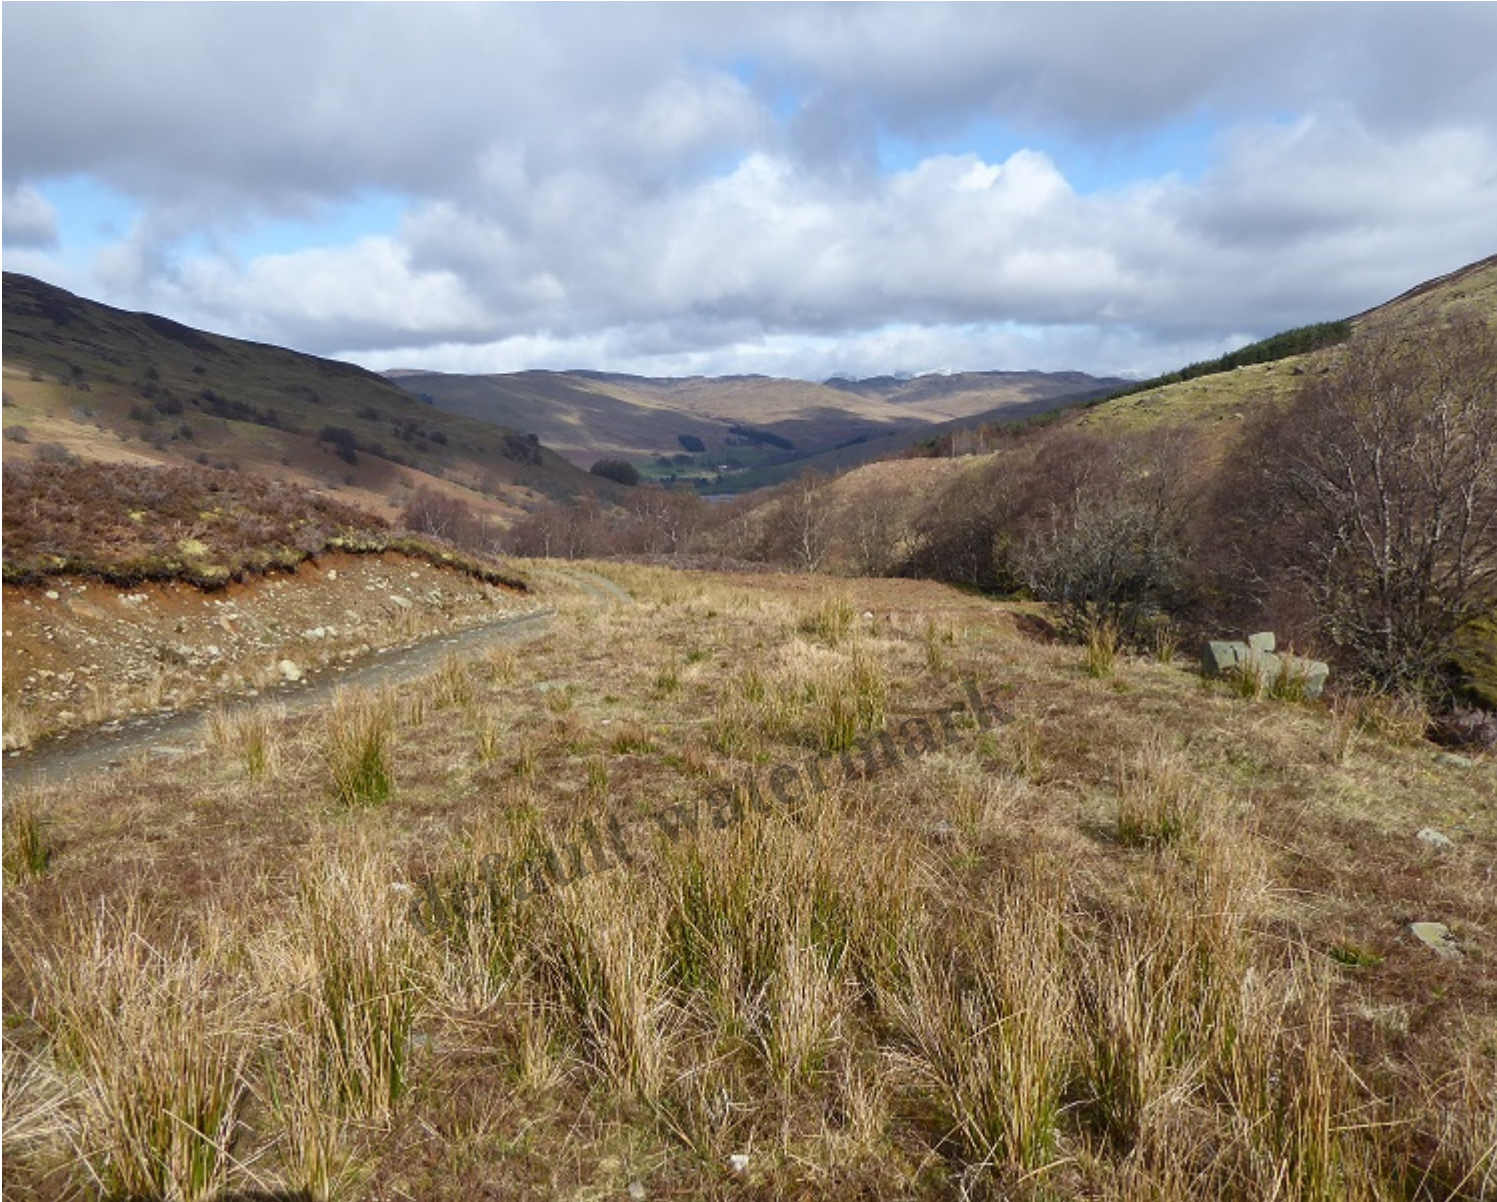
Same view from closer up: a few years and I suspect it will be very difficult, even for vegetation experts, to detect line of the pipeline, quite a contrast to the permanent landscape scar created by the track. According to my old OS Map, dating from 1988, at that time there was just a path up the west side of the burn. Now there is a vehicle track on both sides.

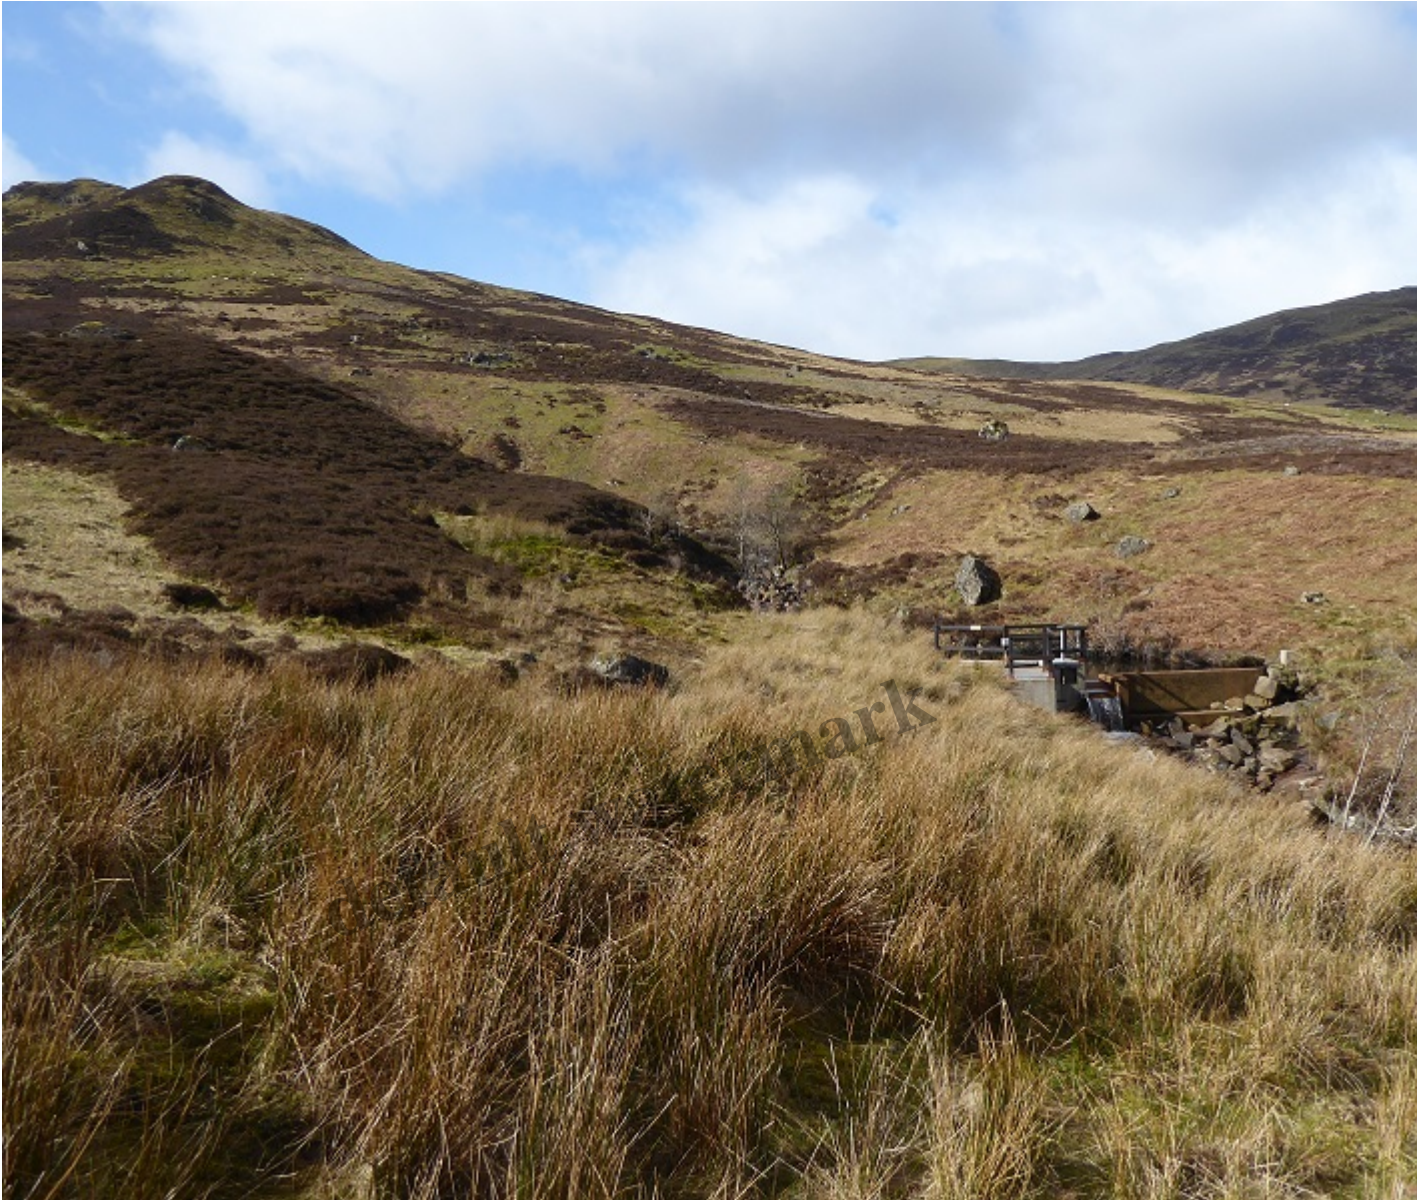
View of western intake above fork in the burn – the main walker’s path up Ben Vorlich from the north
the skyline

There are two intake to the hydro scheme. The main visual impact of the western intake is the concrete on left side of dam which has not been faced with natural materials. The concrete on the right side appears to have coloured due to water flowing over it regularly so it blends better into the landscape. The wooden safety fence is also unobtrusive and fits in Park’s subsequent policy to use natural materials, such as wood for fencing.

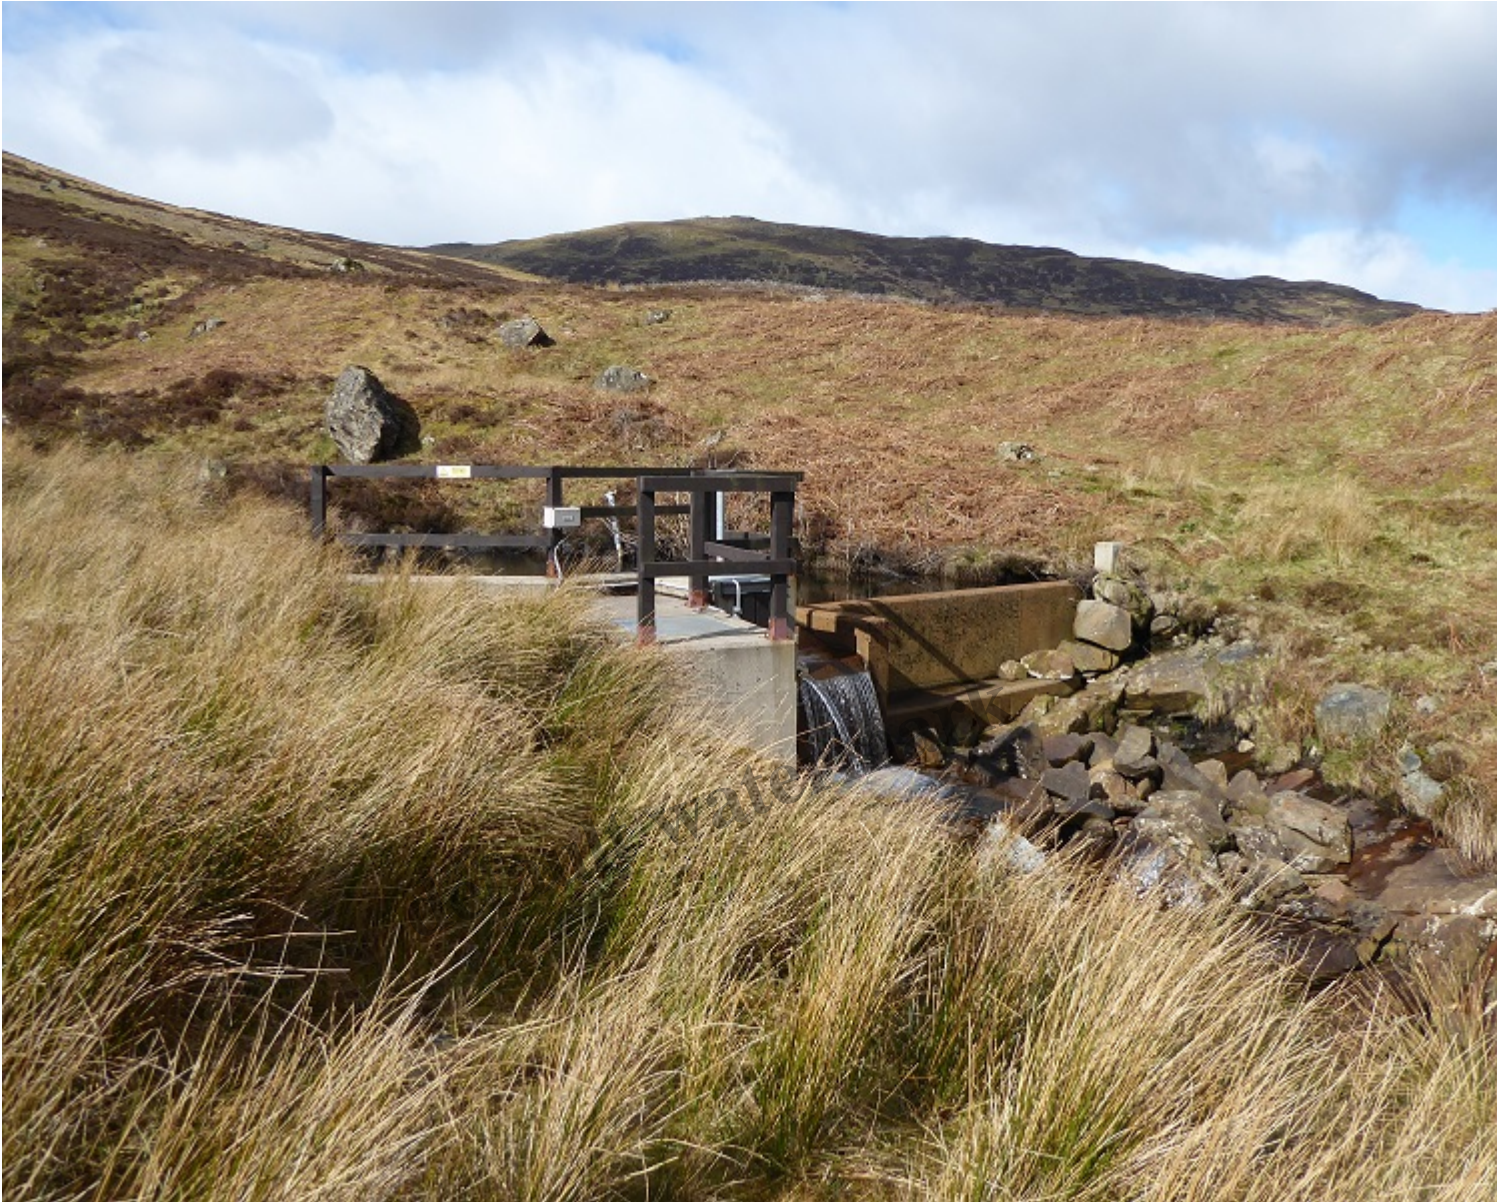
Closer up the main visual impact of the dam remains the grey/white concrete. If our National Parks and other planning authorities required intake structures to be finished in stone, except where likely to be stained by water, their visual impact would reduce considerably. The cost of this would be minimal and it could reduce carbon imprints.

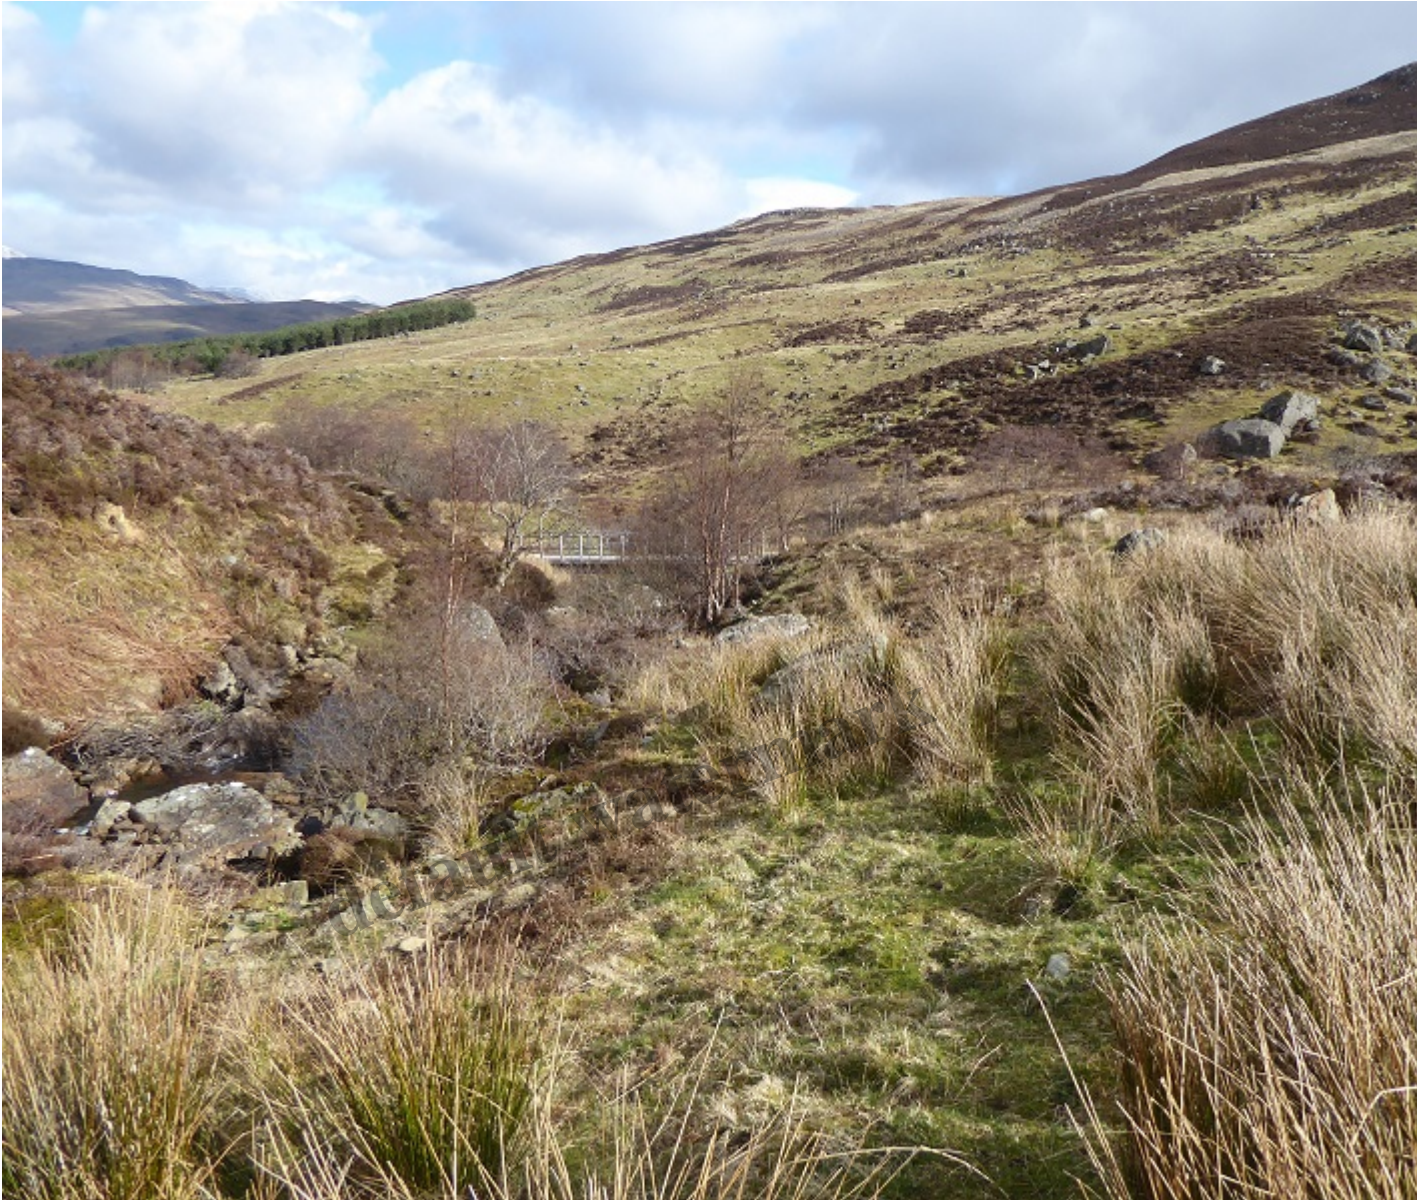
View from just below western intake dam to bridge (where pipe crosses burn). The pipe runs beneath grassy/mossy section in centre of photo. Even though the greenery is probably explained by the failure of heather to recover yet, its almost impossible to tell now that this conceals a pipeline – successful re

The visual impact of the dam is also reduced because the track does not go right up to the dam, as in most later developments in the Park. There is nothing to draw your eye to it and as a result many people walking up the track probably miss it.

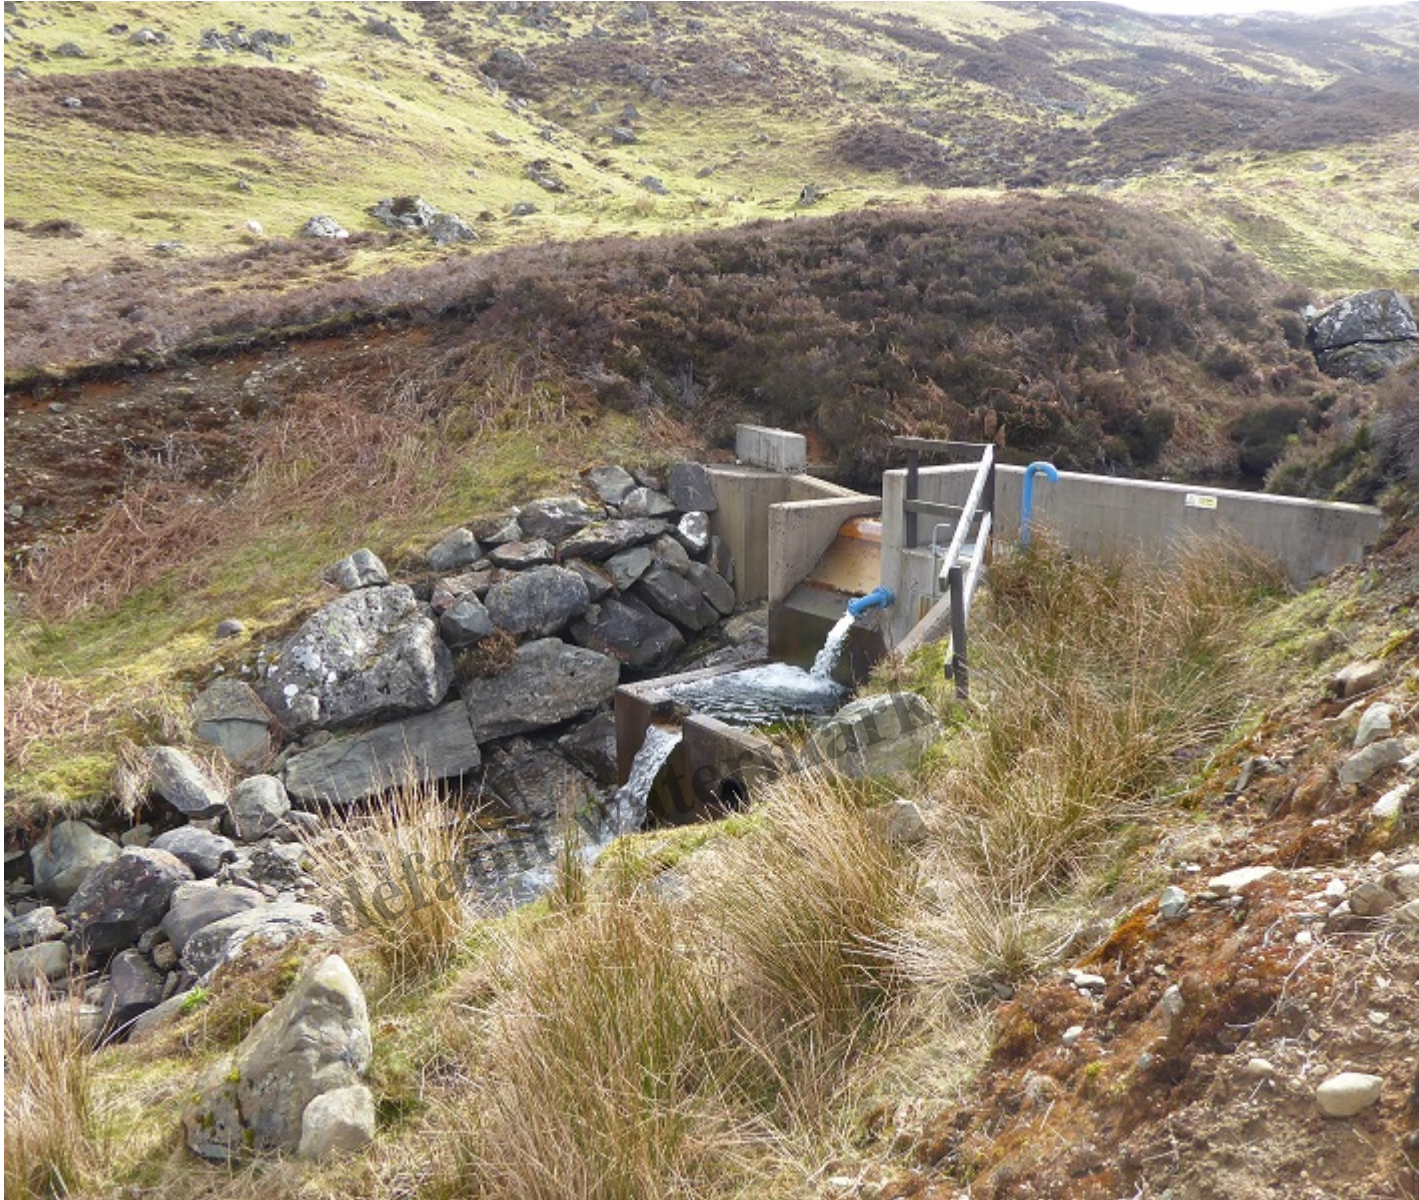
Eastern intake on Allt

The second intake is closer to the track than the first and more intrusive. While the lower concrete has stained there is a much greater expanse of light grey concrete retaining wall, which is made even more obvious by the Lomond blue piping. Added to this there rip-rap boulder embankment on the far side of the burn and the excavation of the banks on either side of the burn where vegetation has not recovered (its too steep, just like the bank of the track below the bridge). The design of this intake could, in my view, have been considerable improved and the impact on the landscape reduced.

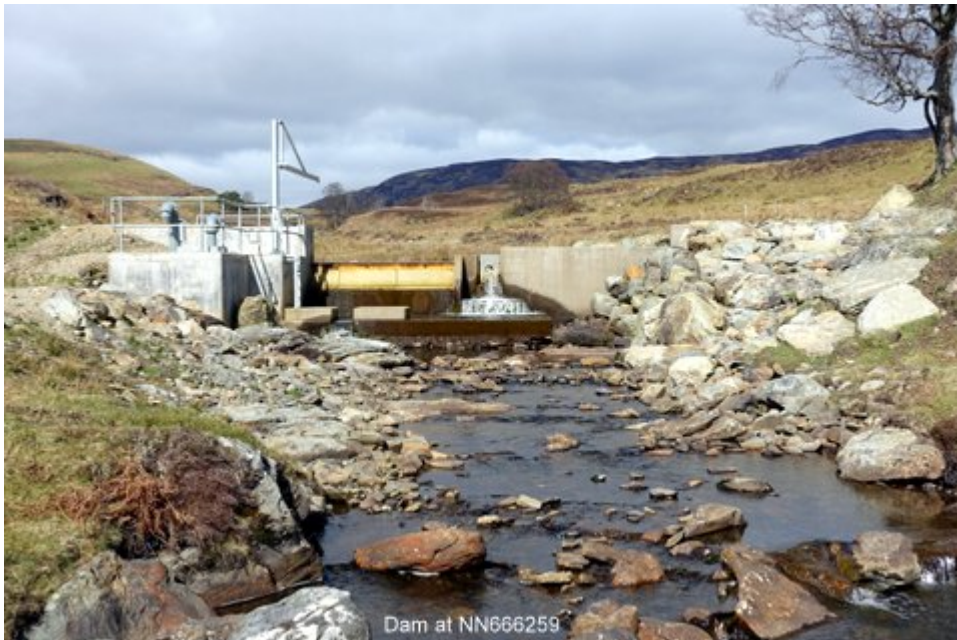
While the intake is outwith the National Park, it is fairly typical of those found within our National Parks, being constructed out of white/grey concrete partially concealed by rip rap tendering. The gantry adds to the visual impact although viewers will note the piping is not bright "Lomond" blue. The location of

this dam in a wide open glen makes it more visible than those at Ardvorlich.

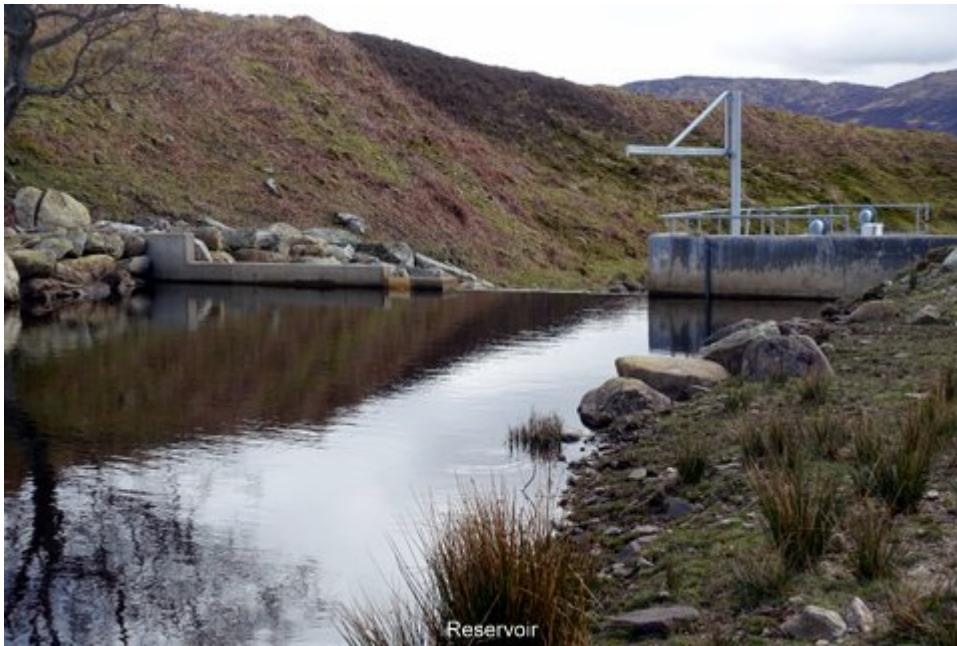
View of intake from above – photo credit Jim Robertson

The rip-rap bouldering looks as artificial as the concrete dam.

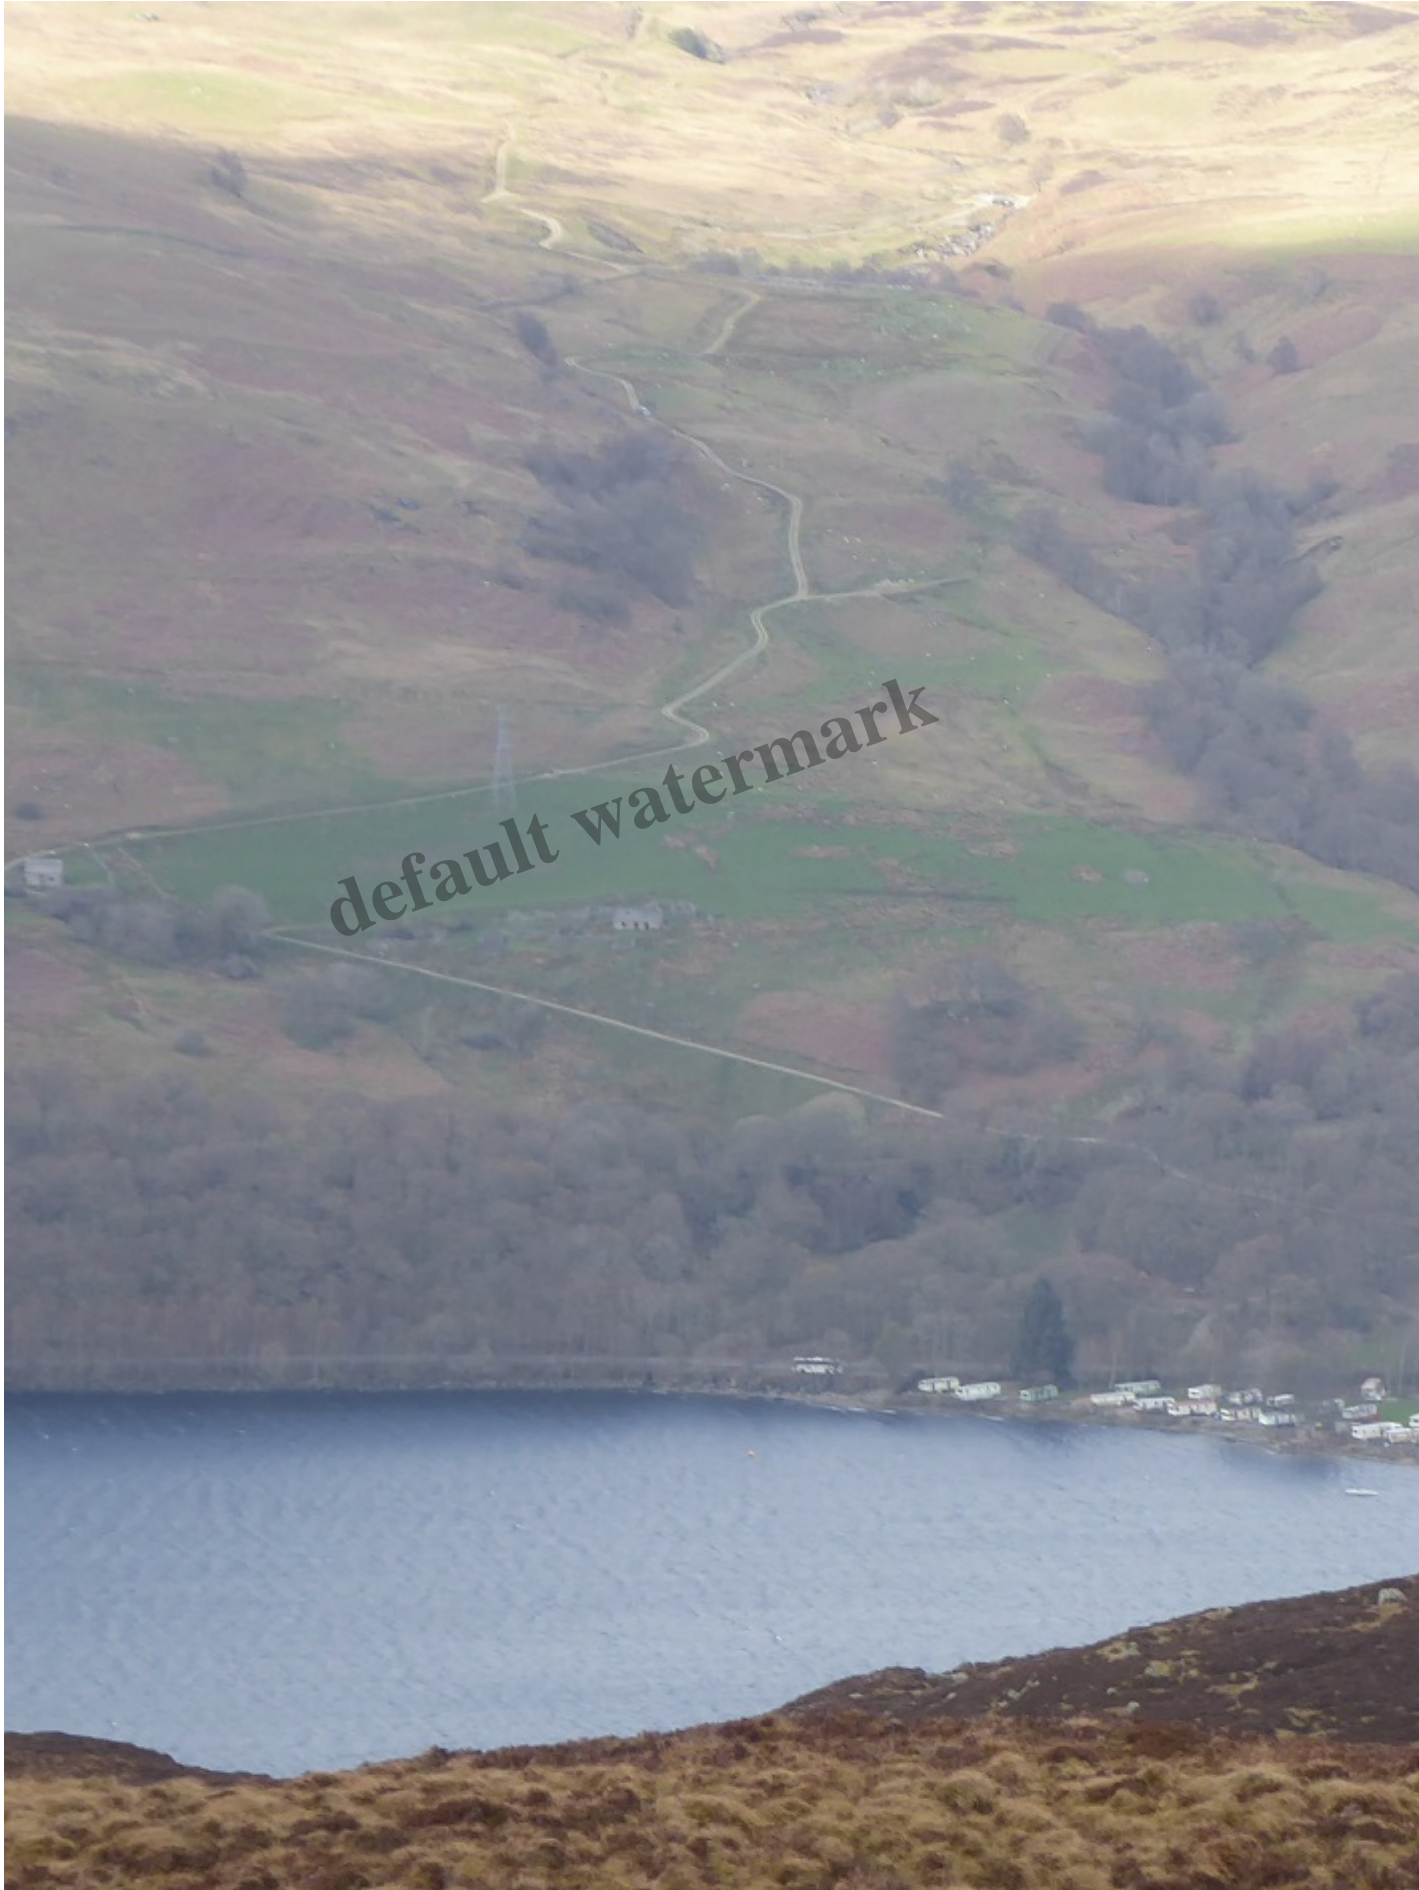
View of Tarken Glen from Meall Rheamhar above Fin Glen – the power house is behind the large ag covered area to the left of the burn.

The photo demonstrates once again that the main impact of hydro schemes is not the pipeline, where these are buried, but the access tracks. While in this case the track was already in place, where tracks cut across the grain of the landscape, as in the middle ground of this photos where the track goes diagonally uphill, they are particularly prominent. While the LLTNPA did refer to the visual impact of the scheme from the South Loch Earn road, it made no recommendations about what might be done to mitigate the impact of what can be seen from the National Park.

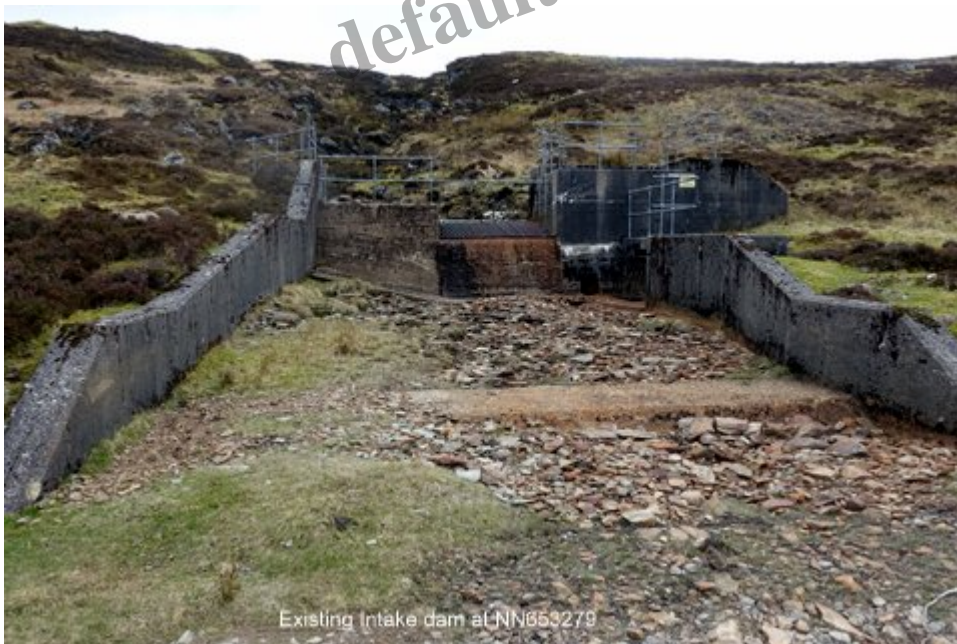
Existing Intake dam at NN853279

Jim's photo though raises questions about how much progress has been made in reducing the impact of dams and hydro intakes. In this case, the intake diverts all the normal flow of the burn, which will only flow in spate conditions, whereas intakes are always designed nowadays, due to greater awareness of hydrology and the framework of water catchment plans, to maintain some flow. Are the concrete embankments of the existing hydro intake though any worse than the rip rap tendering shown in Jim's second photo of the new scheme?

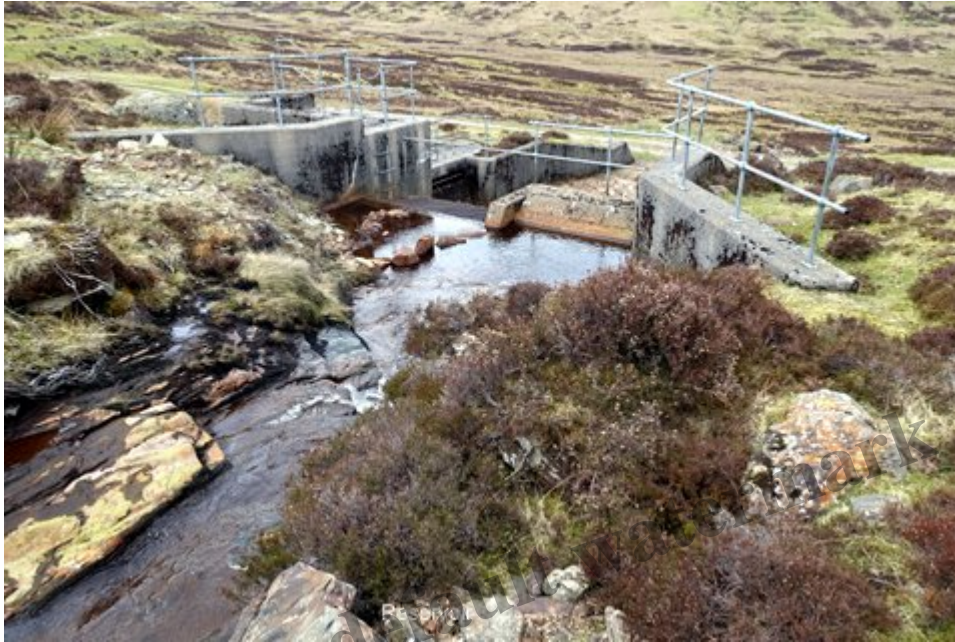
View from above intake – Photo Credit Jim Robertson

The photos also demonstrate just how long it takes for concrete retaining walls to be colonised by mosses and lichens and to start blending into the landscape. A good reason why the LLTNPA needs to enforce its guidance that concrete dam structures should wherever possible be faced with natural materials.
