The Loch Earn hydro schemes â?? and surprise general elections!

Ardvorlich estate hydro scheme

Tarken Glen hydro scheme

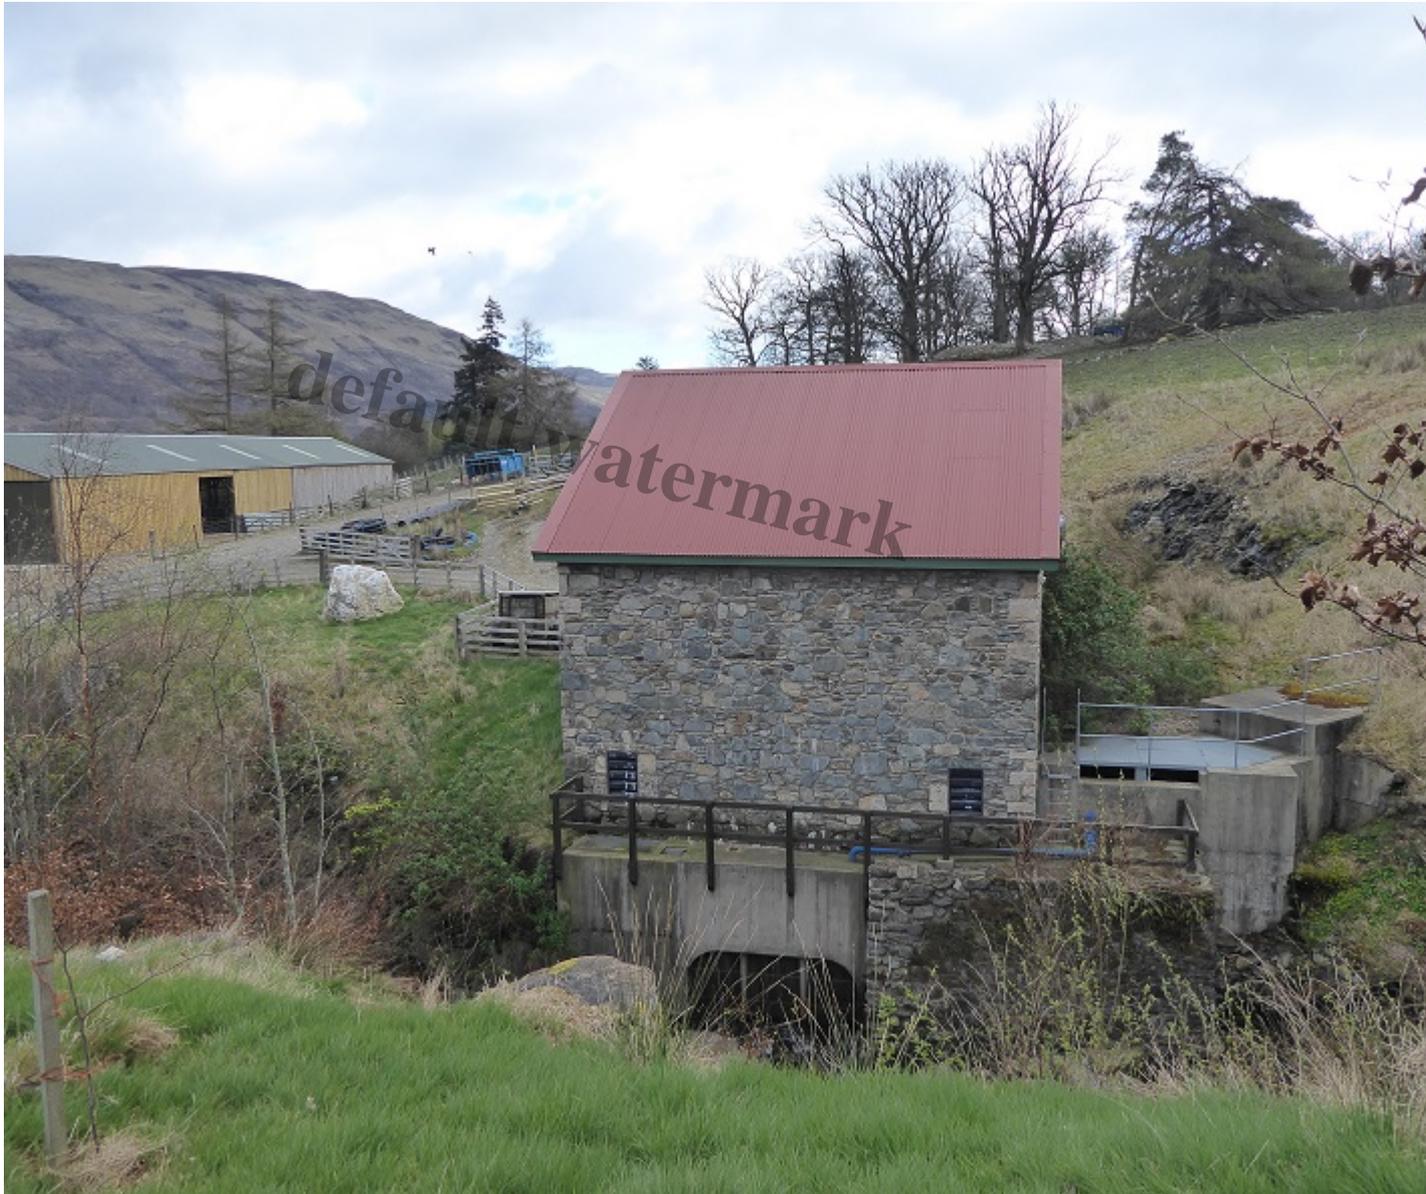
The Ardvorlich powerhouse on the east side of the burn followed by the main path up Ben Vorlich from the burn. It was designed to resemble the traditional water mill that was once located here. Had the intake and the concrete structure also been finished in natural stone, this aspiration would have been met.

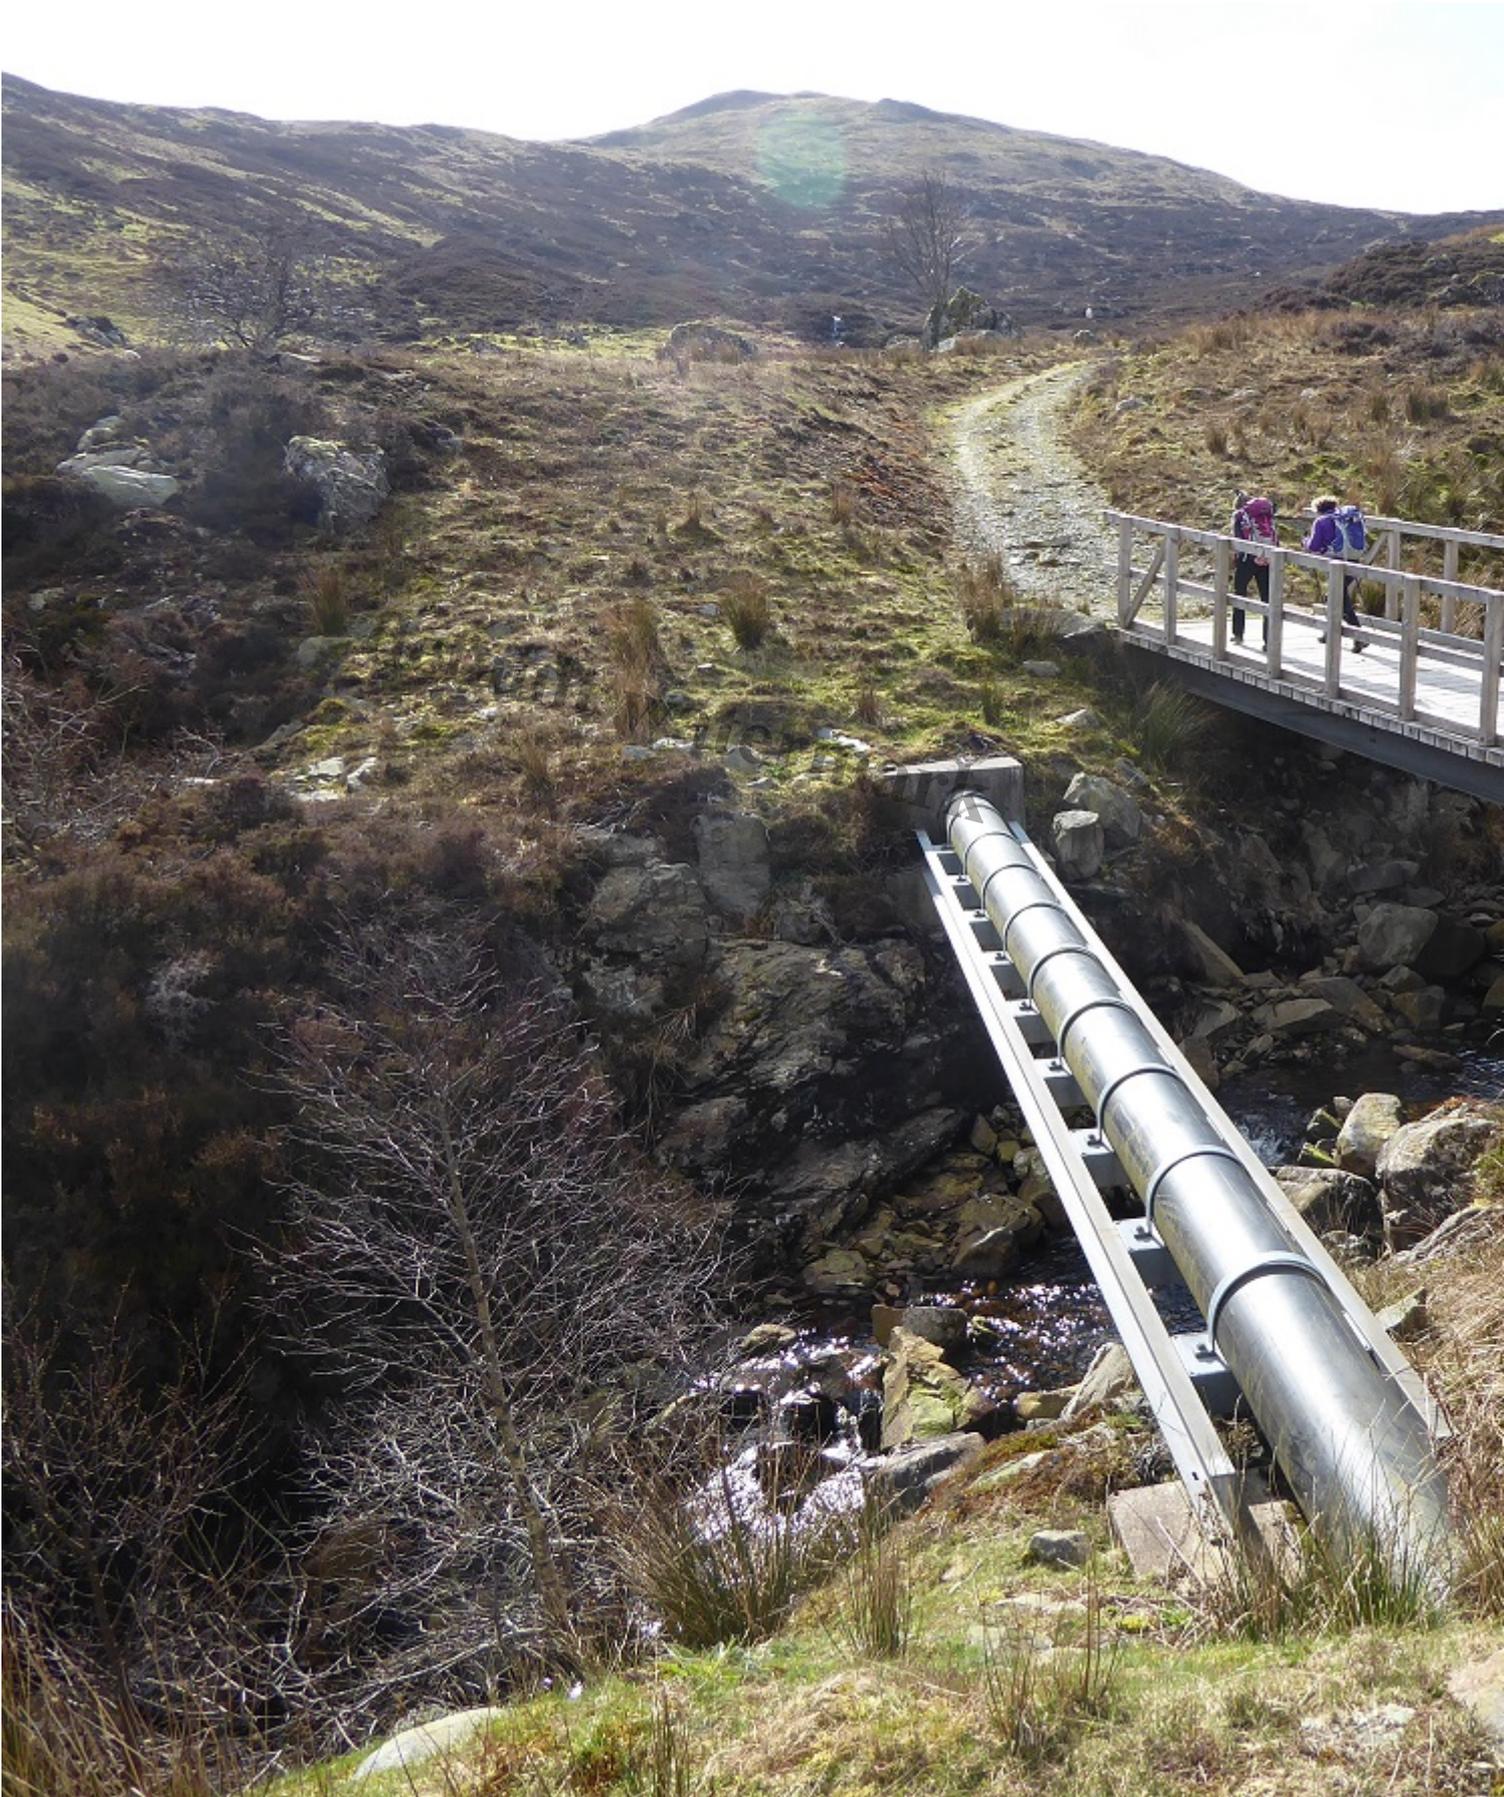
The Ardvorlich hydro was granted planning permission back in 2009, before the LLTNPA published its guidance stating that pipes should wherever possible be placed under bridges and the only paper currently on the planning portal is the decision notice ([see here](#)). Its not possible therefore to what what consideration was given to this pipe across the burn which in my view is the single worst aspect of scheme. It should not have been so difficult to align the pipe with the bridge and track so the pipe was concealed by the bridge as at Keltie Water.

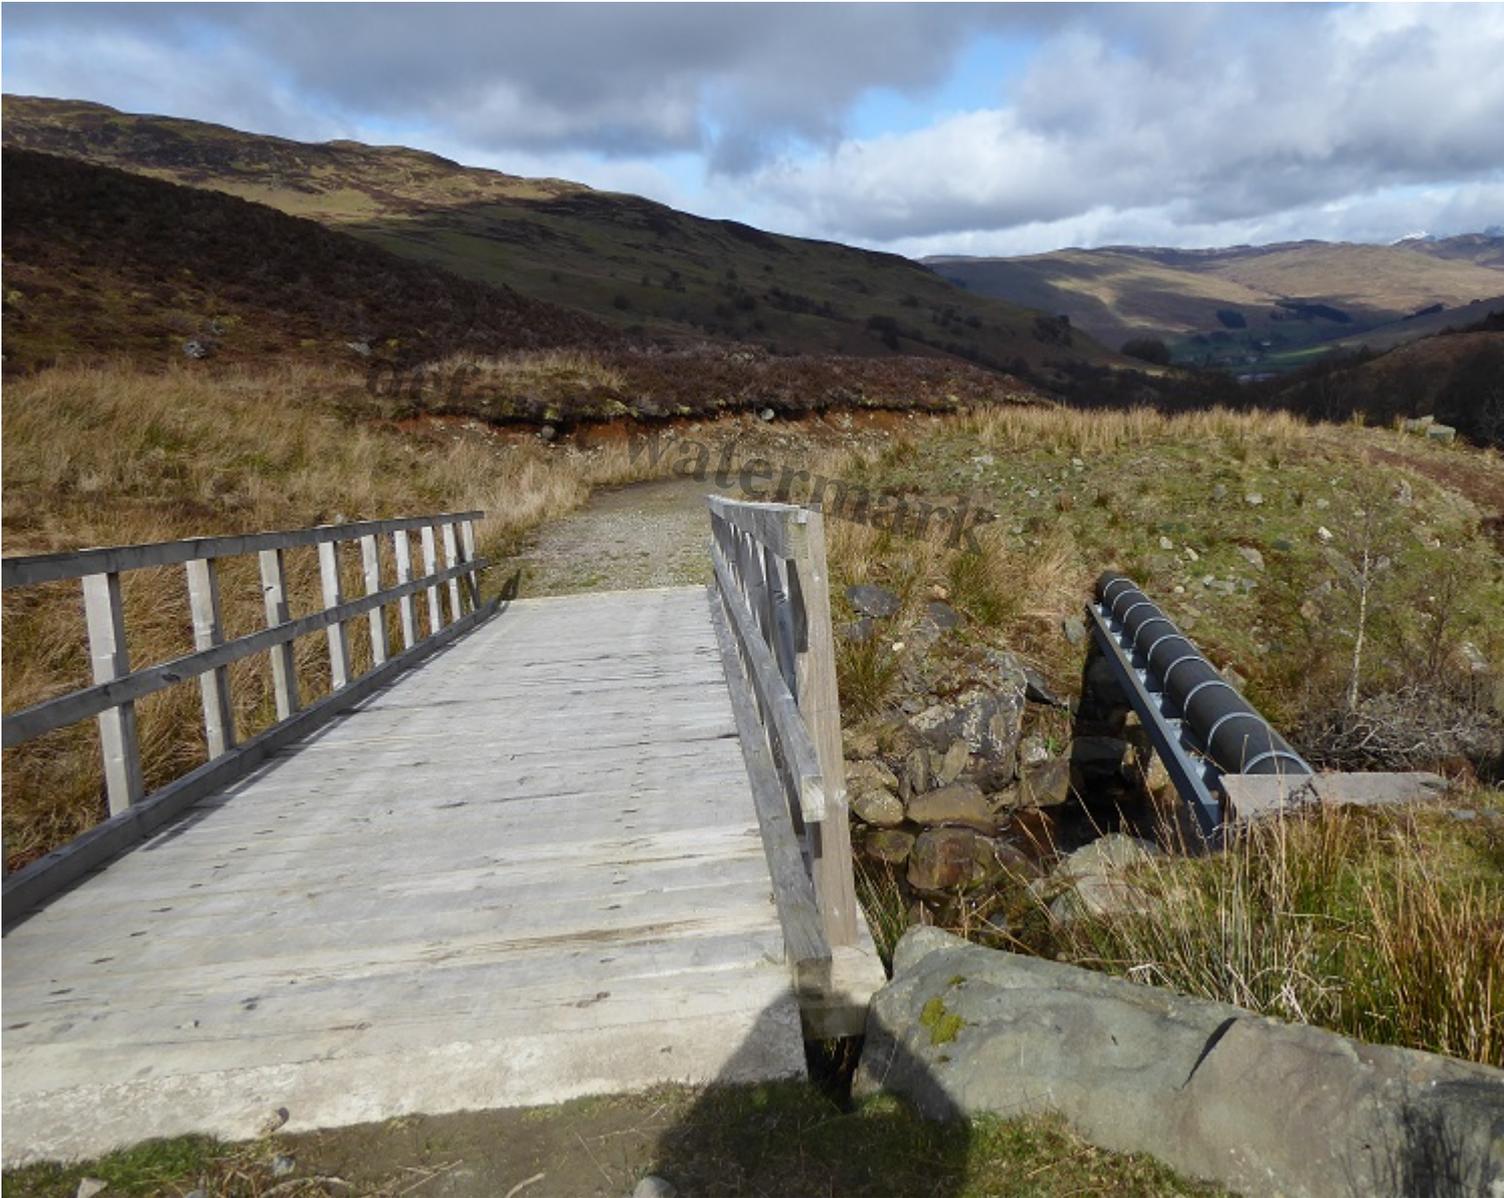
The biggest landscape impact is not where pipe runs underground â?? the ground above the buried pipe is recovering well â?? but the steep edge of the track â?? too steep to regenerate naturally and which is likely to continue eroding for years.

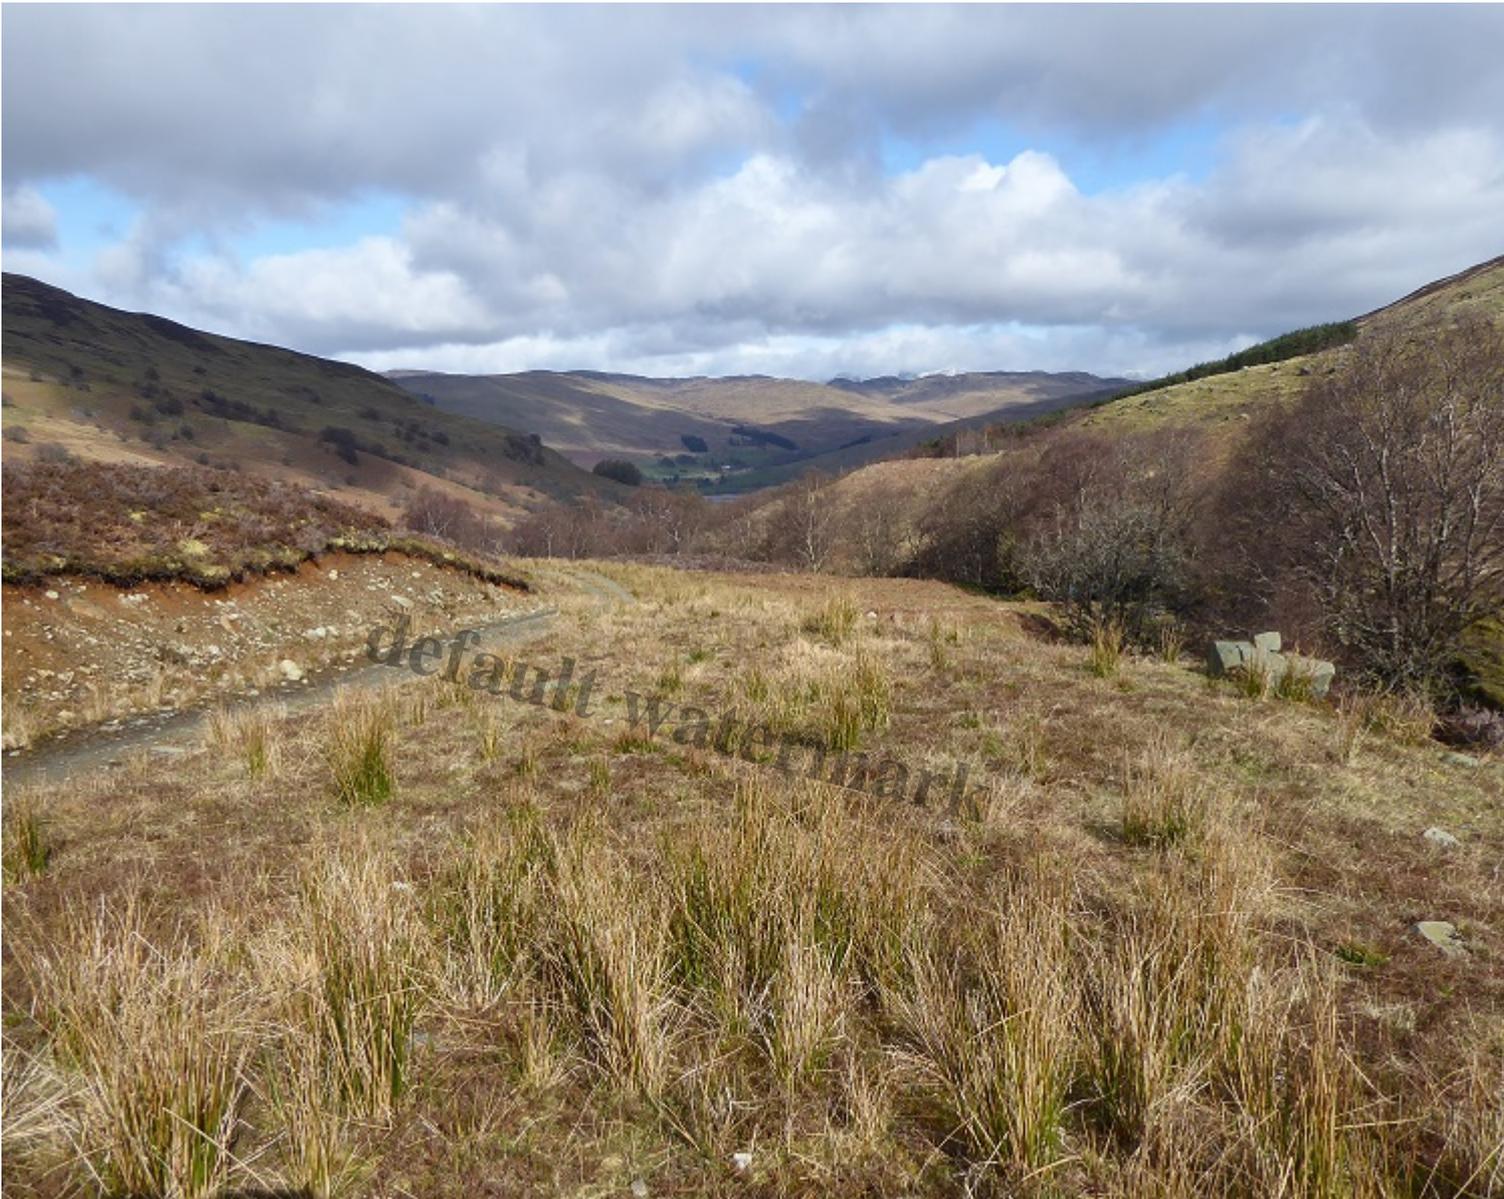
Same view from closer up: a few years and I suspect it will be very difficult, even for vegetation experts, to detect line of the pipeline, quite a contrast to the permanent landscape scar created by the track. According to my old OS Map, dating from 1988, at that time there was just a path up the west side of the burn. Now there is a vehicle track on both sides.

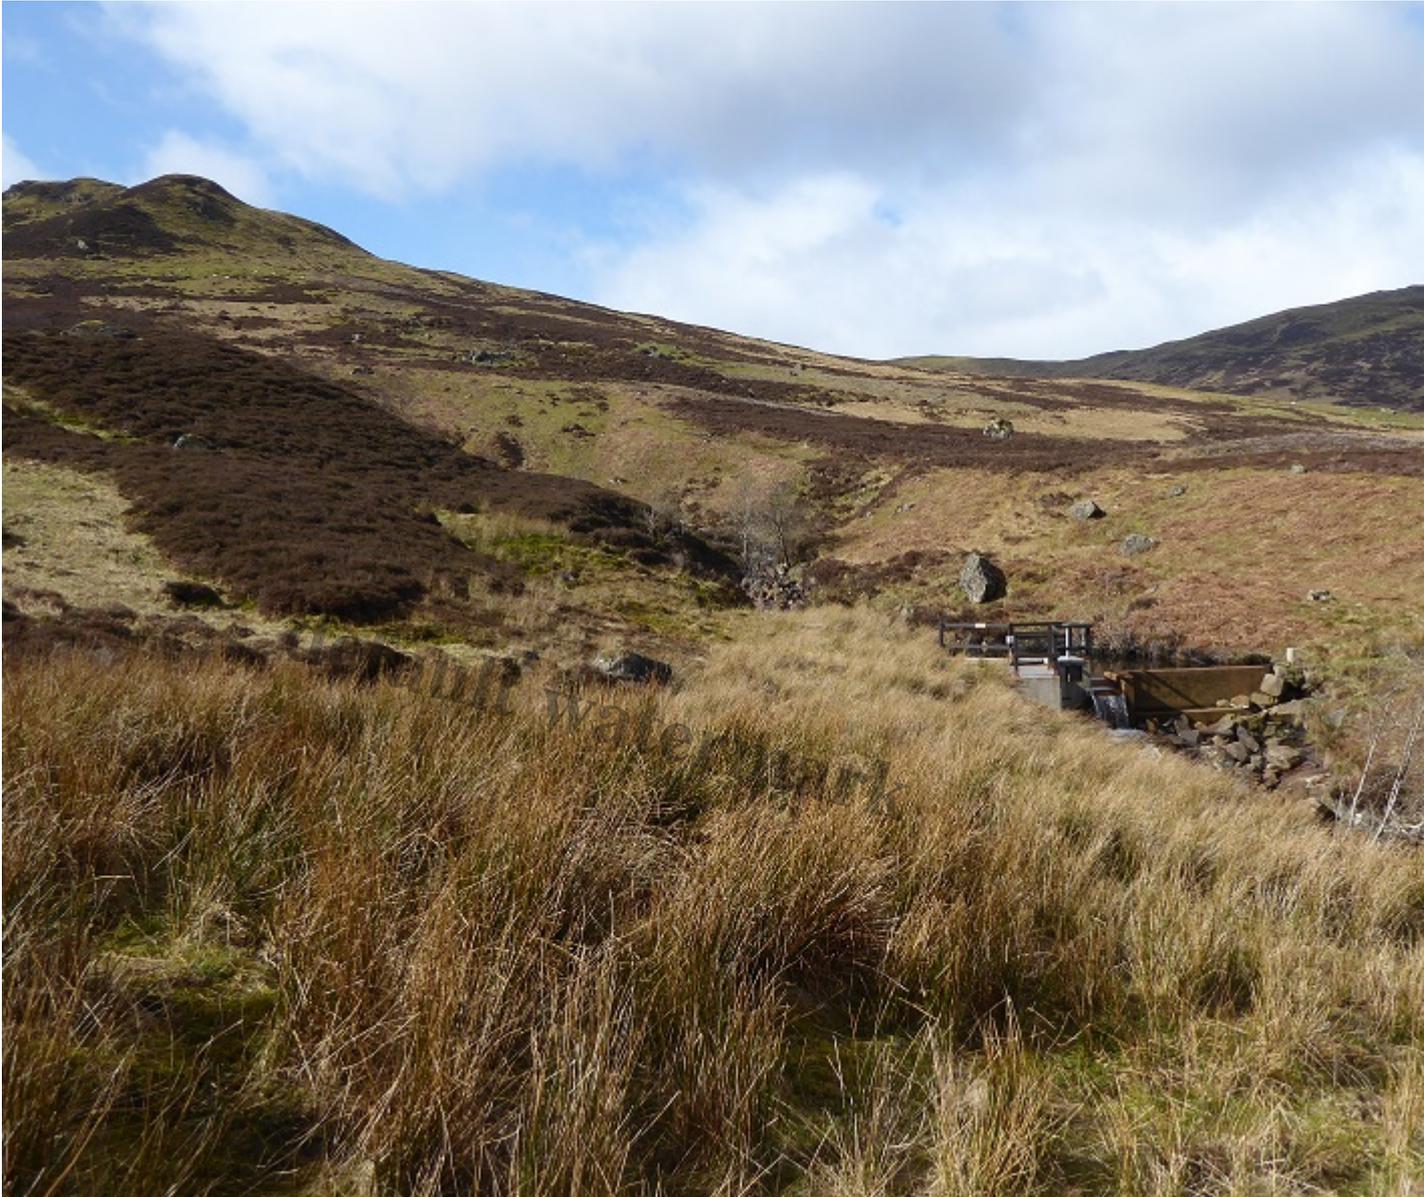
View of western intake above fork in the burn – the main walker’s path up Ben Vorlich from the up the skyline

There are two intake to the hydro scheme. The main visual impact of the western intake is the concrete on left side of dam which has not been faced with natural materials. The concrete on the right side appears to have coloured due to water flowing over it regularly so it blends better into the landscape. The wooden safety fence is also unobtrusive and fits in Park’s subsequent policy to use natural materials, such as wood for fencing.

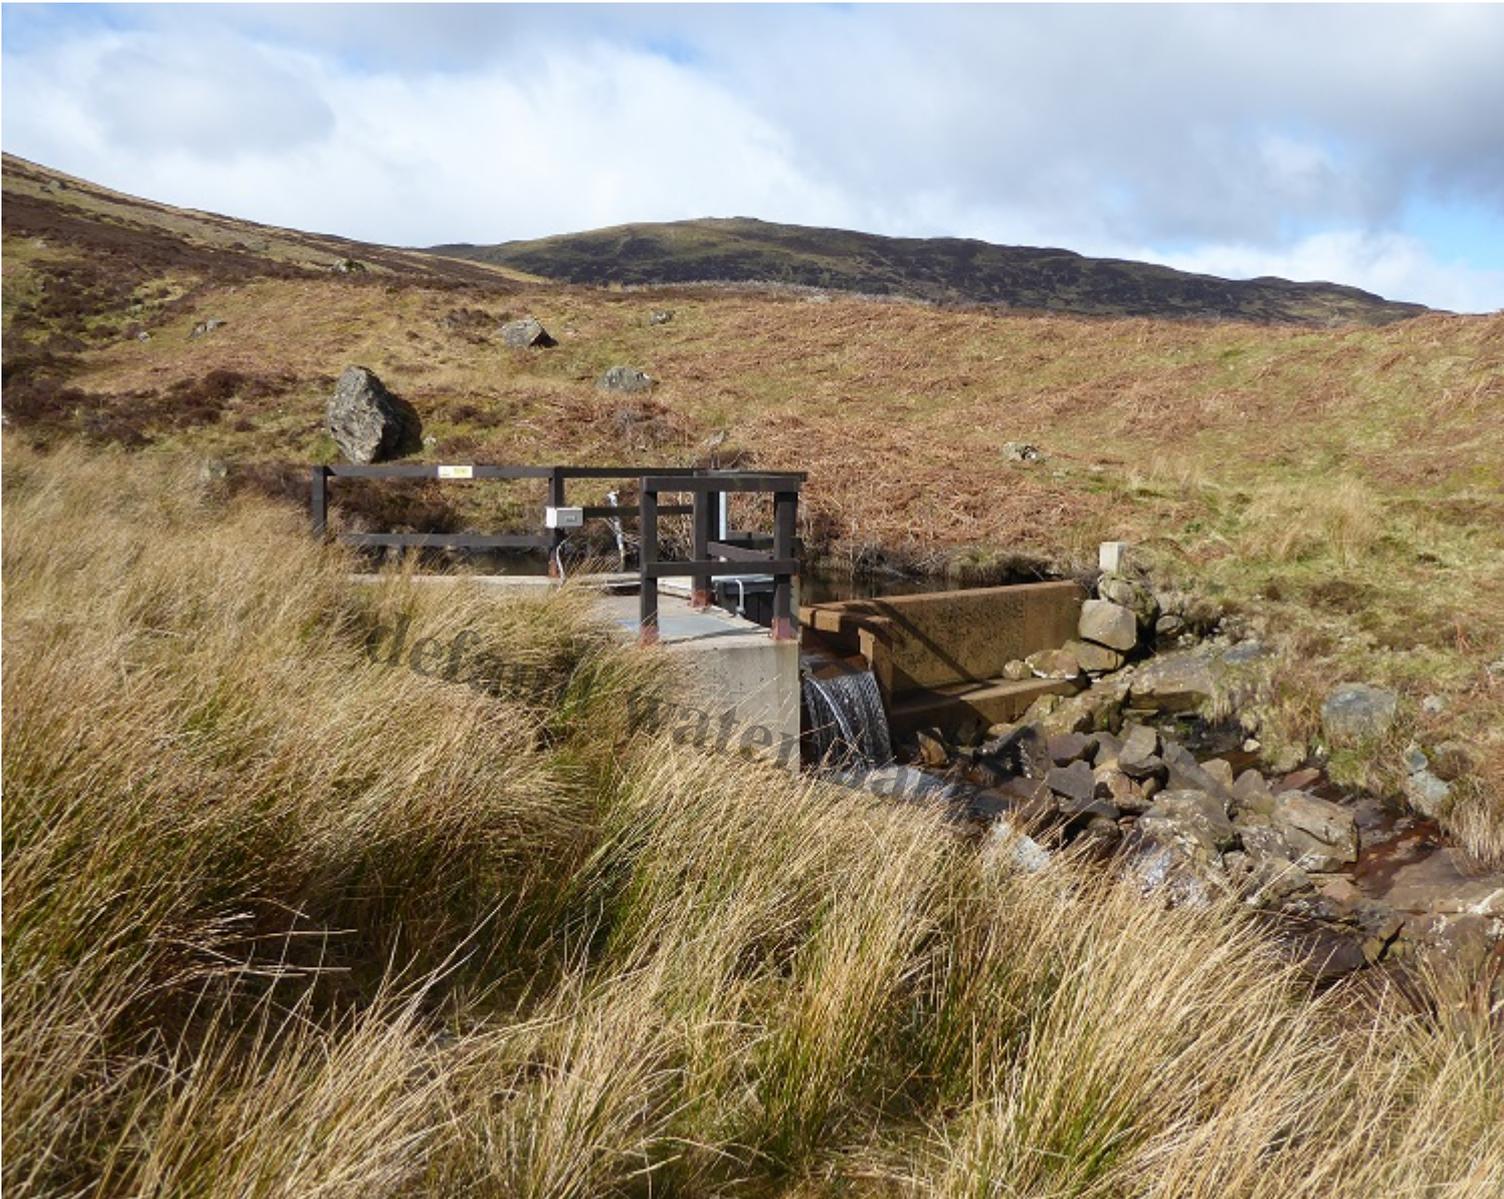
Closer up the main visual impact of the dam remains the grey/white concrete. If our National Parks and other planning authorities required intake structures to be finished in stone, except where likely to be stained by water, their visual impact would reduce considerably. The cost of this would be minimal and it could reduce carbon imprints.

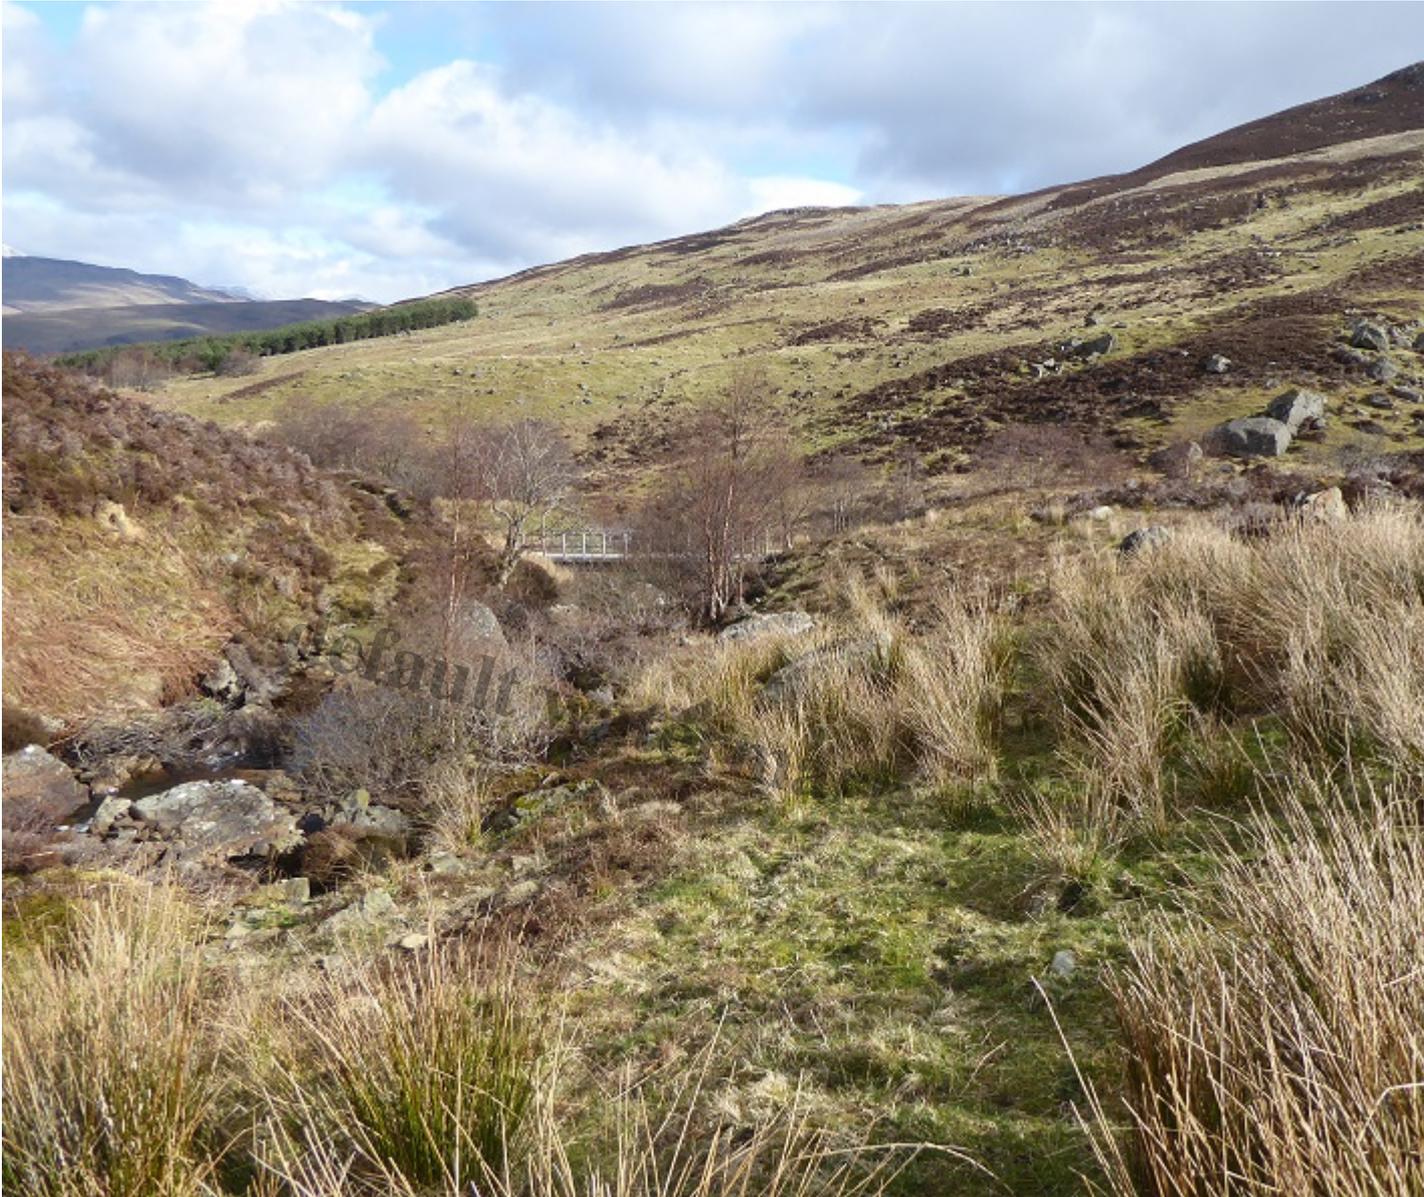
View from just below western intake dam to bridge (where pipe crosses burn). The pipe runs beneath grassy/mossy section in centre of photo. Even though the greenery is probably explained by the failure of heather to recover yet, its almost impossible to tell now that this conceals a pipeline - a successful

The visual impact of the dam is also reduced because the track does not go right up to the dam, as in most later developments in the Park. There is nothing to draw your eye to it and as a result many people walking up the track probably miss it.

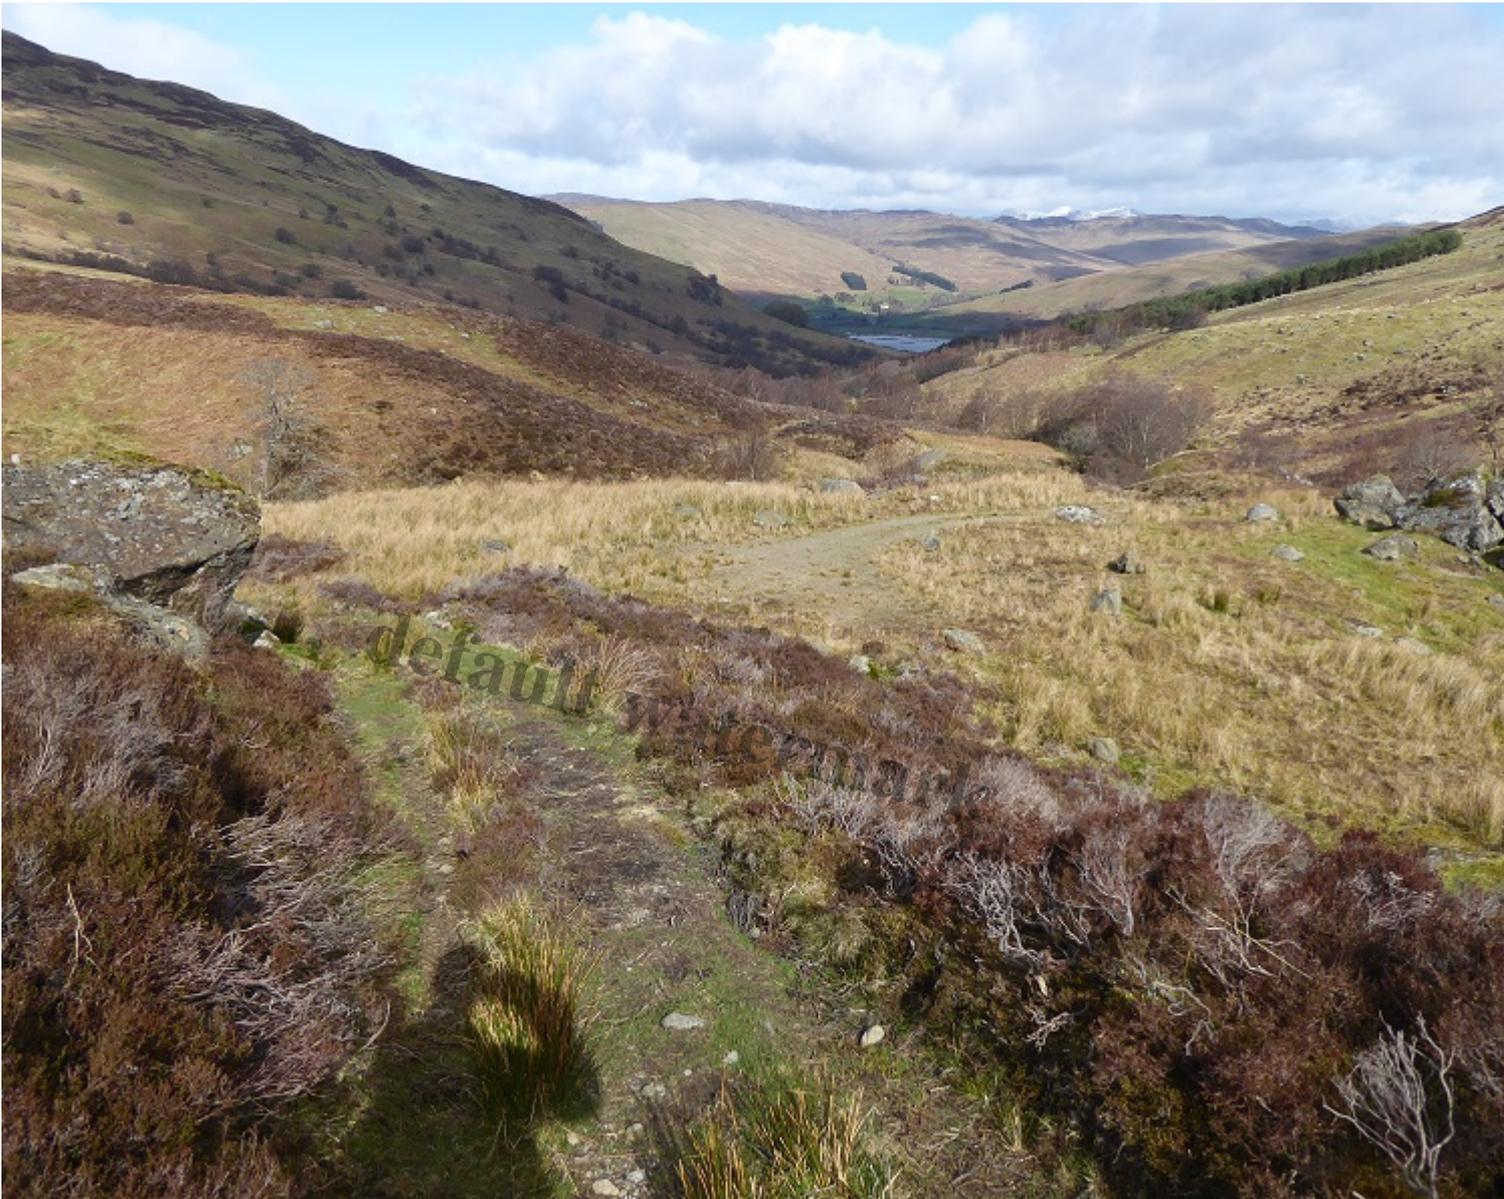
The formal track also ends short of the eastern intake (to right of view in photo) although an ATV eroded track continues up the glen (in place of the old path). What is good about this track is that there is no large turning area which is so common with so many other hydro tracks.

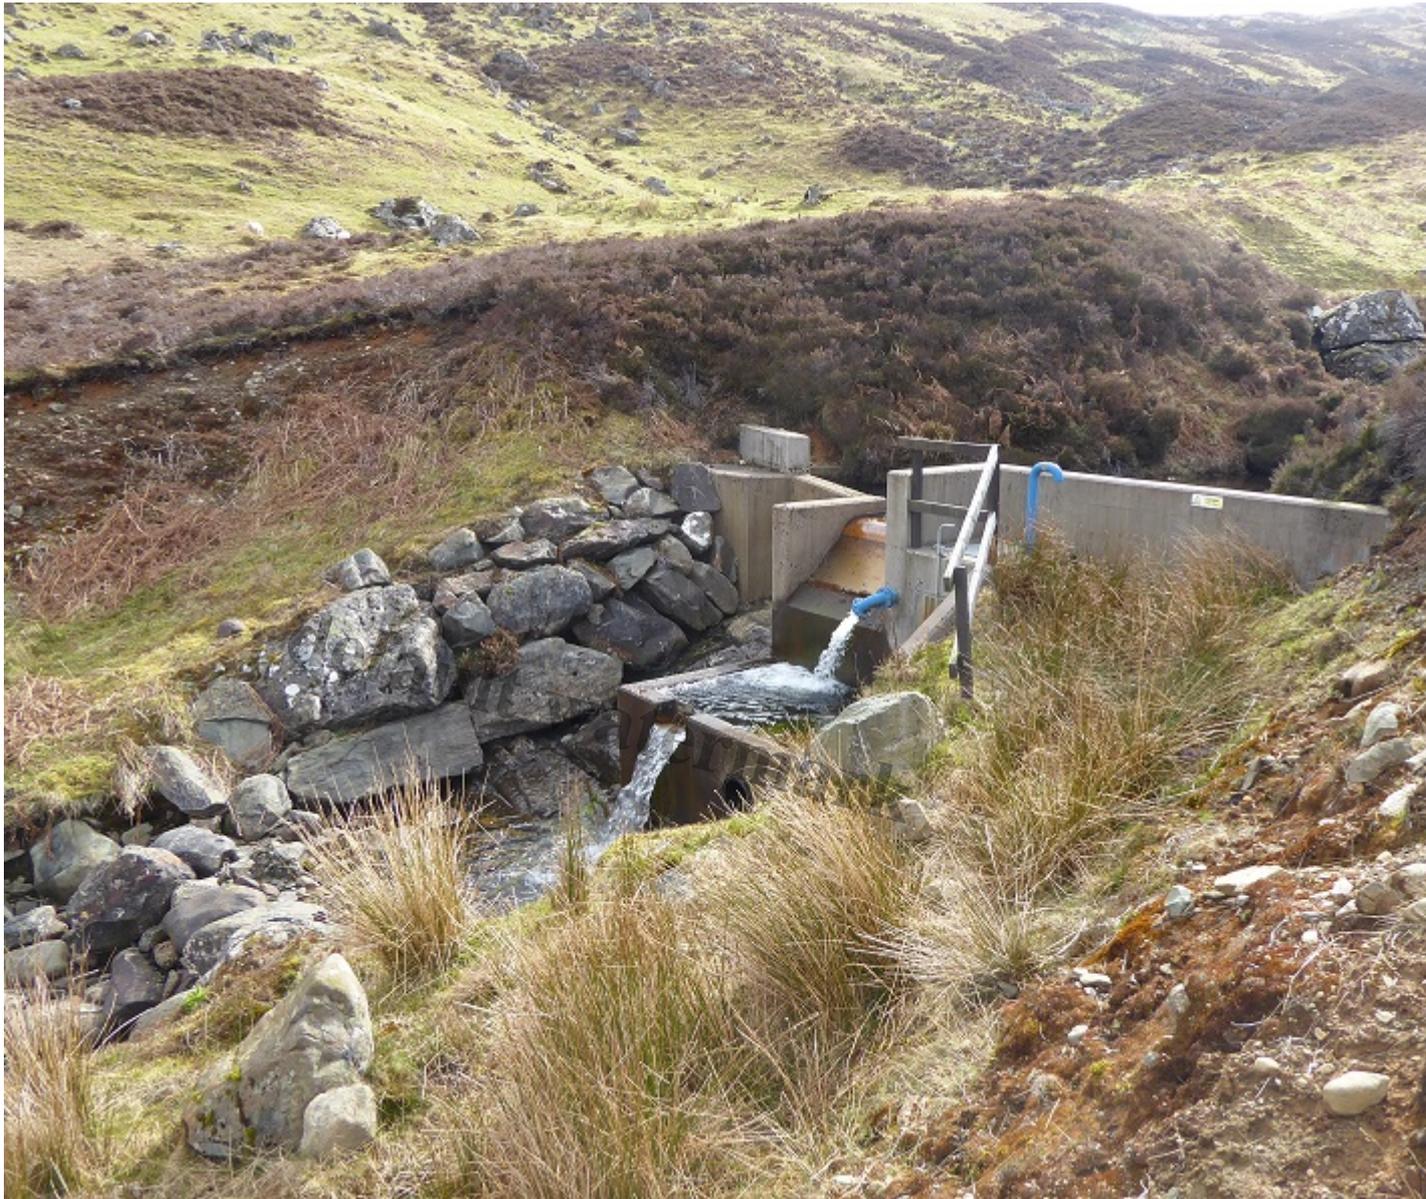
Eastern intake on Allt

The second intake is closer to the track than the first and more intrusive. While the lower concrete has stained there is a much greater expanse of light grey concrete retaining wall, which is made even more obvious by the Lomond blue piping. Added to this there rip-rap boulder embankment on the far side of the burn and the excavation of the banks on either side of the burn where vegetation has not recovered (its too steep, just like the bank of the track below the bridge). The design of this intake could, in my view, have been considerable improved and the impact on the landscape reduced.

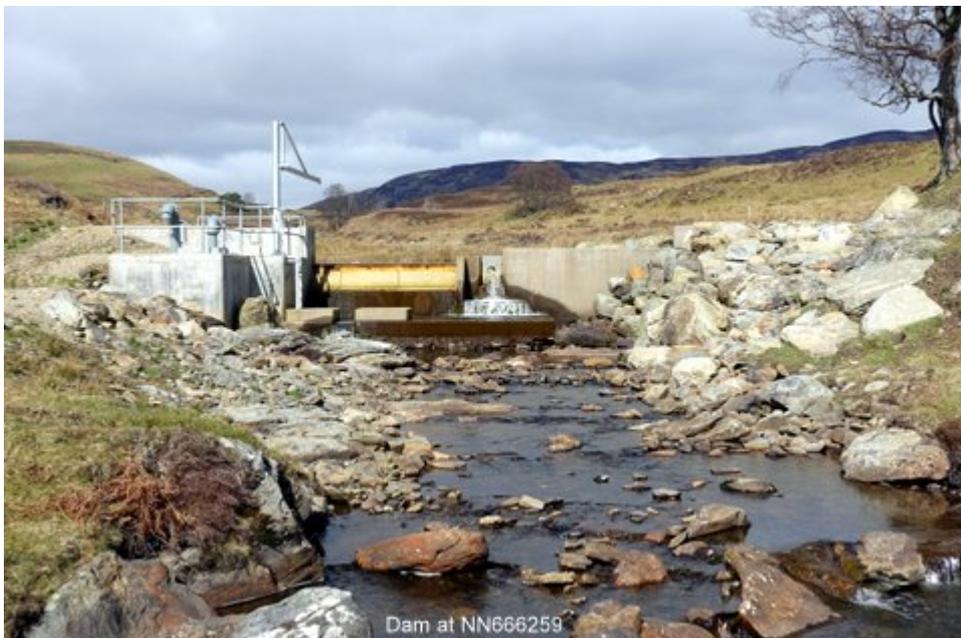
While the intake is outwith the National Park, it is fairly typical of those found within our National Parks, being constructed out of white/grey concrete partially concealed by rip rap tendering. The gantry adds to the visual impact although viewers will note the piping is not bright blue. The location

of this dam in a wide open glen makes it more visible than those at Ardvorlich.

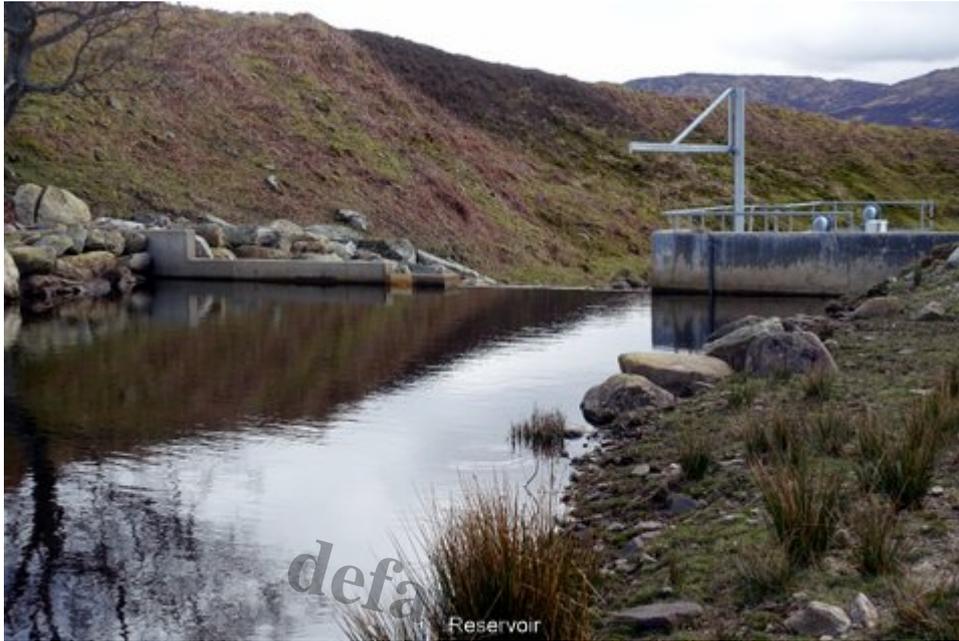
View of intake from above - photo credit Jim Robertson

The rip-rap bouldering looks as artificial as the concrete dam.

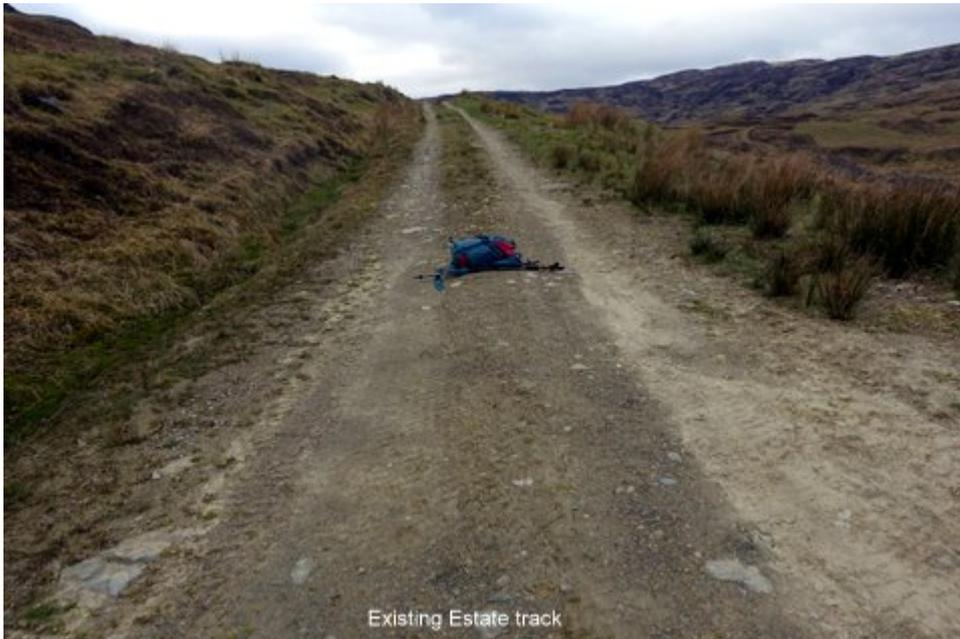
Existing Estate track

An existing track was used for construction purposes and, because the size of the scheme was relatively small, it appears the track did not require extensive upgrading. Vegetation appears to be recovering well which will give it a more "natural" feel for walkers.

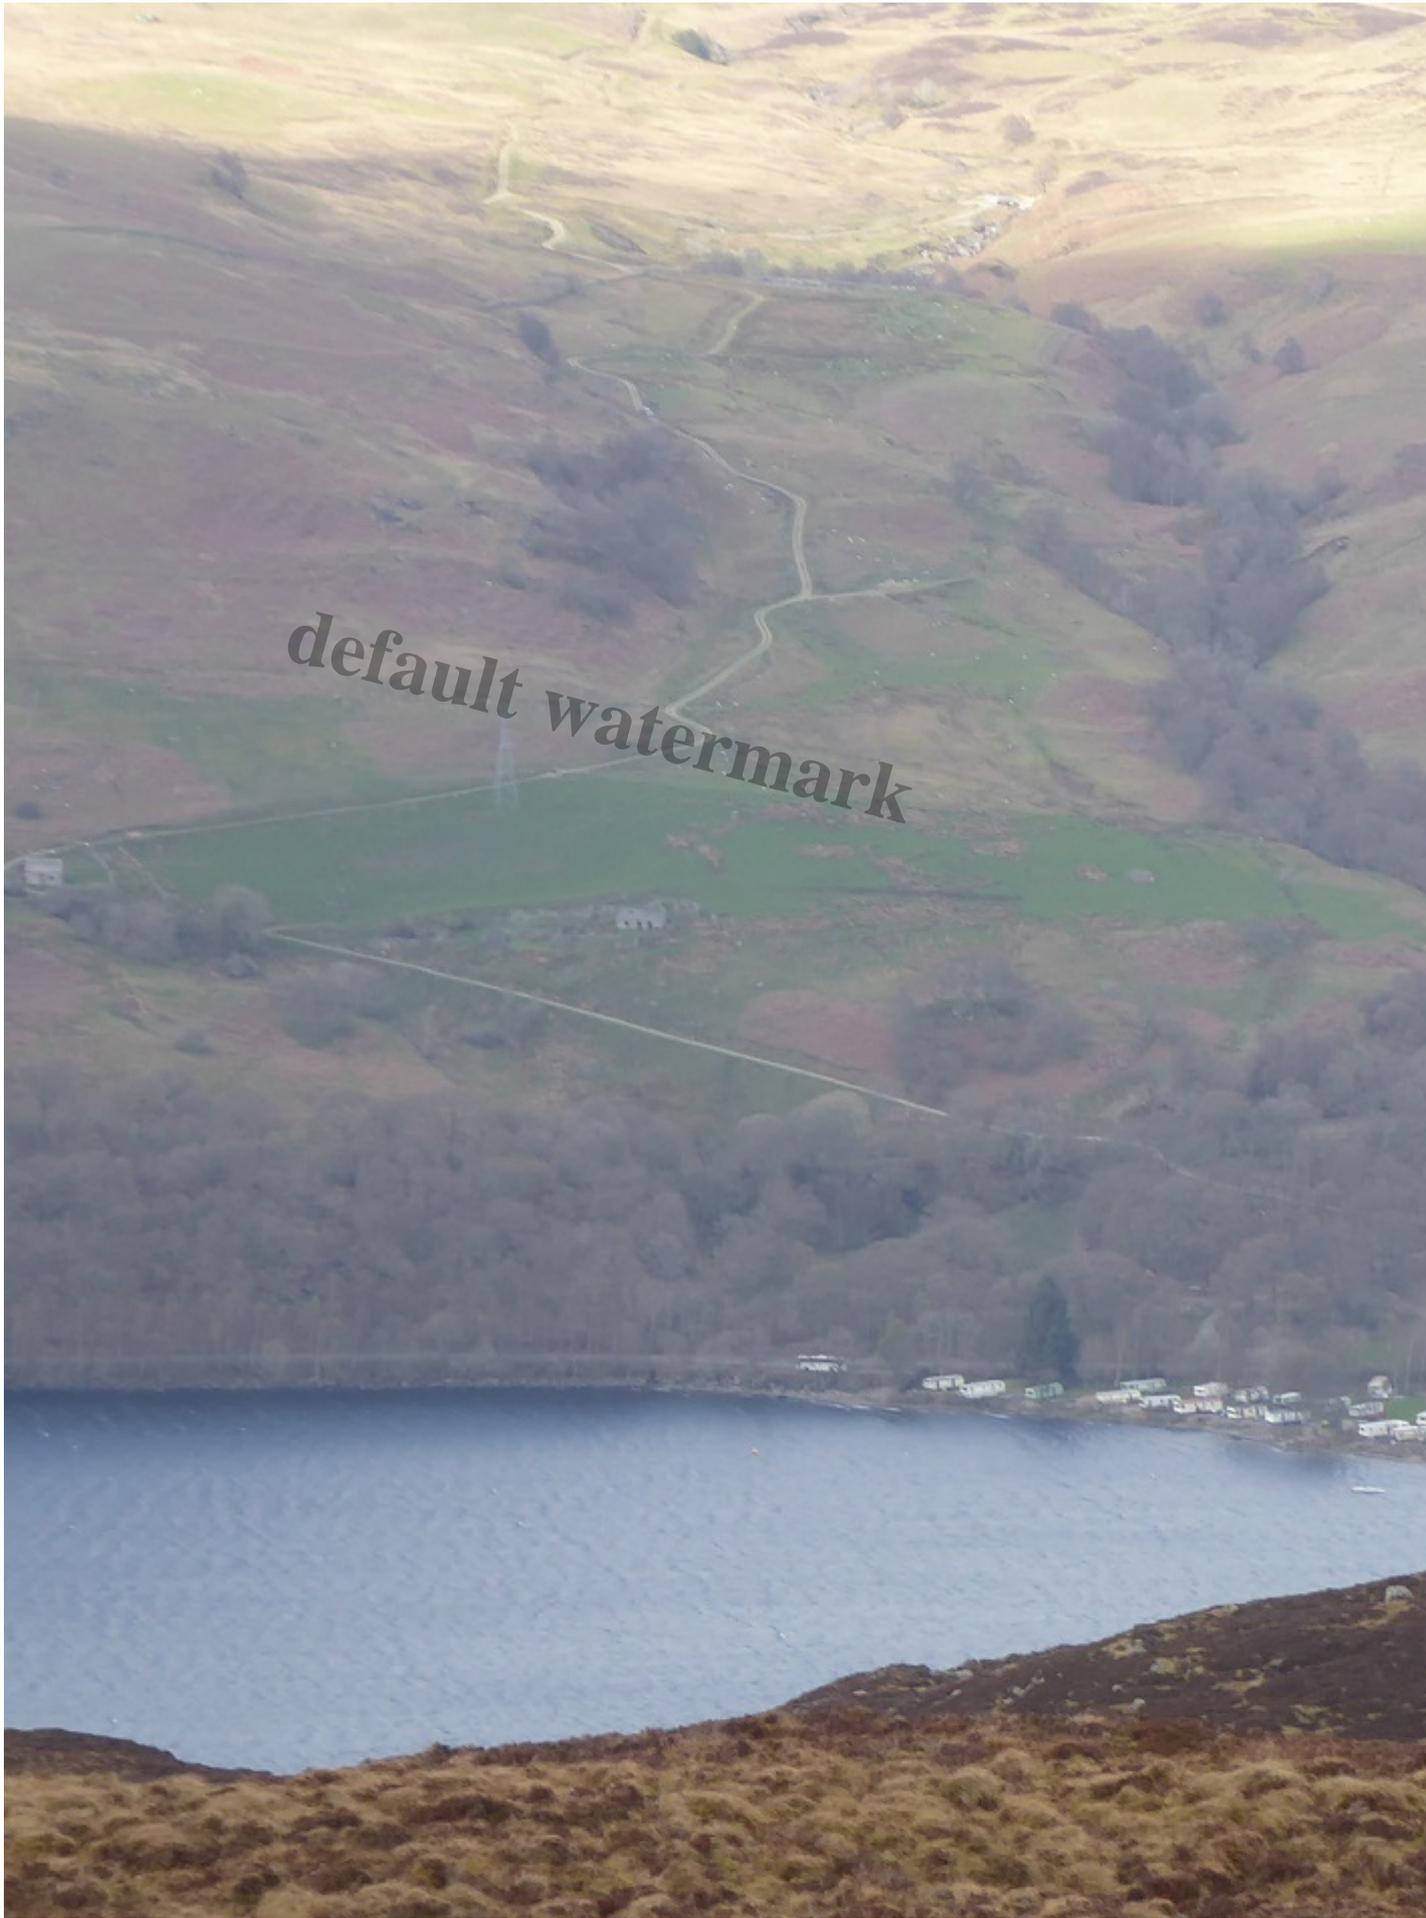
View of Tarken Glen from Meall Rheamhar above Fin Glen – the power house is behind the large covered area to the left of the burn.

The photo demonstrates once again that the main impact of hydro schemes is not the pipeline, where these are buried, but the access tracks. While in this case the track was already in place, where tracks cut across the grain of the landscape, as in the middle ground of this photos where the track goes diagonally uphill, they are particularly prominent. While the LLTNPA did refer to the visual impact of the scheme from the South Loch Earn road, it made no recommendations about what might be done to mitigate the impact of what can be seen from the National Park.
