The Loch Earn hydro schemes â?? and surprise general elections!

Ardvorlich estate hydro scheme

Tarken Glen hydro scheme

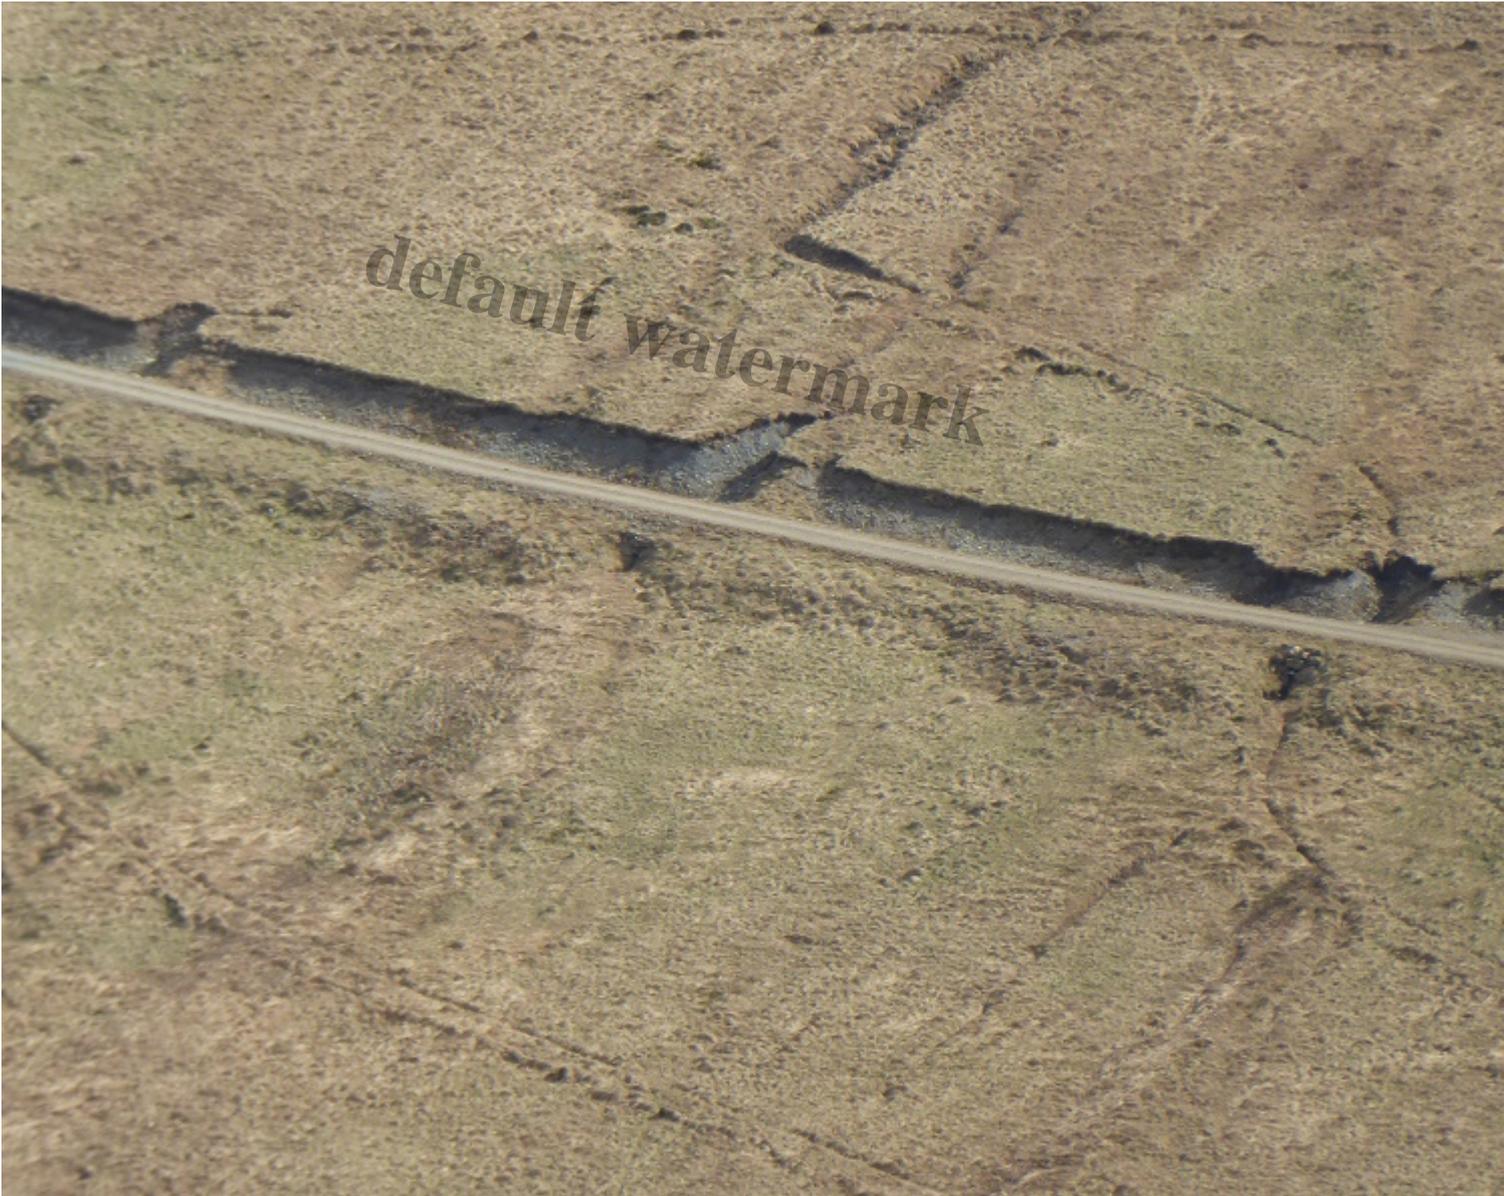
The Tarken Glen track though is not nearly as bad as the new track (above) you can see from the summit of Meall Rheamhar in Gleann Ghoinean which again lies outwith the National Park boundary to the south.

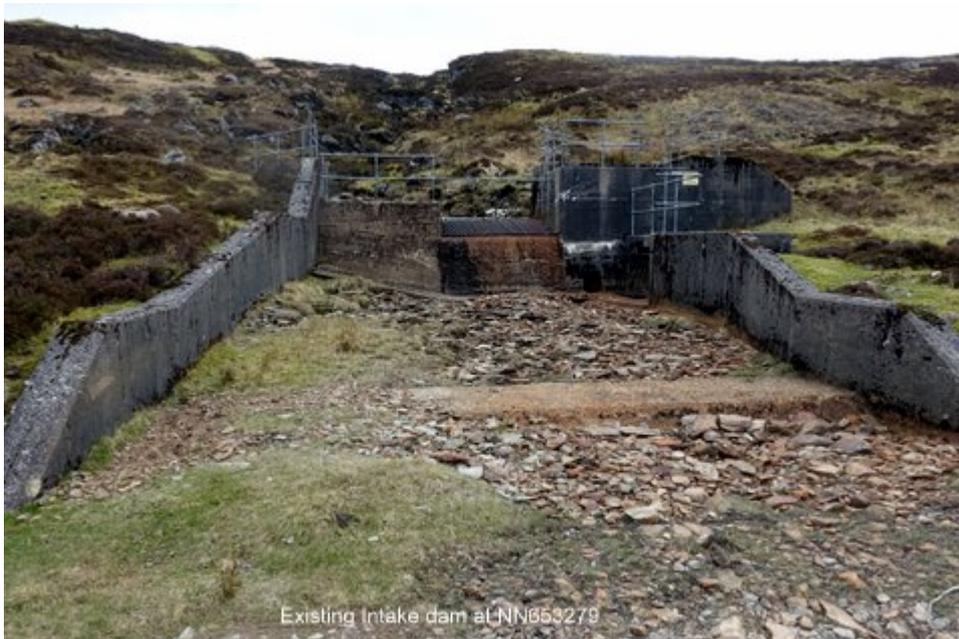
Jimâ??s photo though raises questions about how much progress has been made in reducing the impact of dams and hydro intakes. In this case, the intake diverts all the normal flow of the burn, which will only flow in spate conditions, whereas intakes are always designed nowadays, due to greater awareness of hydrology and the framework of water catchment plans, to maintain some flow. Are the concrete embankments of the existing hydro intake though any worse than the rip rap tendering shown in Jimâ??s second photo of the new scheme?

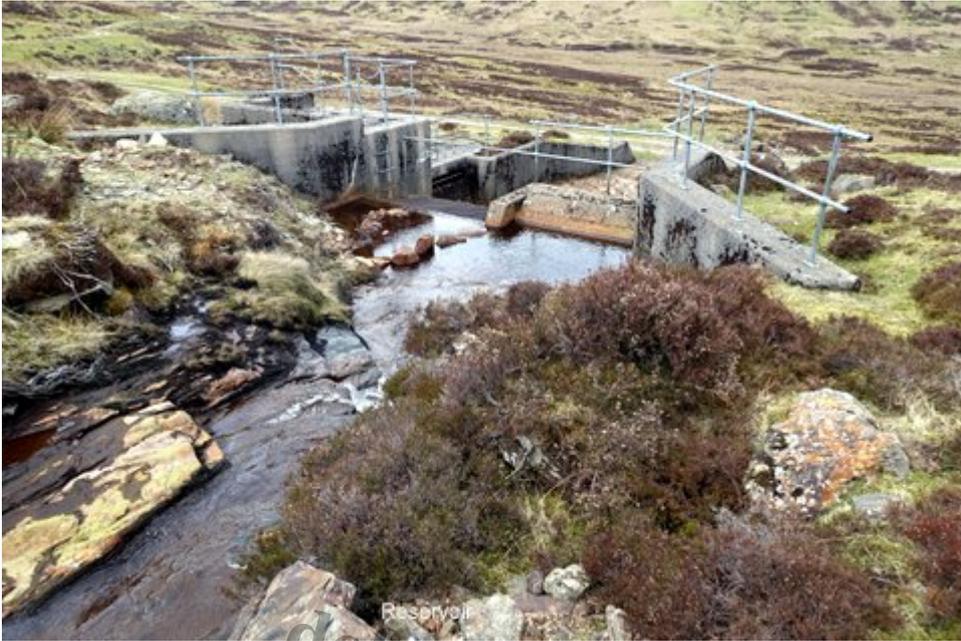
View from above intake â?? Photo Credit Jim Robertson

The photos also demonstrate just how long it takes for concrete retaining walls to be colonised by mosses and lichens and to start blending into the landscape. A good reason why the LLTNPA needs to enforce its guidance that concrete dam structures should wherever possible be faced with natural materials.
