Will the repair of the Cairngorm Funicular Railway work (3)?

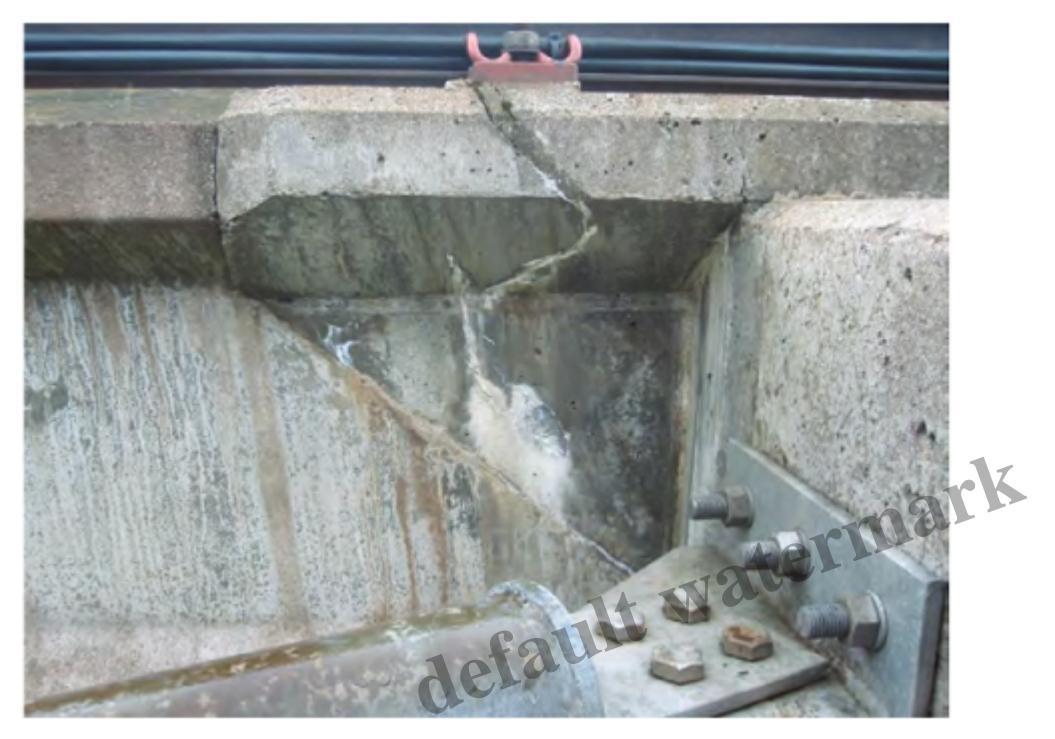
Figure 2-6 Cracking at a pier 9 (refer defect 1)

Unfortunately we are unable to do a site visit at present and have been unable to check from photos if it is the only pier in that section that exhibits damage. If it is, then why is it in such poor condition? Above ground work was not included in the planning application to the Cairngorms National Park Authority and because of that it is not clear what superstructural repairs are include in the £16m repair to the funicular. Information about that is important for understanding what has gone wrong and why repairs are needed.

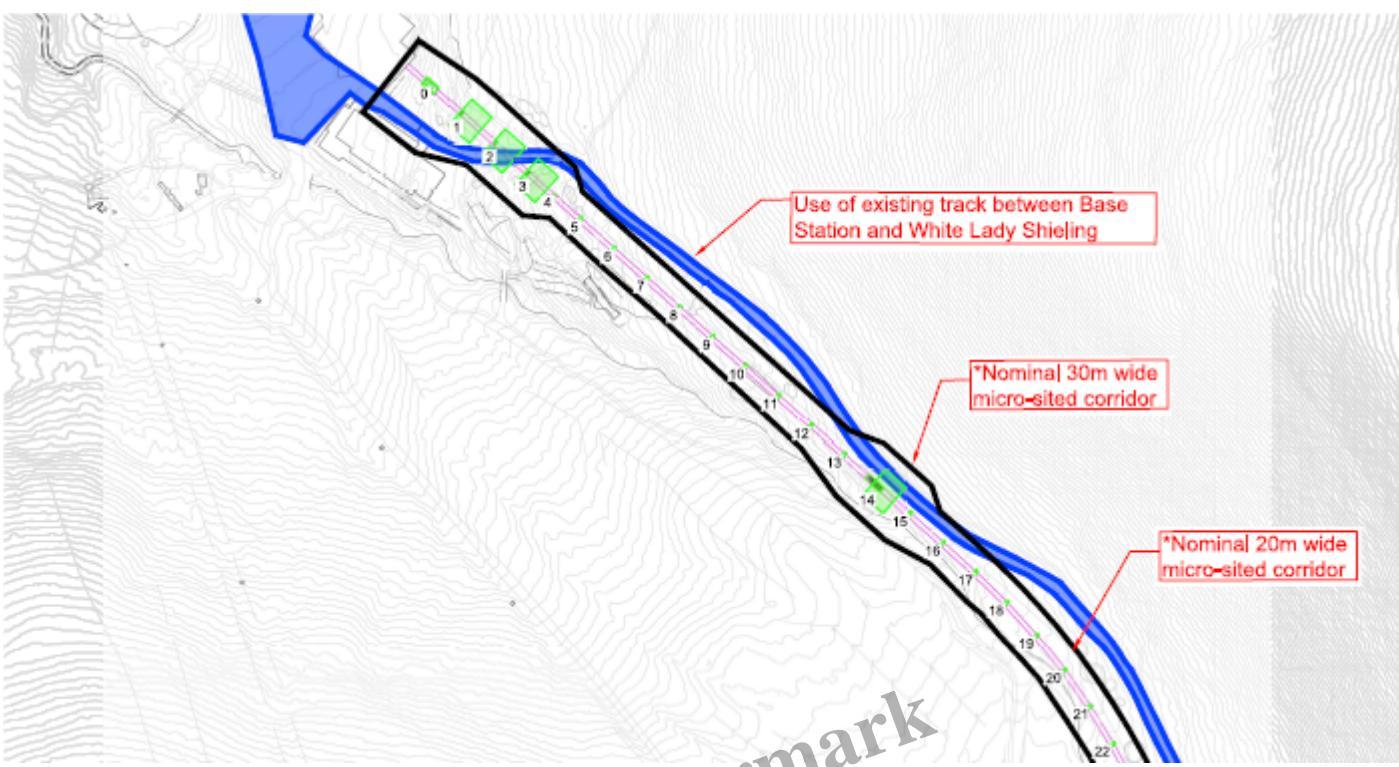
Extract from Planning documents. Green squares indicate work where ground works are planned and include pier 14, an anchor block, but not the ten piers below.

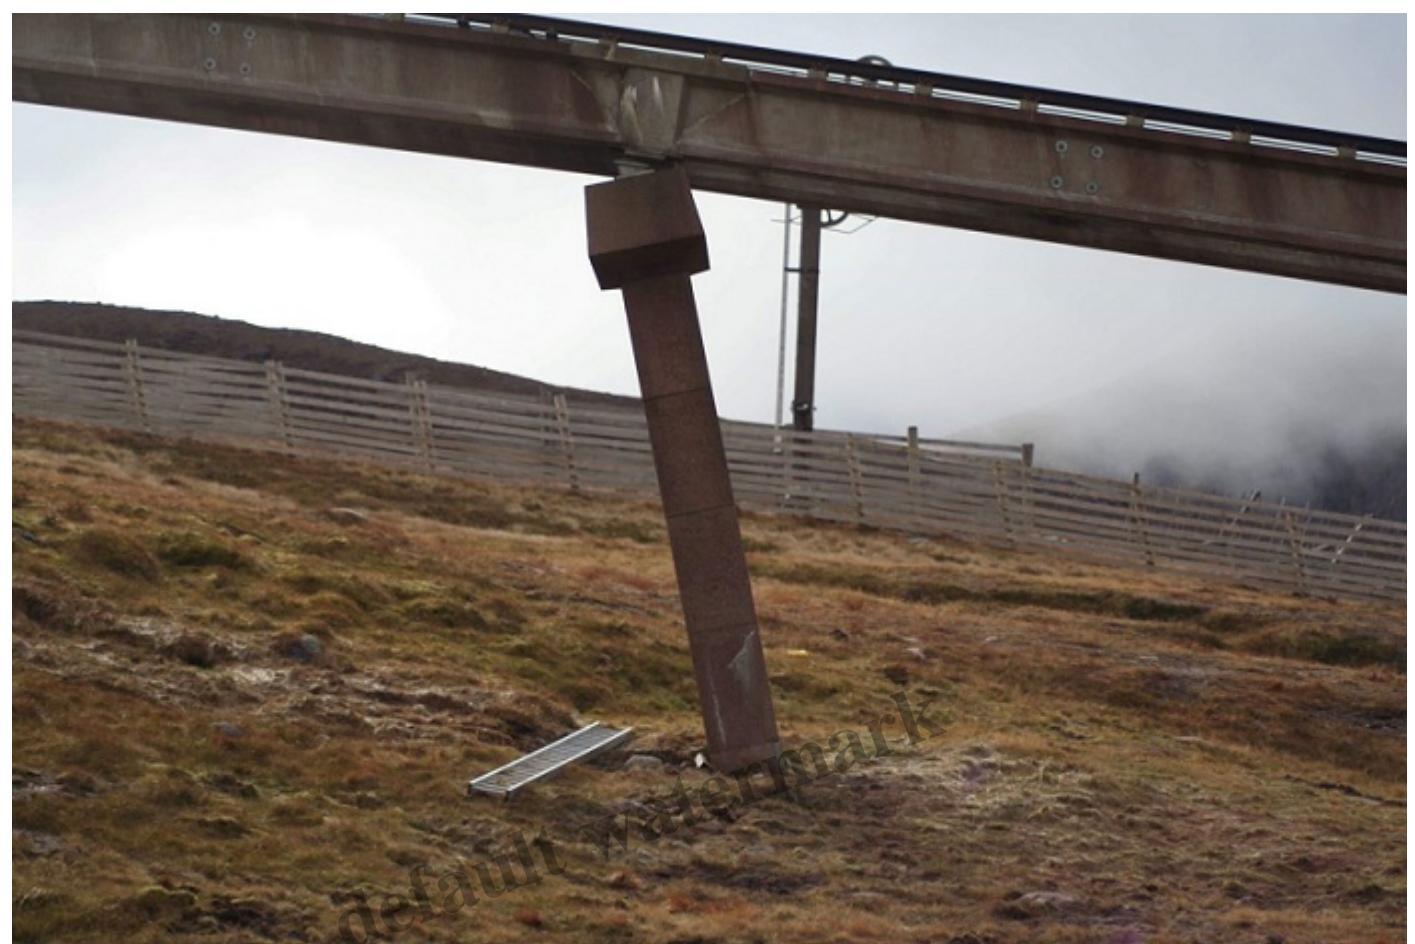
This appears to be Pier 90 or 91

(NB the following photo appears to show the pier leaning more than it is, as you can see from the fence posts behind, but is the only one we have showing a taller pier)

The COWI report says that it is the taller piers that are most affected. Another person who has contacted parkswatch has been a civil engineer and pointed out that a pier of this height should be wider at its base in order to support the weight higher up, that it should taper up to the highest point. But that would have meant that the preformed concrete outer shell at the bottom (no 5) would be larger and contain more re-inforcing than the next one up (No 4) and so on to the top. It could also have meant that the foundations for these taller piers would have to be bigger as well. It was said in the Audit Scotland report of 2009 that, because of the increasing costs, ways were being looked at to try and save money. Was using pre-formed shells of only one size one of the cost saving exercises and did this leave the taller pillars weaker than the short ones placing more stress on the foundations?
