The Ben Glas hydro scheme and Glen Falloch five years on – what does the LLTNPA stand for?

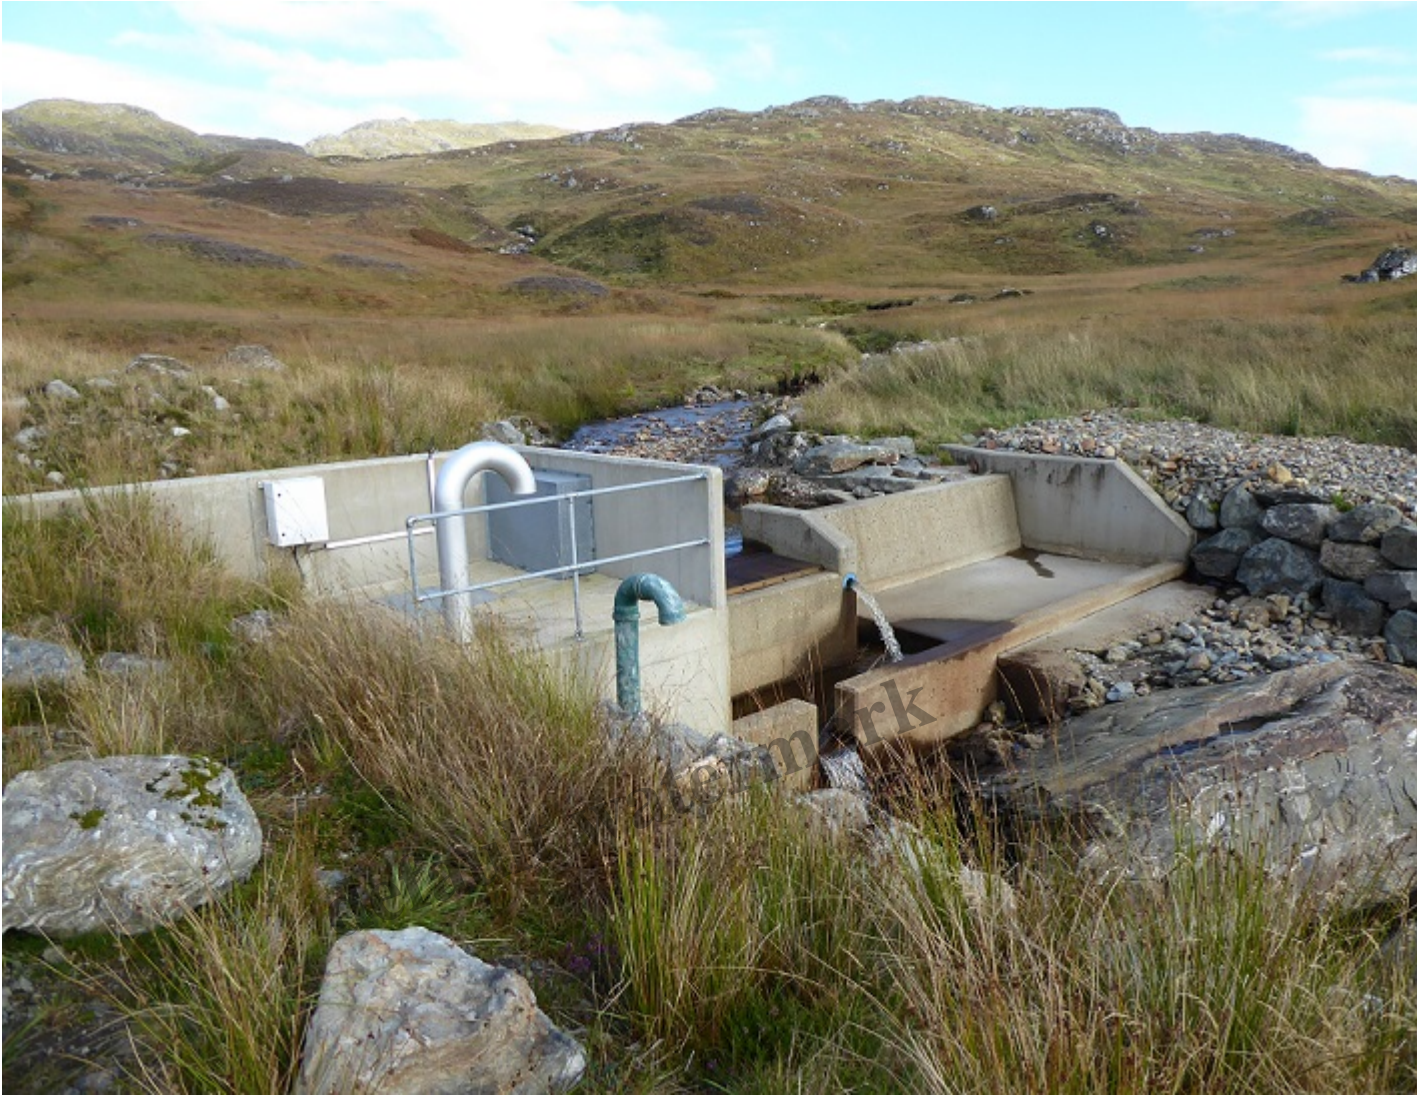
First hydro intake, by the most popular hillwalkers path up Beinn Chabhair. Photo credit Louise Brimelow.

Five years after construction, the Ben Glas hydro intakes remain ugly structures, an insensitive human imposition of a wild landscape. Both the Ben Glas hydro intakes are situated in what is now the Ben More and Ben Ledi Wild Land Area (WLA) but were granted consent in 2009, five years before the WLA came into existence.

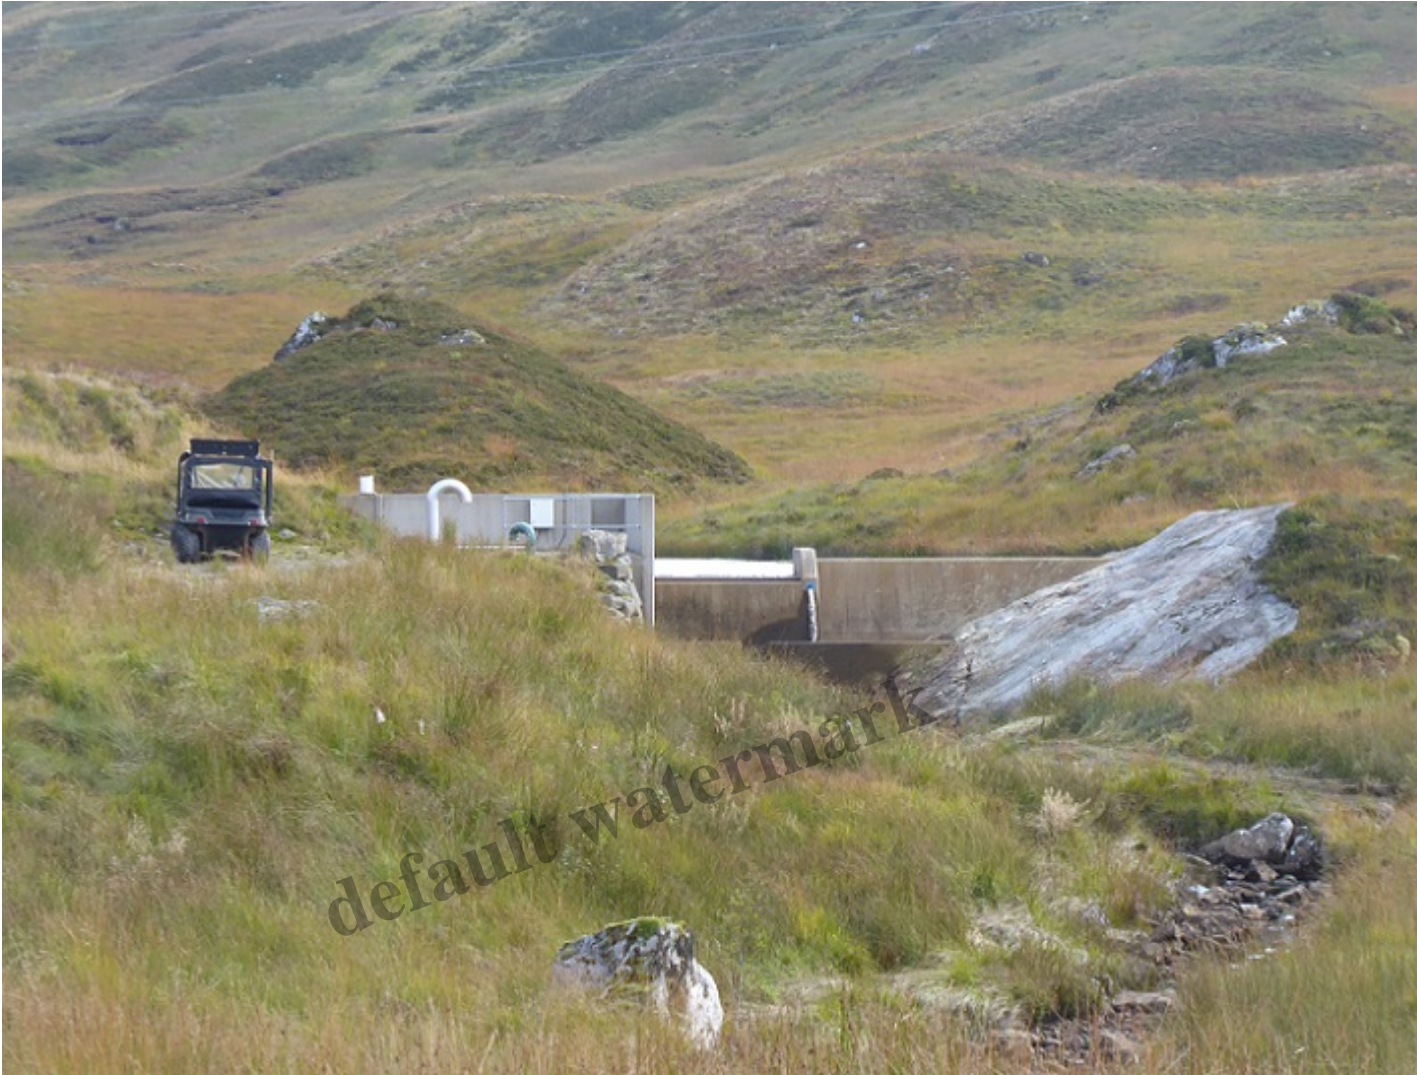
Second hydro intake, with pool behind and half empty burn below. Photo credit Louise Brimelow.

Instead, they allowed significant quantities of climate polluting concrete, with barely a token attempt at disguise: a couple of once blue pipes painted; the pile of boulders placed in front of part of the wing wall on the left. It is too late now for the LLTNPA to force the people hiding behind the complex company structure which owns this highly profitable scheme to do anything to improve it. The time-limit for Planning Authorities to take action after a development has been completed is generally limited to four years.

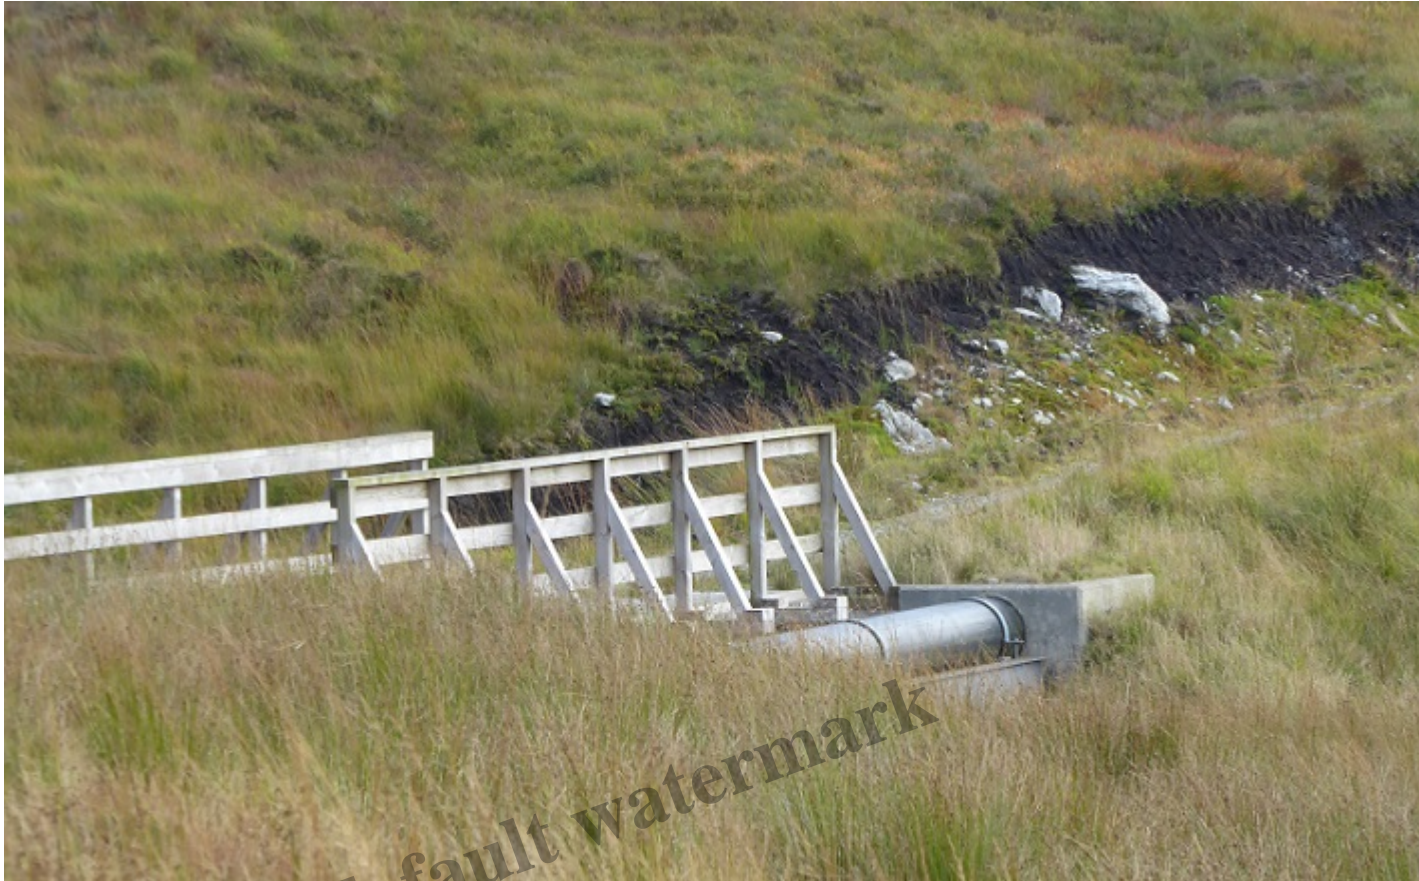
Section of track, bridge and hydro pipe just below the second hydro intake. Photo credit Louise Brimelow.

Further failures of the planning system under the LLTNPA are illustrated by this photo. The LLTNPA's own guidance on renewable developments stated pipes should be concealed below bridges where possible. Why not here? Five years later the edge of the peat bog above remains exposed DESPITE the LLTNPA having, with the assistance of the Scottish Government, paid out undisclosed sums to restore exposed surfaces of peat in the damaged bog above. If it wasn't true, it would be hard to make up.

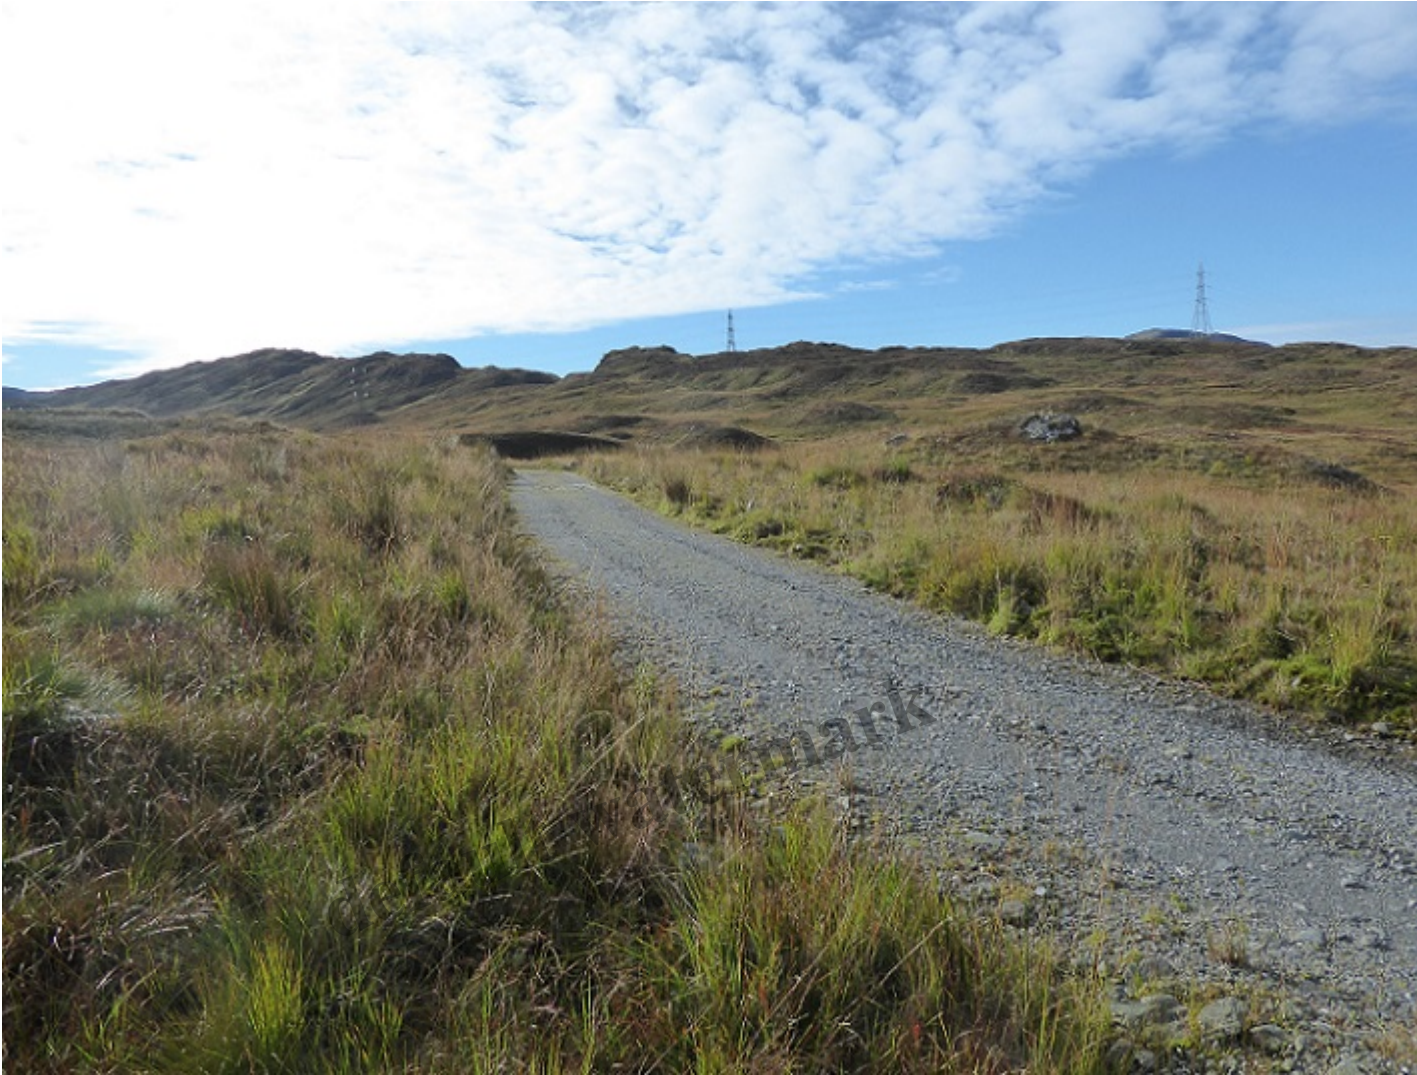
A section of the horizontal section of the hydro track below the intakes. The wheel marks show it is far broader than was needed for vehicles to access the site. Photo credit Louise Brimelow.

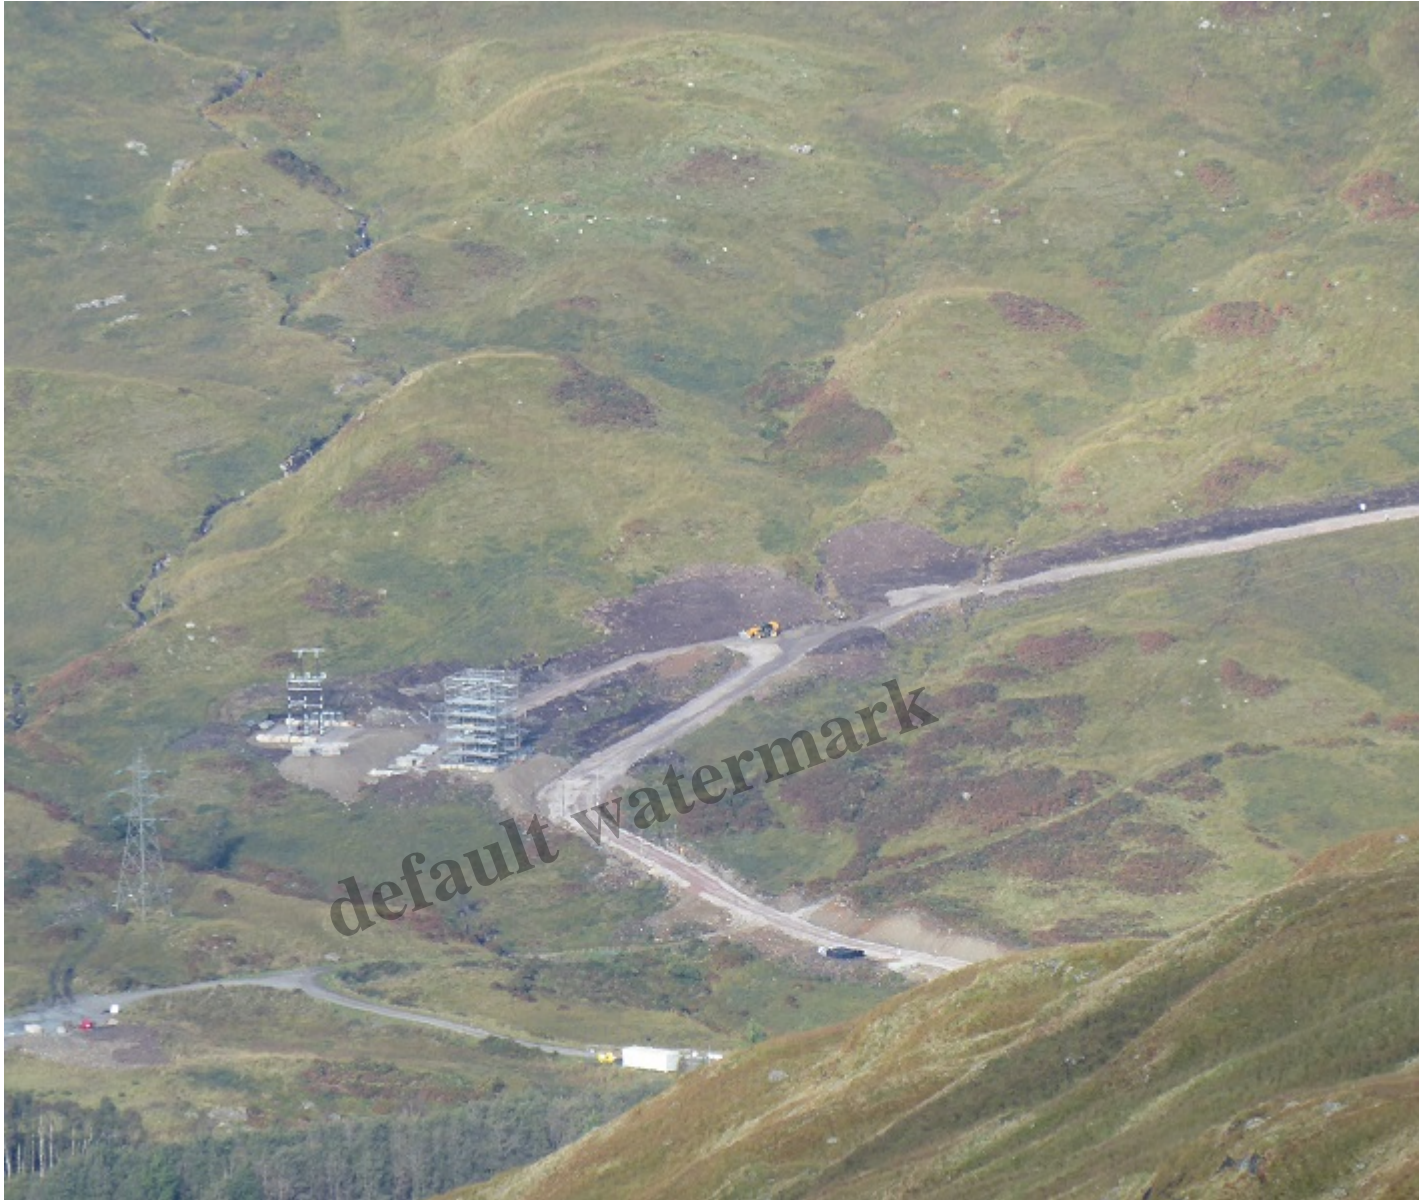
Across Glen Falloch from the Allt a Chuilinn, the Eas Eonan hydro track runs up to the Ben Lui Wild Area, with the Cononish Goldmine know gnawing into it from the far side. Looking at the photo I was shocked by the visual impact of the new track just to its right. This has been constructed as part of Scottish and Southern Energy (SSE)'s VISTA project intended to reduce the visual impact of overhead powerlines by burying them.

Close up of new temporary track and old and new towers above Derrydarroch
