## The Ben Glas hydro scheme and Glen Falloch five years on – what does the LLTNPA stand for?

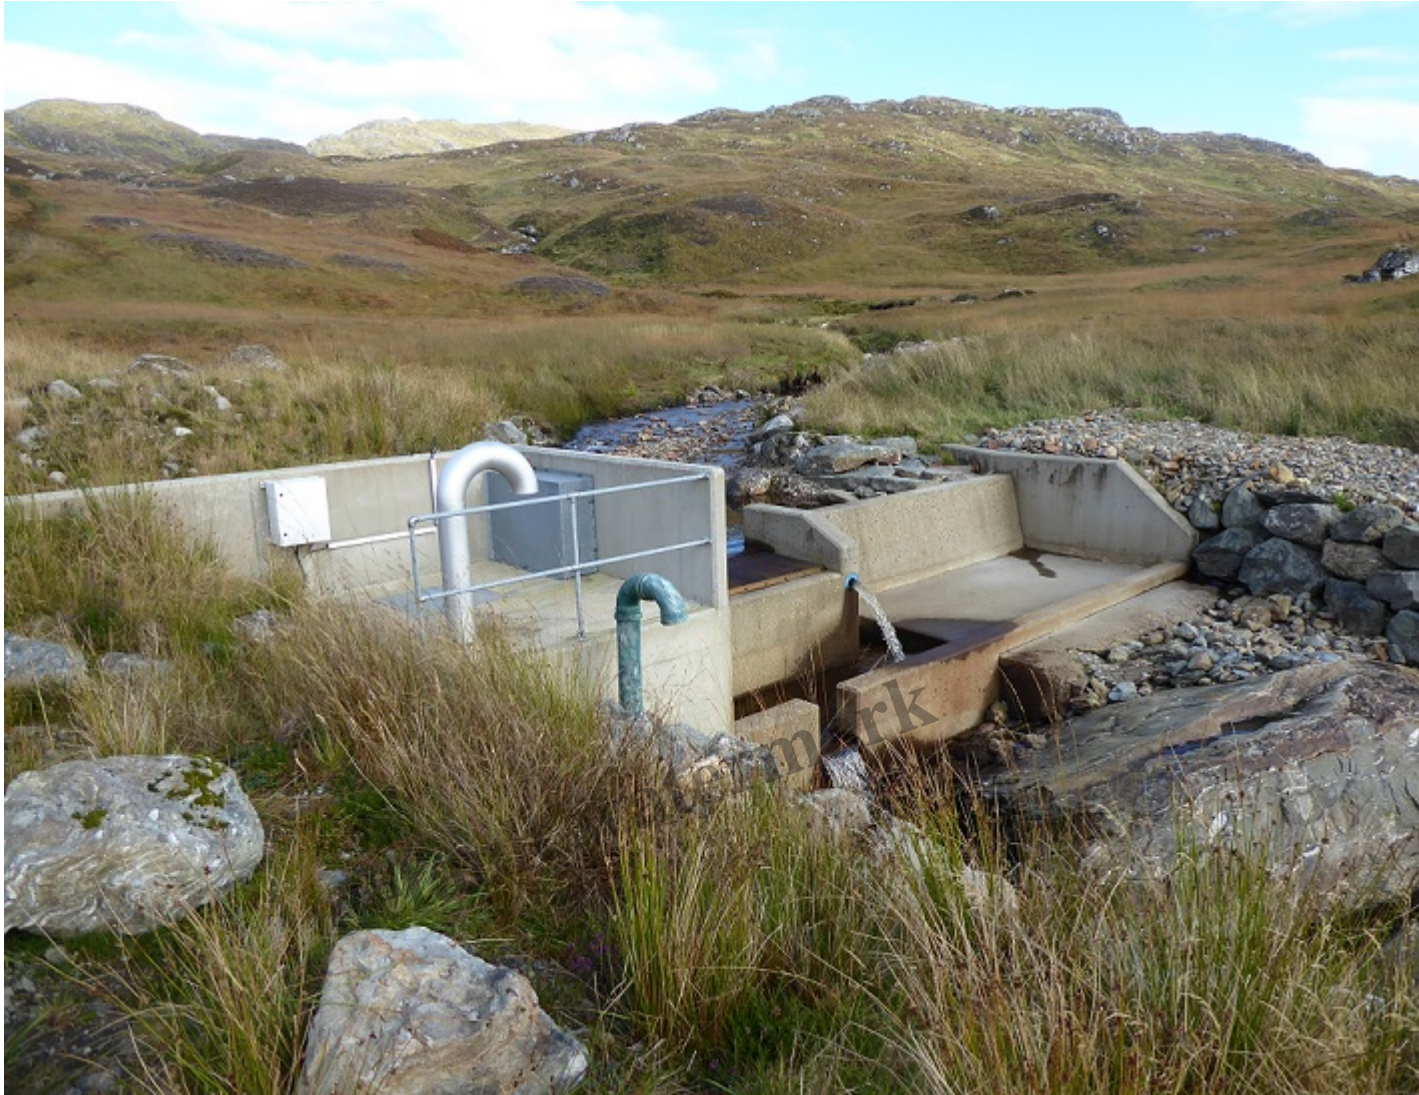
First hydro intake, by the most popular hillwalkers path up Beinn Chabhair. Photo credit Louise Brimelow.

Five years after construction, the Ben Glas hydro intakes remain ugly structures, an insensitive human imposition of a wild landscape. Both the Ben Glas hydro intakes are situated in what is now the Ben More and Ben Ledi Wild Land Area (WLA) but were granted consent in 2009, five years before the WLA came into existence.

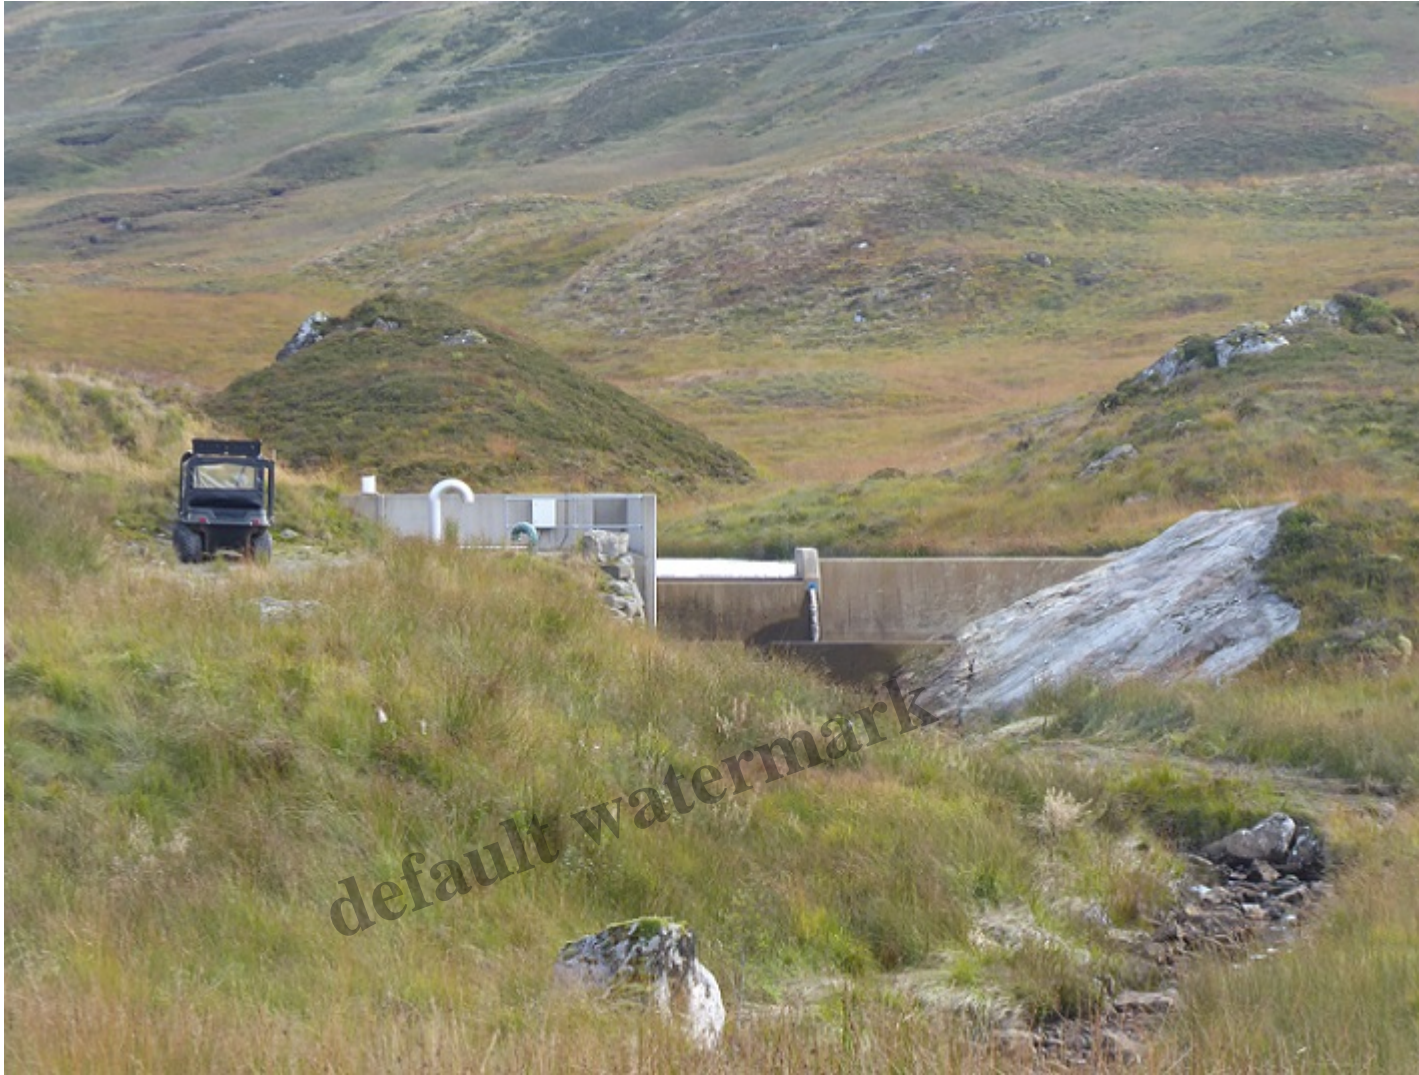
Second hydro intake, with pool behind and half empty burn below. Photo credit Louise Brimelow.

Instead, they allowed significant quantities of climate polluting concrete, with barely a token attempt at disguise: a couple of once blue pipes painted; the pile of boulders placed in front of part of the wing wall on the left. It is too late now for the LLTNPA to force the people hiding behind the complex company structure which owns this highly profitable scheme to do anything to improve it. The time-limit for Planning Authorities to take action after a development has been completed is generally limited to four years.

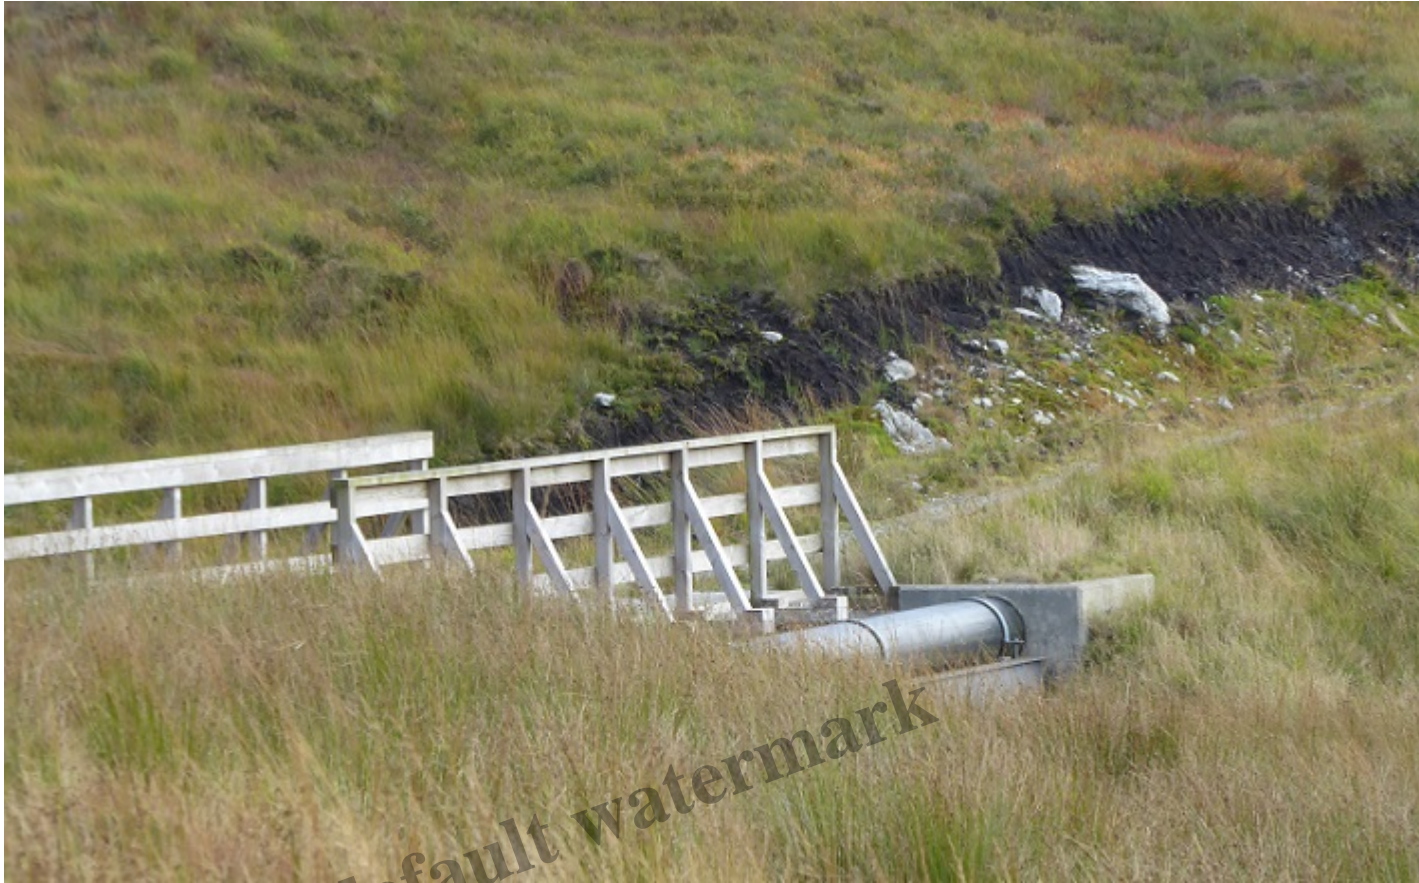
Section of track, bridge and hydro pipe just below the second hydro intake. Photo credit Louise Brimelow.

Further failures of the planning system under the LLTNPA are illustrated by this photo. The LLTNPA's own guidance on renewable developments stated pipes should be concealed below bridges where possible. Why not here? Five years later the edge of the peat bog above remains exposed DESPITE the LLTNPA having, with the assistance of the Scottish Government, paid out undisclosed sums to restore exposed surfaces of peat in the damaged bog above. If it wasn't true, it would be hard to make up.

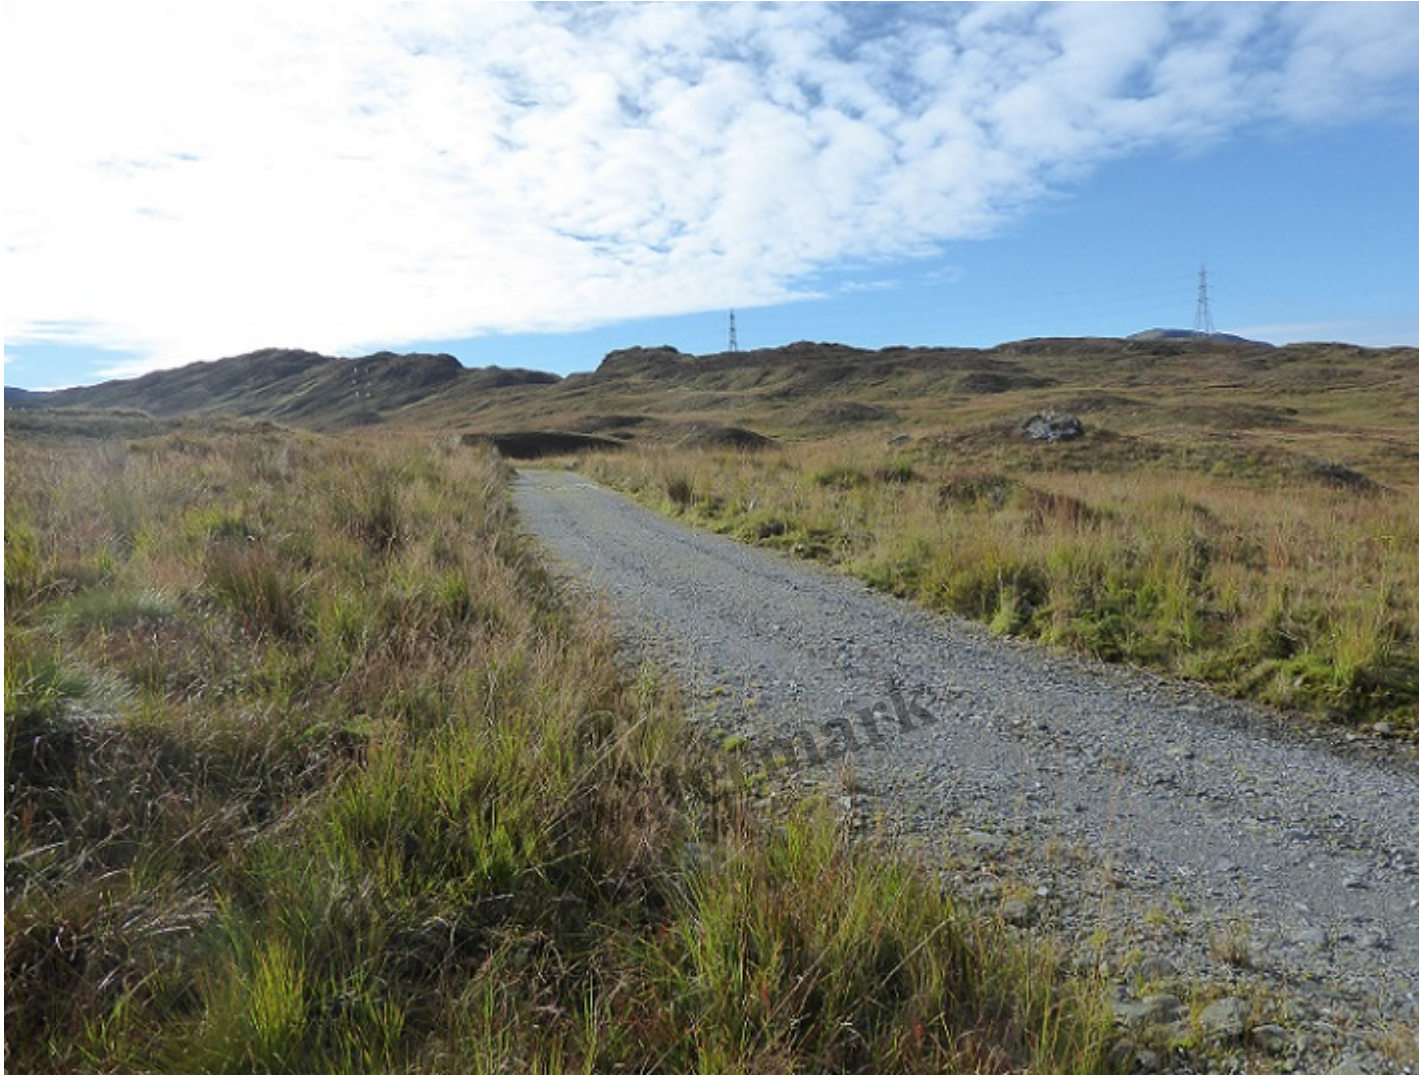
A section of the horizontal section of the hydro track below the intakes. The wheel marks show it is far broader than was needed for vehicles to access the site. Photo credit Louise Brimelow.

Prior to the hydro scheme the main detractor in this part of the Wild Land Area, referred to in NatureScot's Wild Land Assessment ([see here](#)), was the powerline running from Inverarnan, at the head of Loch Lomond, over to Loch Katrine. Under the original Scottish Government planning consent, the track was to be fully restored, but then the LLTNPA granted Glen Falloch Estate planning permission to retain it. It's unnecessarily wide but returning the aggregate to the quarry from which it was excavated would have been expensive. If these schemes were really about a greener world, electric trucks powered by the hydro might have done the job.

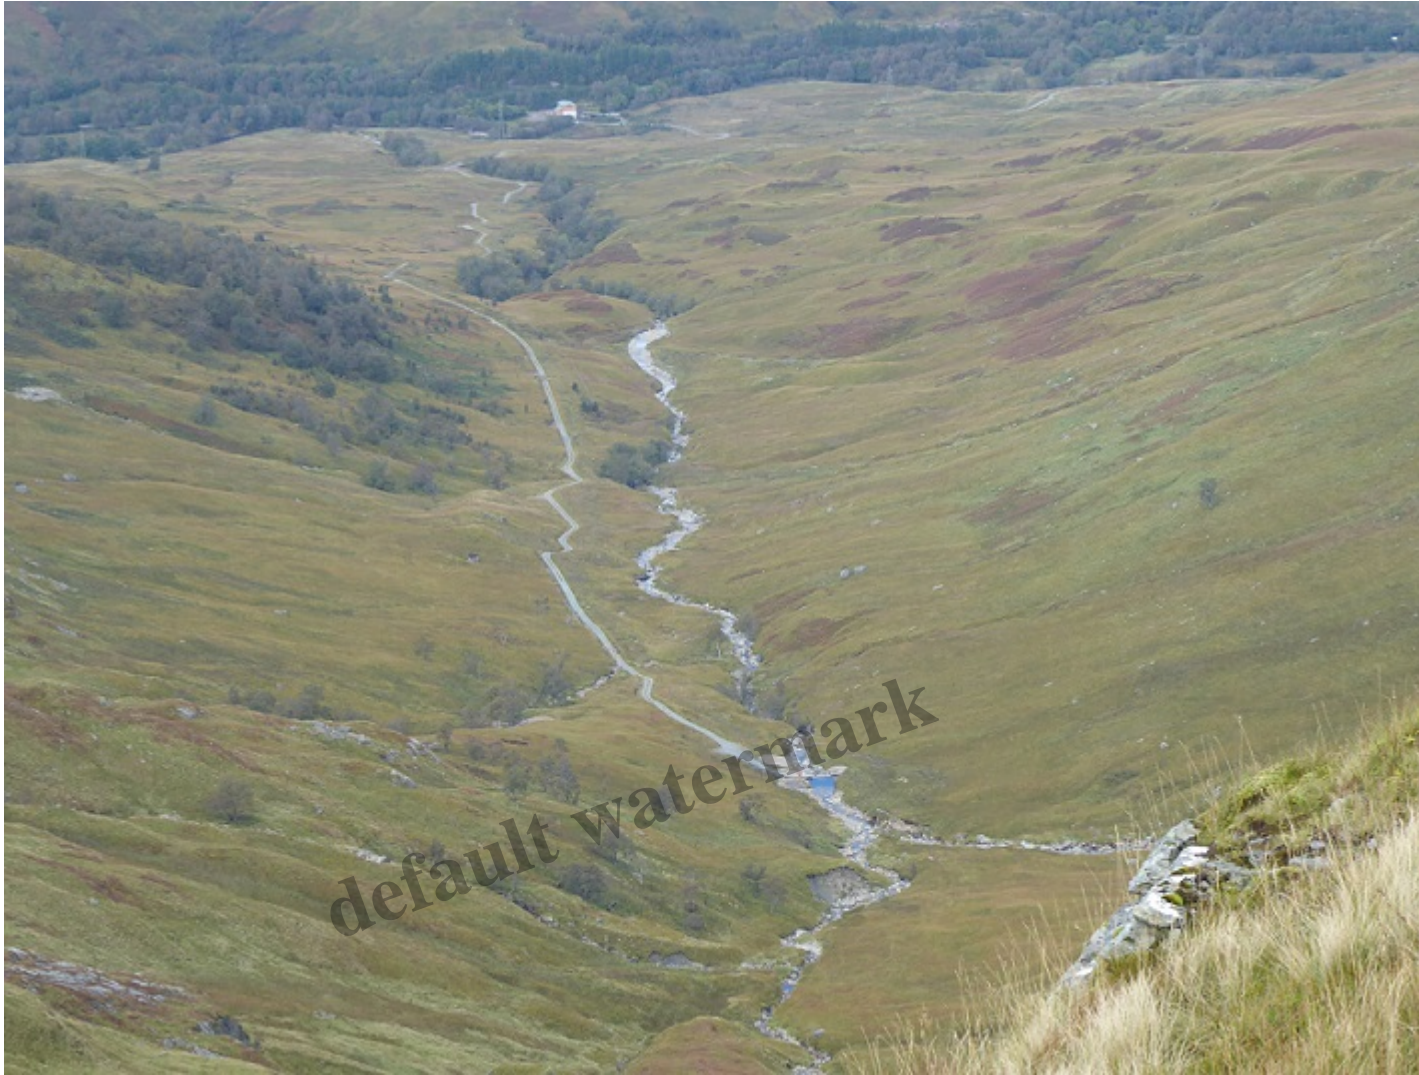
Allt a Chuilinn main intake and hydro track, just outside the Wild Land Area boundary, with the visually prominent Derrydarroch powerhouse behind. Look carefully and you can just see another powerline. Photo credit Louise Brimelow.

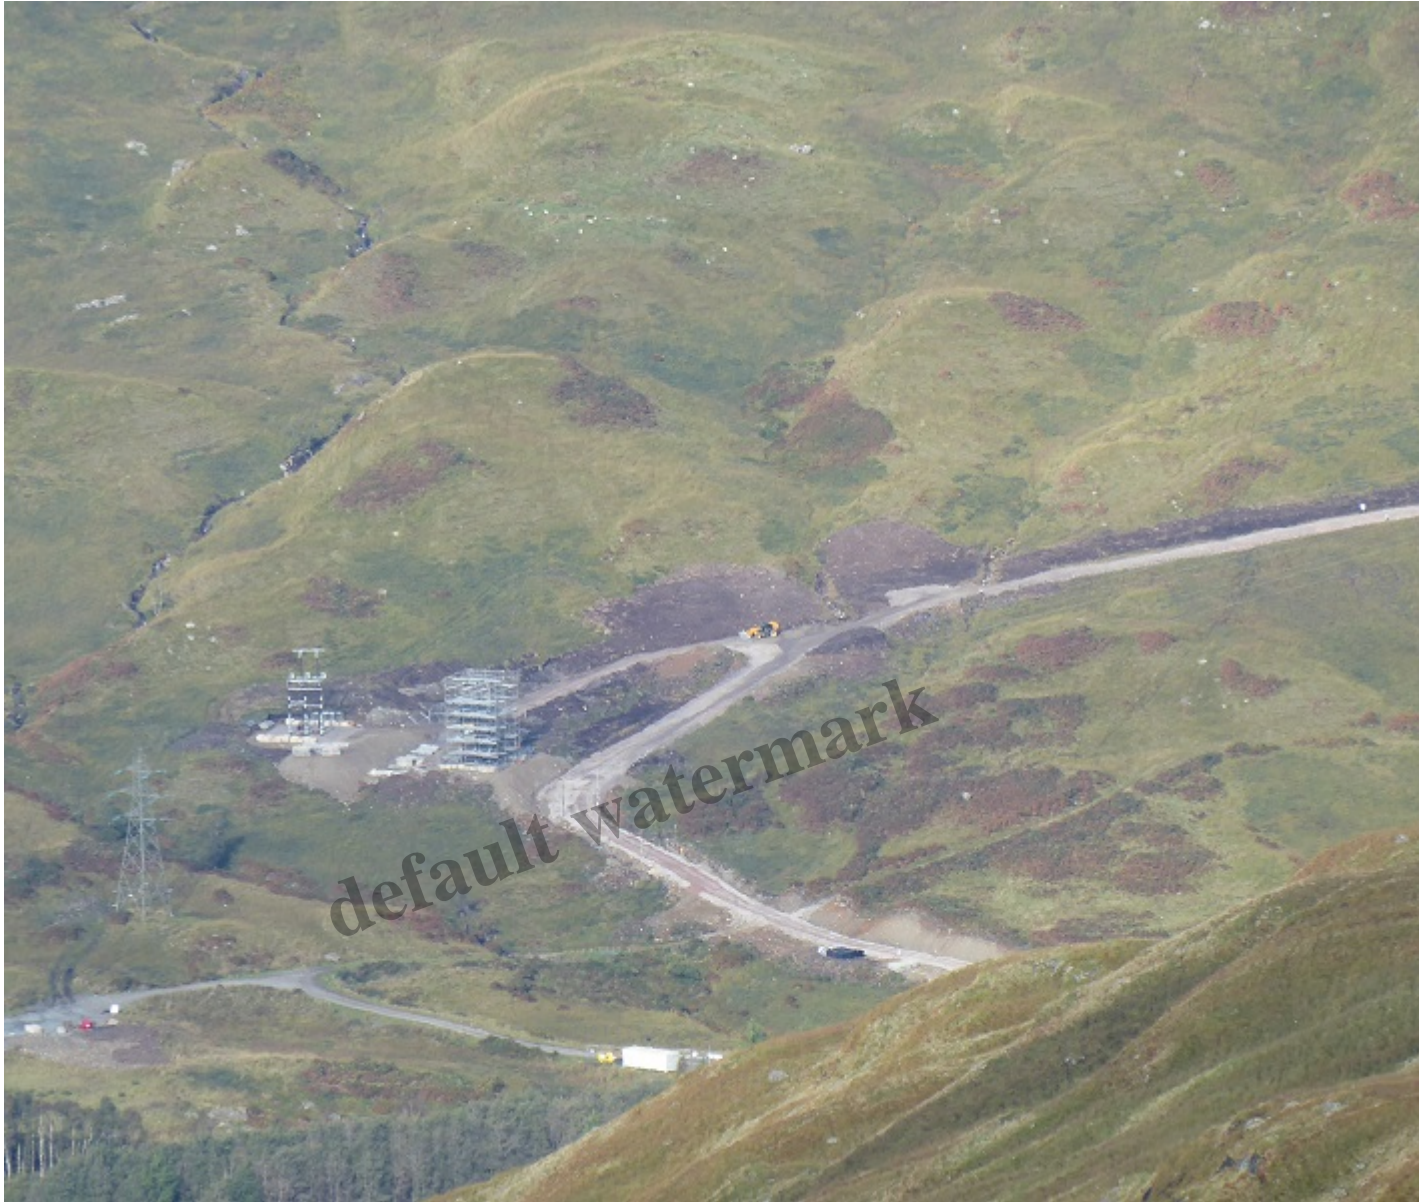
Close up of new temporary track and old and new towers above Derrydarroch

well but I had wanted to re-visit the site before blogging about it. Having seen the photo of the track, I am now much more concerned. A visit and time will tell, but I hope LLTNPA staff are keeping a close eye on what is happening and not leaving it to trust, as they did with the hydro tracks.
