The Ben Glas hydro scheme and Glen Falloch five years on – what does the LLTNPA stand for?

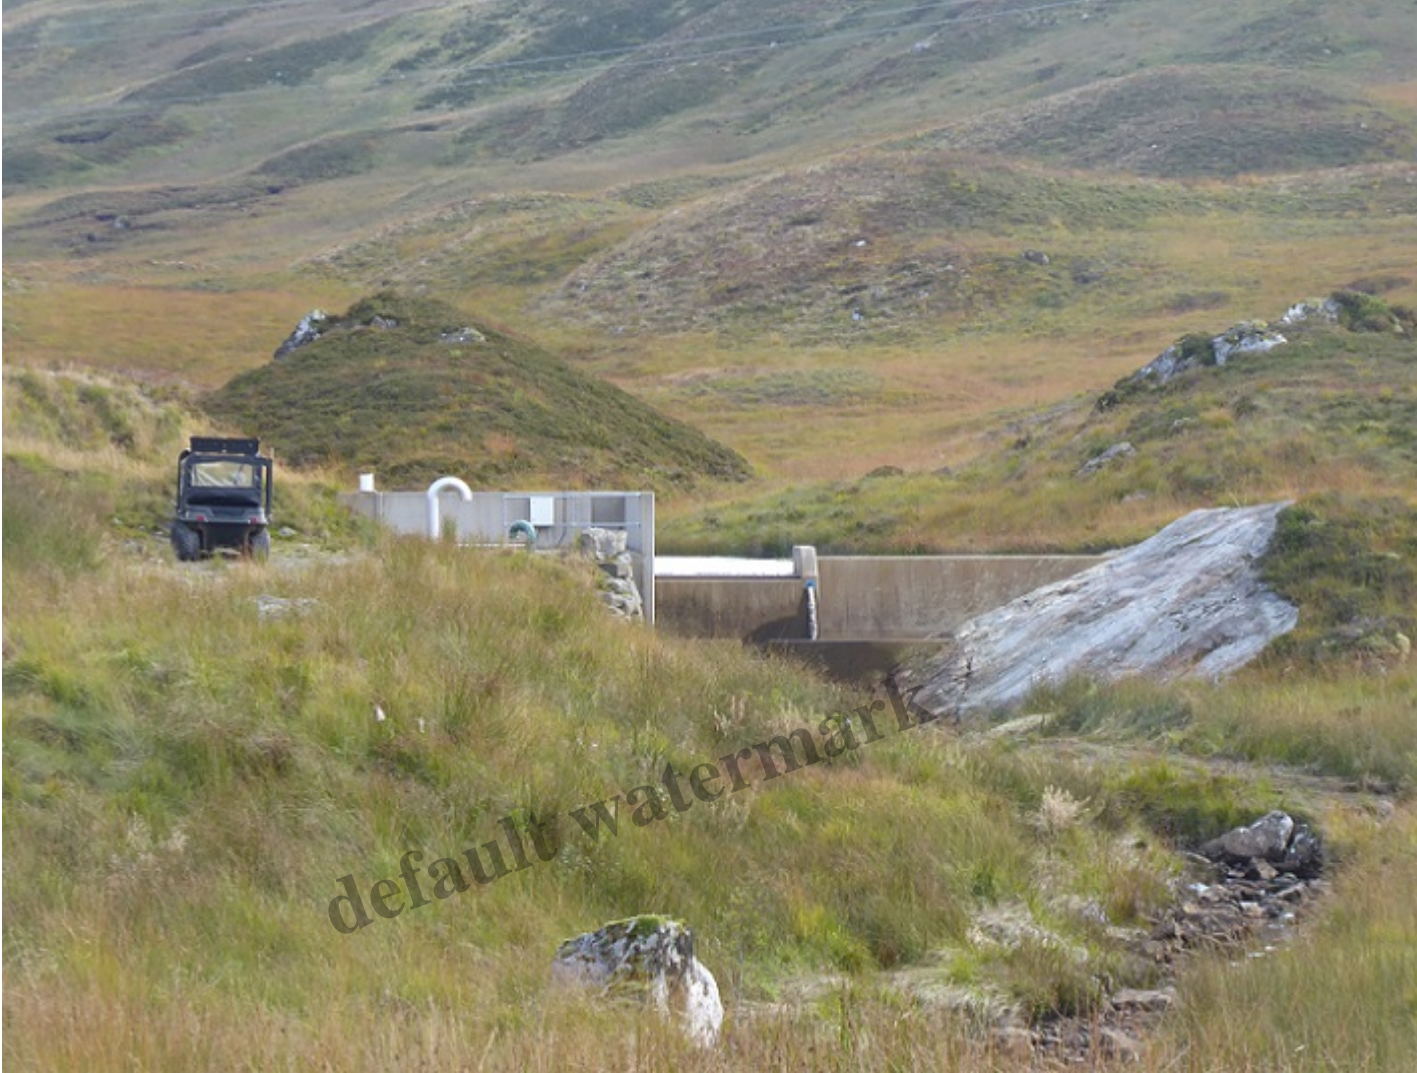
Second hydro intake, with pool behind and half empty burn below. Photo credit Louise Brimelow.

Instead, they allowed significant quantities of climate polluting concrete, with barely a token attempt at disguise: a couple of once blue pipes painted; the pile of boulders placed in front of part of the wing wall on the left. It is too late now for the LLTNPA to force the people hiding behind the complex company structure which owns this highly profitable scheme to do anything to improve it. The time-limit for Planning Authorities to take action after a development has been completed is generally limited to four years.
