The Ben Glas hydro scheme and Glen Falloch five years on â?? what does the LLTNPA stand for?

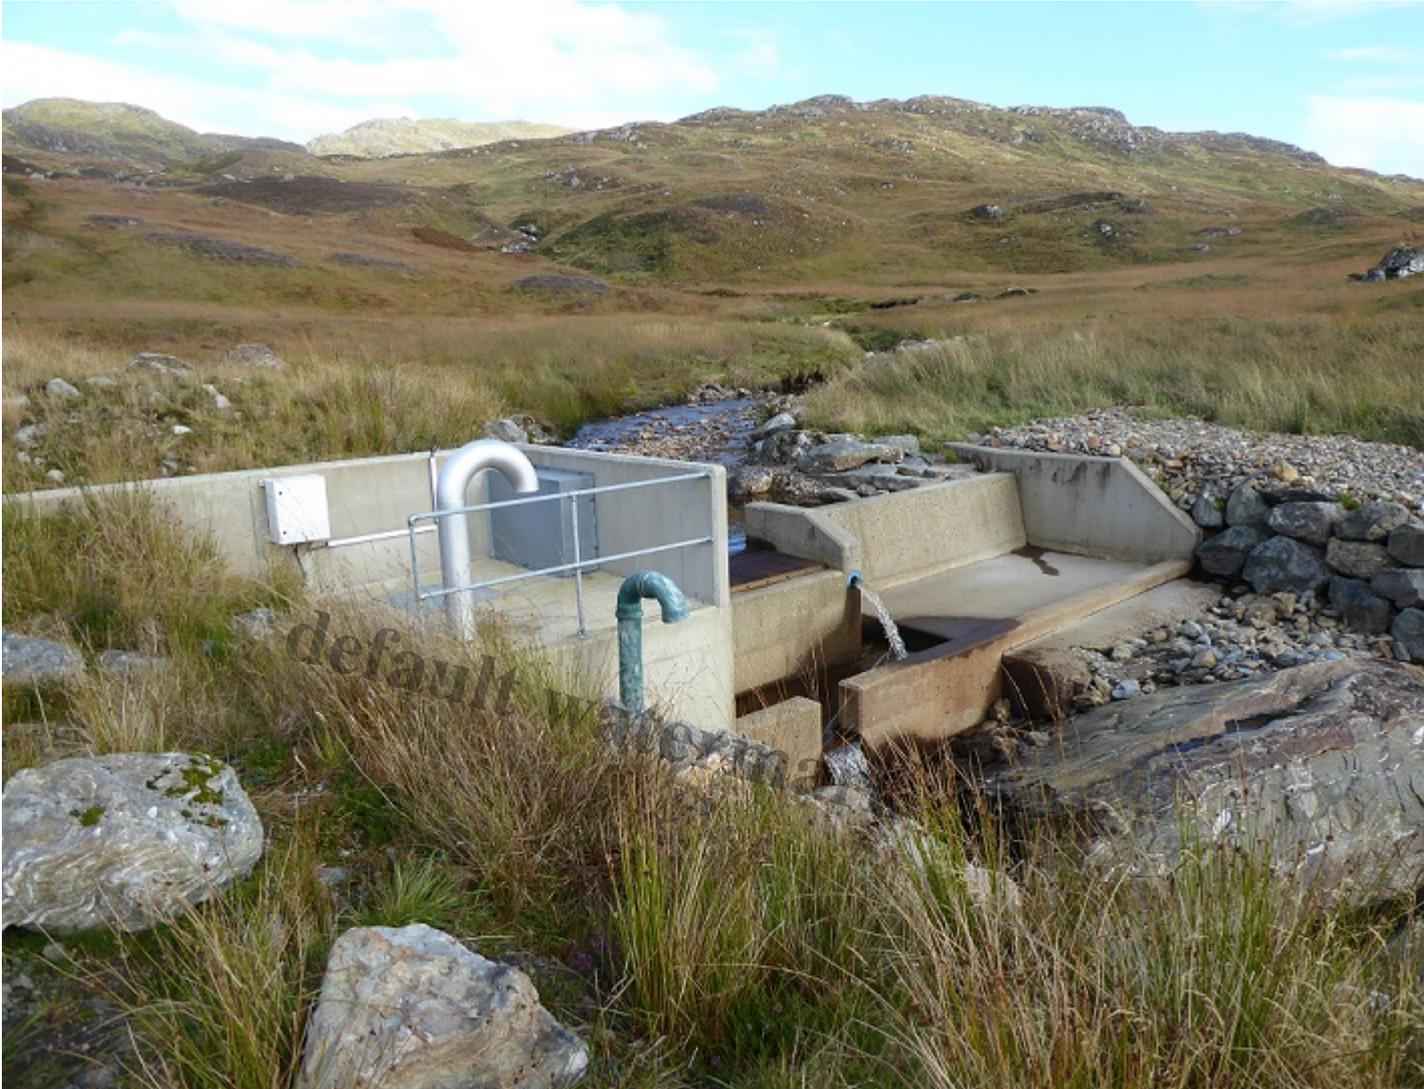
First hydro intake, by the most popular hillwalkers path up Beinn Chabhair. Photo credit Louise Brimelow.

Five years after construction, the Ben Glas hydro intakes remain ugly structures, an insensitive human imposition of a wild landscape. Both the Ben Glas hydro intakes are situated in what is now the Ben More and Ben Ledi Wild Land Area (WLA) but were granted consent in 2009, five years before the WLA came into existence.

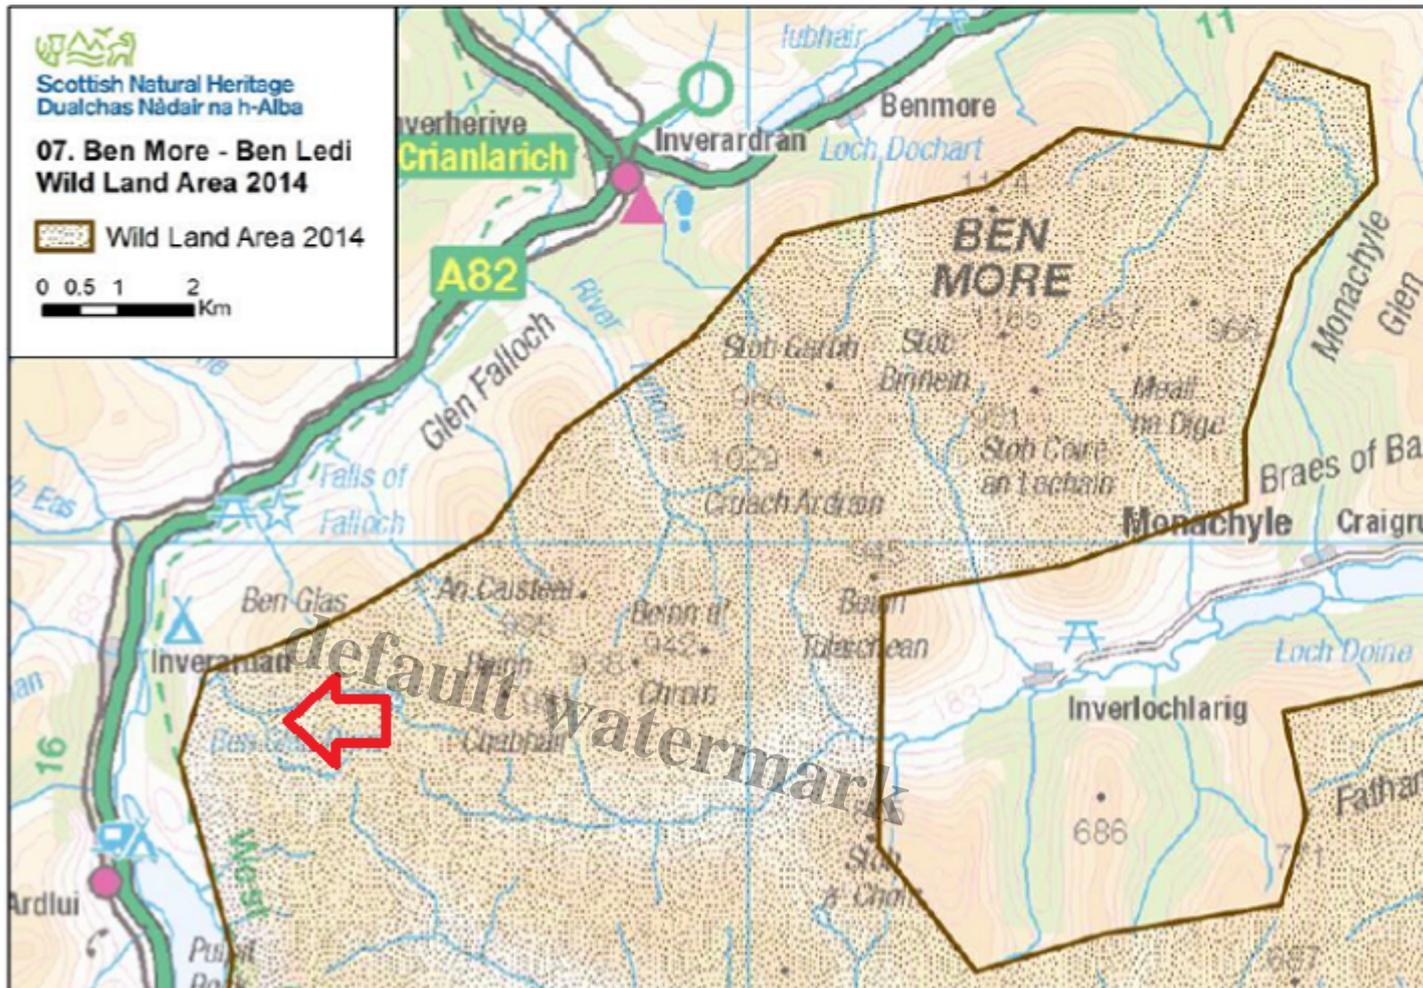
The two intakes are located just above the main fork in the burn which flows over Eagle Falls

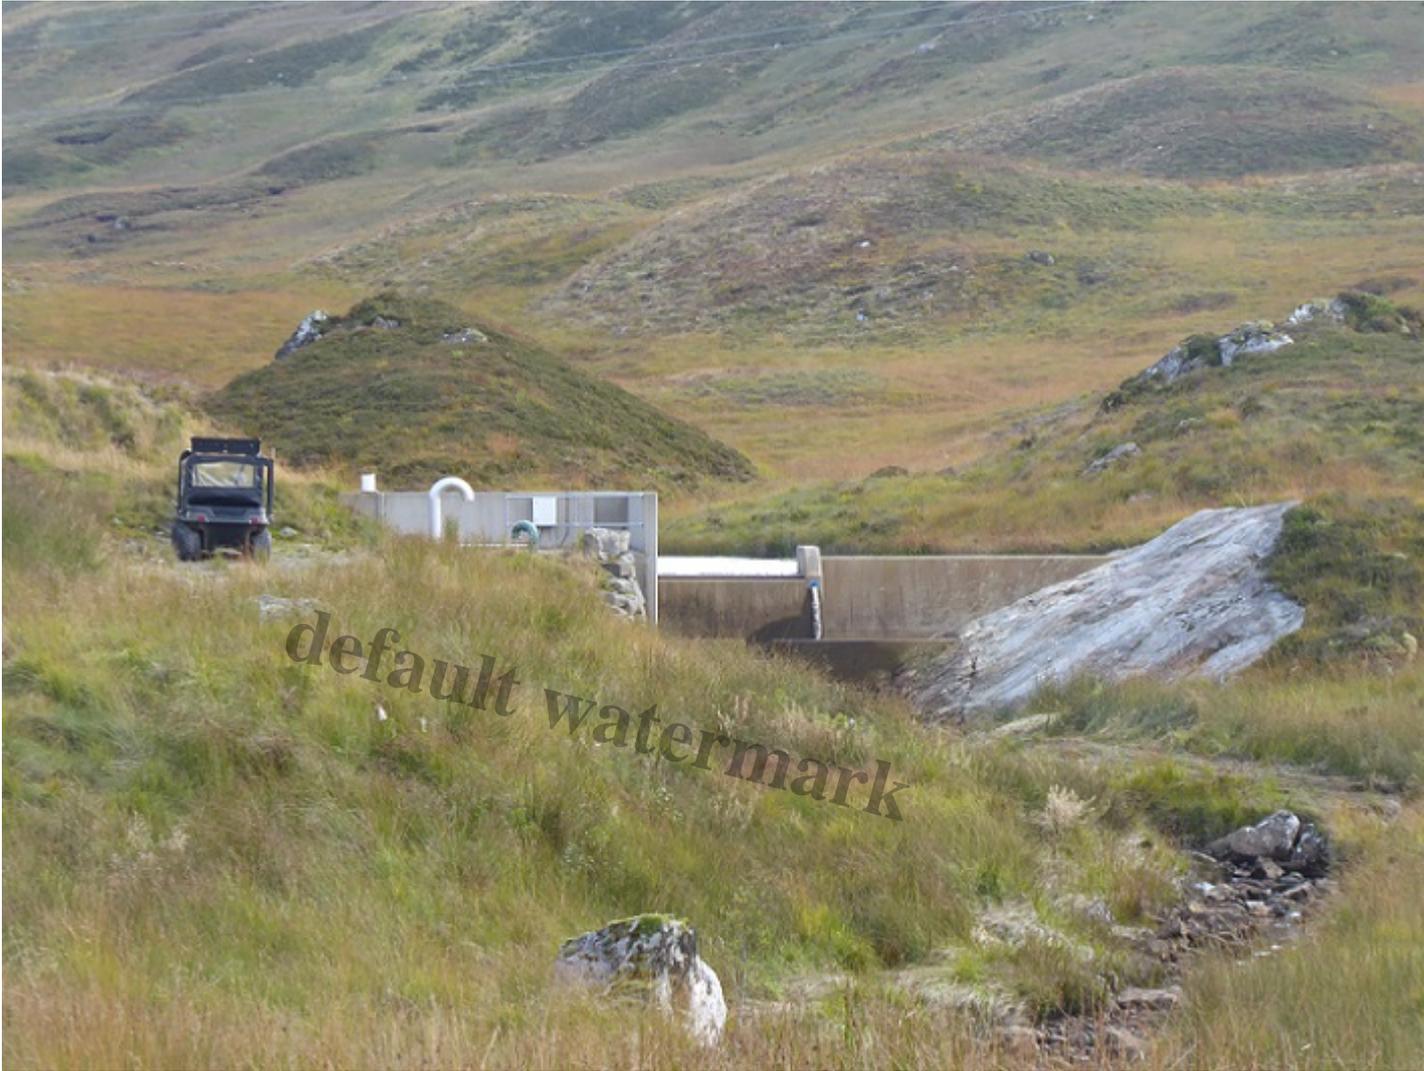
Second hydro intake, with pool behind and half empty burn below. Photo credit Louise Brimelow.

Instead, they allowed significant quantities of climate polluting concrete, with barely a token attempt at disguise: a couple of once blue pipes painted; the pile of boulders placed in front of part of the wing wall on the left. It is too late now for the LLTNPA to force the people hiding behind the complex company structure which owns this highly profitable scheme to do anything to improve it. The time-limit for Planning Authorities to take action after a development has been completed is generally limited to four years.

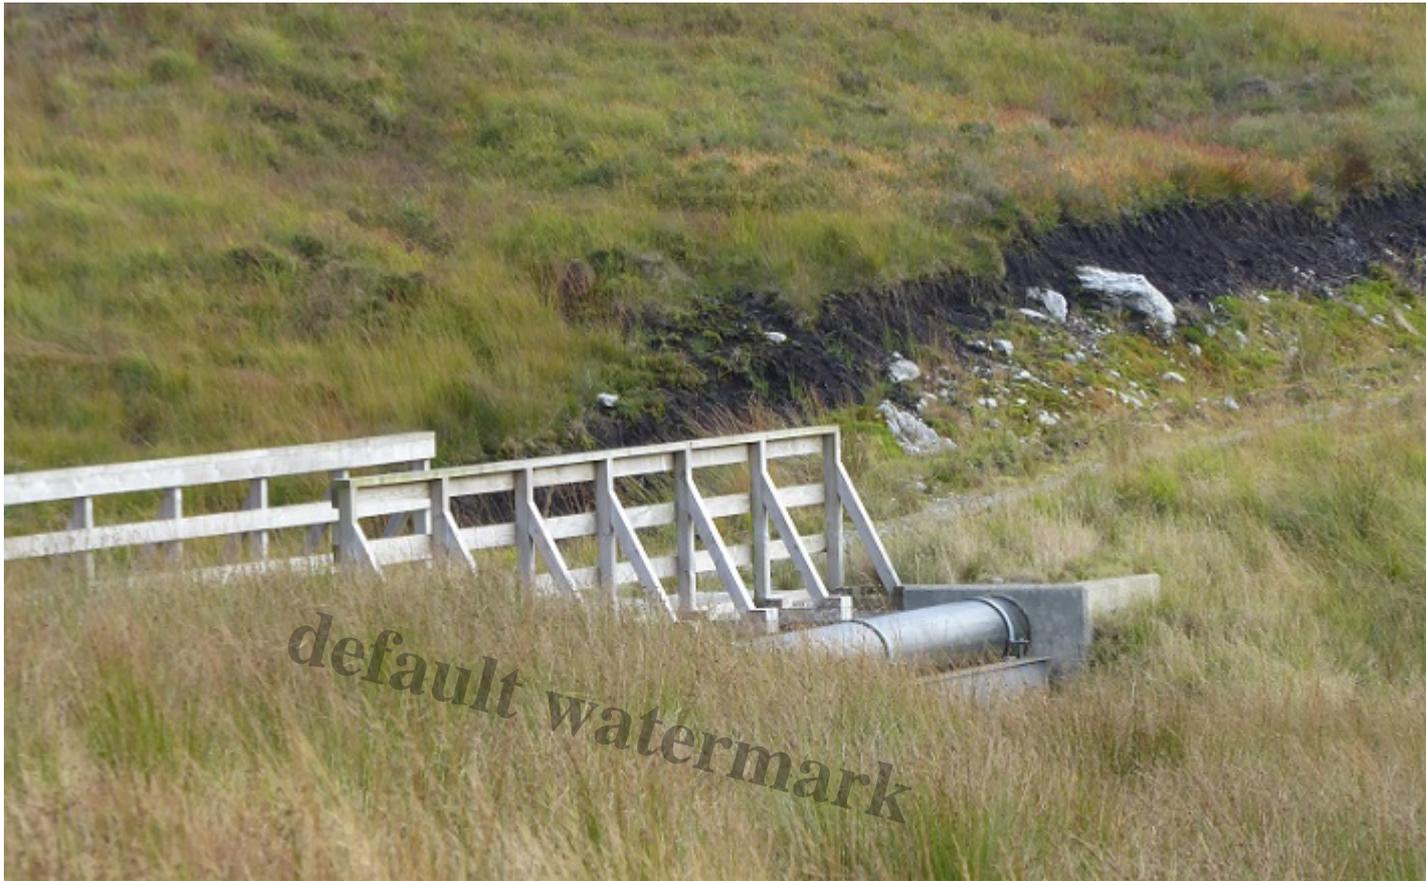
Section of track, bridge and hydro pipe just below the second hydro intake. Photo credit Louise Brimelow.

Further failures of the planning system under the LLTNPA are illustrated by this photo. The LLTNPA's own guidance on renewable developments stated pipes should be concealed below bridges where possible. Why not here? Five years later the edge of the peat bog above remains exposed DESPITE the LLTNPA having, with the assistance of the Scottish Government, paid out undisclosed sums to restore exposed surfaces of peat in the damaged bog above. If it wasn't true, it would be hard to make up.

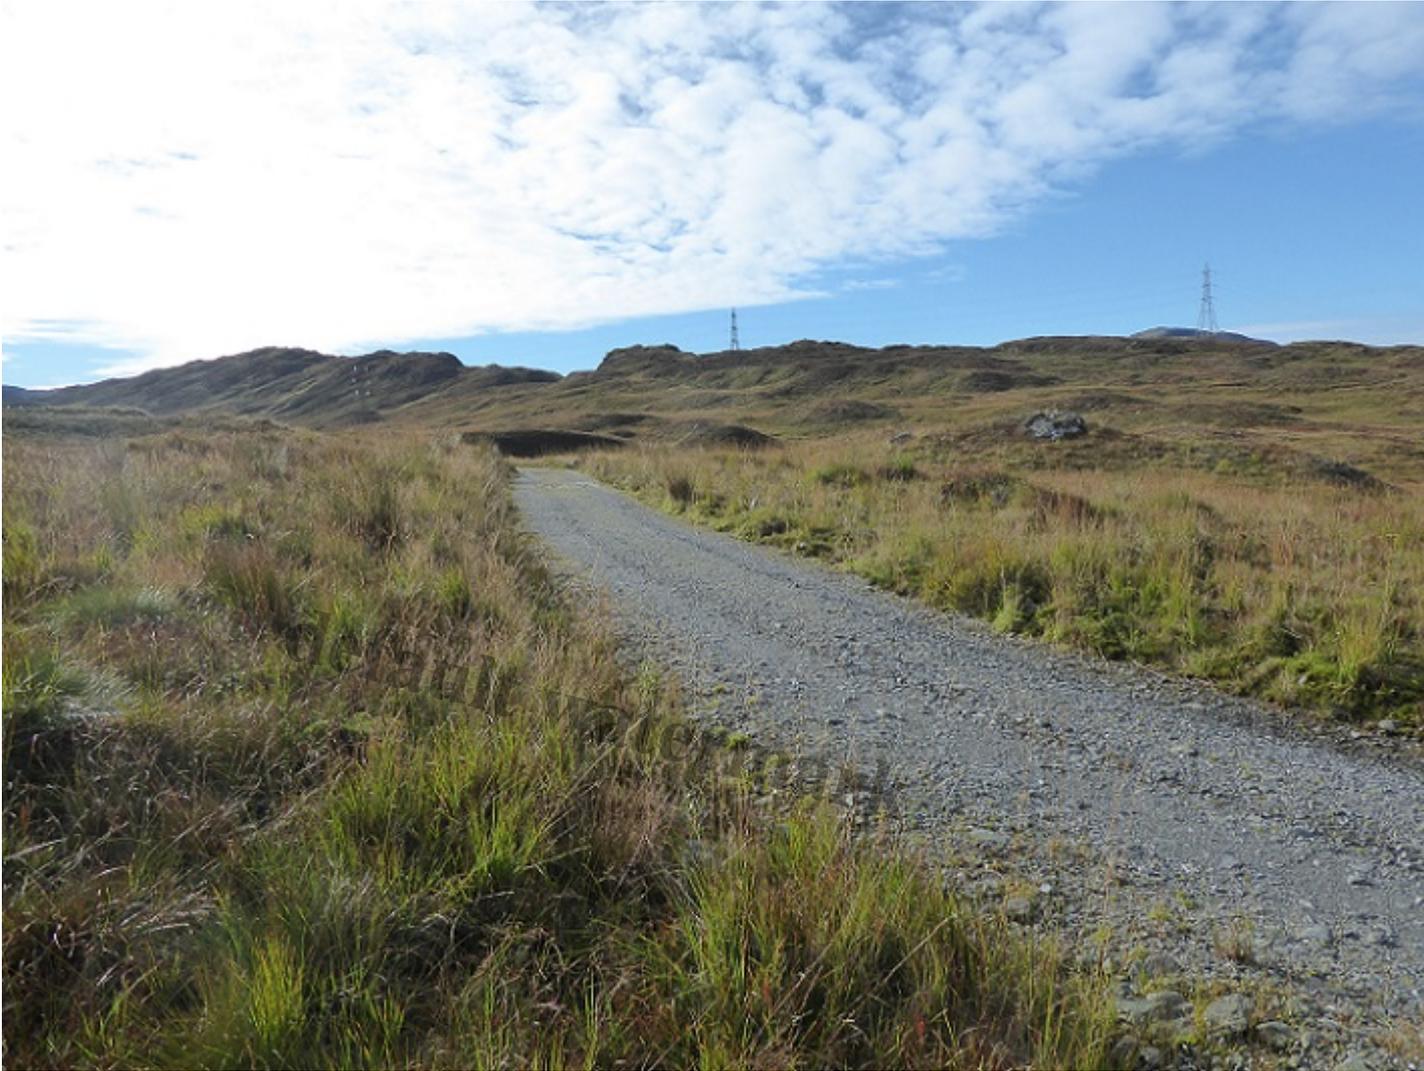
A section of the horizontal section of the hydro track below the intakes. The wheel marks show it is far broader than was needed for vehicles to access the site. Photo credit Louise Brimelow.

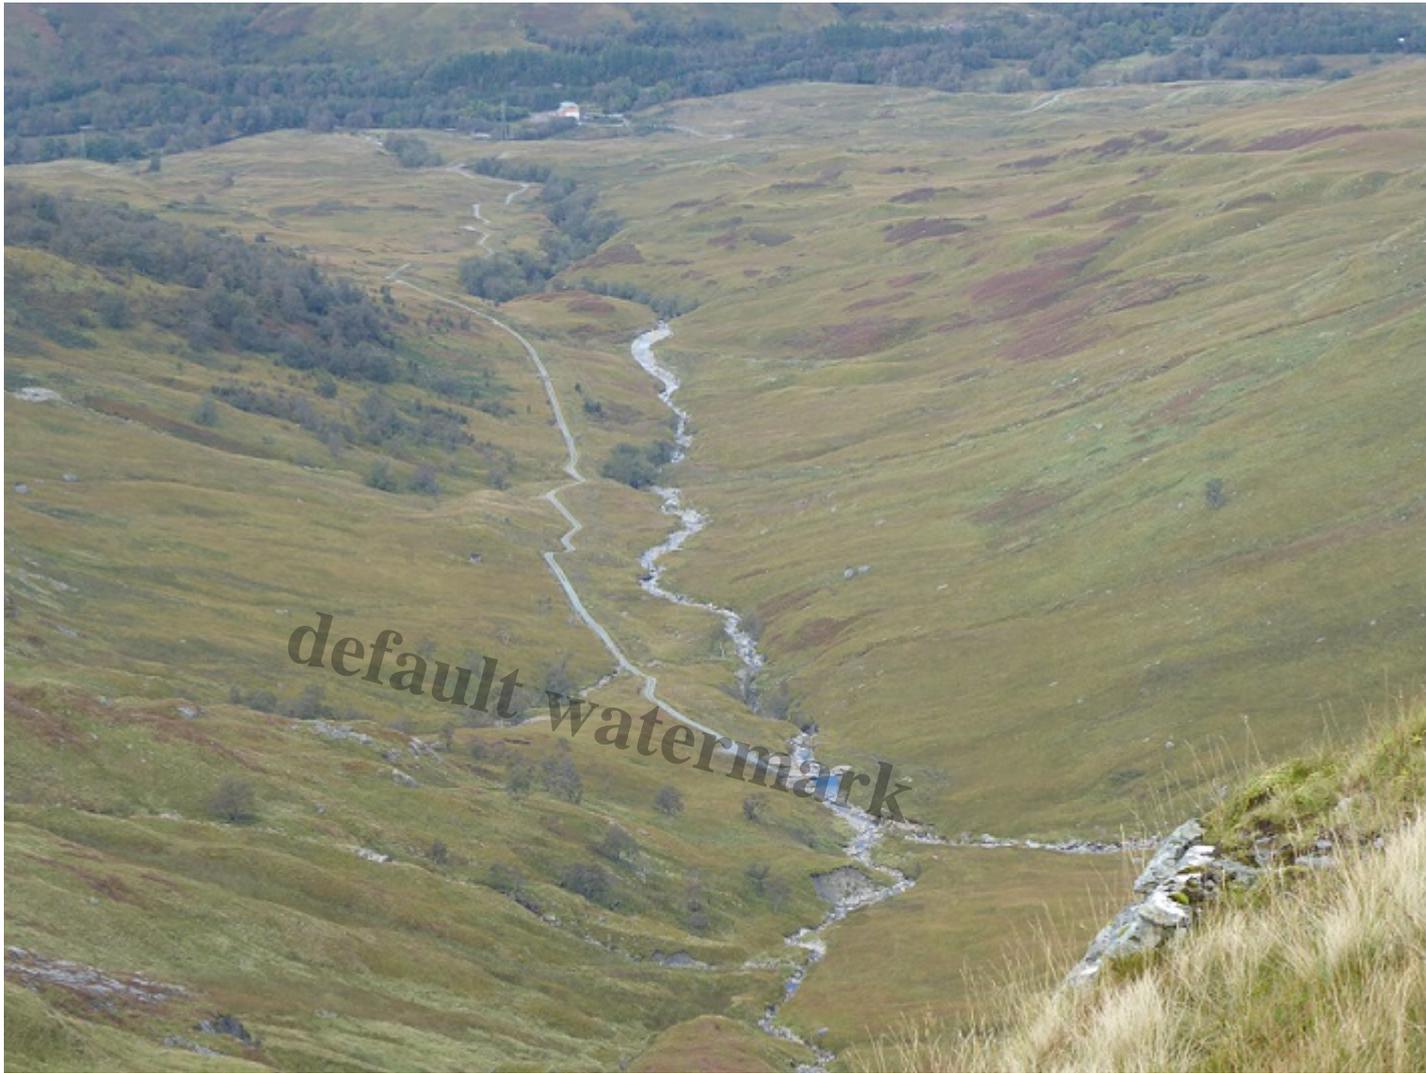
Allt a Chuilinn main intake and hydro track, just outside the Wild Land Area boundary, with the visually prominent Derrydarroch powerhouse behind. Look carefully and you can just see another powerline. Photo credit Louise Brimelow.

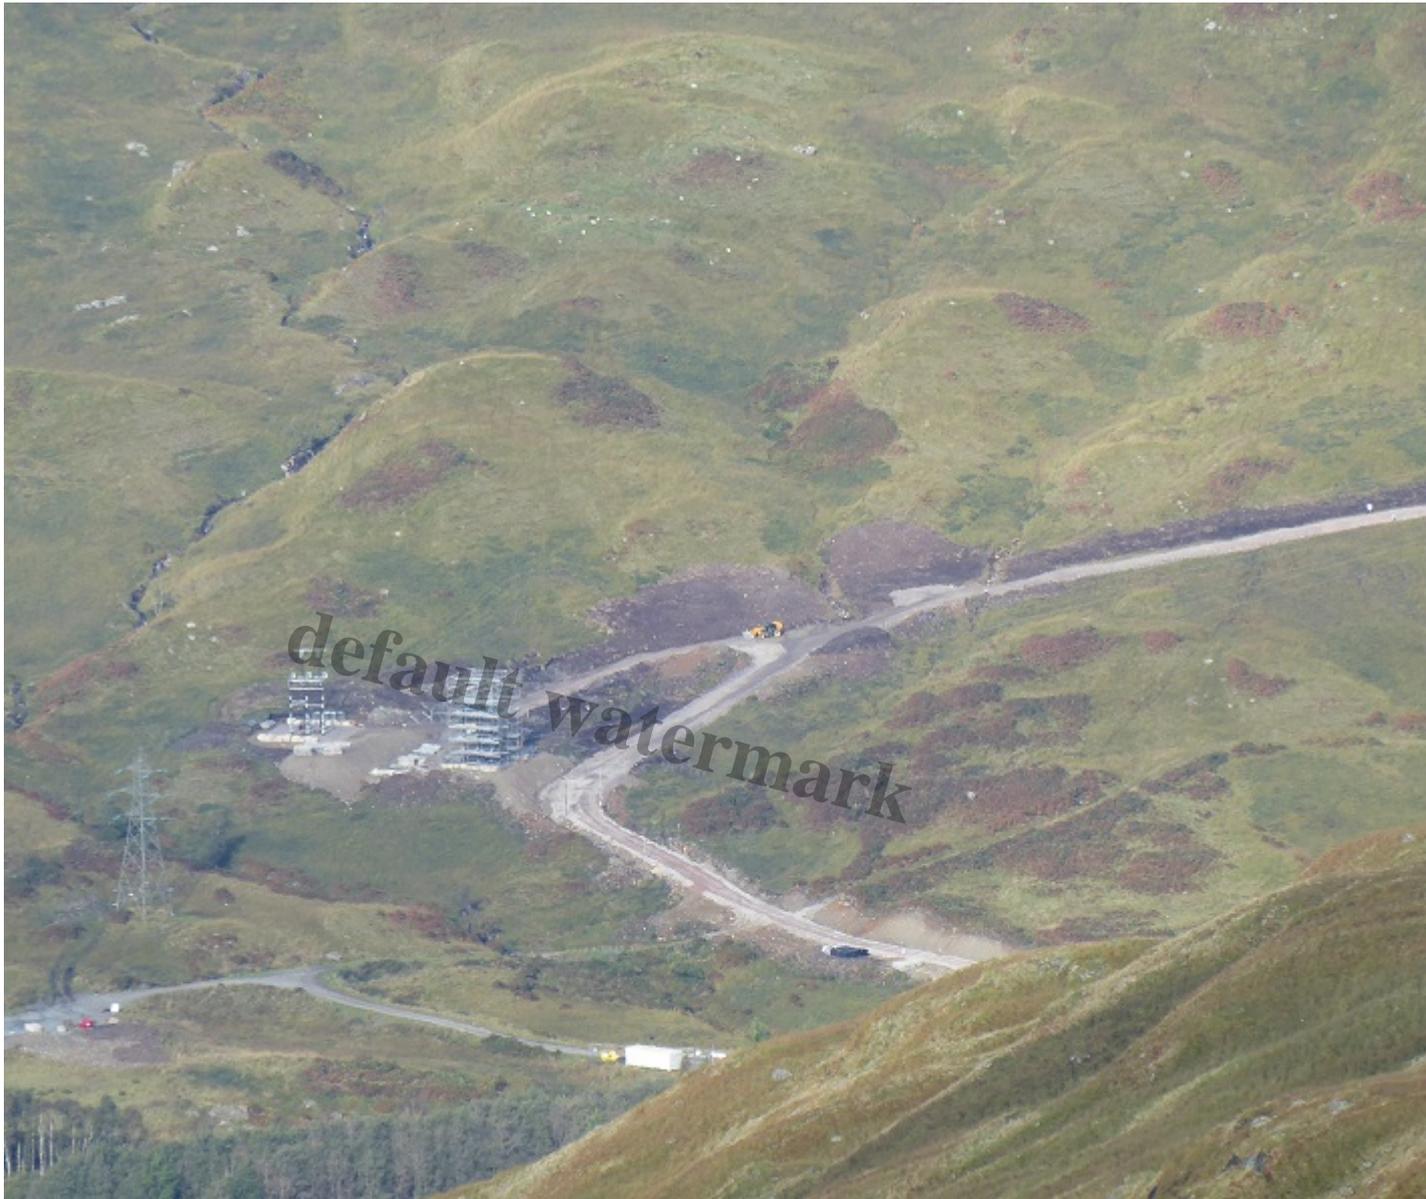
Across Glen Falloch from the Allt a Chuilinn, the Eas Eonan hydro track runs up to the Ben Lui Wild Area, with the Cononish Goldmine know gnawing into it from the far side. Looking at the photo I was shocked by the visual impact of the new track just to its right. This has been constructed as part of Scottish and Southern Energy (SSE)'s VISTA project intended to reduce the visual impact of overhead powerlines by burying them.

Close up of new temporary track and old and new towers above Derrydarroch
