And still the silt flows on the Pitmain Estate â?? what is the point of the Cairngorms National Park Planning Authority?

June 10, 2023

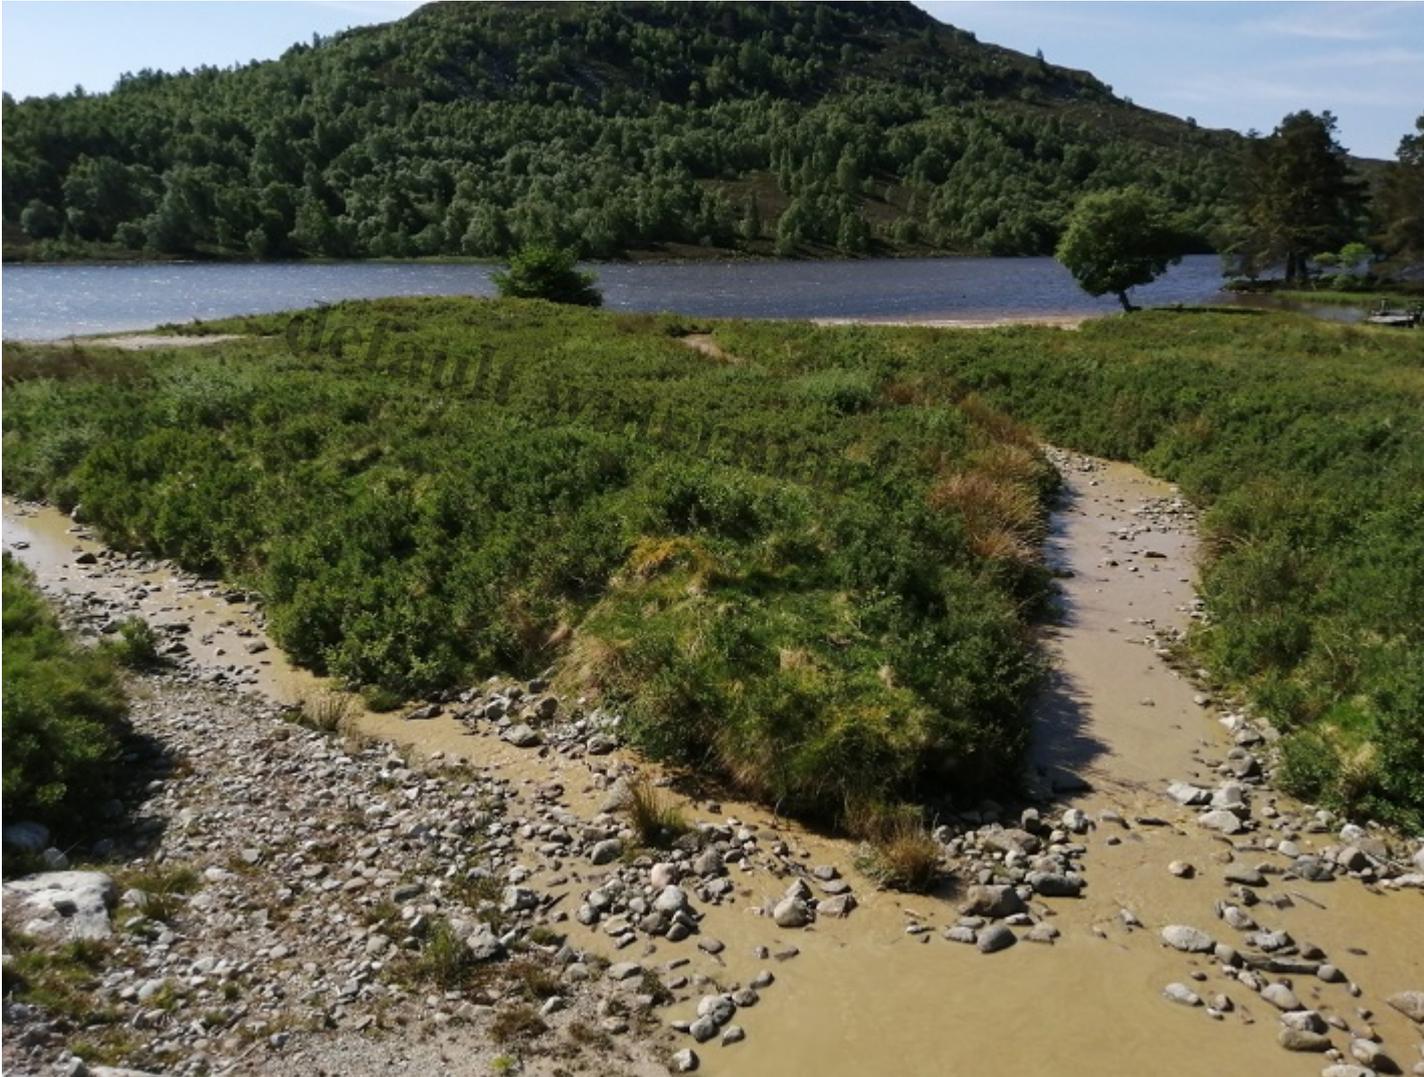
Outflow of Gynack overflow channel 9th June where it flows into Loch Gynack. Photo credit Parkswatch reader

There is no doubt, however, that the silt that was being washed into Loch Gynack yesterday was flowing the overflow channel which is currently being repaired after it failed soon after construction ([see here](#)). The silt is therefore a planning enforcement matter.

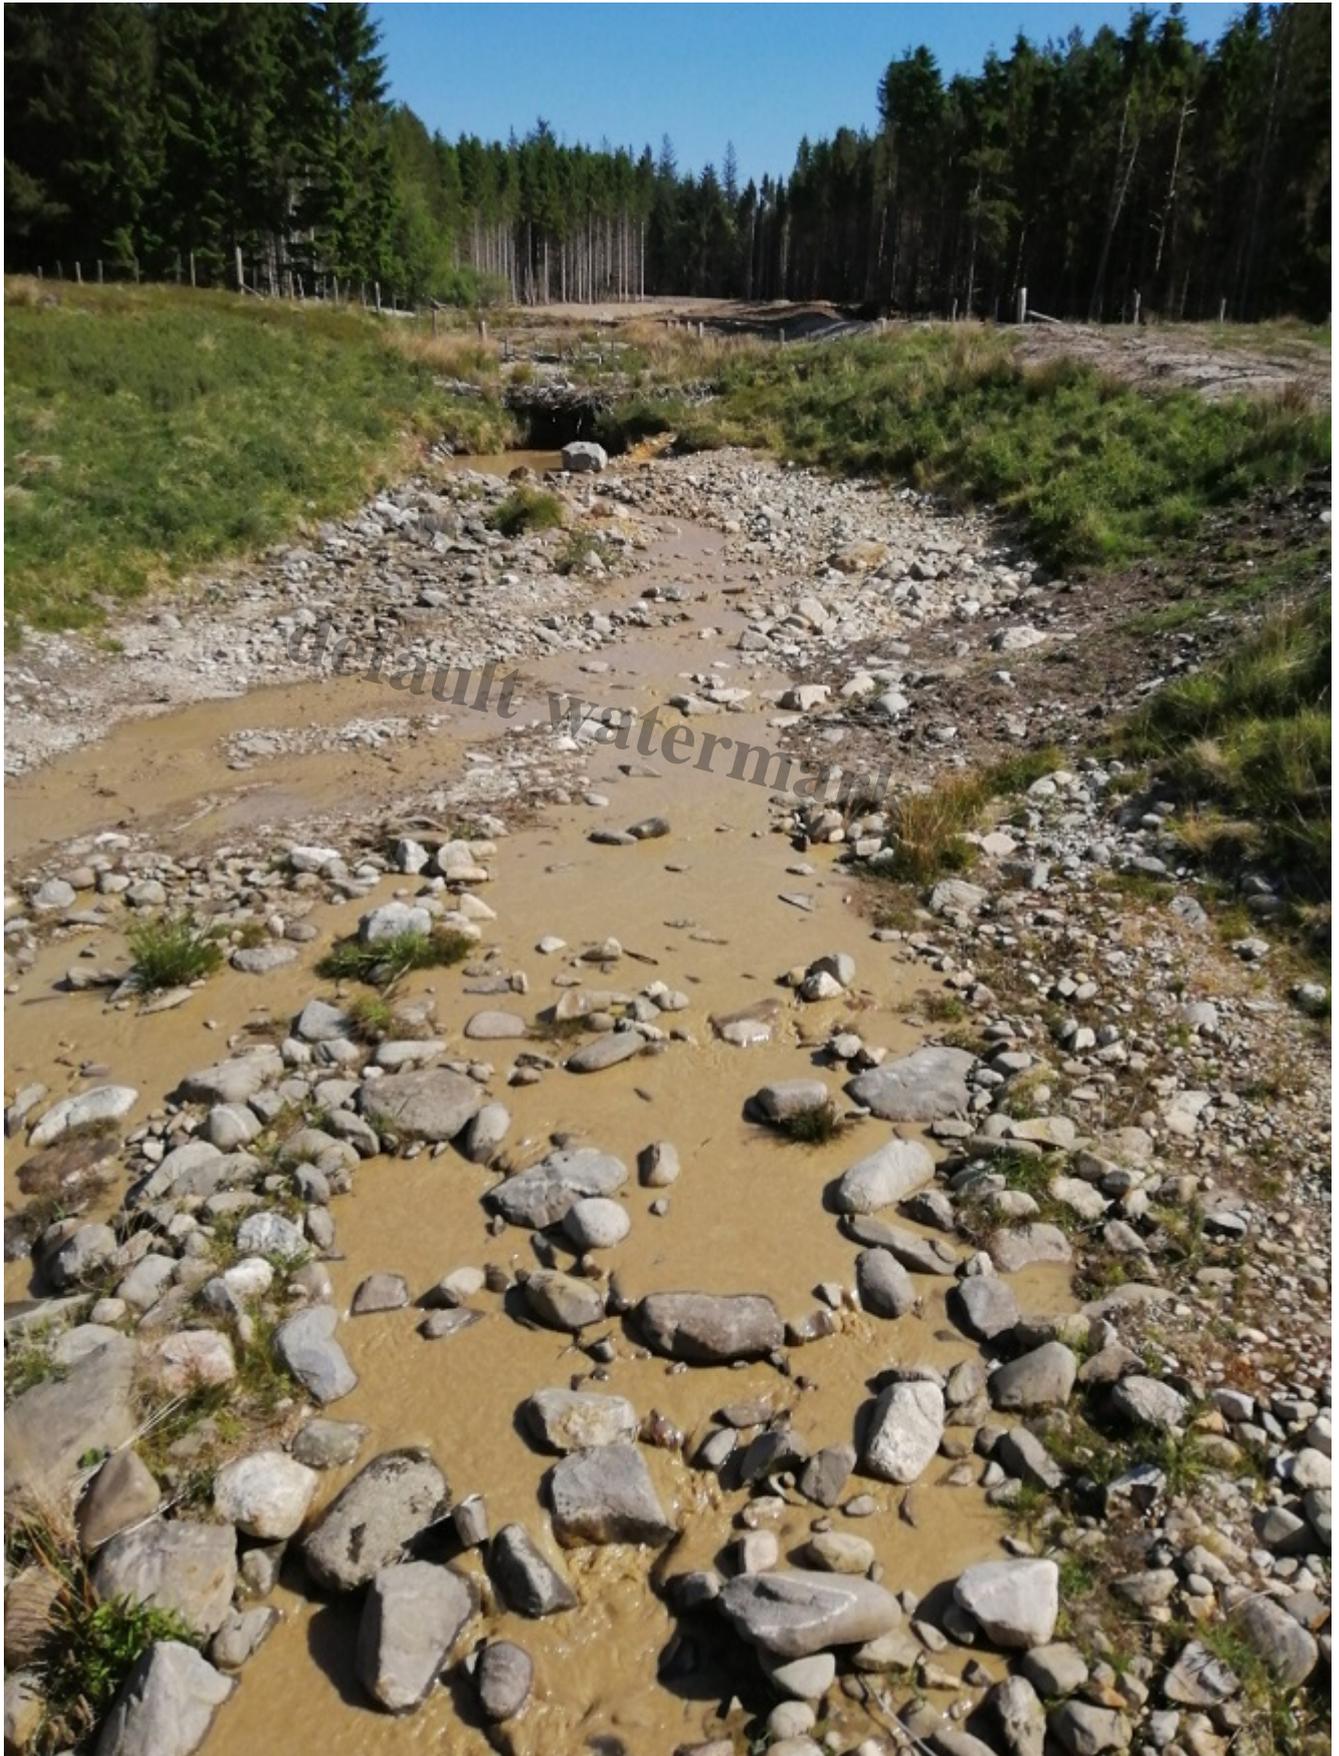
The silt sedimentation pond was shown on the original plans as being situated just above the fence in the photo â?? yesterday it was clearly not working

The photos from 9th June suggest that neither the diversion culverts nor the sedimentation pond, as proposed in the original plans, have been operating properly during the repairs works. So why, six weeks later, have neither the CNPA or SEPA done anything to rectify this and prevent the flow of silt into the river system?

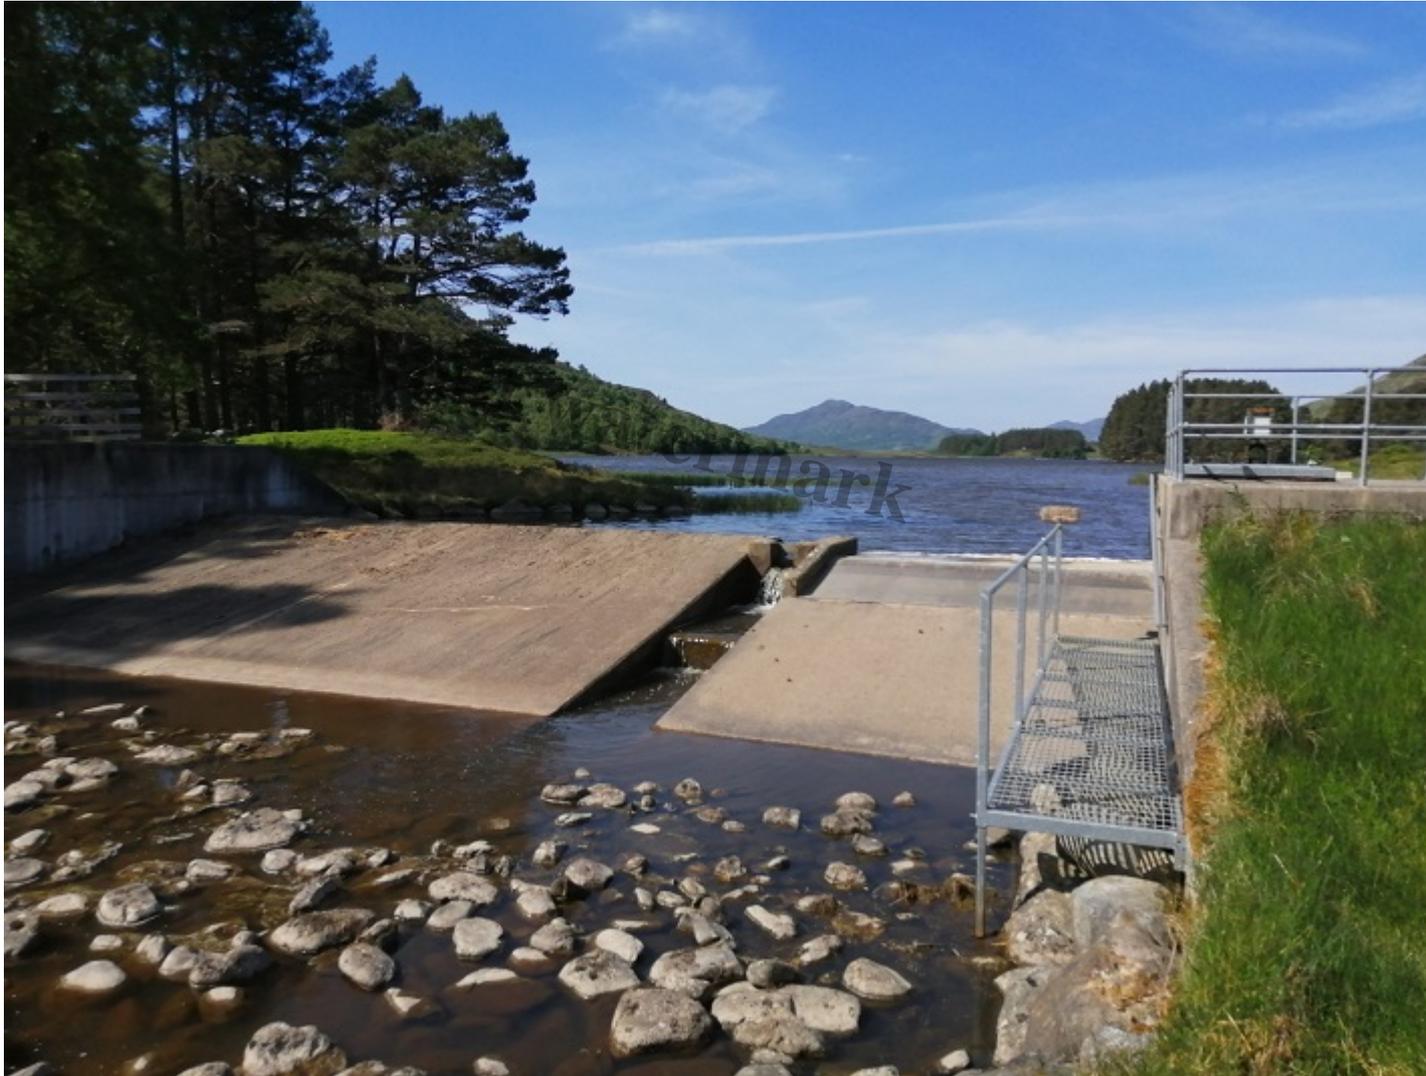
The Loch Gynack outflow, which now also serves as a hydro intake. The water on 9th June appears slightly murky. Photo credit Parkswatch reader.

Loch Gynack, itself, acts like a giant sedimentation pond for the silt flowing down the overflow, however that has not been sufficient to stop some of the silt flowing out and down into the River Spey Special Area of Conservation below. NatureScot, the agency responsible for these protected areas, should also be up in arms.

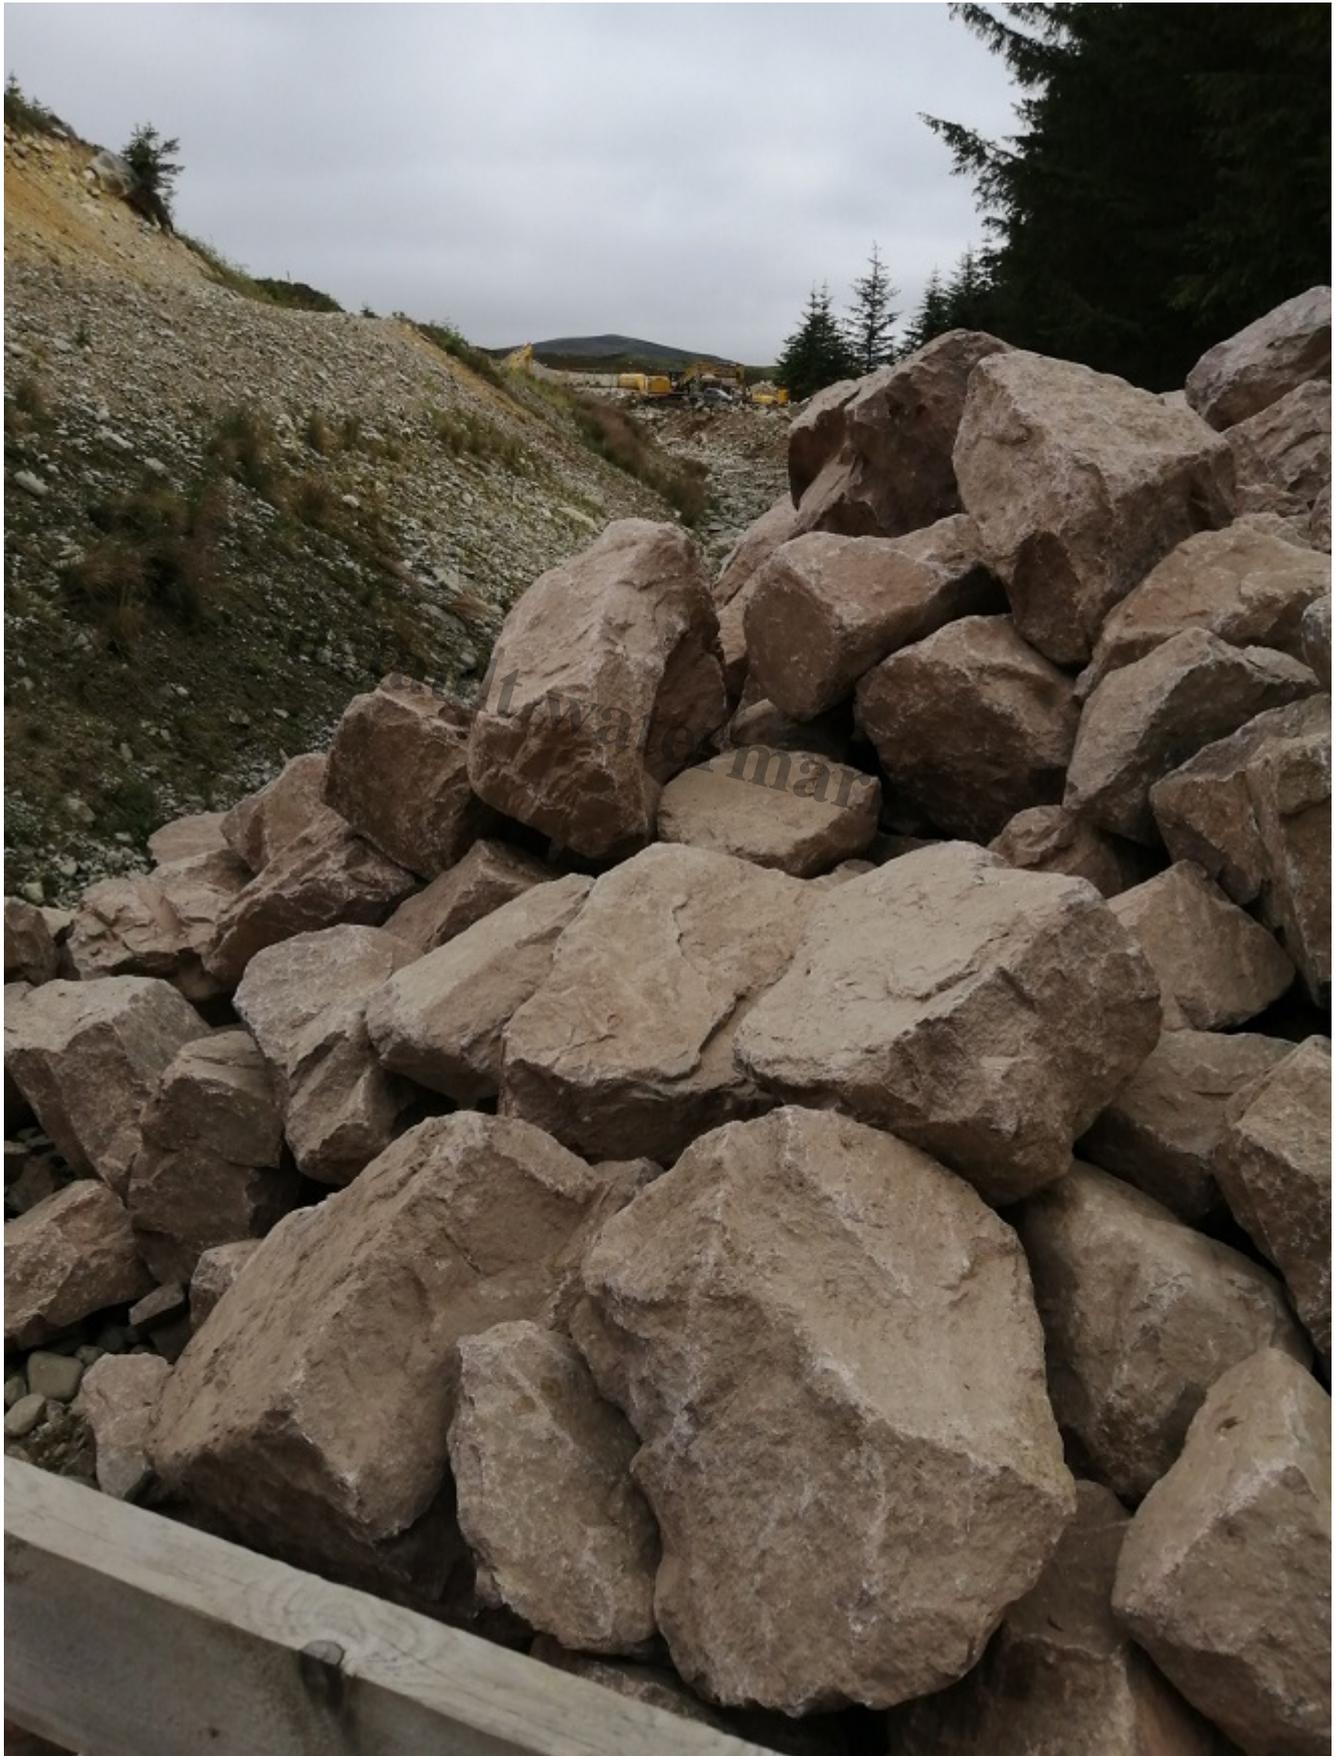
View from the bridge over the overflow channel, with the intake to the diversion scheme visible on the near horizon. Photo credit Parkswatch reader.

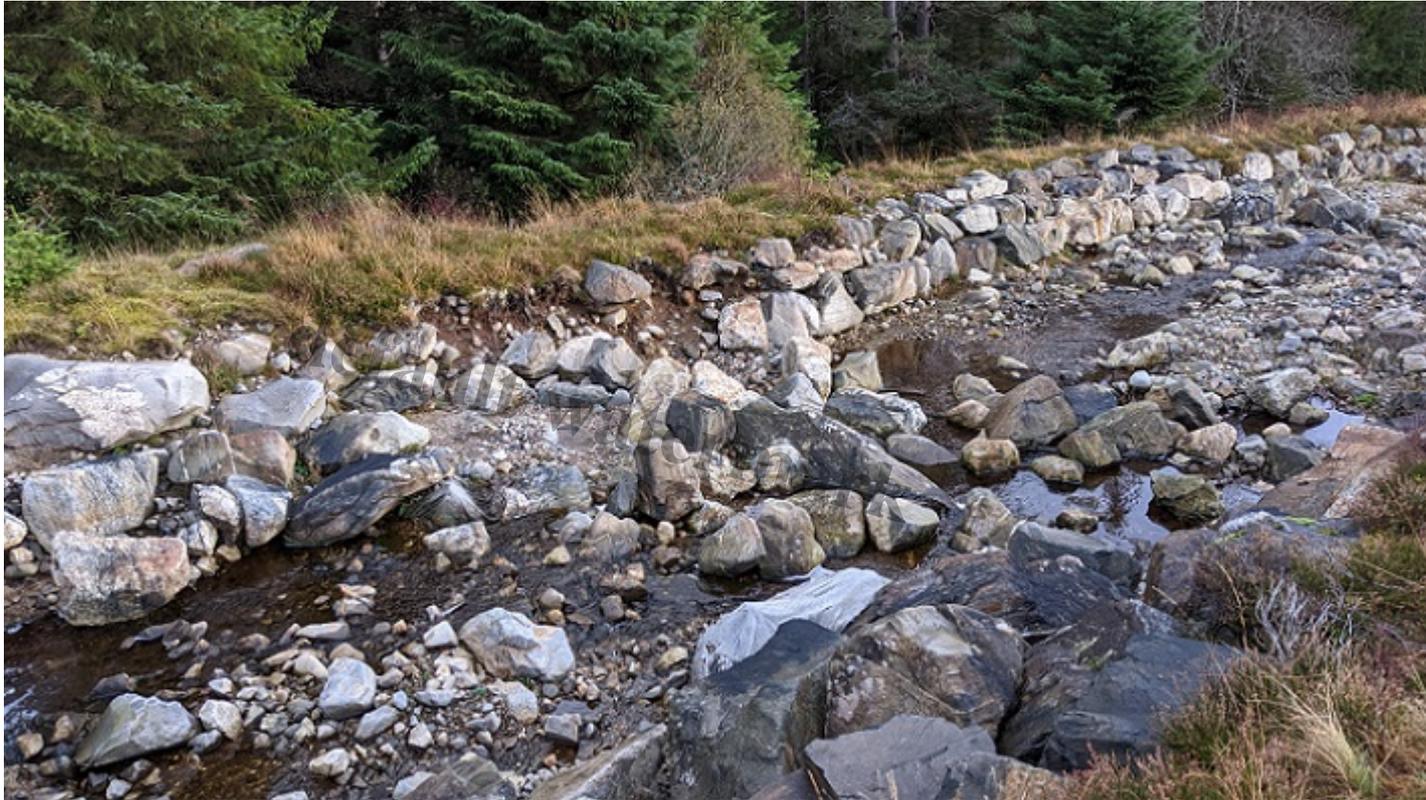
Photo 2022.

Meantime other recent photos suggest that large amounts of rock re-inforcement has been brought in to Pitmain to reinforce the sides of the overflow channel. Whether this will work is a moot point as some of the rip rap bouldering used to line the channel previously was washed away soon after it was first used:

Judging by a comparison of the size of the boulders in the two photos, the idea appears to be that enormous rocks – rumoured to have come from a quarry near Nairn – will contain flood water where smaller ones didn't.

There are reasons to doubt that, given the force that flood water will be forced through the boulders and the size of the bank behind, but perhaps the current plan is to embed the new boulders in concrete? That surely should require a fresh planning application. Unfortunately, without any plans there is no way for anyone to evaluate the current repair work, either whether it will work or the environmental costs.
