## HIE's decision to close the Cairn Gorm funicular again! (2) What's happening?

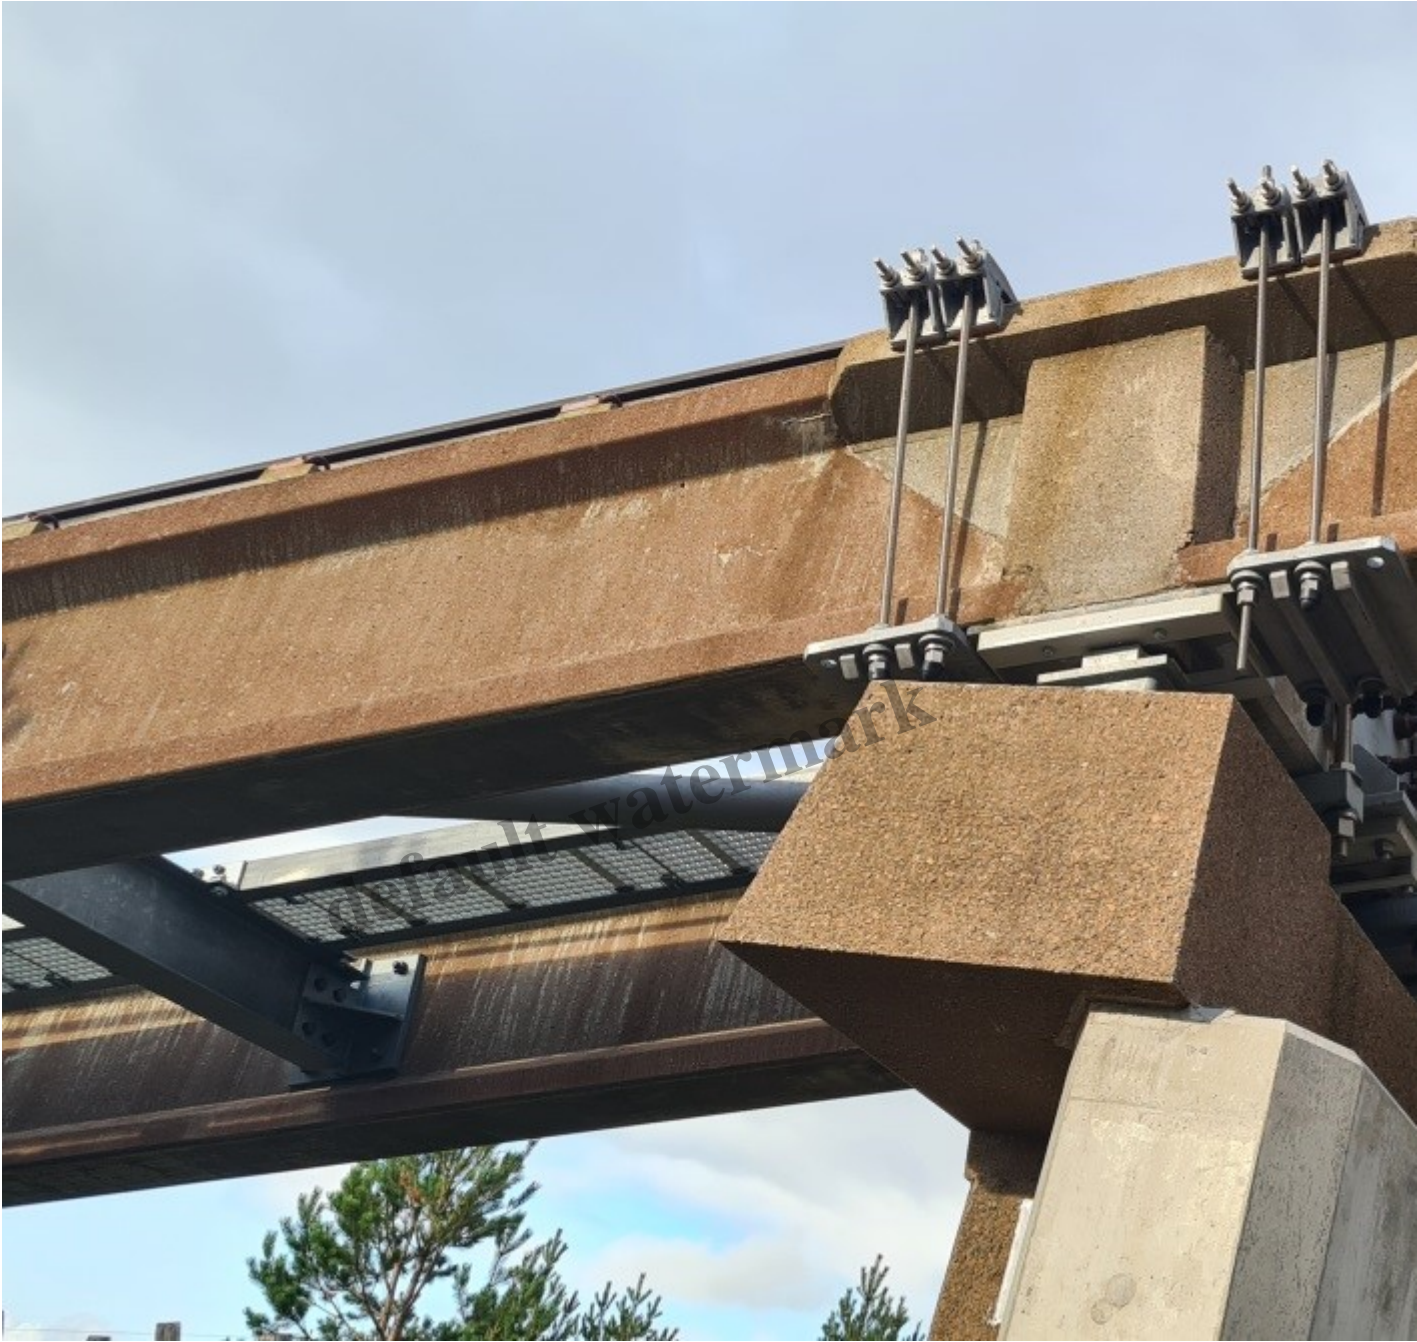
This photo shows how the scarf joints (where the “I” beams meet the in-situ blocks) have been strengthened. The “I” beams in this picture appear to be sound with no brackets holding them together but ingress into the joint

The real problem with more than tripling the weight of the beams was that their span meant they were too large to support their own weight given their intended use. It is for that reason that brackets have been added to strengthen the thinnest section of the beams on either side of each scarf joint as in the photo above.

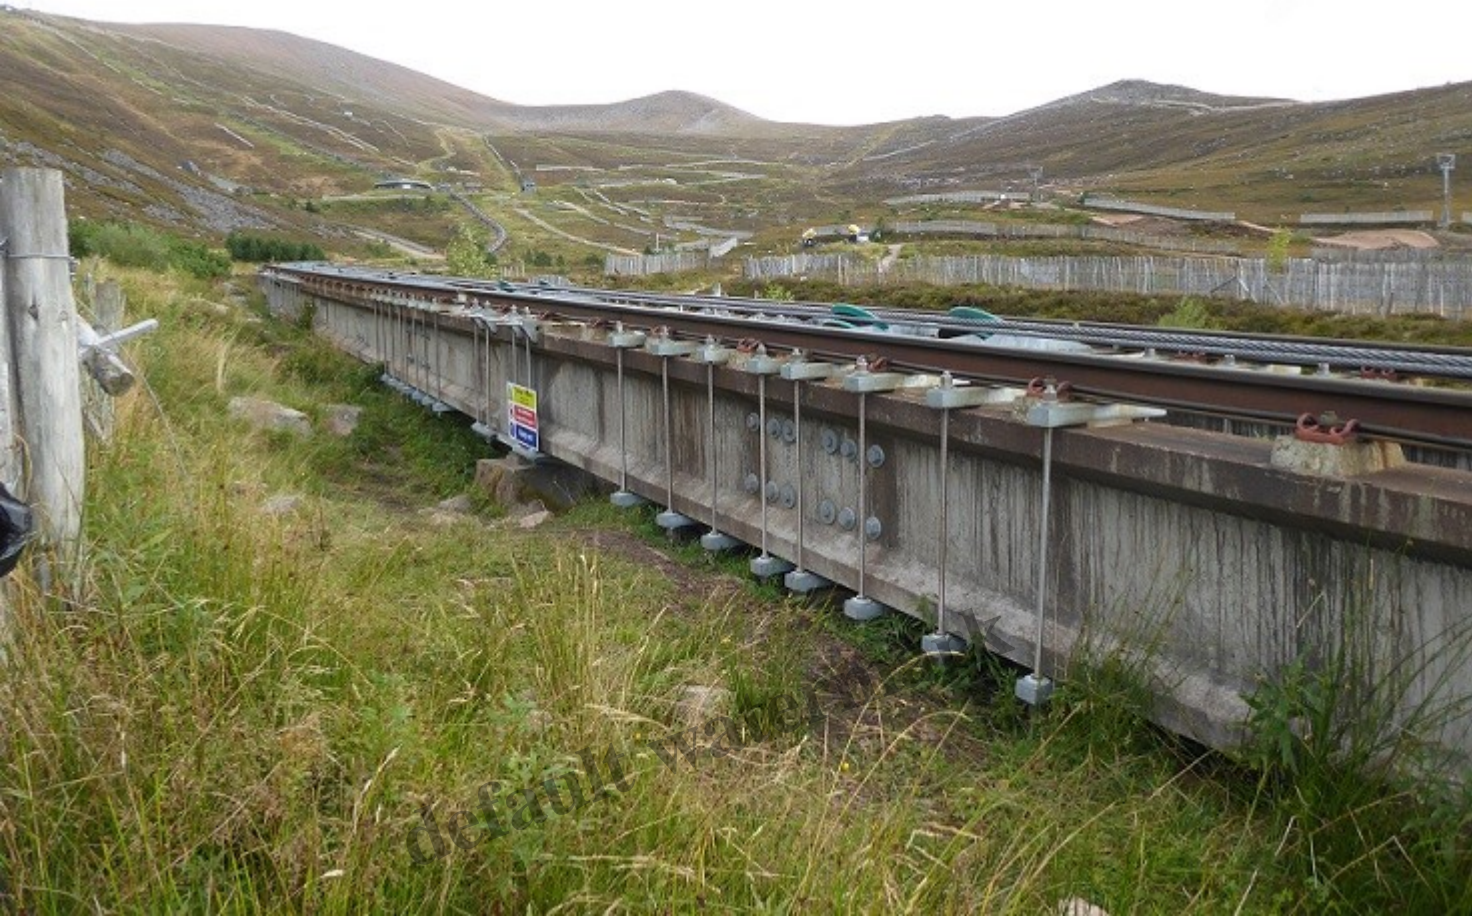
However, there are also brackets around beams on the lower section of straight horizontal track. This suggests that some of the beams may have been breaking up under their own weight.
