## HIE's decision to close the Cairn Gorm funicular again! (2) What's happening?

October 13, 2023

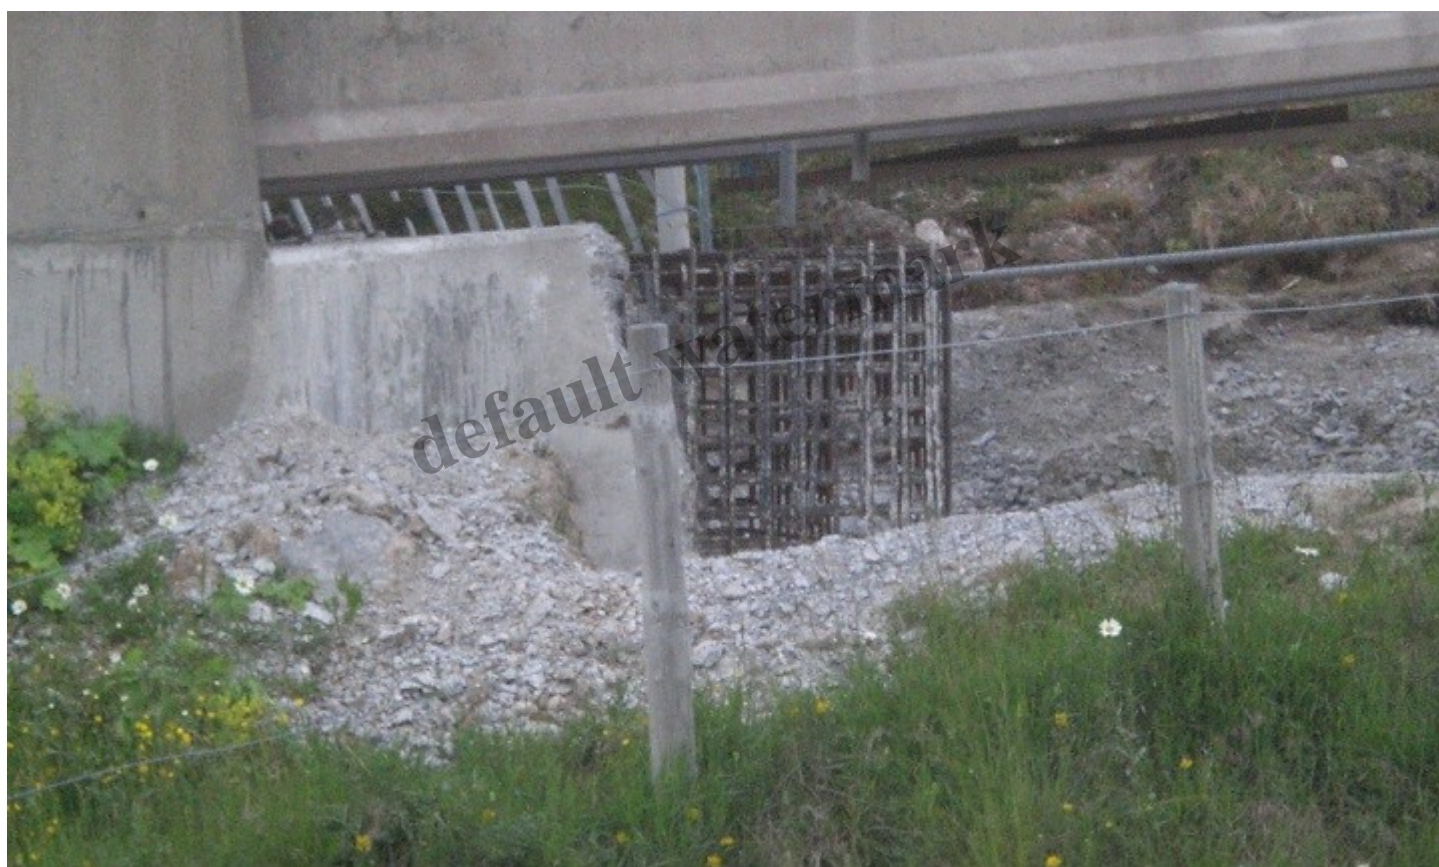
The bottom anchor block (photo above) – which is designed to stop the section of railway above moving downhill – and a few piers (photo below) have been reinforced but this is the exception, not the rule, and the explanation for why this was needed in these cases is unclear.

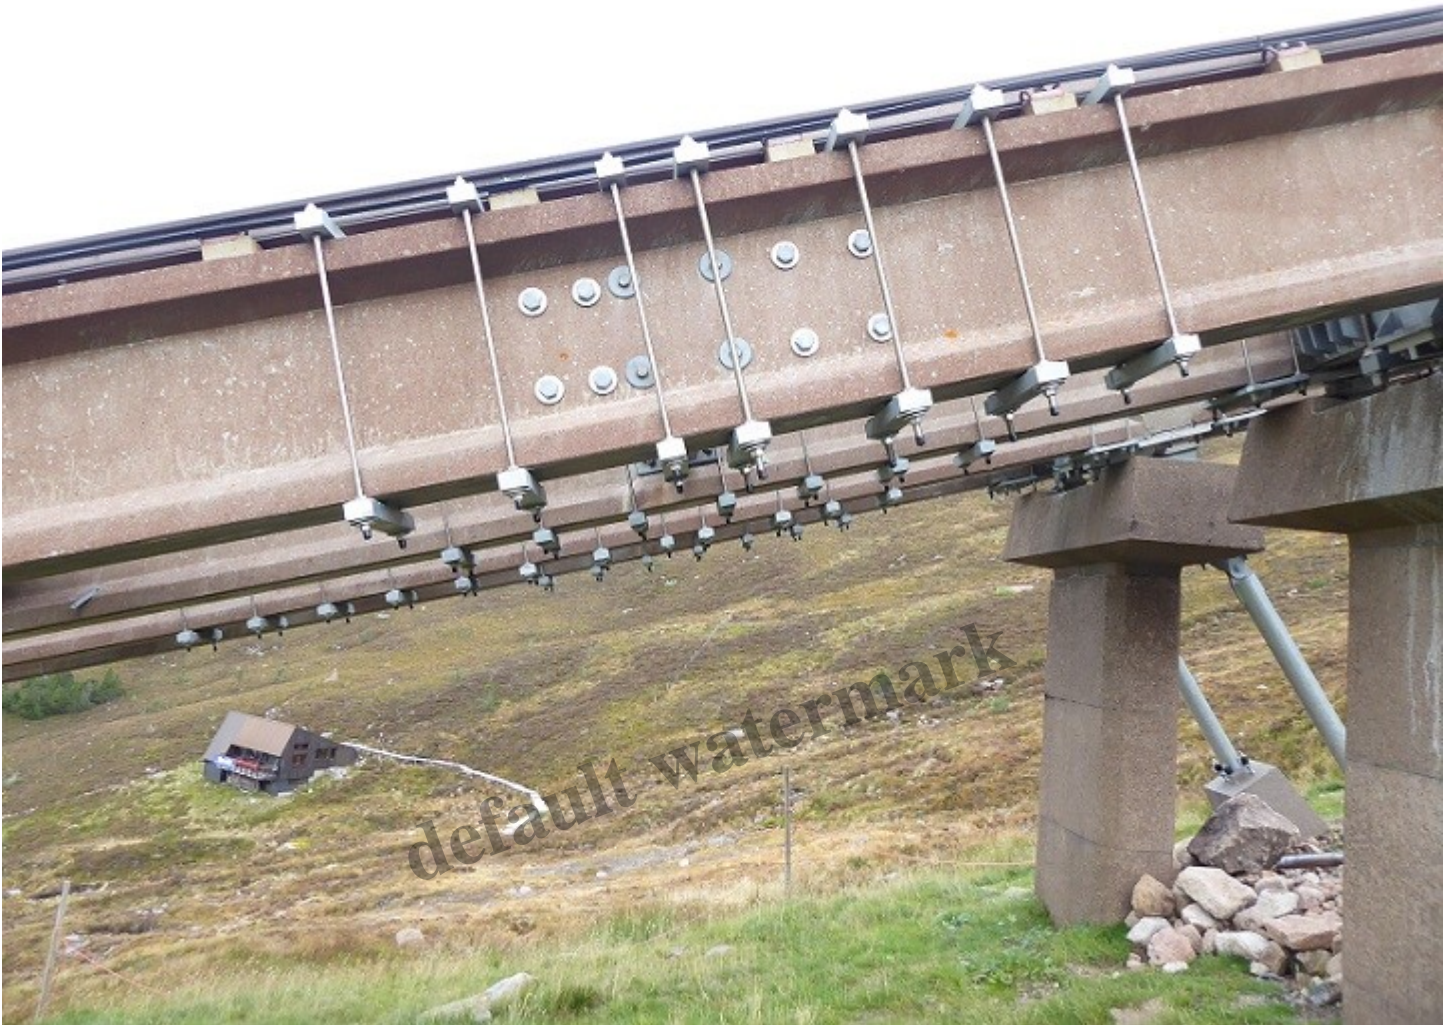
The numbers of brackets used to reinforce the concrete beams varies, as you can see from the photo above. This suggests that the risk of beams breaking up varied and when to use them was a finely judged exercise (easy to get wrong)

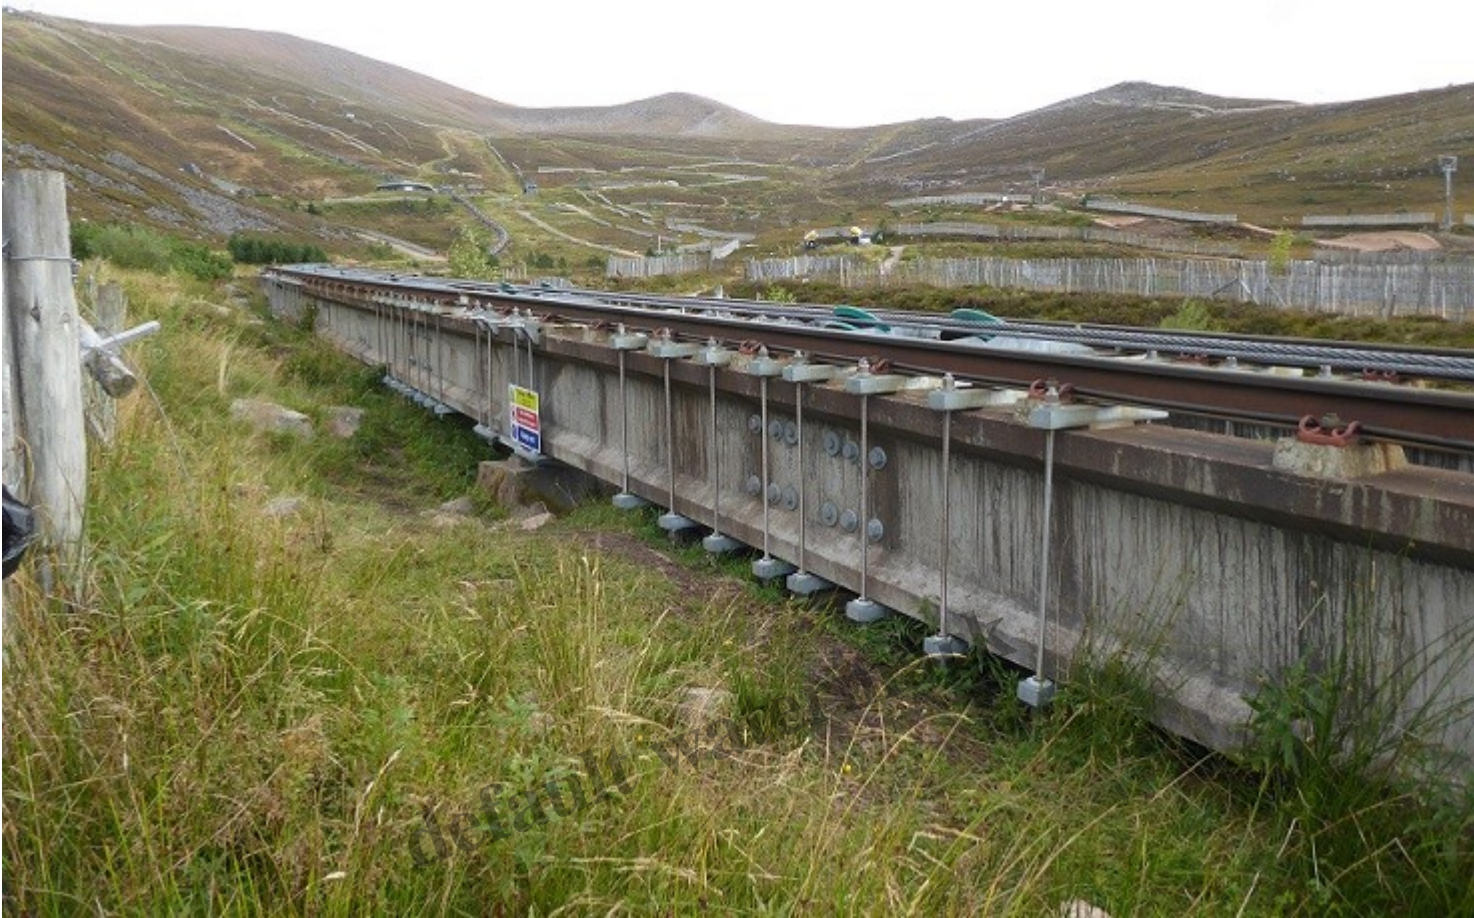
However, there are also brackets around beams on the lower section of straight horizontal track. This suggests that some of the beams may have been breaking up under their own weight.
