HIE's decision to close the Cairn Gorm funicular again (3)

(A) The steel strengthening brackets

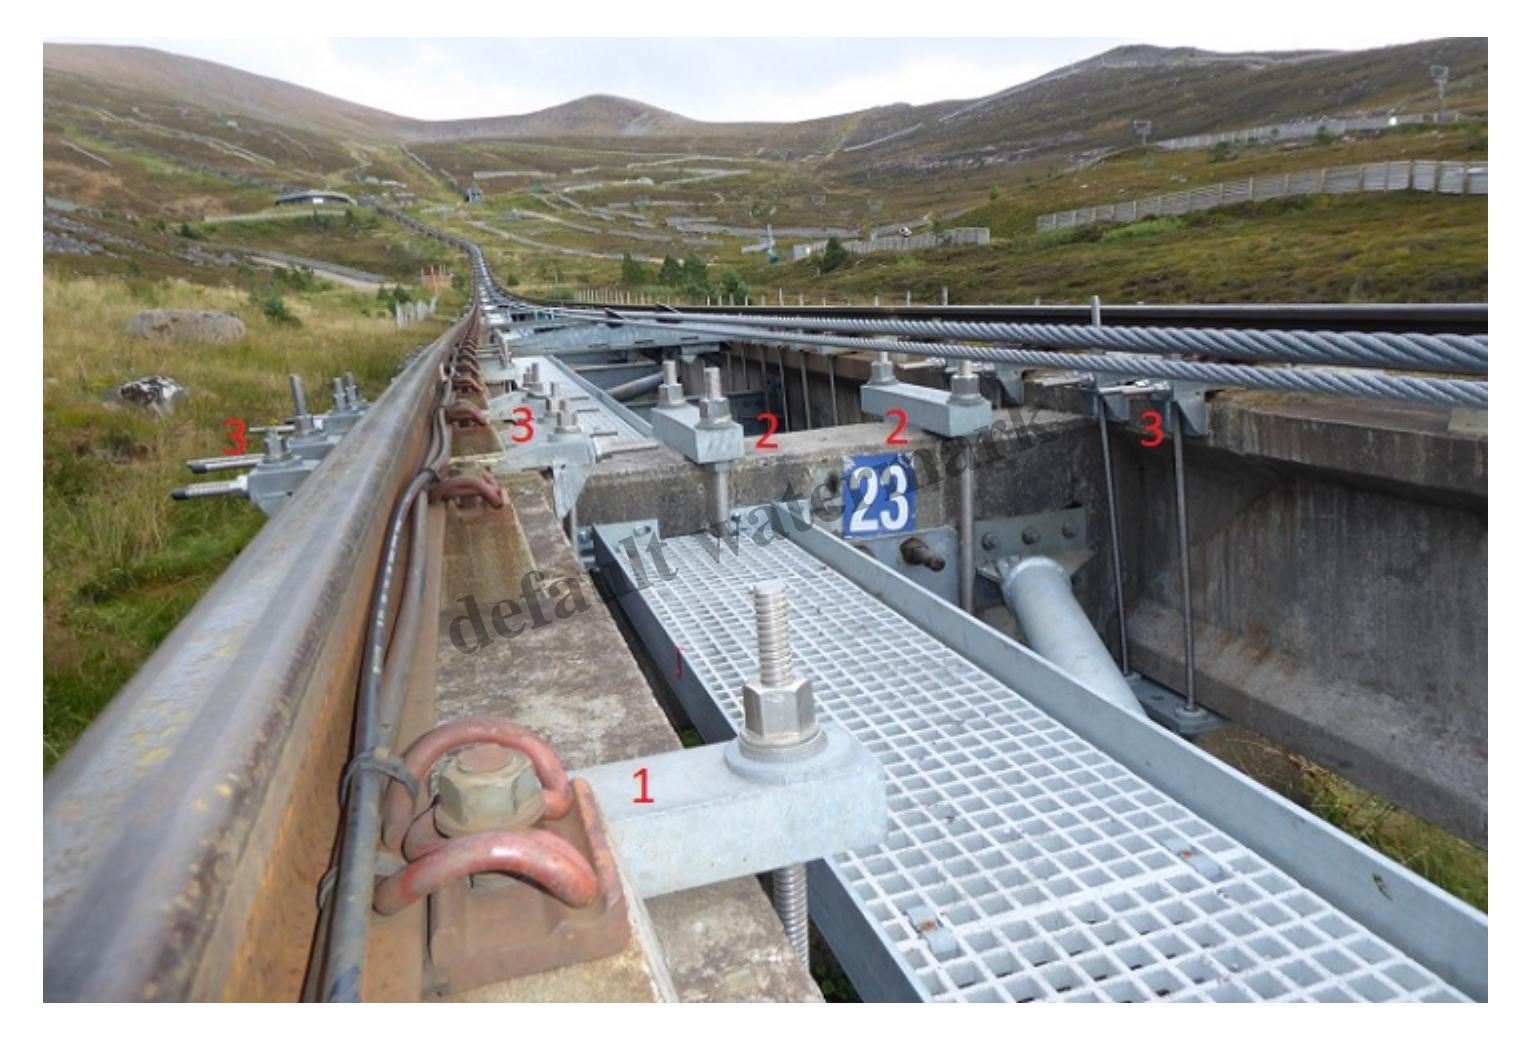
This picture shows the three different types of bracket used in the strengthening works.

- Type 1. The bracket in the foreground (used in the central section of the "I" beam
- Type 2. The brackets around the insitu block either side of the number 23
- Type 3. The brackets around the scarf joint, more clearly seen on the right of the next picture.

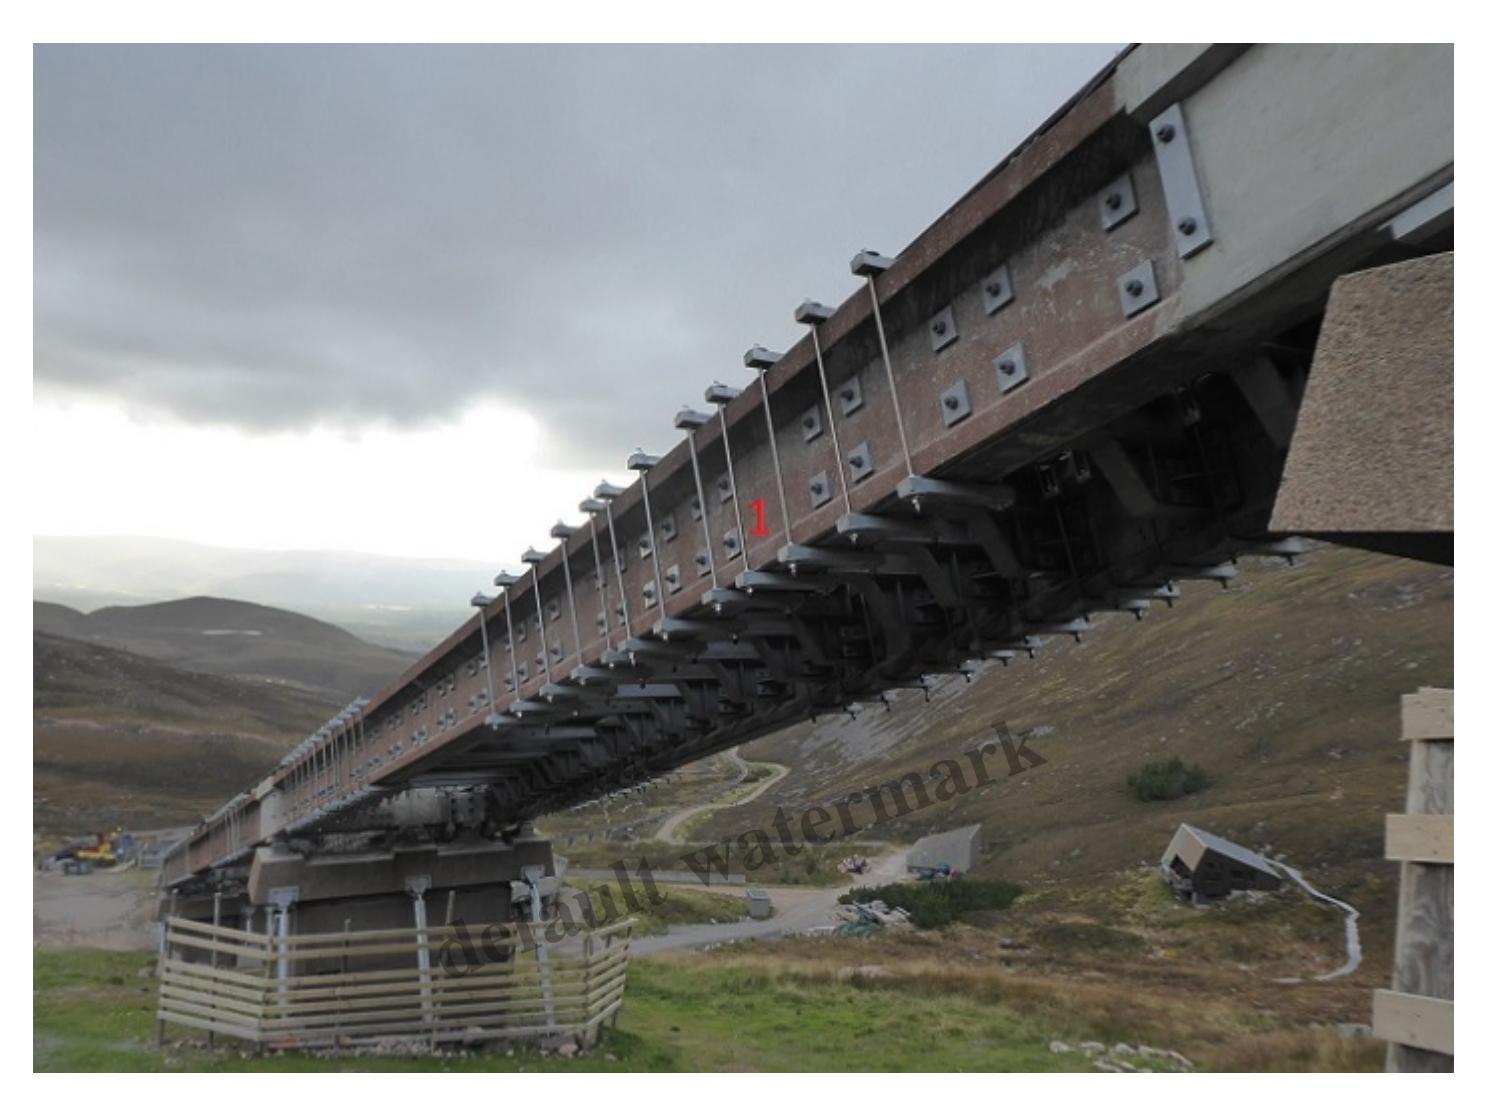
with this next one taken in September 2023:

That is a massive quantity of steelwork that has been added.

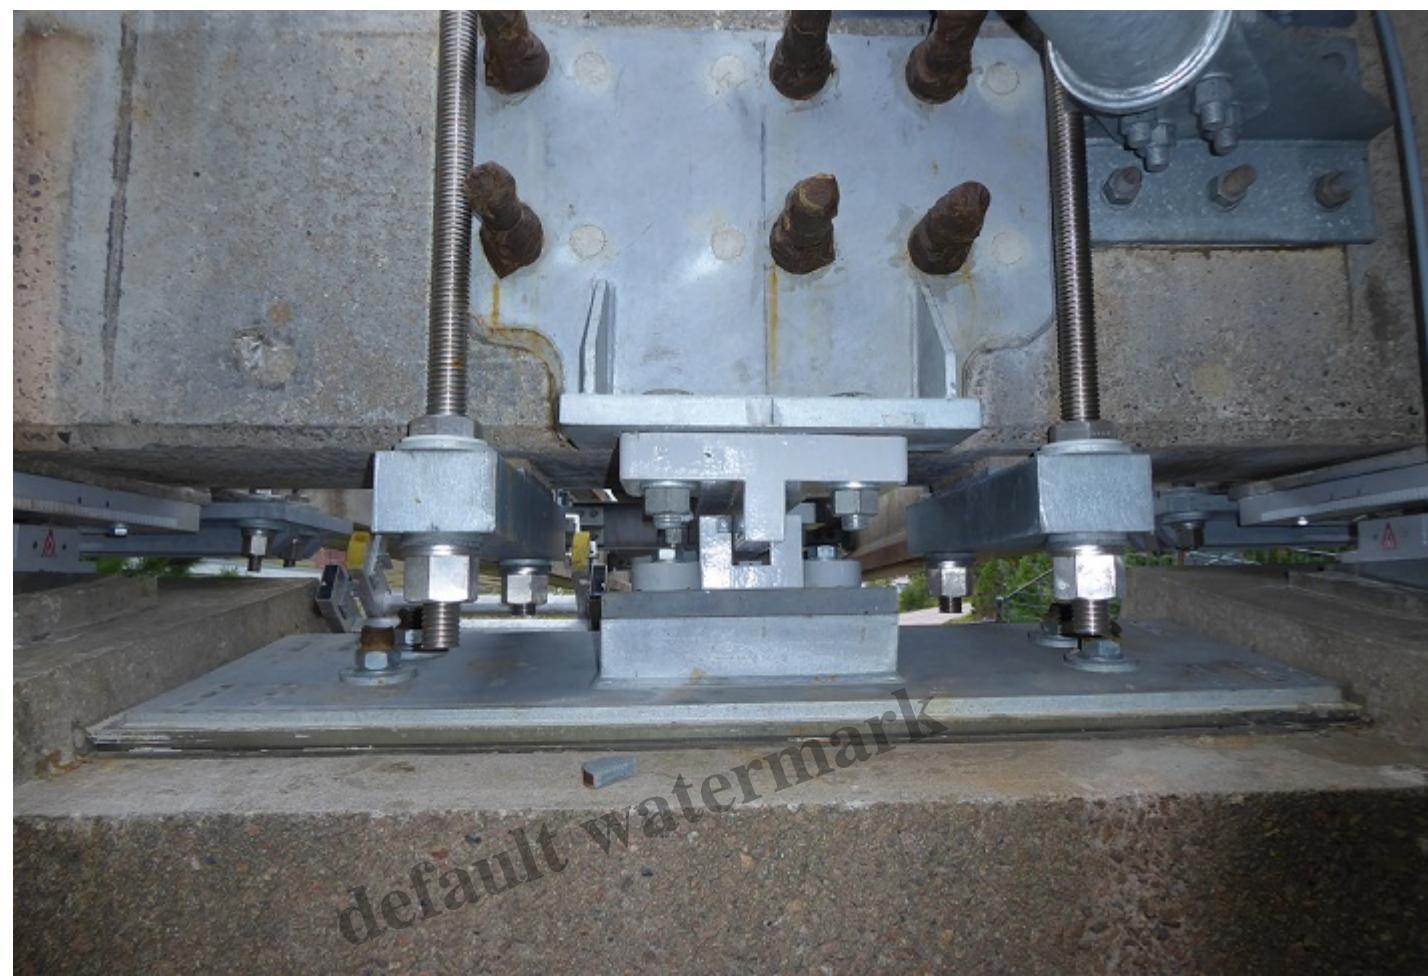
Central bearing with in situ block above and new brackets on each side

All the in-situ joints, apart from the anchor blocks, have at least two Type 2 brackets whose purpose appears to be to strengthen the block around the new central bearings that have been fitted.

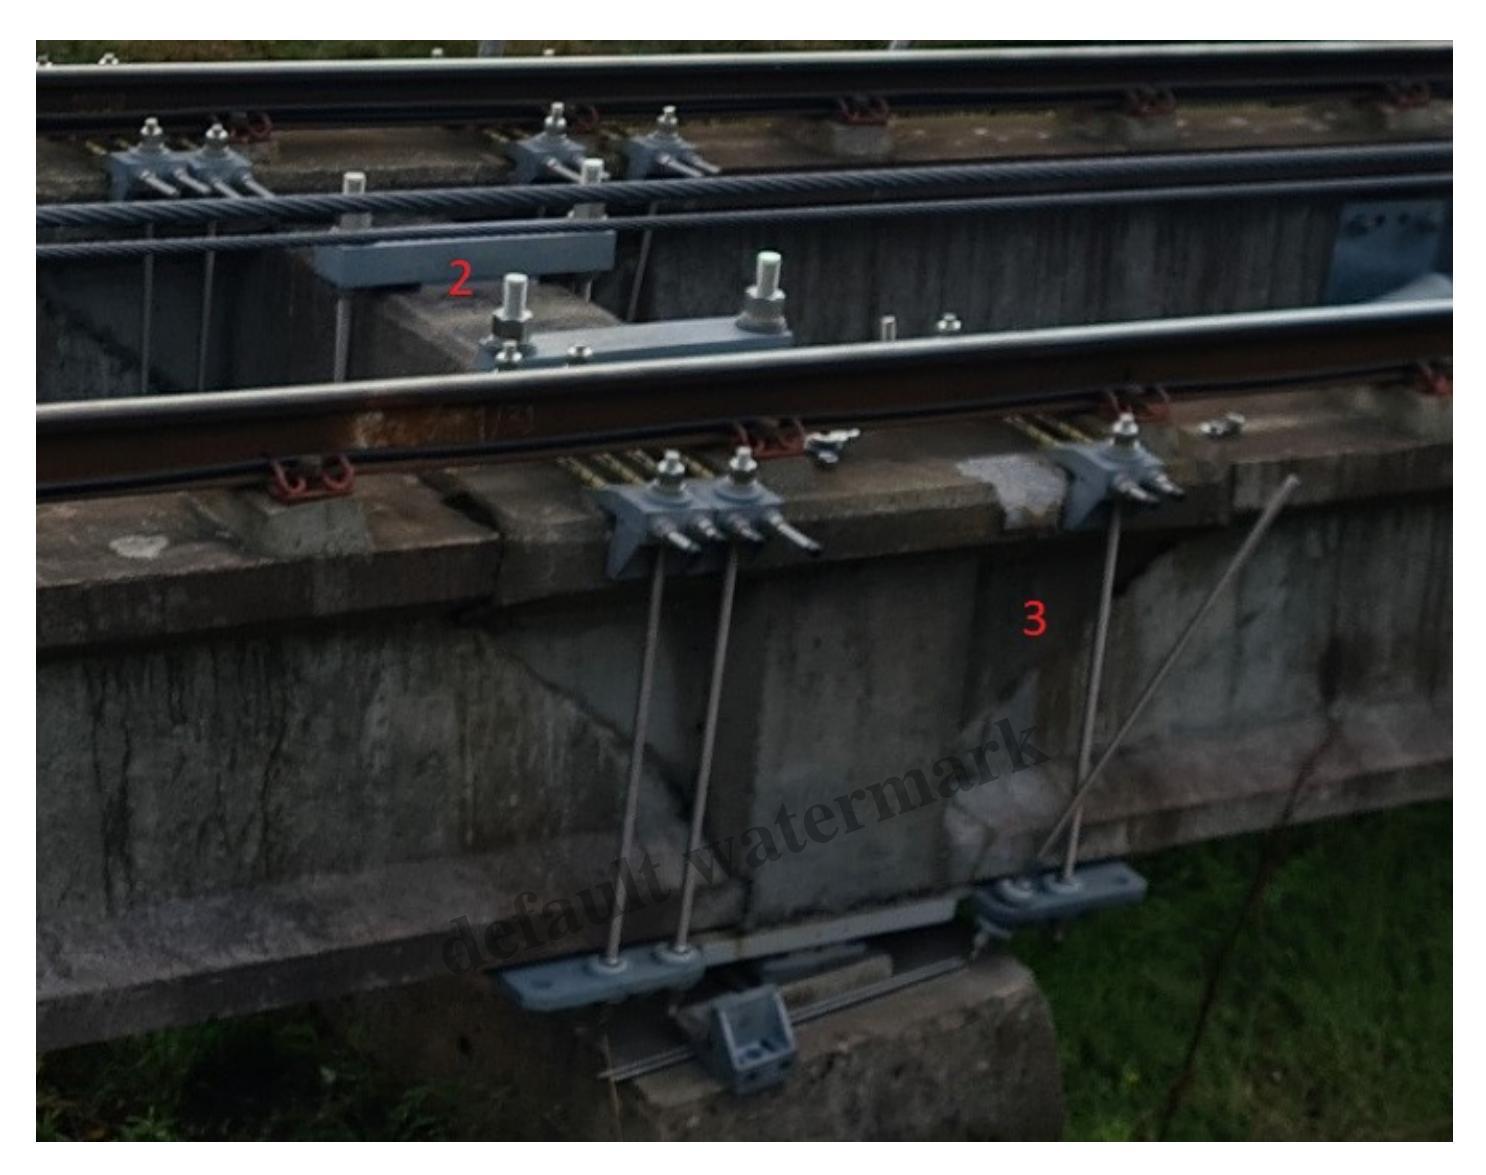
Anyone who has replaced the cylinder head on an engine will know that the cylinder head bolts have a tightening sequence AND gradually increasing torque settings. The reason for this is to ensure even loading on all parts of the cylinder head. The same applies to the brackets on the "I" beams and the insitu blocks but are even more critical on the type 3 brackets fitted to the scarf joints because there are four lengths of studding as opposed to two. One corner could be putting excessive force onto the concrete at that point. Is that what has happened here?

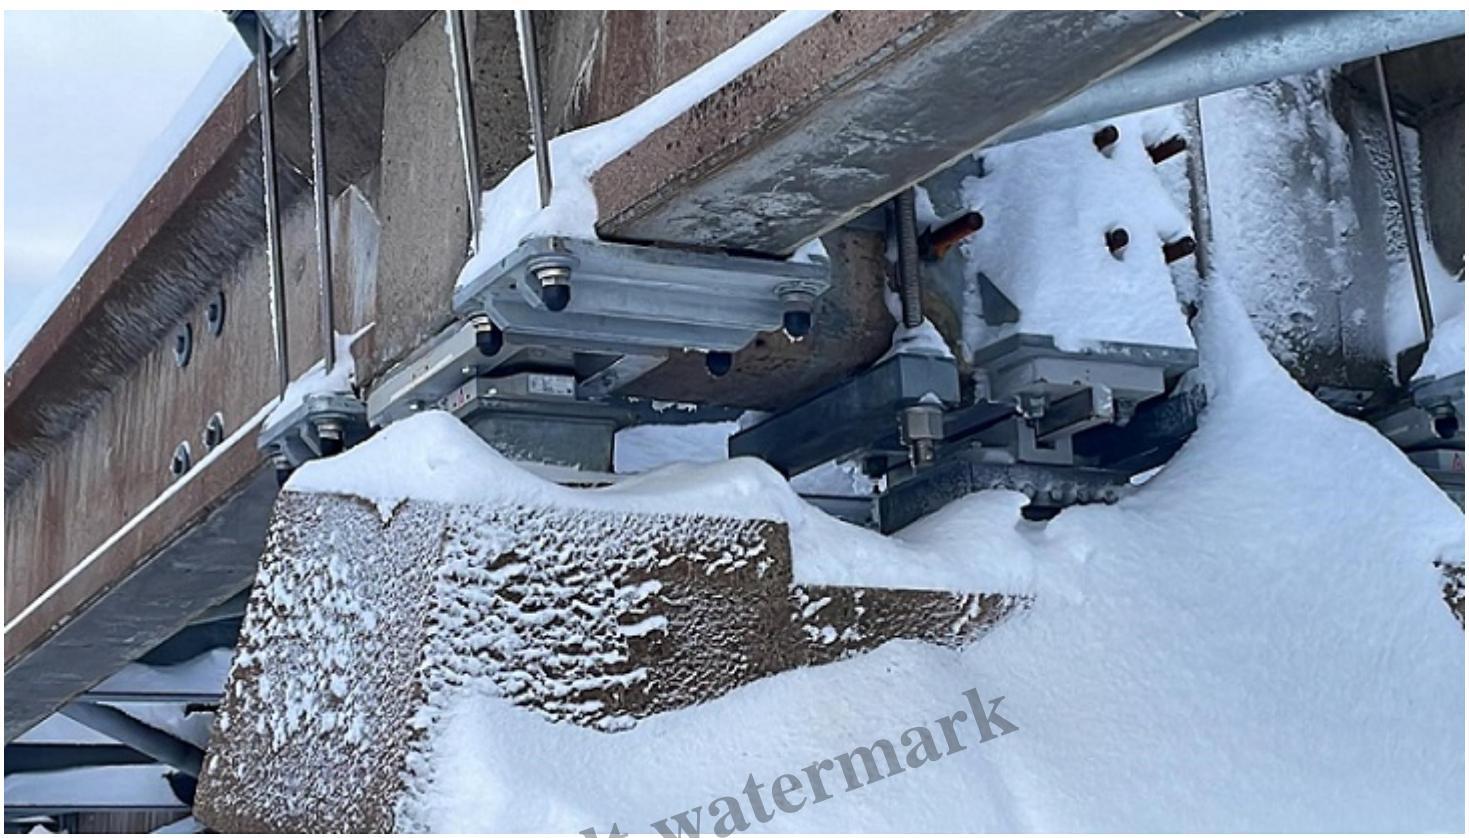
The following picture shows one type of cap as fitted to what I have labeled as a type 3 or scarf joint bracket.

It is used to stop the ingress of water into the threads of the nut/ studding interface which reduces corrosion. The positioning of the caps should therefore have been on the top of all vertical studding NOT the bottom.

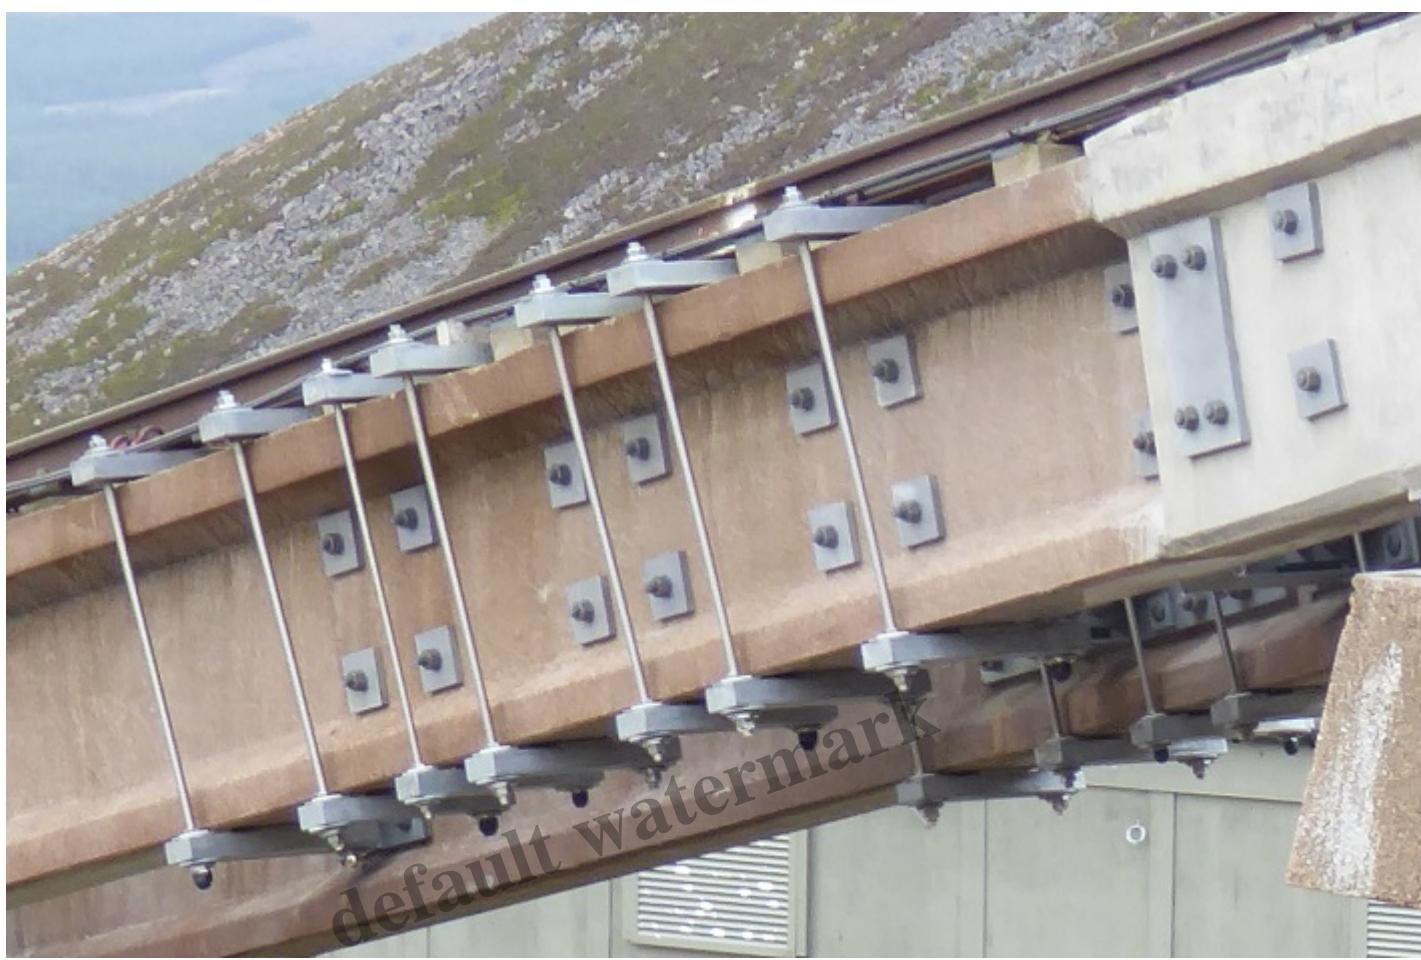
Some caps on bottom, none on top of brackets where most needed!

How many times in the past have we been told about poor workmanship and quality control (see photo above and below)? Did someone not carry enough plastic caps to do the job and forgot to get and fit the extra ones? Has nothing been learned from past mistakes? Apparently not.

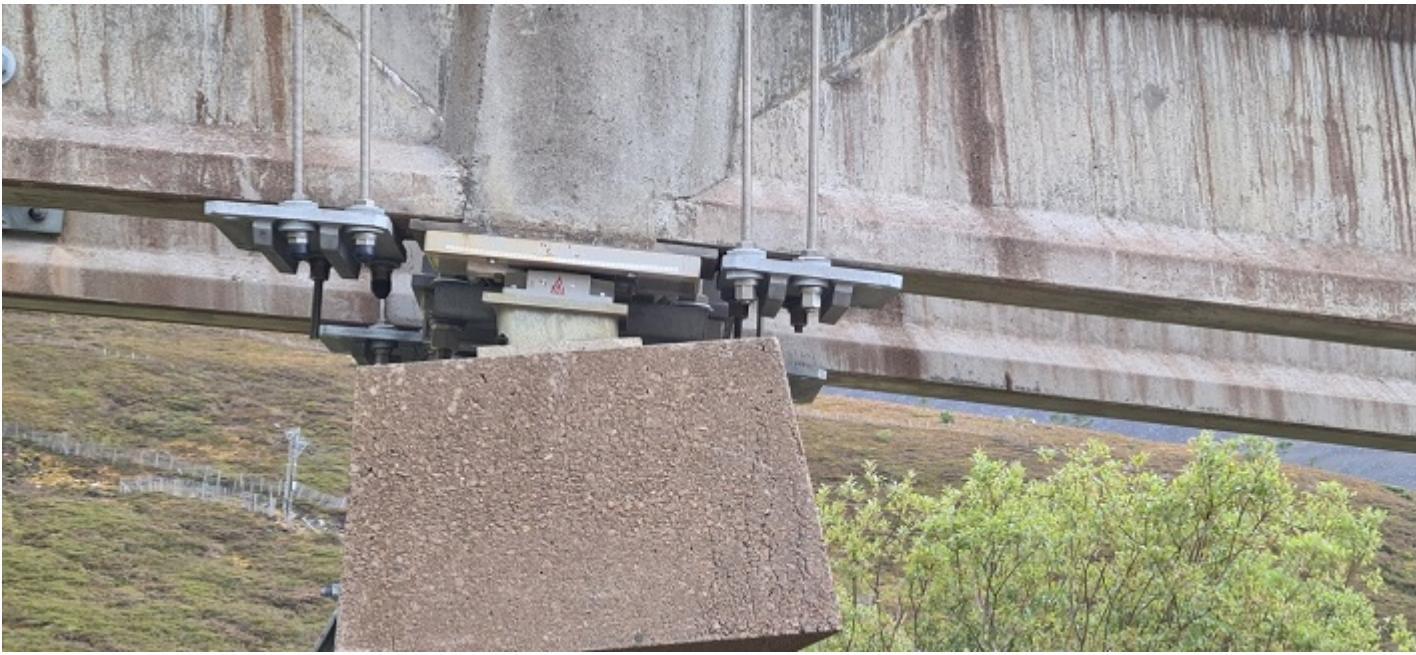
While not that easy to see there are three black plastic caps on the uphill side but none on the downhill side. The protruding stud on the uphill side, a health and safety risk, has not been capped.

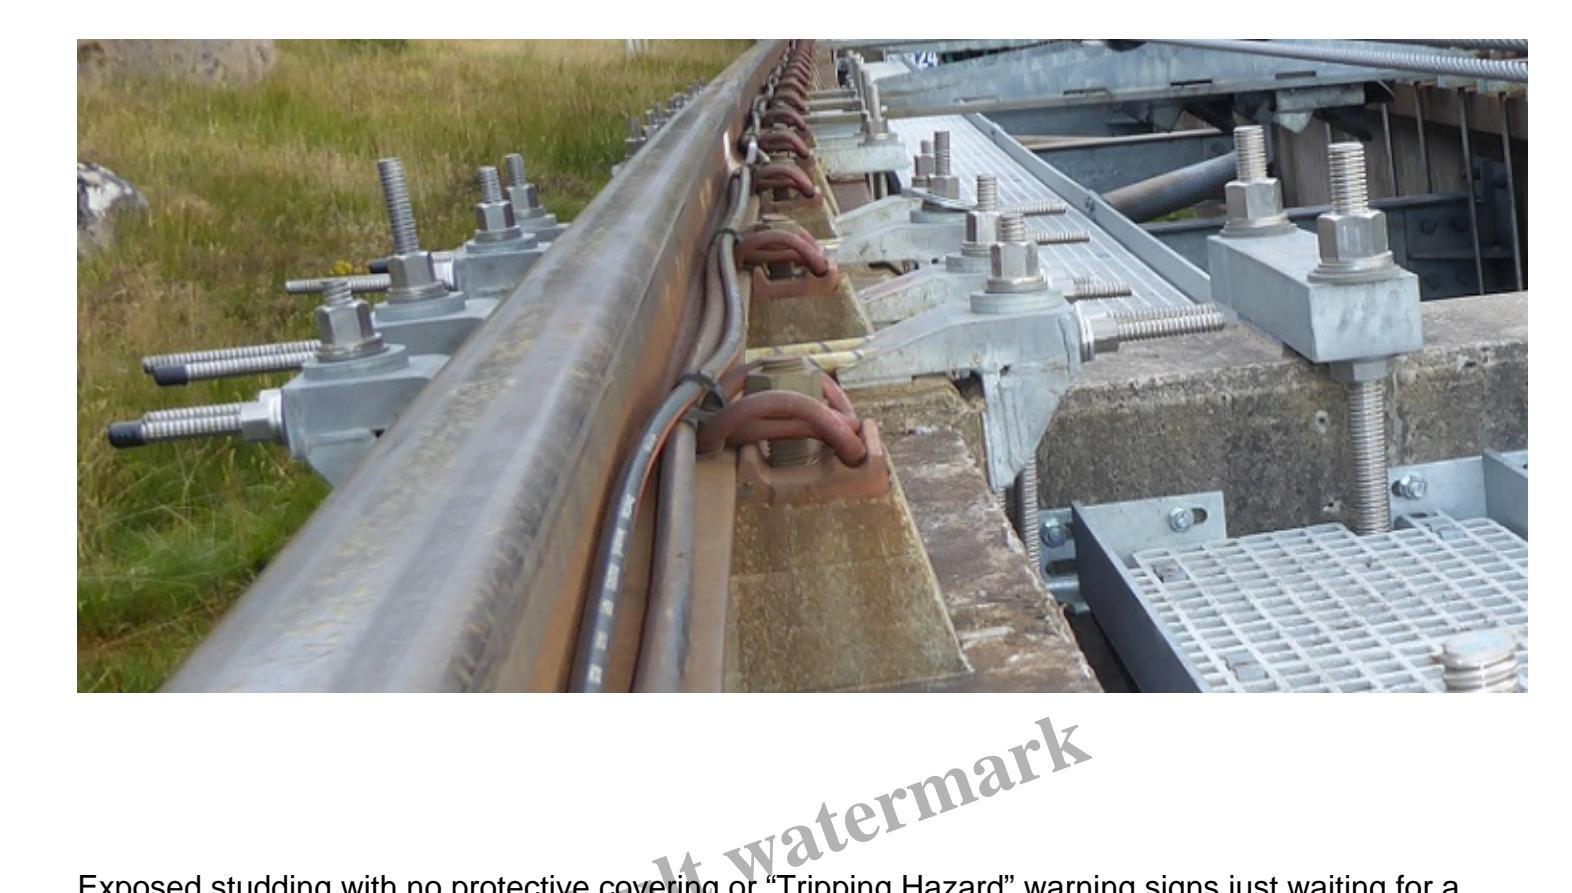
And what about this close up from the top-most photo as another example of poor workmanship/ quality control as well as a H & S risk?

Exposed studding with no protective covering or "Tripping Hazard" warning signs just waiting for a moments lapse in concentration by maintenance staff on the new walkway! All excess lengths of studding should have been cut to less than one nut length above/ beyond the nut. Or a better idea, why not order the correct length in the first place instead of paying for material that is not needed?
