# Concrete and its use on the funicular

## Description

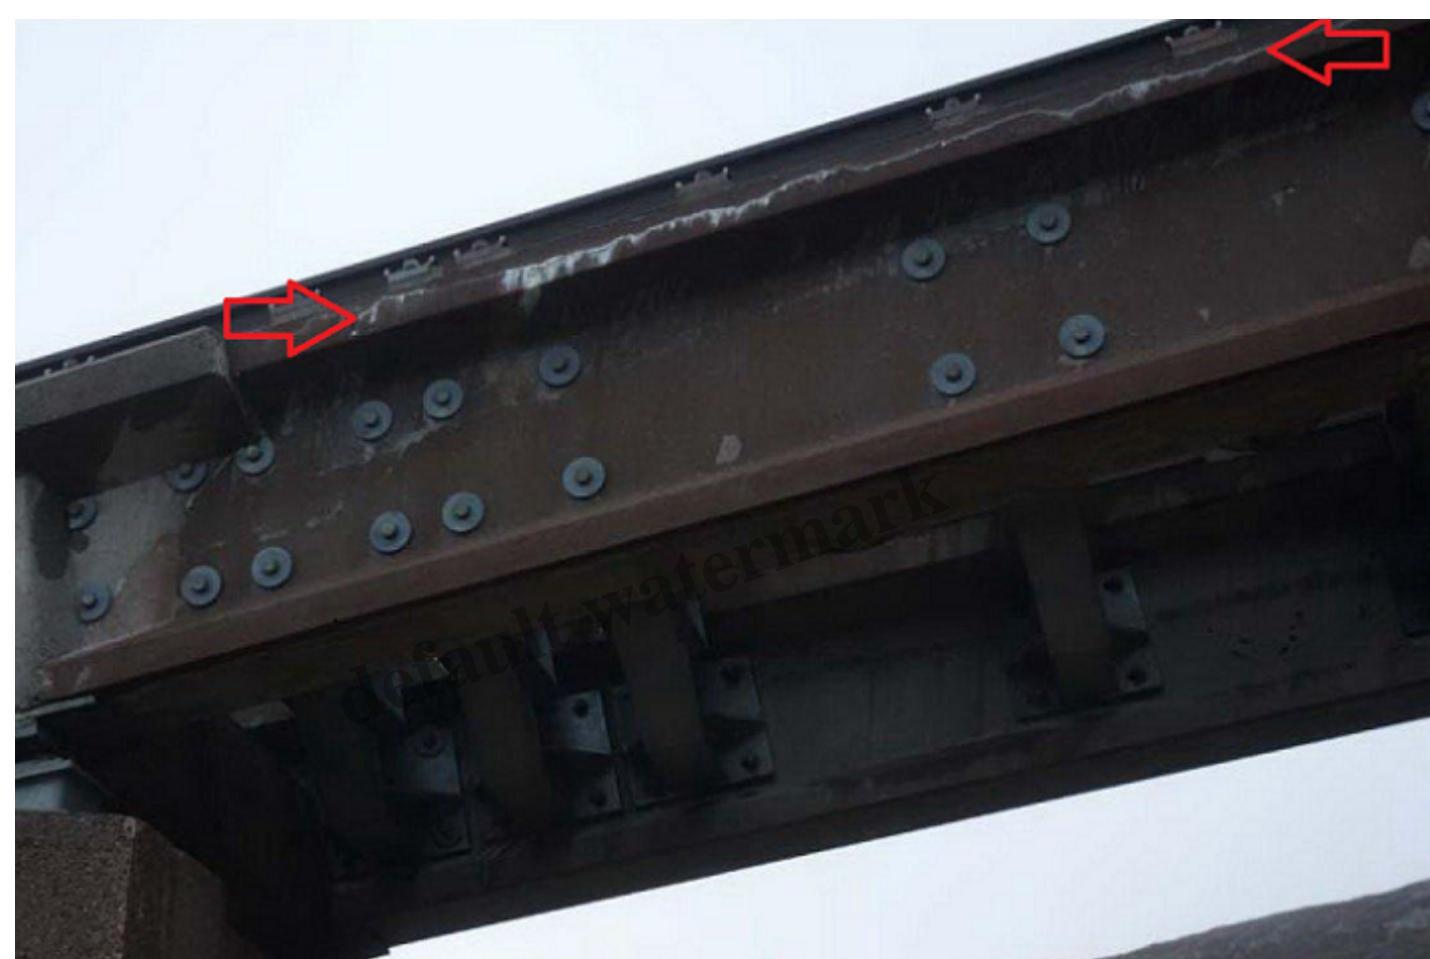
The right hand "I" beam, looking uphill, just above Pier 51 (bottom left) showing the calcite bleed and crack running along the flange (arrow). The left hand arrow is just to the right of the insitu joint.

"2.2 A crack was clearly seen running along the length of the beam positioned at about mid height of the top flange. It appeared to extend from the lower end up to about mid span. See appendix B for a sketch and photo showing this.

- The writer has been carrying out annual inspections for the last three years. This feature was observed for the first time during last year's inspection.
- The crack is evident on both sides of the beam at the same height and over the same length.
- The crack is particularly evident due to calcite bleed, showing up white. This was seen as significant at the low end, diminishing along the length."

This crack was *"observed for the first time"* in the 2016 inspection when it was described as being a few cms. long. By the 2017 inspection it had increased to almost 9m! That is more than a crack, it is the top layer of concrete above the reinforcing rebars inside the beam delaminating. Was this caused by water ingress and rusting of the rebar at the insitu joint?

"5.2 It is thought that the problem is a latent defect within the original fabrication of the beams, most likely due to a cold joint within the concrete pour".

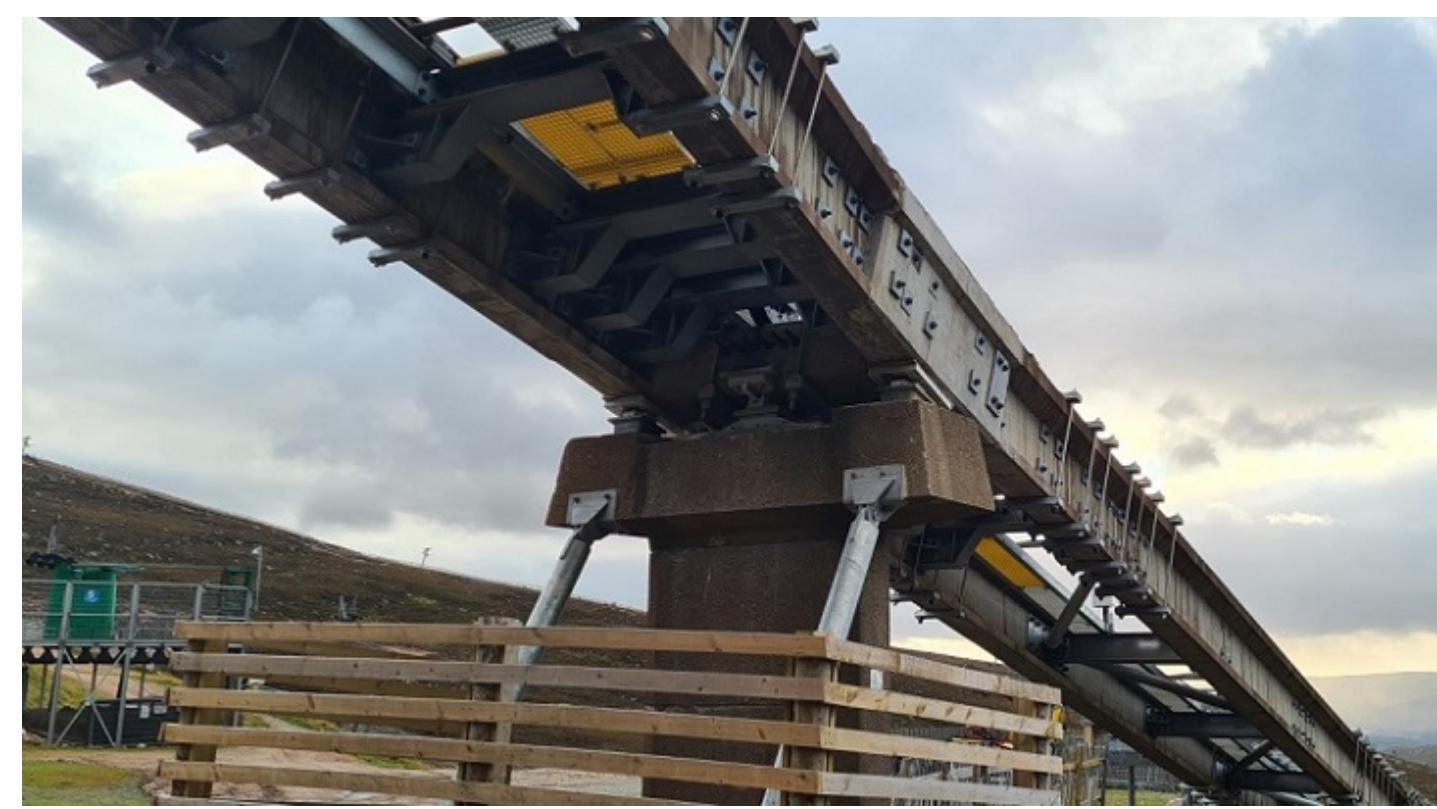
Pier 51 viewed from the north side, looking downhill, showing the new rectangular section of

concrete at the insitu joint. Note the absence of scaffolding. September 2023.

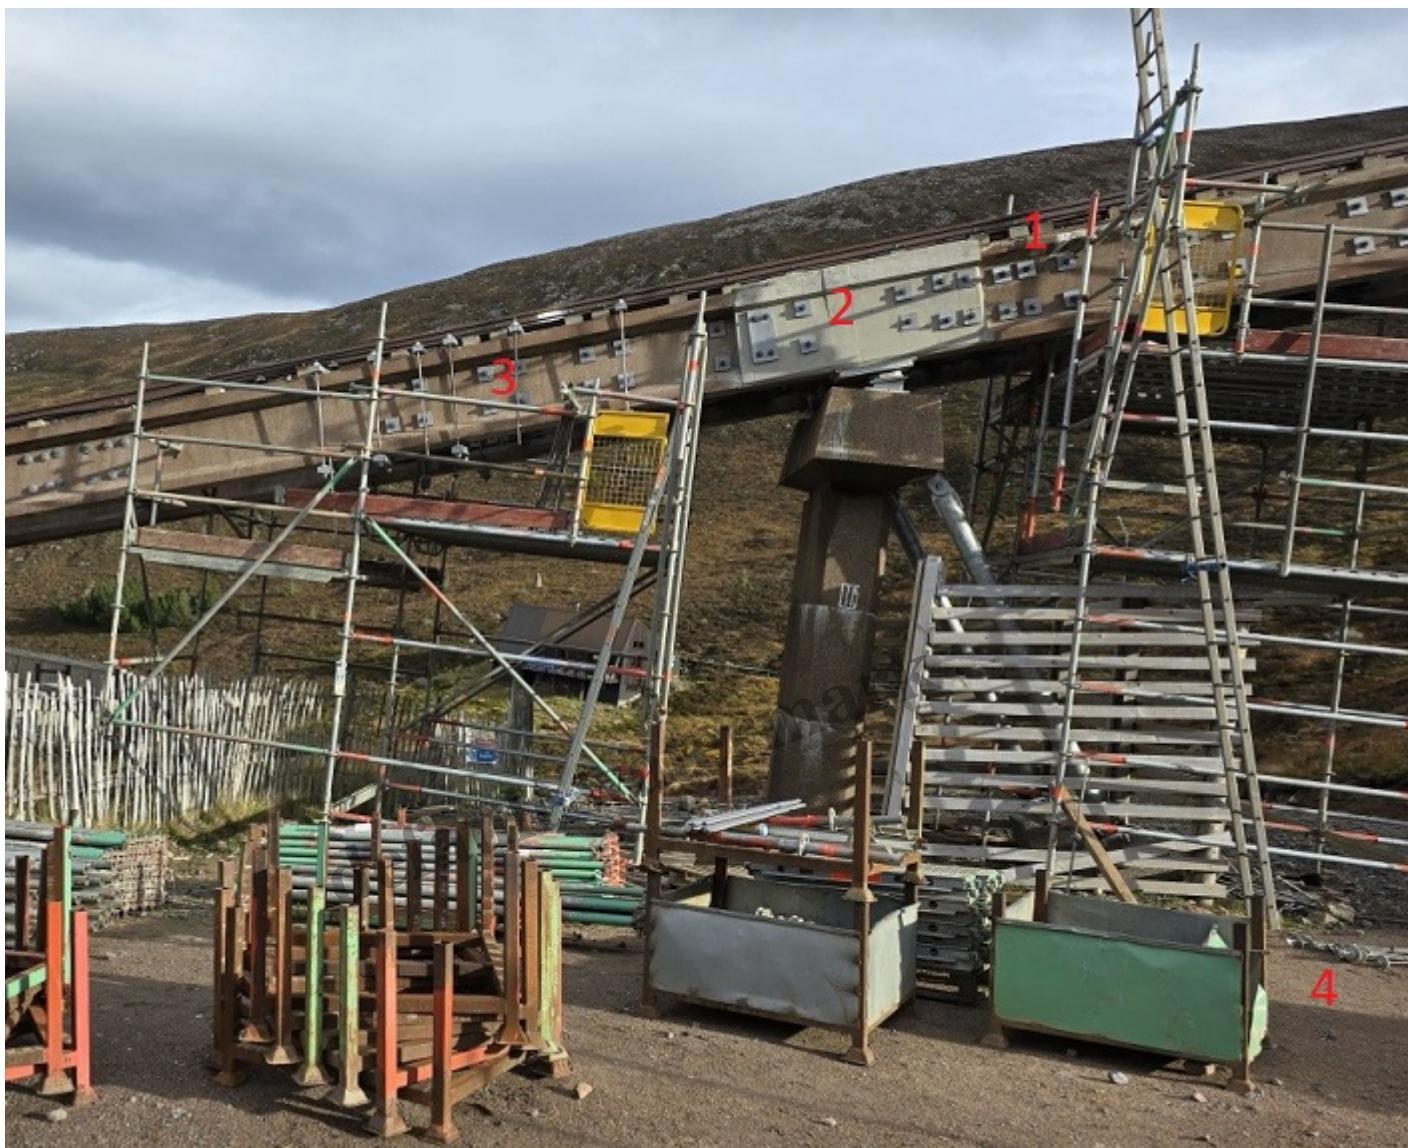
Pier 51 view from the south side October 2024. (1) shows the location of the calcite bleed and crack, (2) the extended insitu joint, (3) metal brackets hanging loose on the beam and (4) metal brackets lying on the ground:

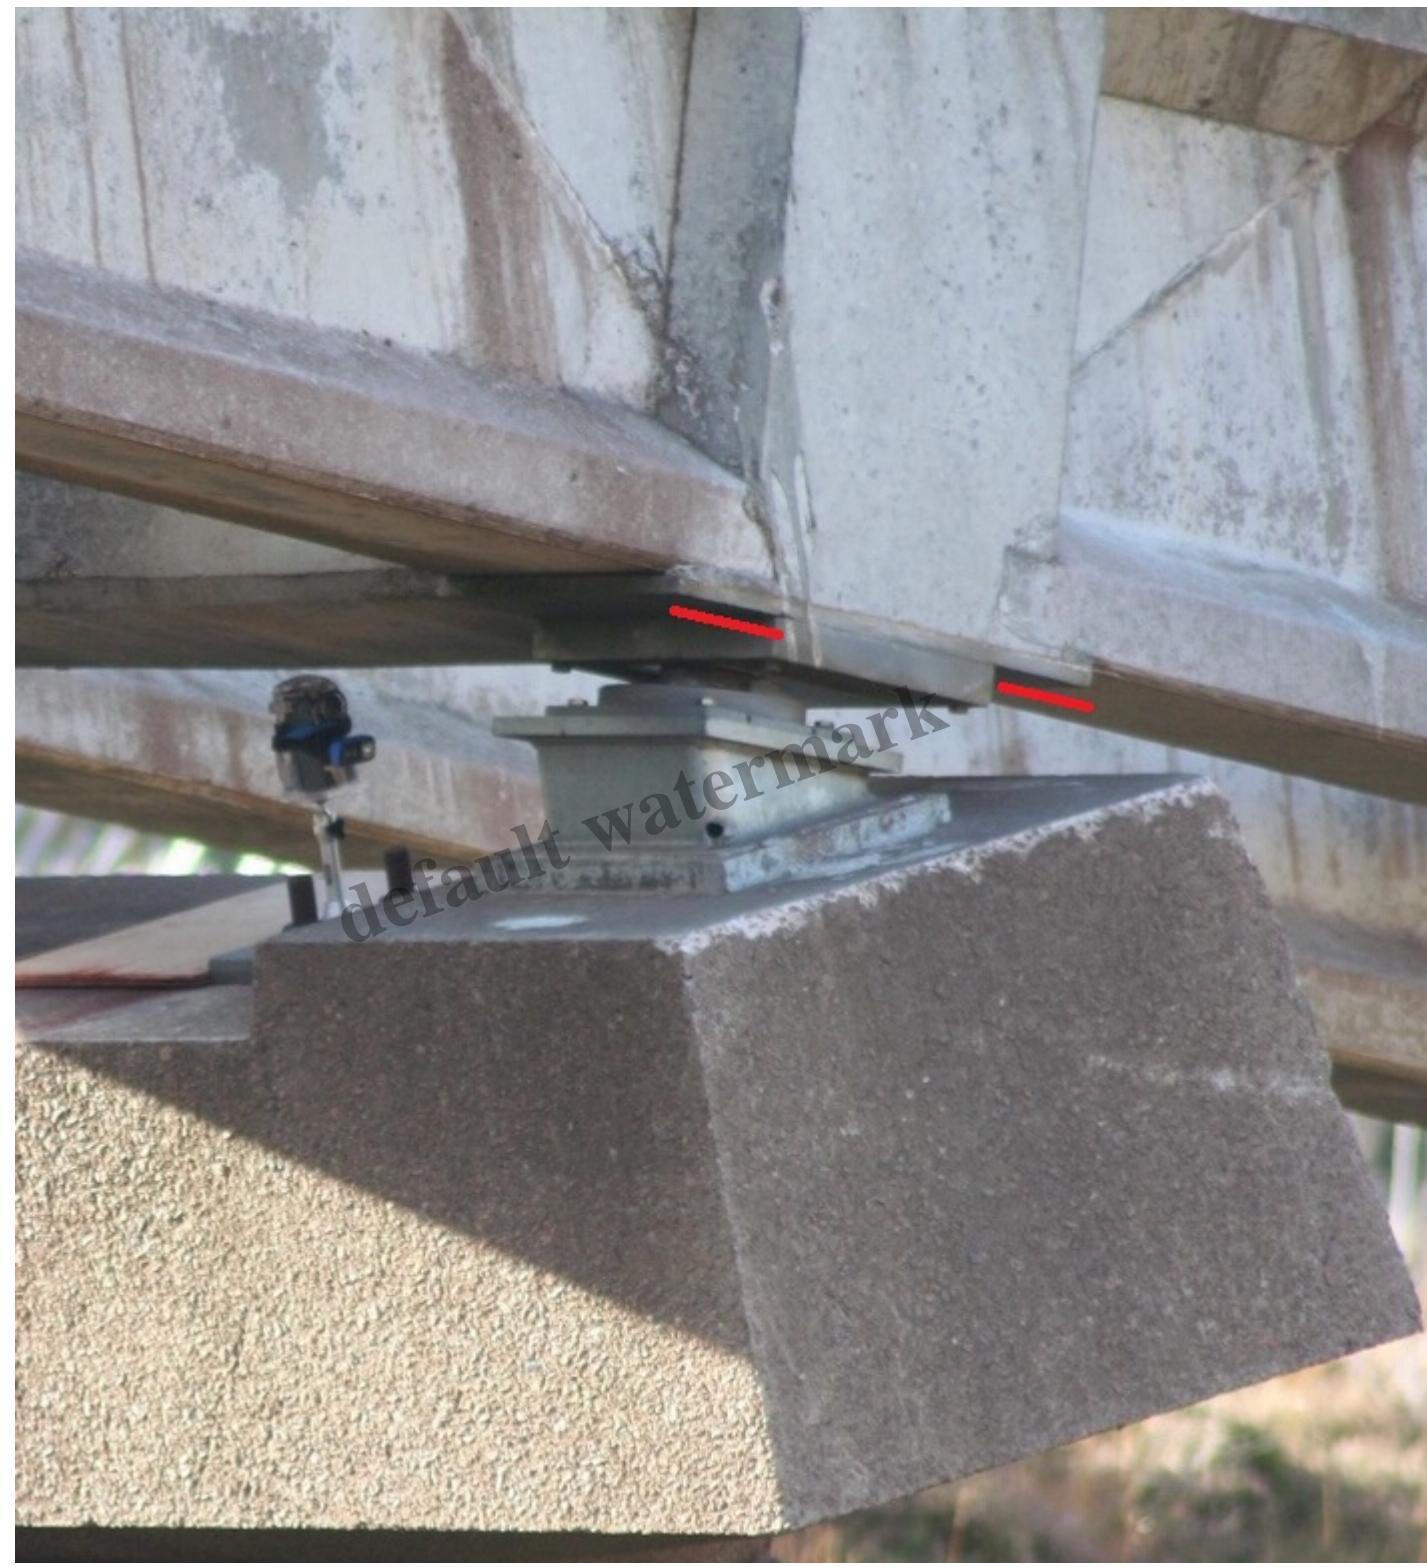
The plate supporting the end of the beams

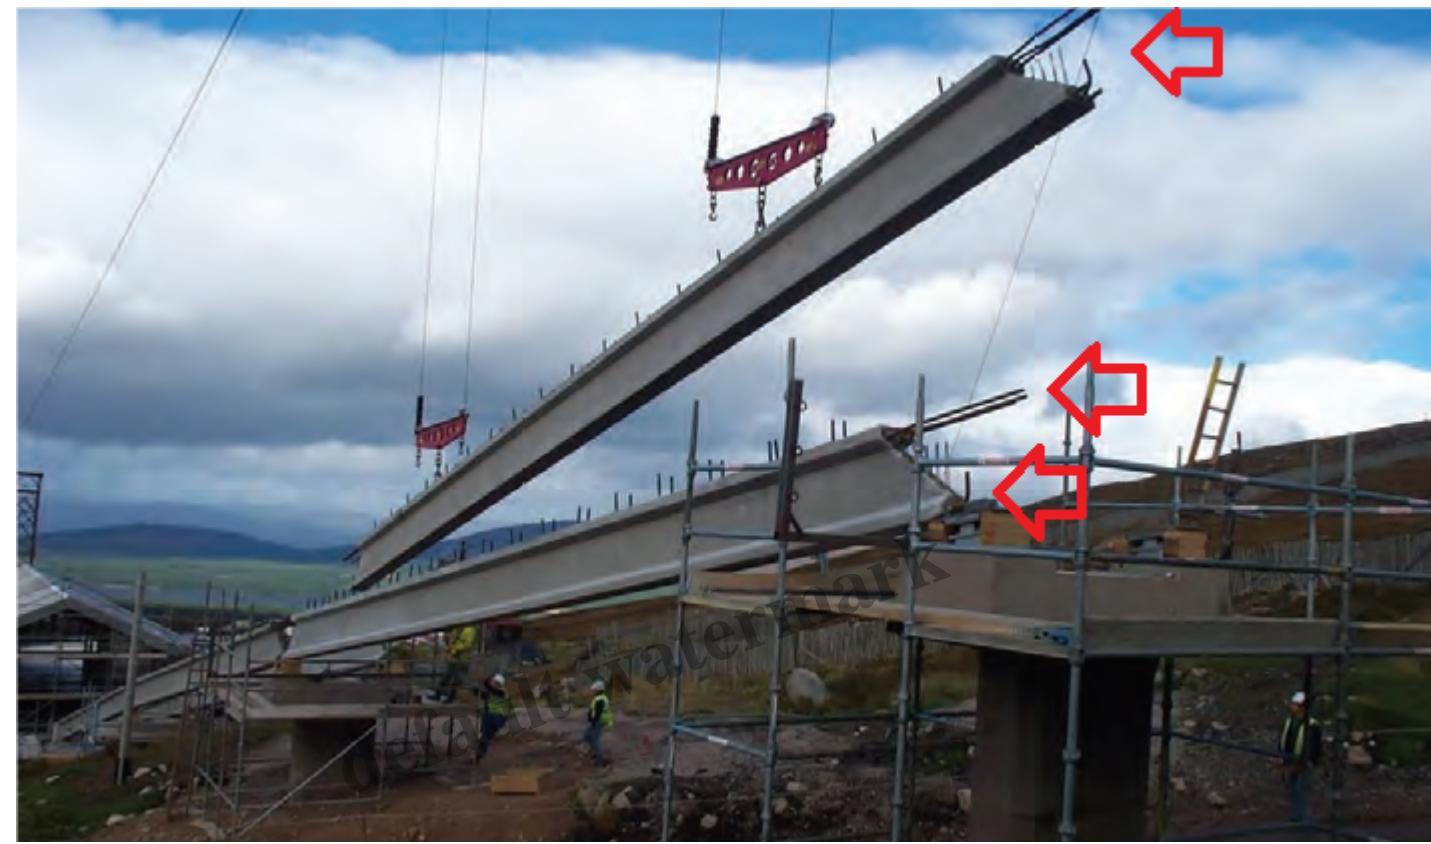
Figure 3-1 Precast beam installation from Cowi Report showing protruding rebars

The picture below shows the rebar protruding from the concrete. The lengths of rebar protruding from the top flange were used to connect one "I" beam to the next and hold them in place:
