Is a thunderbolt about to finish the funicular pantomime?

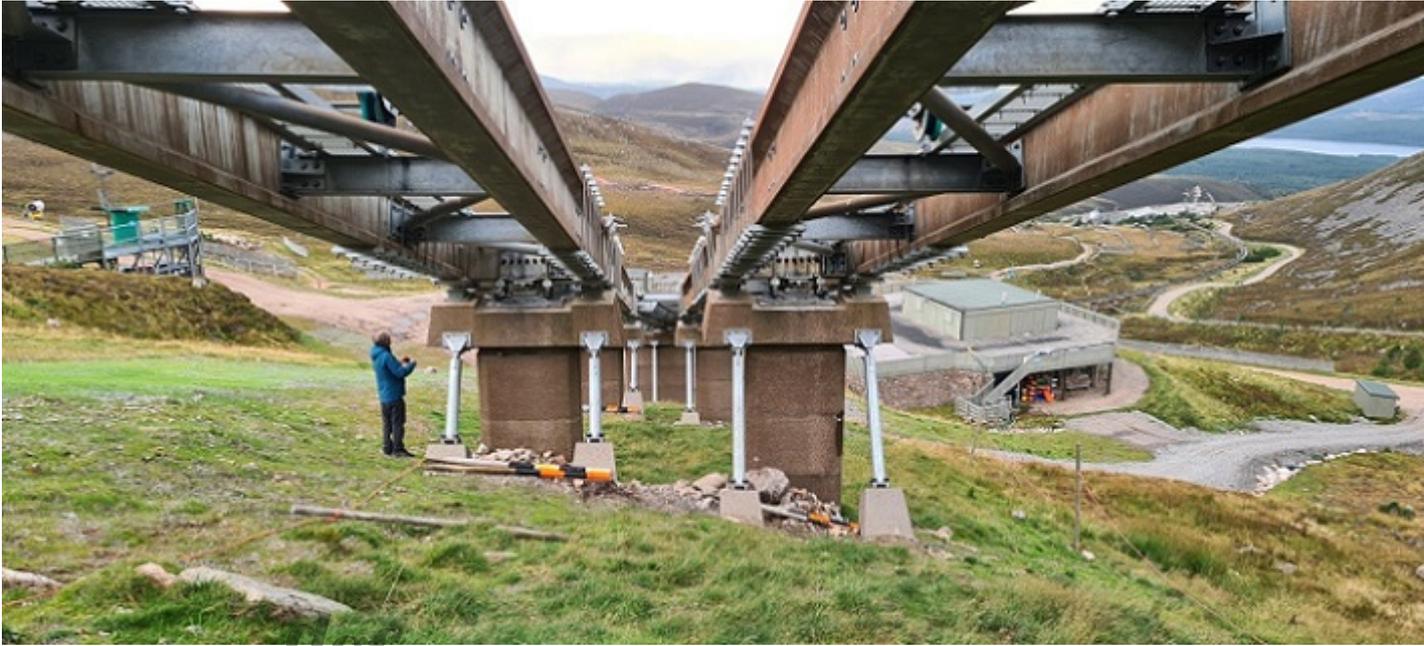
When lightning strikes a building it very rarely causes major damage because of the use of lightning conductors, but in the case of the funicular it would appear that the use of suitable conductors has been missed and there is certainly no earth bonding between every metal component! This has been raised with HIE and Cairngorm Mountain (Scotland) Ltd whose response so far is that the funicular rails were earthed in the bottom and top stations. That fails to address the issues being raised.

The repairs have involved the additions of multiple separate steel supports and brackets to the existing steel cross members between the concrete beams. Photo credit Gordon Bulloch.

Option 1: link up and then earth all the various bits of steel being used to prop up the structure which is likely to be time-consuming and expensive, or

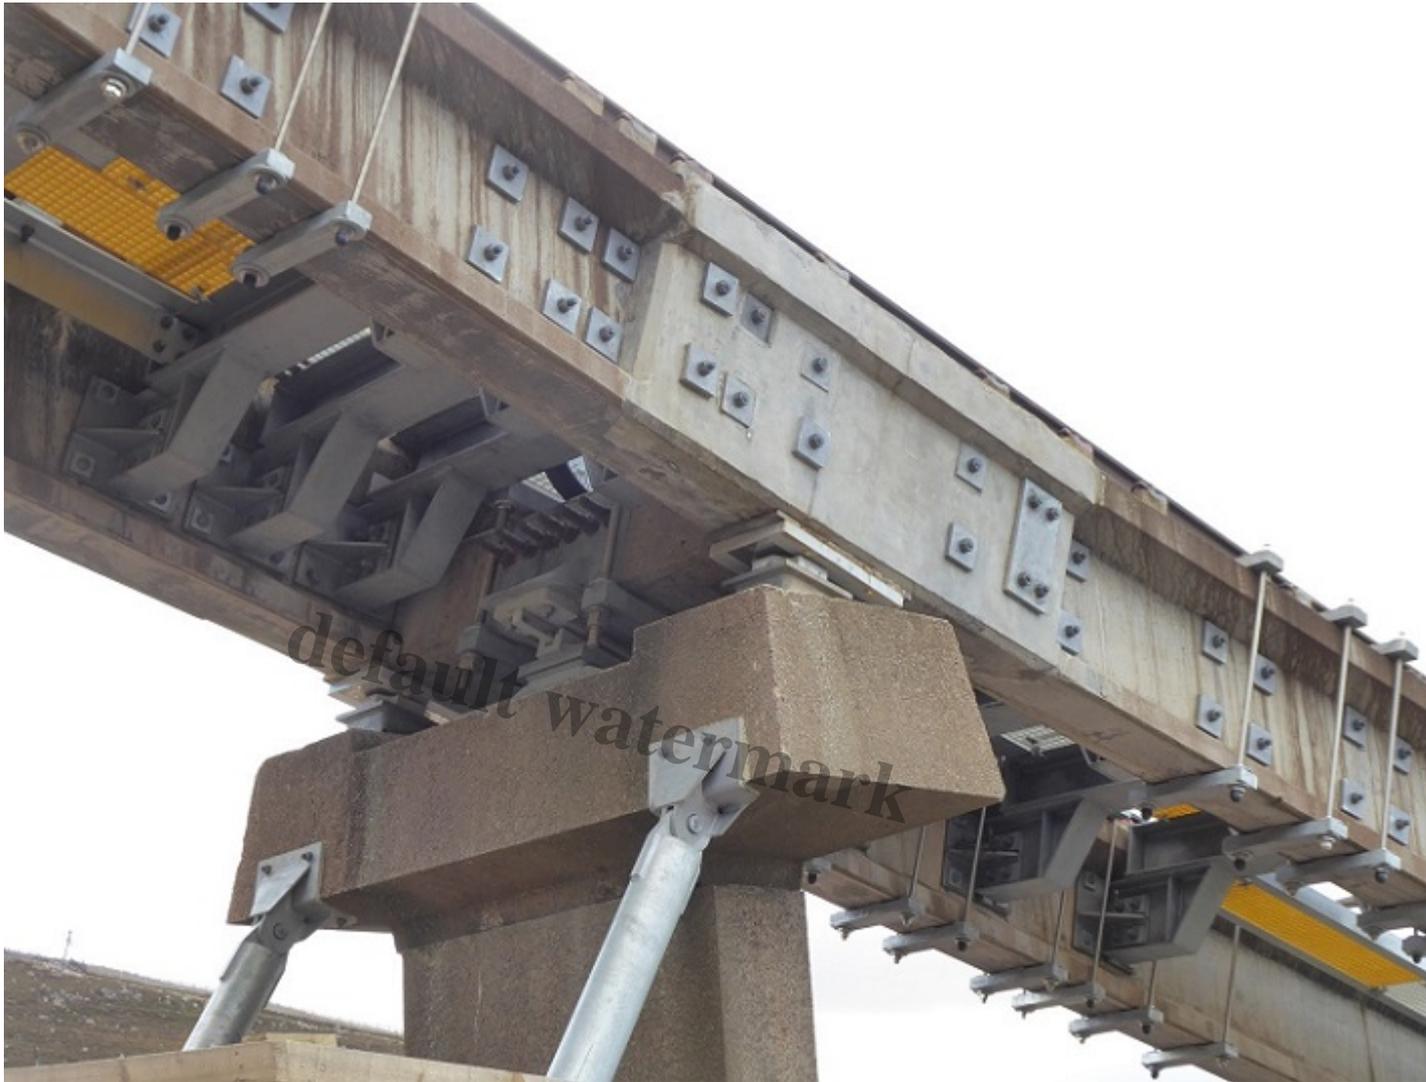
Multiple unearthed steel components. Photo credit Gordon Bulloch.

To determine how much earth bonding is required to make the structure lightning proof, a qualified electrical technician will first have to check for electrical resistance between **every** support bearing, bolt, cross member, plate, strengthening bracket, length of studding, steel prop etc. The plus side is that if the props were used as part of the lightning conductor arrangement, it may be that only the top and bottom of one prop would need to be connected to all the other bits of steel near it with a lightning rod at the bottom.
